**PROJECT MEMORANDUM**  
**PG&E WINDSOR SUBSTATION PROJECT**

**To:** Eric Chiang, Project Manager, CPUC  
**From:** Vida Strong, Aspen Project Manager  
**Date:** December 23, 2016  
**Subject:** Monitoring Report #3 – December 12 to December 18, 2016

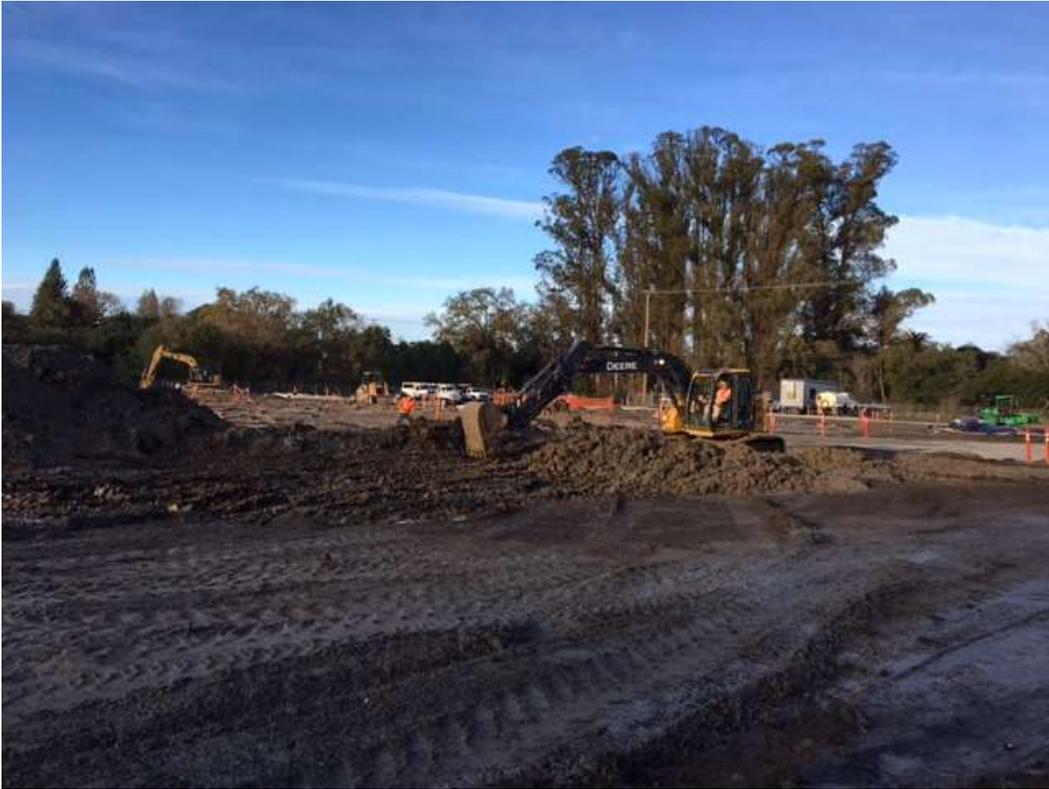
Figure 1 – Excavating soil in central area of substation site, December 12, 2016.

Construction activities occurred Monday and Tuesday, December 12<sup>th</sup> and 13<sup>th</sup>, and included excavating soil from the central trench area for continued addition of base rock (see Figure 1). The excavated soil was stockpiled and covered at the end of the day. On the south side of the site, fences around two of the tree protection zones were relocated to within approximately 3 feet of the existing cyclone fence to enable construction of the substation pad, while protecting the trees. Mirafi fabric was installed, and rock was spread over the fabric to a depth of 6 inches and compacted with vibra plates (see Figure 2).

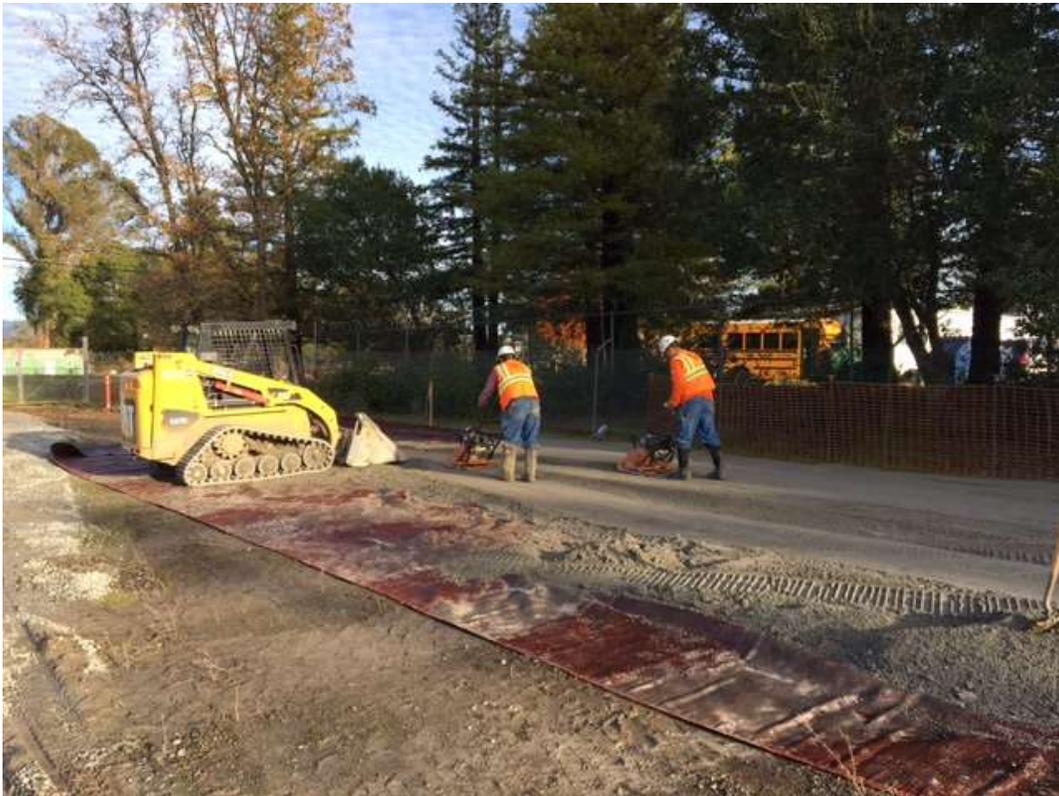
Figure 2 – Compacting base rock on southern side of substation site, December 12, 2016.

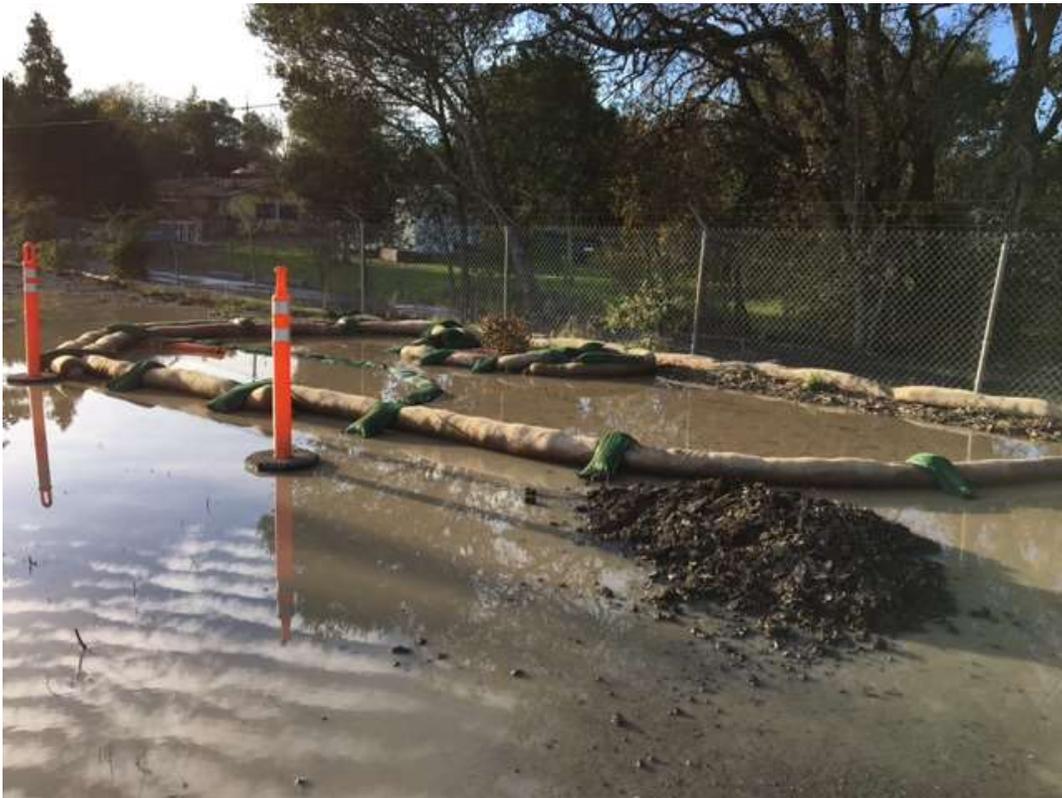
At the time of the CPUC EM's site visit on Wednesday, December 12<sup>th</sup>, crews were excavating soil from the middle of the site, and laying and compacting base rock on the south side of the site. There was a lot of storm water on the site that was flowing towards the drainage inlets and the northern perimeter of the site (see Figure 3). The CPUC EM discussed concerns about turbid water leaving the site with the PG&E Environmental Inspector (EI) and adding BMPs around the two drain inlets on the north side.

Figure 3 – Water flowing to drainage inlets on northern side of substation site, December 12, 2016.

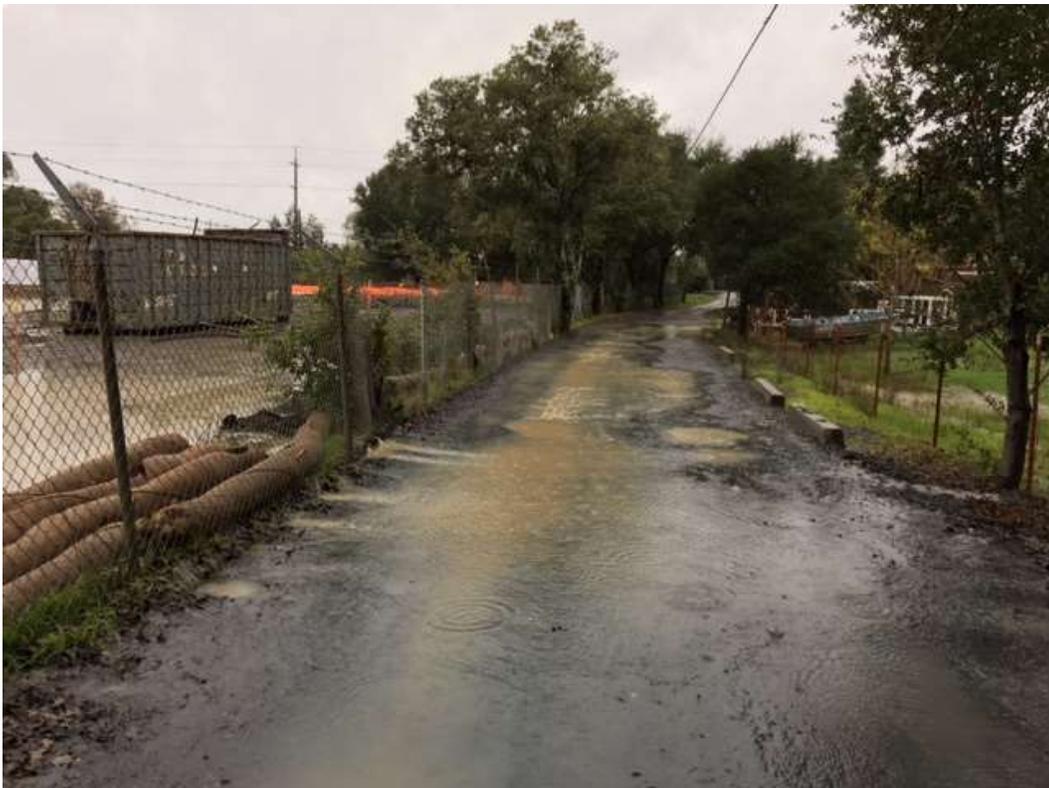
The CPUC EM conducted a site visit of the perimeter of the substation site on Thursday, December 15<sup>th</sup>, a little after 2 pm during the storm event. Even though there was a lot of water that accumulated at the site during the rain event, the BMPs held up fairly well. There was one small area where sediment laden water was leaving the site, crossing Herb Road (see Figure 4), and entering an unnamed ephemeral drainage (see Figure 5) that flows to Sotoyome Creek, which eventually flows to the Russian River.

Figure 4 – Sediment laden water crossing Herb Road, December 15, 2016.

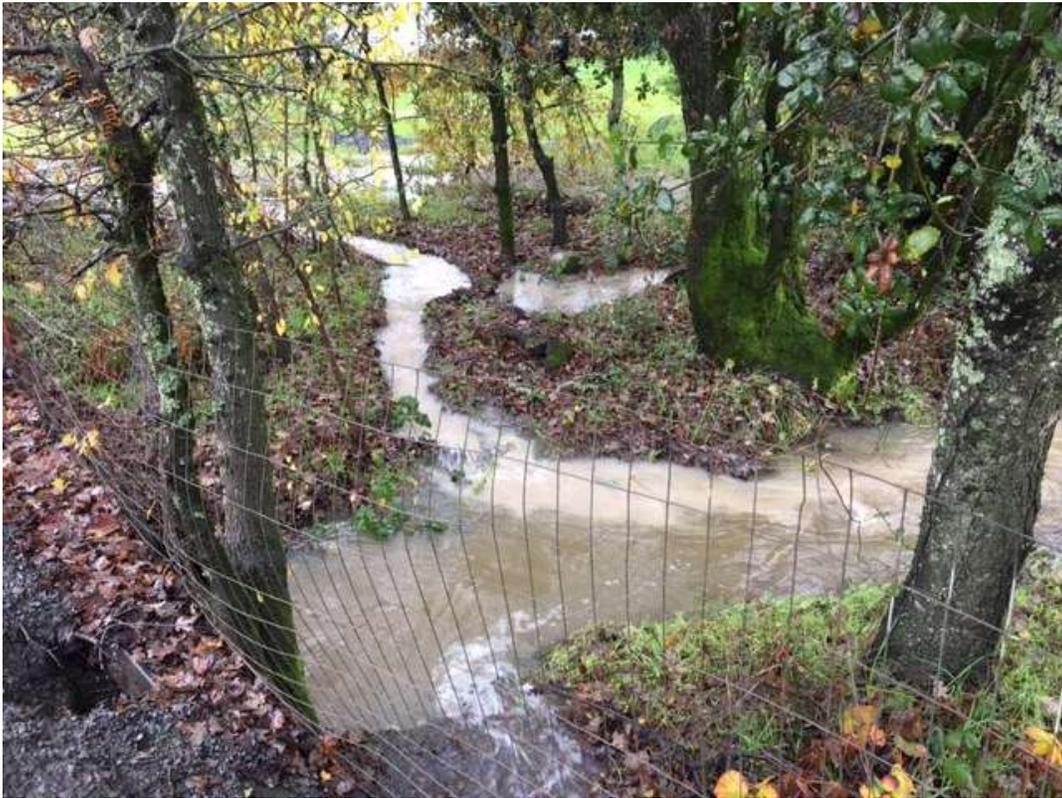
Figure 5 – Sediment laden water entering ephemeral drainage, December 15, 2016.

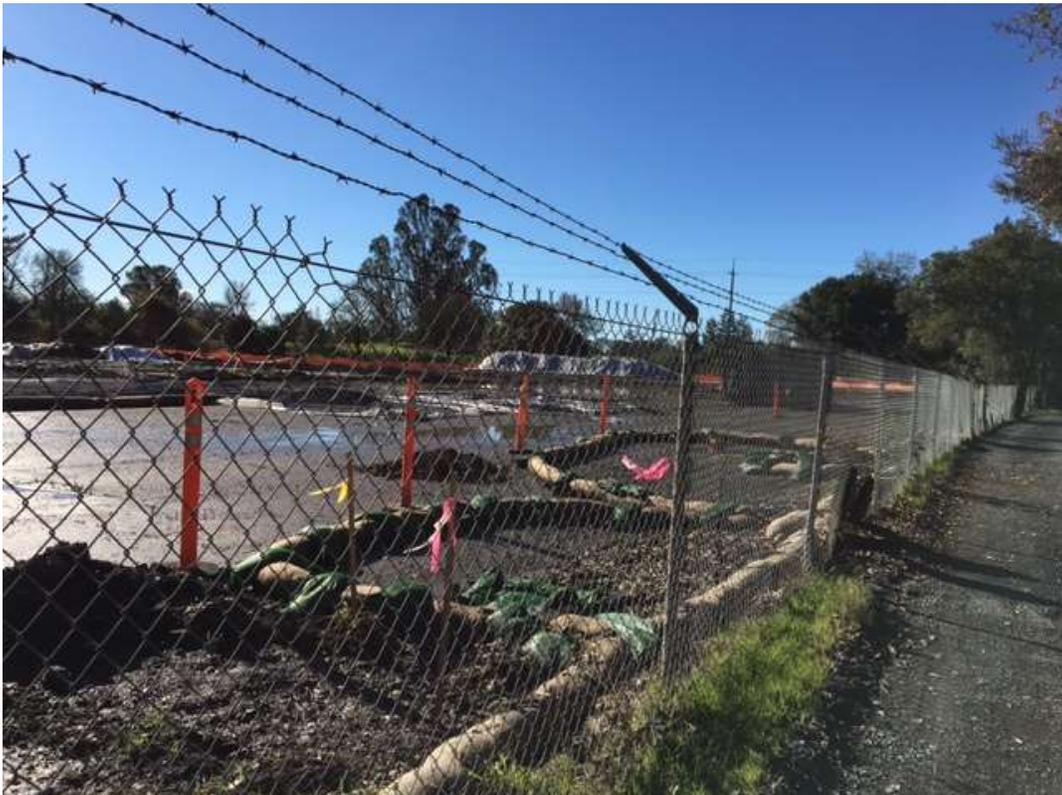
The CPUC EM conducted another site visit on Friday, December 16<sup>th</sup>, around 11 am after the storm event. Much of the water from the storm event had left the site and there was no water around the drainage inlets (see Figure 6) and the ephemeral drainage was running fairly clear (see Figure 7).

Figure 6 – Drainage inlets on the north side of the substation site after storm event, December 16, 2016.

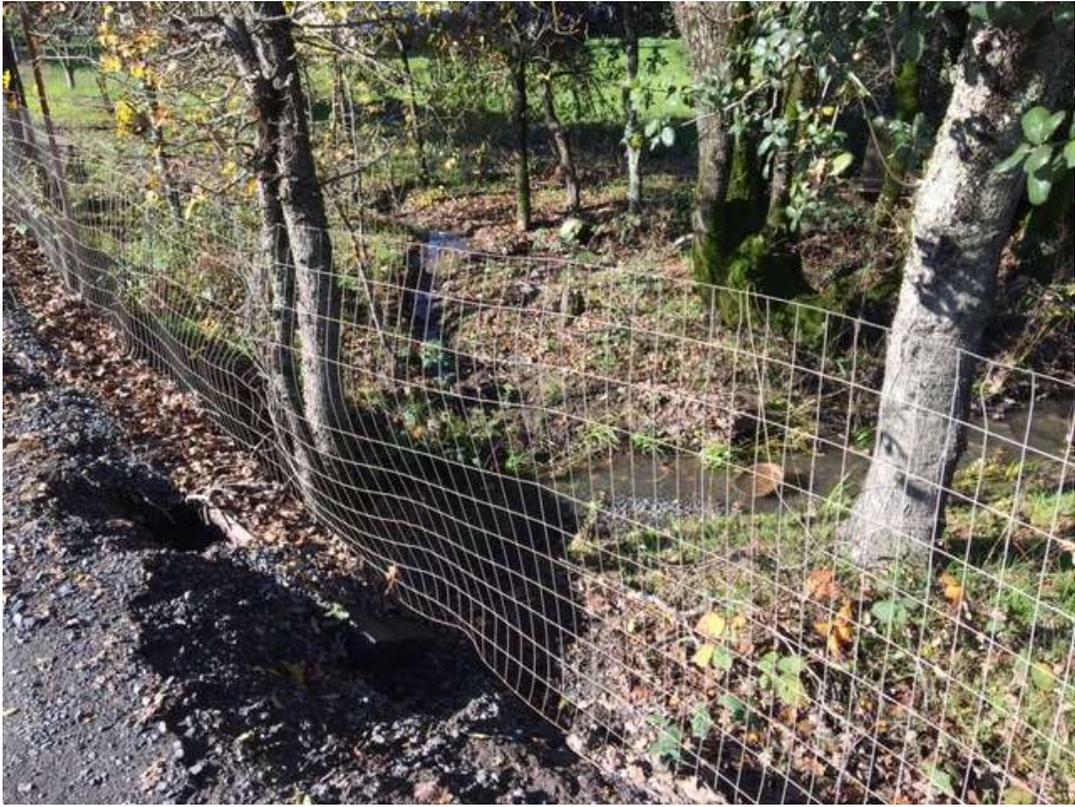
Figure 7 – Ephemeral drainage to which drainage inlets flow after storm event, December 16, 2016.
