**PROJECT MEMORANDUM**  
**PG&E WINDSOR SUBSTATION PROJECT**

**To:** Eric Chiang, Project Manager, CPUC  
**From:** Vida Strong, Aspen Project Manager  
**Date:** October 25, 2017  
**Subject:** Monitoring Report #37 – October 9, 2017 to October 22, 2017

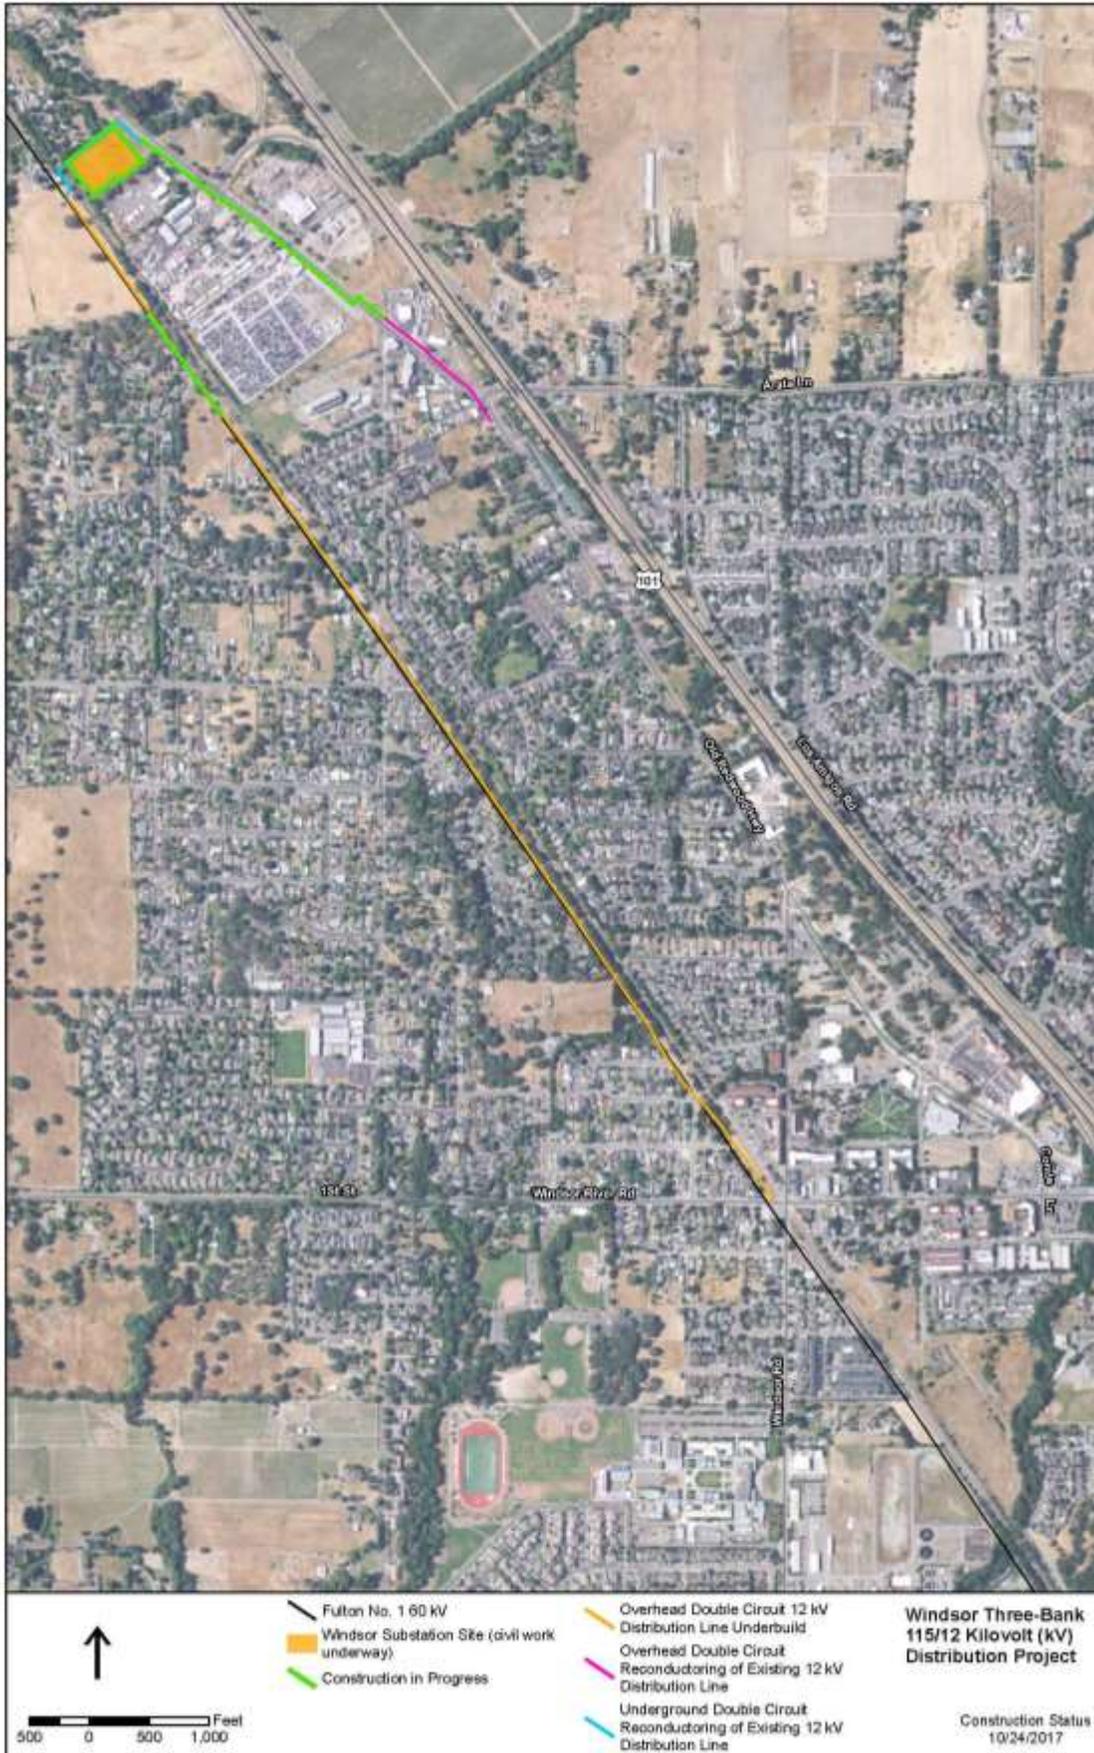
EXHIBIT A – CONSTRUCTION STATUS

This report provides a summary of the construction and compliance activities associated with the PG&E Windsor Substation Project which includes the construction of the Windsor Substation, as well as 12 kV distribution line underbuild and reconductoring work (see Exhibit A).

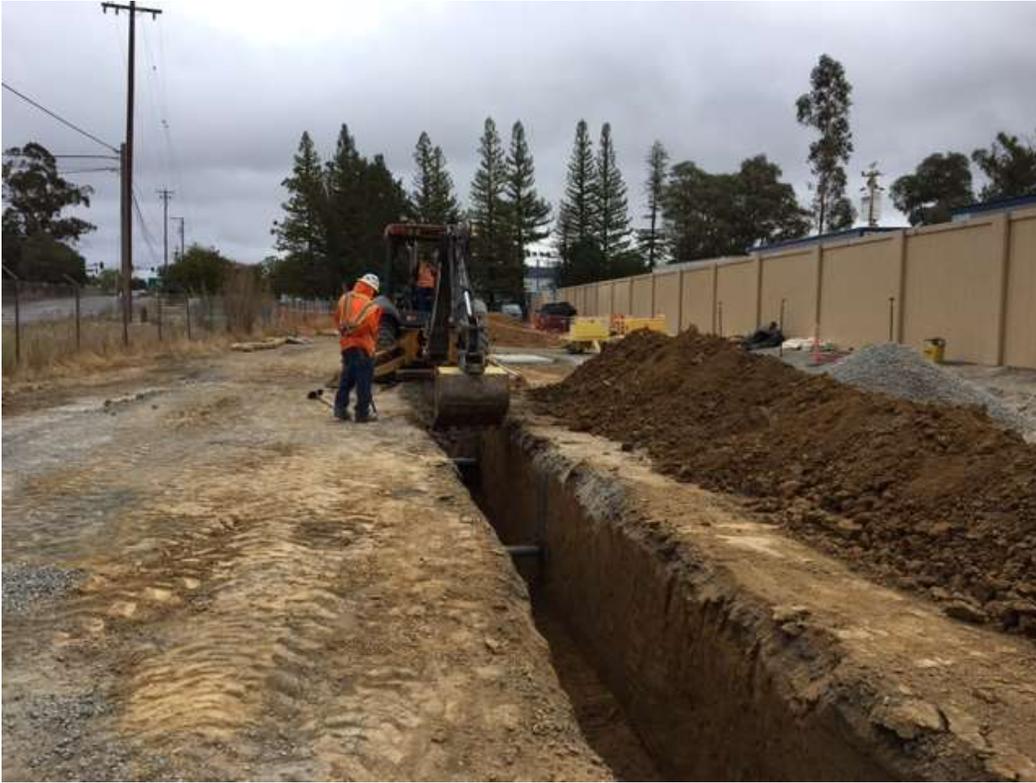
Conduit trenches for the distribution line were excavated, conduit installed to pull boxes, and the trenches backfilled on the eastern perimeter (see Figure 1).

Figure 1 – Conduit trenching on east side of substation – view south, October 19, 2017.

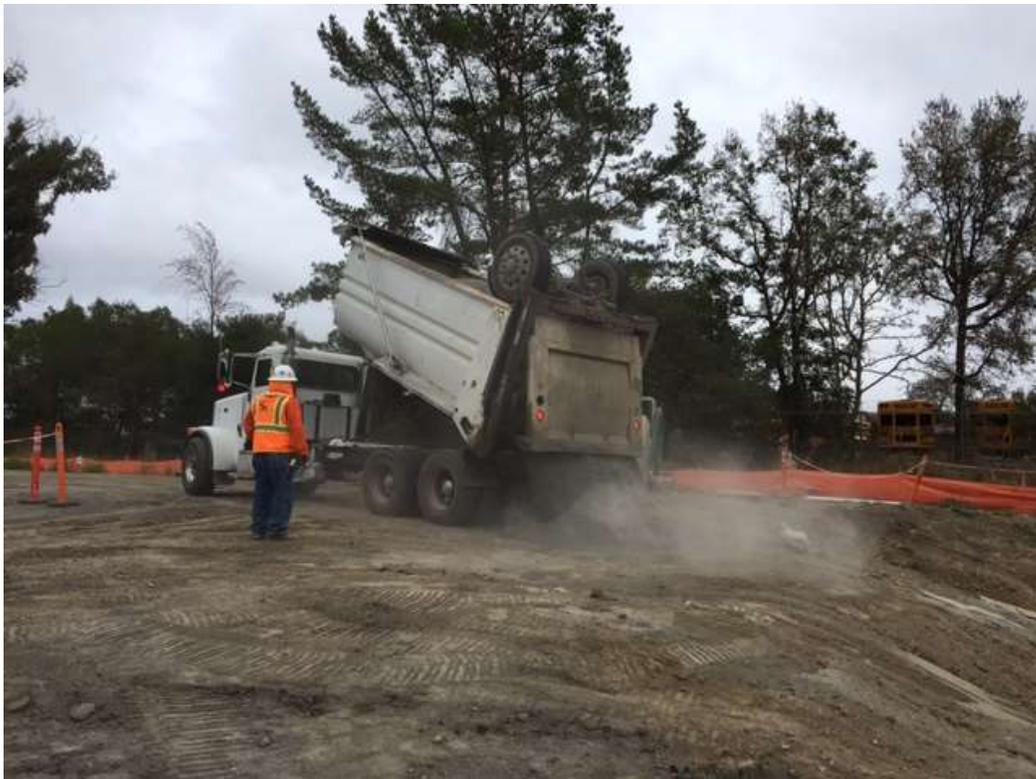
Deliveries of base rock and sand occurred for the build-up of the substation pad to grade and for around the SPCC pond (see Figure 2).

Figure 2 – Delivery of base rock and sand – view south, October 19, 2017.

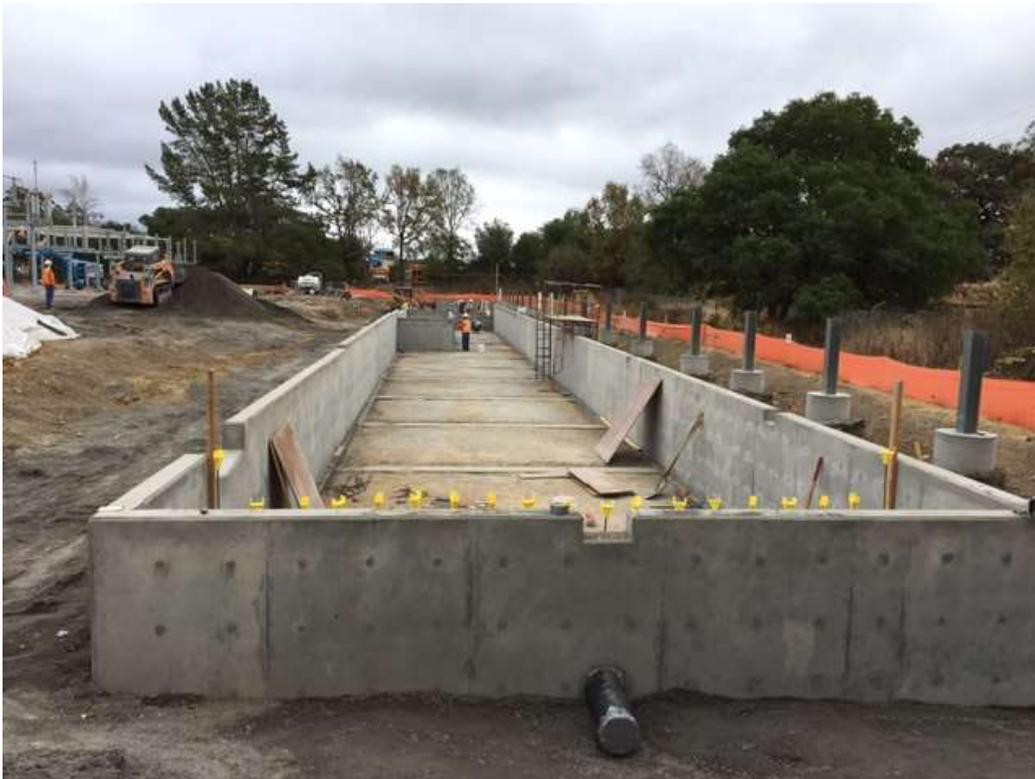
Crews backfilled and compacted engineered fill around the SPCC pond (see Figure 3).

Figure 3 – Backfilling and compacting fill around SPCC pond – view south, October 19, 2017.

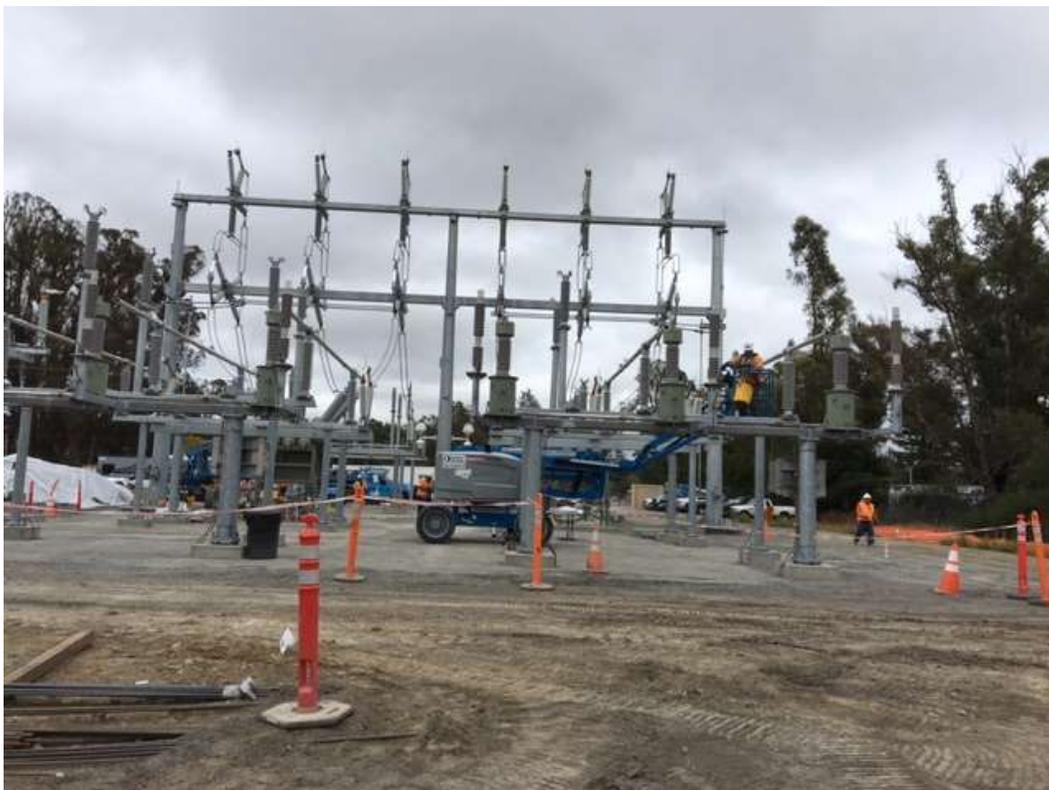
On the southwest side of the site, installation of transmission switches and insulators on dead-end structures continued (see Figure 4).

Figure 4 – Installing switches and insulators on dead-end structures – view east, October 19, 2017.

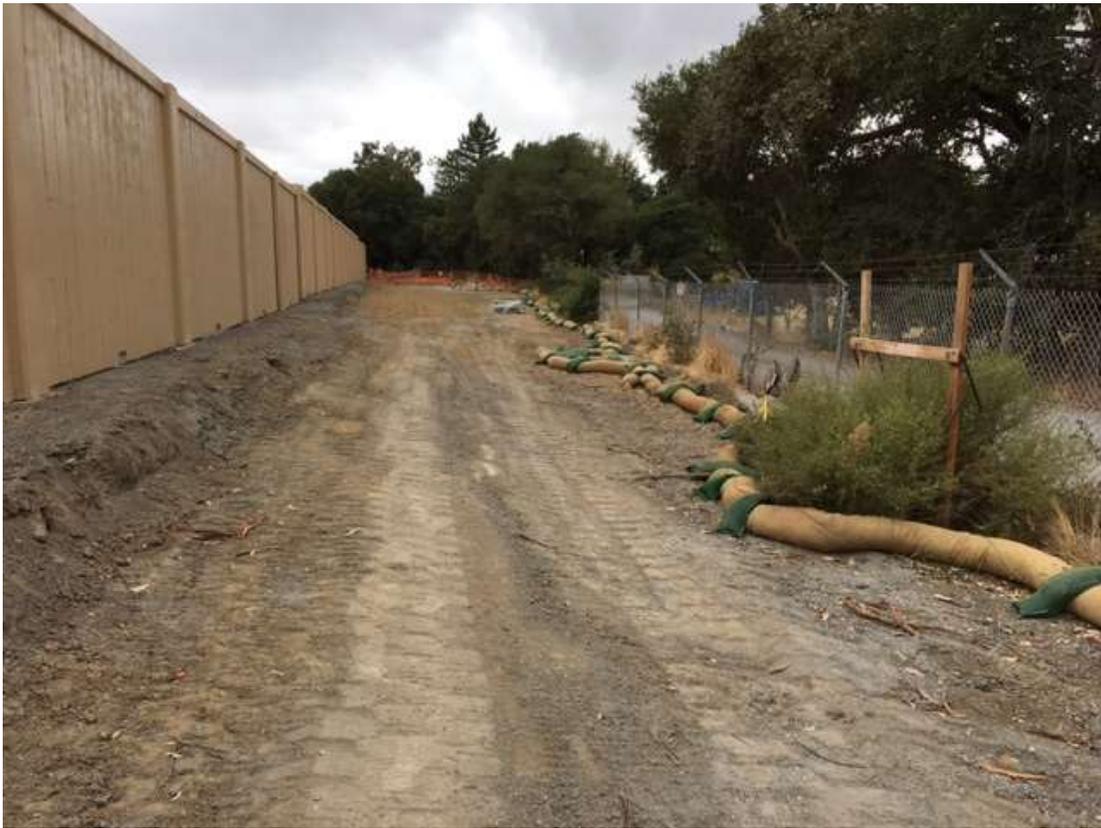
2. PG&E’s SWPPP contractor, Steve Stetson of Aetna, conducted inspections on October 17, 19, and 20. No issues were identified. In advance of rain occurring on October 19, wattles and gravel bags were in place along the north perimeter of the substation site and around drain inlets, and remaining spoil piles were covered (see Figure 5).

Figure 5 – Additional BMPs installed along northern perimeter and around drainage inlets – view west, October 19, 2017.
