California Public Utilities Commission <i>Mitigation Monitoring, Compliance, and Reporting Program</i>
	Mira Sorrento Distribution Substation Project Compliance Status Report: 007 August 25, 2013

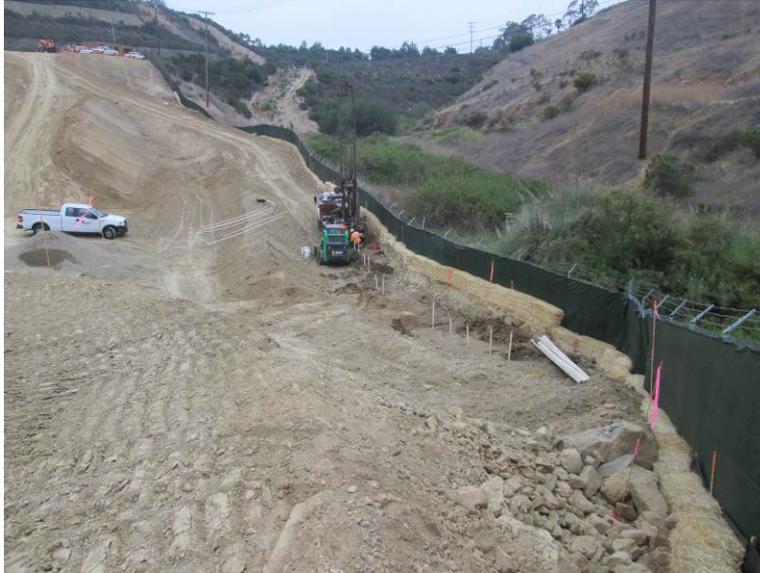
Photo 1: A series of groundwater wells were drilled along the eastern limits of the project site that will be utilized for groundwater extraction.

Construction activities during the reporting period primarily consisted of preparing the site for dewatering groundwater. A drill rig was used to drill a linear series of groundwater extraction wells along the eastern perimeter (see Photo 1 – Attachment A). Three filtering tanks were placed onsite to treat groundwater prior to being discharged (see Photo 2 – Attachment A). In accordance with MM-HY-2, SDG&E submitted a dewatering plan to CPUC prior to extracting any groundwater.

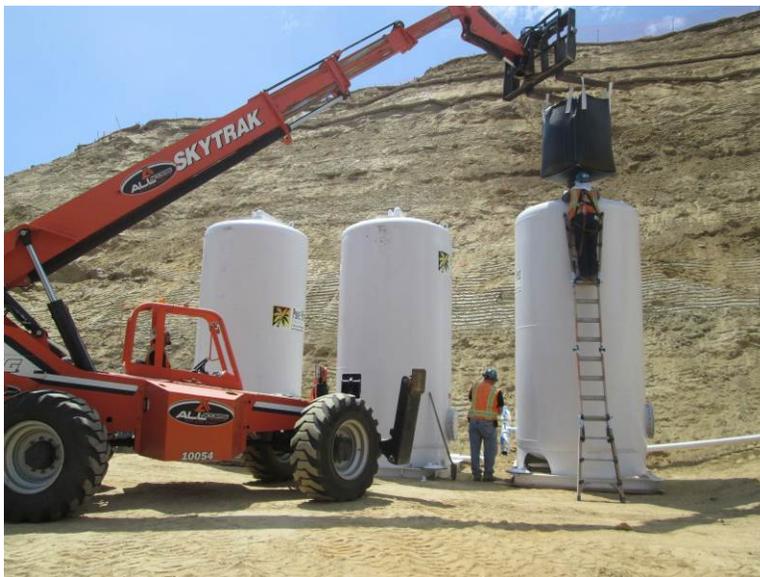
Photo 2: Filter tanks were observed being placed onsite to filter groundwater being extracted prior to any discharges offsite.

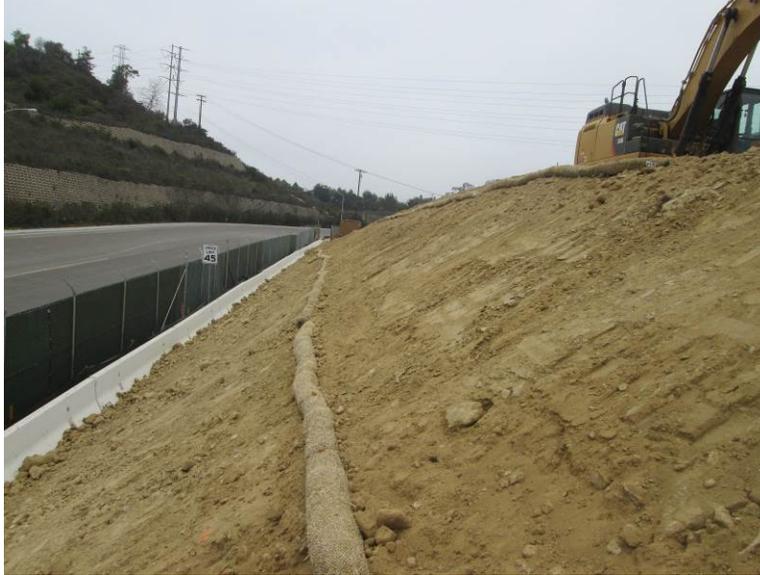
Photo 3: In accordance with APM-HYD-1, storm water control BMPs were observed along the site perimeter to minimize erosion and silt laden runoff.

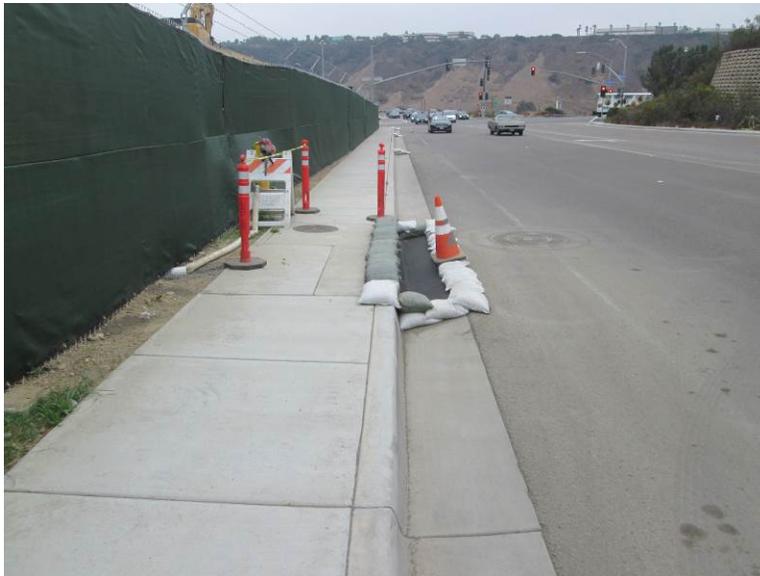
Photo 4: In accordance with APM-HYD-1, inlet protection BMPs designed to avoid or minimize silt from entering waterways, including filter fabric and gravel bags, were observed at two inlets along Mira Sorrento Place.

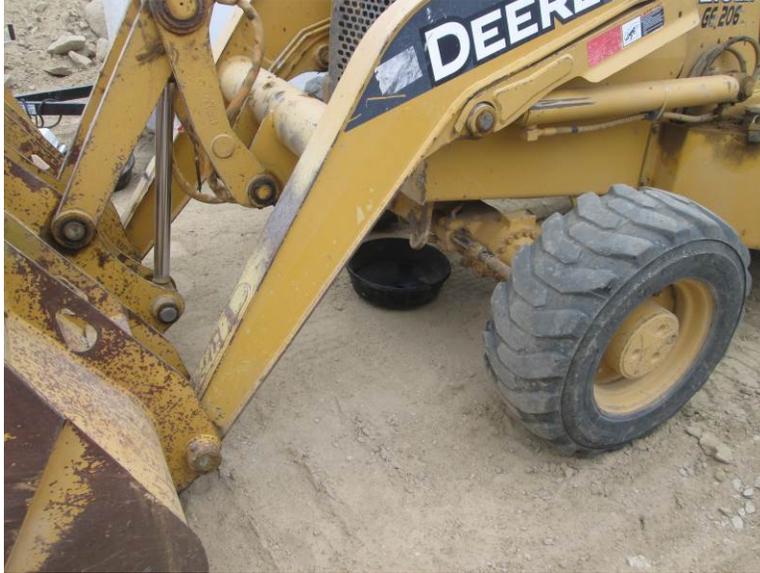
Photo 5: In accordance with APM-HYD-1, drip pans were used under construction equipment to prevent potential leaks from being discharged into the soil.

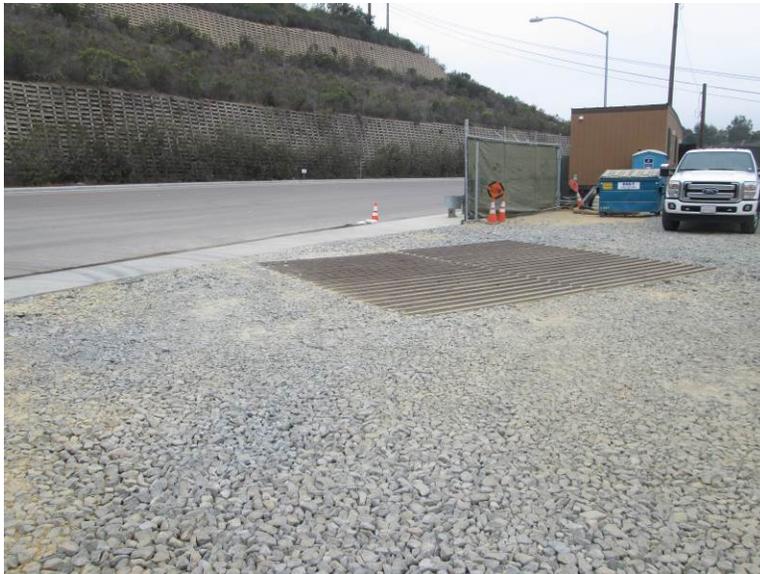
Photo 6: In accordance with APM-HYD-1, anti-dirt tracking control BMPs including a rock apron and rumble plates, were observed at the site ingress/egress point to prevent dirt from being tracked onto Mira Sorrento Place.

In accordance with APM BIO-3, SDG&E has prepared a Storm Water Pollution Prevention Plan (SWPPP) under the General Construction Permit, and is implementing Best Management Practices (BMPs) to avoid or minimize potential impacts to water quality. Storm water control BMPs observed on-site included silt fence and straw bales along the eastern perimeter, straw wattles on the face of cut slopes created during excavation, and silt fencing and k-rail along the western perimeter (see Photo 3 – Attachment A). Inlet protection BMPs observed on-site included filter fabric and gravel bags at one inlet within the project site along the western perimeter, and two inlets outside of the project site along Mira Sorrento Place (see Photo 4 – Attachment A). Secondary containment BMPs including visqueen and gravel bags, and drip pans were observed beneath porta-potty facilities, and under all equipment and vehicles that had been staged overnight (see Photo 5 – Attachment A). Anti-dirt tracking control BMPs including a rock apron and rumble plates, were observed at the site ingress/egress to minimize the potential for sediment being tracked onto Mira Sorrento Place (see Photo 6 – Attachment A).
