Biological Resources Studies (E1 to E8)

Appendix E1
Special Status Plant Species Report

Special-status Plant Species Report

Aliso Canyon Turbine Replacement Project
Los Angeles County, California

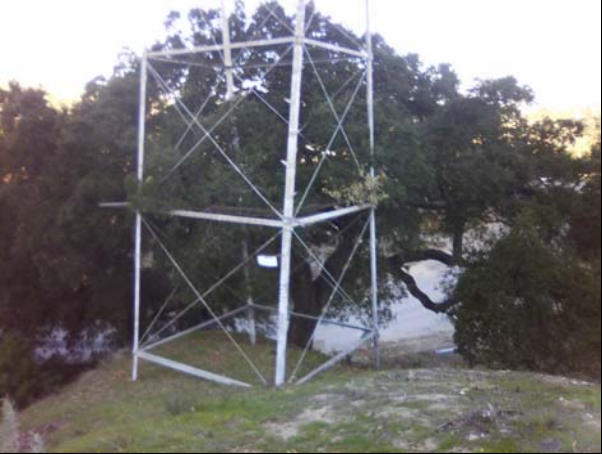
TAG NO	SCIENTIFIC NAME	COMMON NAME	DBH	UTM COORDINATES	GENERAL HEALTH NOTES	ASSOCIATED HABITAT	UNDERSTORY SPECIES	GENERAL NOTES	PROJECT ACTIVITY	POTENTIAL IMPACT	PHOTO
1	<i>Quercus agrifolia</i>	Coast live oak	42"	358833.66, 3802053.00	Proper taper and scaffolding. Cavities with good callous growth. Landscape lighting in tree	Oak woodland transitioning into disturbed/ornamental	<i>Bromus</i> sp. <i>Azalea</i> 'Southern Indica' <i>Aspidistra elatior</i> <i>Zantendeschia aeithiopica</i>	Root system growth downslope on 2:1 slope. A large diameter coast live oak (<i>Quercus agrifolia</i>) along a north facing slope adjacent to Tower 3-8. The oak currently has a canopy within the tower scaffolding. Tree will be accessed from above, avoiding most impacts outside of some pruning within the tower site.	Tower replacement, retaining wall construction	Loss of canopy

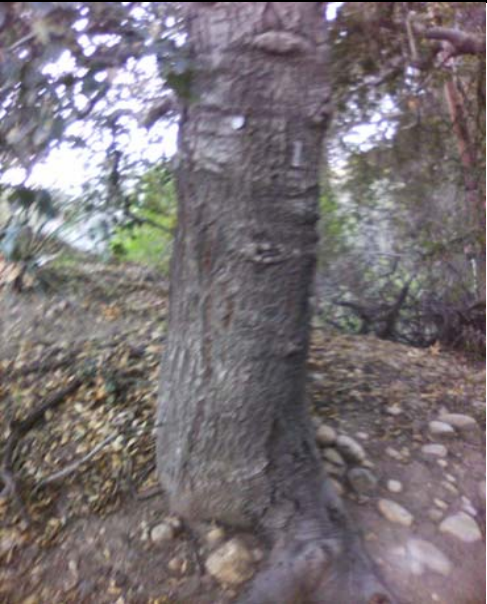
2	<i>Quercus agrifolia</i>	Coast live oak	18"	358896.69, 3802075.00	Border damage on roots. Dead branches and scaffolds.	Oak woodland	Heavy duffus layer; no understory plants.	Adjacent to undelineated ephemeral streambed. Tree is along an ephemeral drainage to the southwest of Tower 3-8. The trees were within the proposed delivery path for construction supplies from Round Canyon Road	Tower replacement	Loss of canopy

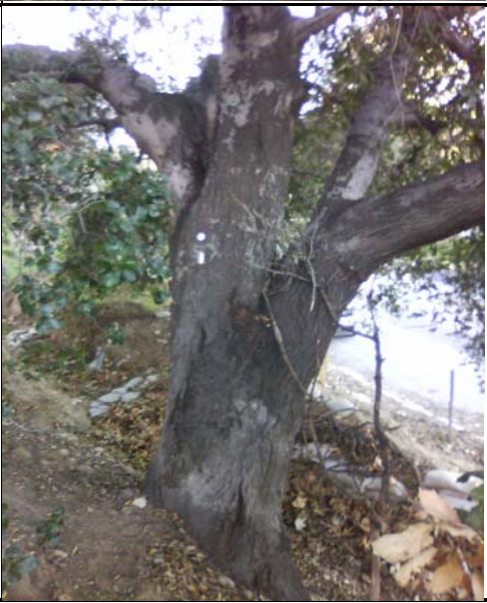
3	<i>Quercus agrifolia</i>	Coast live oak	30"	358931.81, 3802065.75	Codominant scaffolds. Dead branches on approx. 10% of canopy. Erosion on bank has exposed roots.	Oak woodland	Heavy duffus; no understory.	Adjacent to undelineated ephemeral streambed. Tree is along an ephemeral drainage to the southwest of Tower 3-8. The trees were within the proposed delivery path for construction supplies from Round Canyon Road	Tower replacement	Loss of canopy

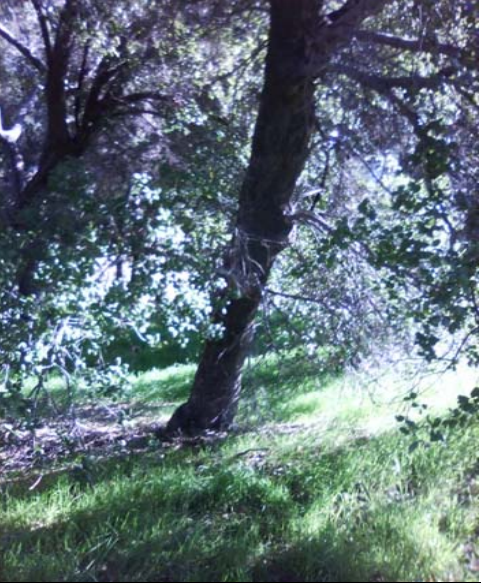
TAG NO	SCIENTIFIC NAME	COMMON NAME	DBH	UTM COORDINATES	GENERAL HEALTH NOTES	ASSOCIATED HABITAT	UNDERSTORY SPECIES	GENERAL NOTES	PROJECT ACTIVITY	POTENTIAL IMPACT	PHOTO
4	<i>Quercus agrifolia</i>	Coast live oak	15"	358927.31, 3802061.50	Sparse canopy. Dead branches. Callous growth on trunk.	Oak woodland	<i>Bromus</i> sp. <i>Sambucus mexicana</i>	The tree is part of a comprehensive oak woodland area on the border of Santa Clarita Trailer Park below the tagged oaks.	Road widening, Tower Replacement	Loss of canopy

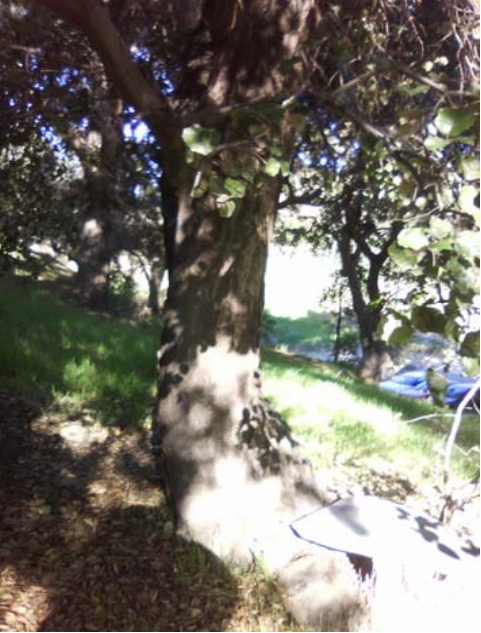
5	<i>Quercus agrifolia</i>	Coast live oak	15"@1',15" @1'	359394.50, 3801510.25	Codominant trunks. Formerly a three trunked tree. Significant burls.	Oak woodland transitioning to disturbed/ornamental (mobile home park)	<i>Bromus</i> sp. <i>Marah macrocarpa</i> <i>Silybum marianum</i>	The tree forms part of a comprehensive oak woodland area on the border of Santa Clarita Trailer Park below the tagged oaks.	Road widening	Root zone disturbance

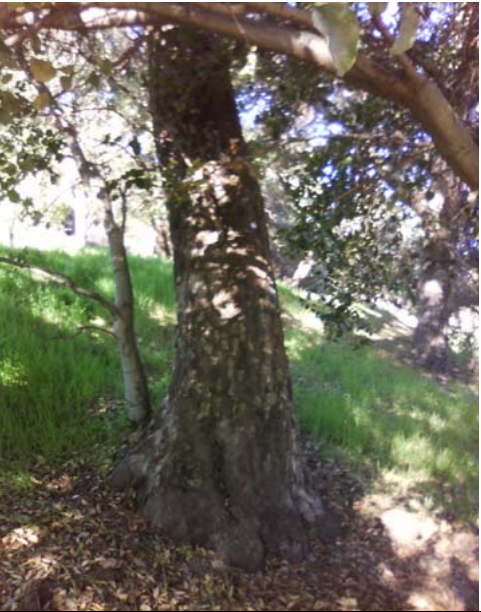
TAG NO	SCIENTIFIC NAME	COMMON NAME	DBH	UTM COORDINATES	GENERAL HEALTH NOTES	ASSOCIATED HABITAT	UNDERSTORY SPECIES	GENERAL NOTES	PROJECT ACTIVITY	POTENTIAL IMPACT	PHOTO
6	<i>Quercus agrifolia</i>	Coast live oak	23"	359377.00, 3801510.00	Large cavity with limited callous growth. Codominant scaffolds. Dead scaffolds and branches. Seepage on scaffolds.	Oak woodland transitioning to disturbed/ornamental (mobile home park)	<i>Bromus</i> sp. <i>Marah macrocarpa</i> <i>Silybum marianum</i>	* Active hummingbird nest. Small side sprout at root flare.	Road widening, vehicular traffic	Root zone disturbance

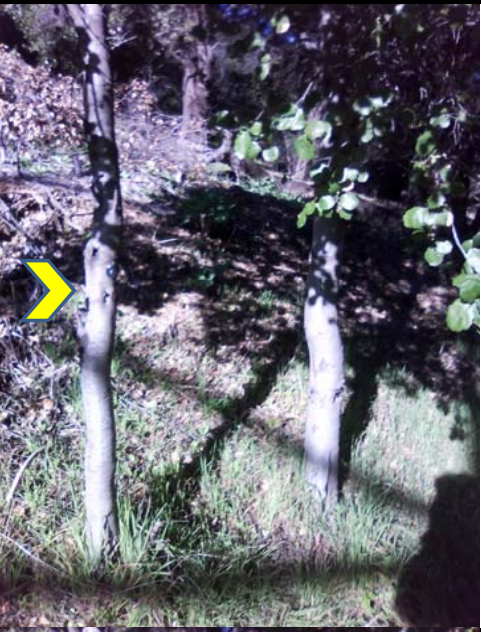
7	<i>Quercus agrifolia</i>	Coast live oak	5"	359774.34, 3801339.25	Young tree. Vigorous growth with large growth cracks	Oak woodland	<i>Bromus</i> sp. <i>Ranunculus californica</i> <i>Galium aparine</i> <i>Eriophyllum confertiflorum</i> <i>Silybum marianum</i>	Adjacent to access road.	Road widening, vehicular traffic	Root zone disturbance

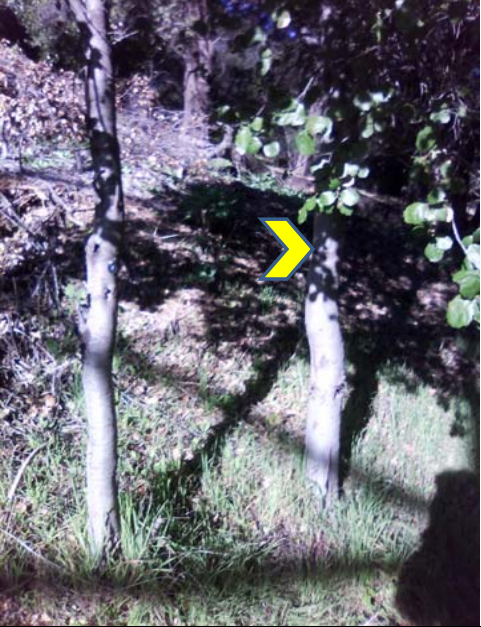
TAG NO	SCIENTIFIC NAME	COMMON NAME	DBH	UTM COORDINATES	GENERAL HEALTH NOTES	ASSOCIATED HABITAT	UNDERSTORY SPECIES	GENERAL NOTES	PROJECT ACTIVITY	POTENTIAL IMPACT	PHOTO
8	<i>Quercus agrifolia</i>	Coast live oak	6"	359778.69, 3801340.75	Young tree. Vigorous growth with large growth cracks	Oak woodland	<i>Bromus</i> sp. <i>Ranunculus californica</i> <i>Galium aparine</i> <i>Marah macrocarpa</i> <i>Medicago polymorpha</i> <i>Silybum marianum</i>	Adjacent to access road.	Road widening, vehicular traffic	Root zone disturbance

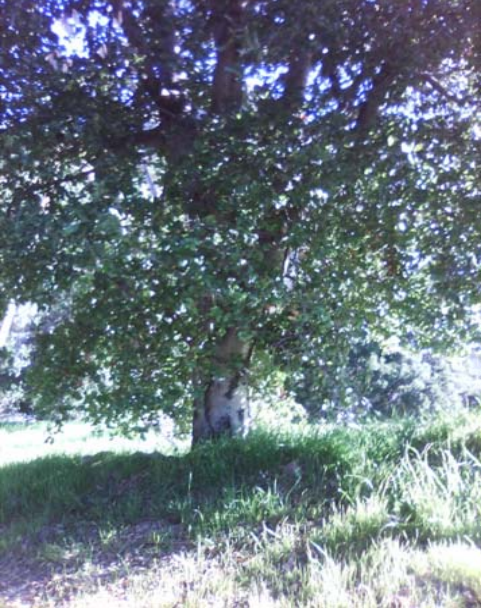
10	<i>Quercus agrifolia</i>	Coast live oak	10"@3', 12"@3'	359791.91, 3801374.00	Codominant scaffolds. Vigorous growth with large growth cracks. Young tree.	Oak woodland	<i>Bromus</i> sp.	Adjacent to the turn around. Potential for impact from grading and heavy machinery operation.	Road widening, vehicular traffic	Loss of canopy, Root zone disturbance

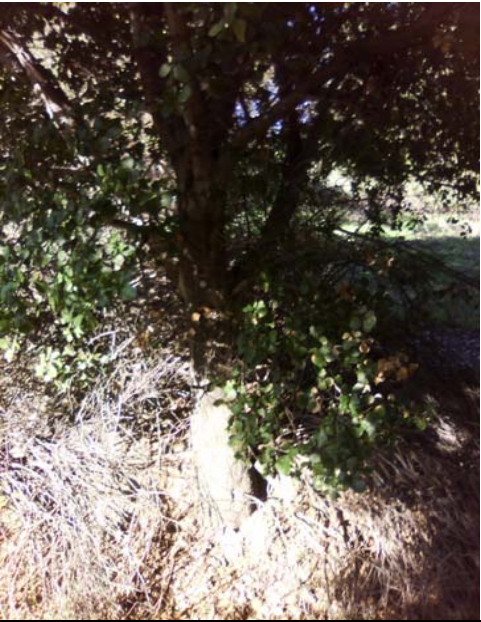
TAG NO	SCIENTIFIC NAME	COMMON NAME	DBH	UTM COORDINATES	GENERAL HEALTH NOTES	ASSOCIATED HABITAT	UNDERSTORY SPECIES	GENERAL NOTES	PROJECT ACTIVITY	POTENTIAL IMPACT	PHOTO
11	<i>Quercus agrifolia</i>	Coast live oak	10"	360933.84, 3800672.25	Good branching. Balanced taper on trunk.	Oak woodland transitioning into Venturan sage scrub.	<i>Silybum mariaunum</i> <i>Artemisisa californica</i> <i>Salvia mellifera</i> <i>Bromus</i> sp. <i>Marah macrocarpa</i>	On embankment adjacent to turn around. Dead woody material underneath canopy.	Road widening, vehicular traffic	Loss of canopy, Root zone disturbance

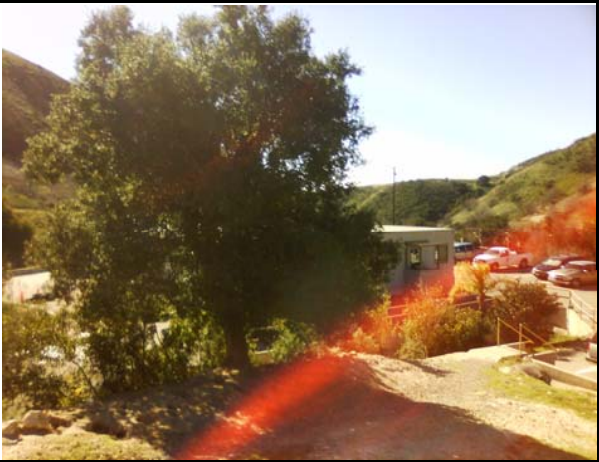
12	<i>Quercus agrifolia</i>	Coast live oak	19"	359129.72, 3798329.25	Young tree within self-corrected incline in trunk. Well balanced canopy.	Ornamental planting on slope adjacent to gravel access path.	Bare soil with signs of pocket gopher (<i>Botta</i> sp.) activity.	Located on engineered slope at site of existing office trailers. Proposed for removal for new compressor station. Tree is suitable for relocation.	Compressor station construction	Removal of tree

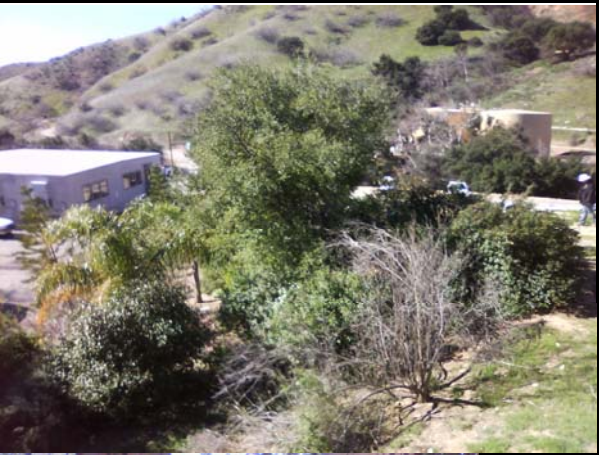
13	<i>Quercus agrifolia</i>	Coast live oak	9"@3', 11"@3'	359128.34, 3798330.75	Young tree with some possible root impacts. Root flare not balanced.	Ornamental planting on slope adjacent to gravel access path.	Bare soil	Planted specimen. Wooden stakes still adjacent to trunk flare. Tree is suitable for relocation.	Compressor station construction	Removal of tree

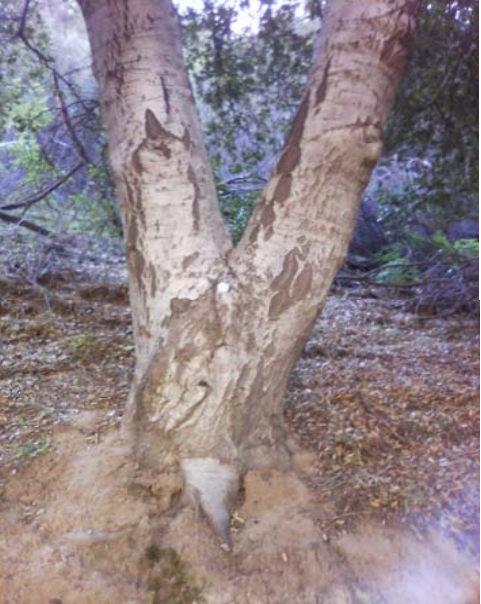
TAG NO	SCIENTIFIC NAME	COMMON NAME	DBH	UTM COORDINATES	GENERAL HEALTH NOTES	ASSOCIATED HABITAT	UNDERSTORY SPECIES	GENERAL NOTES	PROJECT ACTIVITY	POTENTIAL IMPACT	PHOTO
14	<i>Quercus agrifolia</i>	Coast live oak	18"@3', 18"@3'	358844.34, 3798081.00	Codominant trunks. No included bark within trunks. Both trunks are evenly tapered. Dense canopy with minimal dead wood.	Oak woodland and chamise/ceanothus chaparral.	<i>Ranunculus californica</i> <i>Pentagramma triangularis</i> <i>Keckiella cordifolia</i> <i>Marah macrocarpa</i> <i>Galium aparine</i> <i>Sambucus mexicana</i> <i>Silybum marianum</i> <i>Lessingia filaginifolia</i> <i>Asterella</i> sp.	On bank by degraded road. Canopy reaches into undelineated streambed (ephemeral). Evidence of extensive root growth within old road.	Road regrading	Root zone disturbance

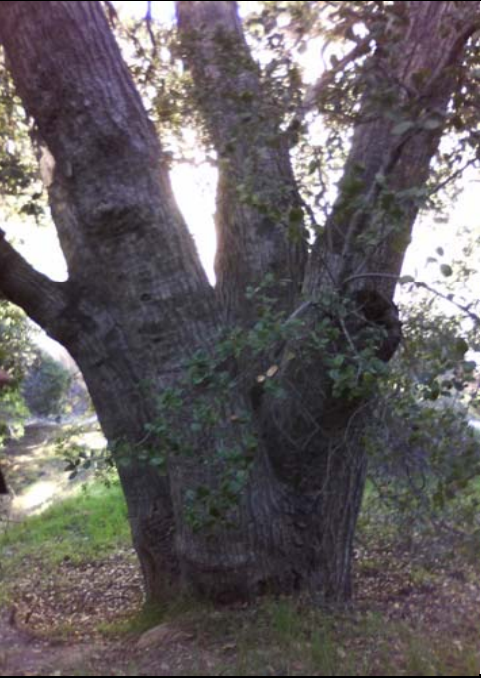
15	<i>Quercus agrifolia</i>	Coast live oak	15'@1', 16'@1', 17'@1', 27'@1'	358535.31, 3802167.75	Multitrunked specimen with decay and pooling water in center of trunks. Large cavity with decay and pooling water on upper trunk. Dense canopy .	Oak woodland/seasonal wash	<i>Lessingia filaginifolia</i> <i>Galium aparine</i> <i>Bromus</i> sp.	Undelineated streambed, approximately 40 percent of the canopy and corresponding root zone within old access road.	Road regrading	Root zone disturbance

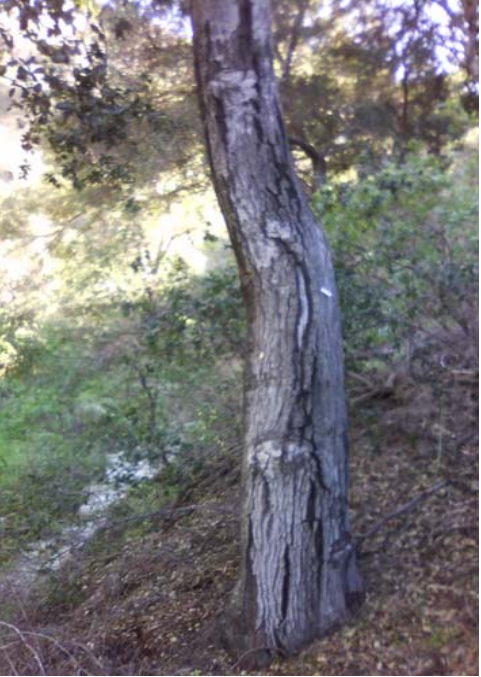
TAG NO	SCIENTIFIC NAME	COMMON NAME	DBH	UTM COORDINATES	GENERAL HEALTH NOTES	ASSOCIATED HABITAT	UNDERSTORY SPECIES	GENERAL NOTES	PROJECT ACTIVITY	POTENTIAL IMPACT	PHOTO
16	<i>Quercus agrifolia</i>	Coast live oak	20"	358858.88, 3802031.00	Calloused cavity on trunk midway. Self corrected incline in trunk. Dense canopy.	Oak woodland/seasonal wash.	<i>Keckiella cordifolia</i> <i>Silybum marianum</i> <i>Galium officinal</i> <i>Eucrypta minutiflora</i> <i>Sambucus mexicana</i>	Within undelineated wash.	Road regrading	Root zone disturbance

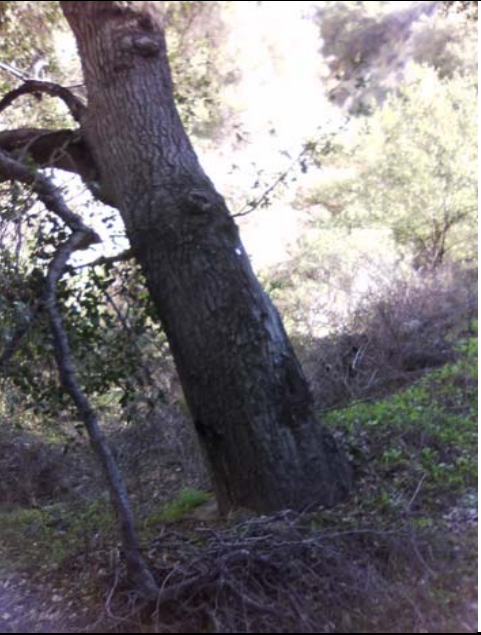
17	<i>Quercus agrifolia</i>	Coast live oak	23"	356890.41, 3804410.25	Some dead wood. Self corrected incline in trunk. Healthy scaffolds. Dense canopy.	Oak woodland	<i>Silybum marianum</i> <i>Mimulus aurianticus</i> <i>Sambucus mexicana</i> <i>Lessingia filaginifolia</i> <i>Claytonia</i> sp.	Approximately 40% of canopy and associated root structure within former road.	Road regrading	Root zone disturbance

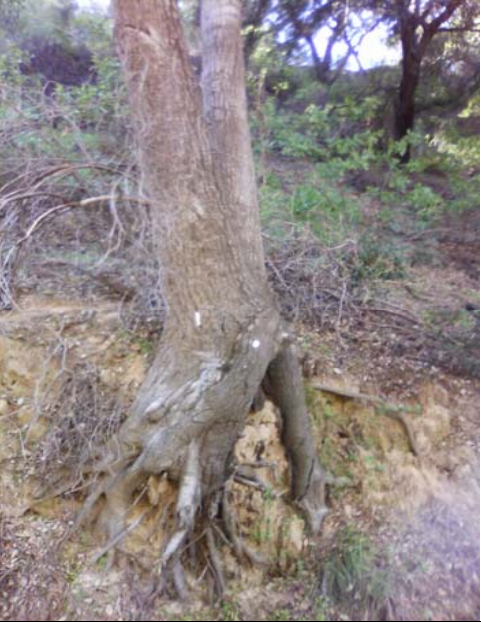
TAG NO	SCIENTIFIC NAME	COMMON NAME	DBH	UTM COORDINATES	GENERAL HEALTH NOTES	ASSOCIATED HABITAT	UNDERSTORY SPECIES	GENERAL NOTES	PROJECT ACTIVITY	POTENTIAL IMPACT	PHOTO
18	<i>Quercus agrifolia</i>	Coast live oak	14"@8", 17"@8"	356886.09, 3804403.00	Exposed roots on embankment. Decay in trunk with surrounding callous formations. Codominant trunks have included bark.	Oak woodland	<i>Marah macrocarpa</i> <i>Mimulus aurianticus</i> <i>Pentagramma triangularis</i> <i>Silybum marianum</i> <i>Keckiella cordifolia</i> <i>Sambucus mexicana</i> <i>Prunus ilicifolia</i> <i>Ceanothus</i> sp.	On bank by degraded road.	Road regrading	Root zone disturbance

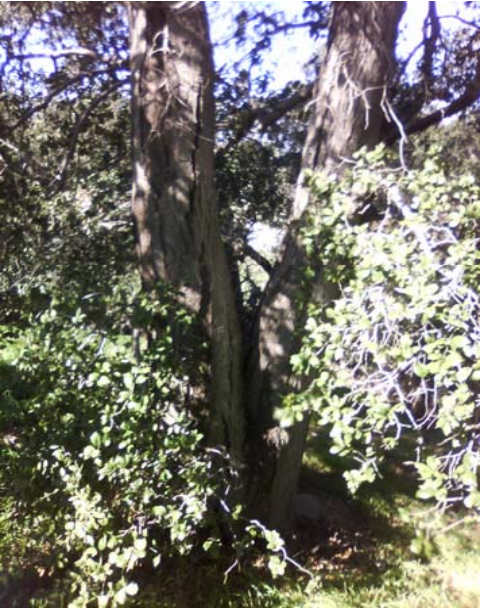
19	<i>Quercus agrifolia</i>	Coast live oak	18"@2', 17"@2'	356884.09, 3804402.00	Codominant trunks. Included bark at crotch. Dense canopy.	Oak woodland transitioning to annual grassland.	<i>Silybum marianum</i> <i>Bromus diandrus</i>	Open field with canopy reaching into Tower 6-5.	Road regrading	Root zone disturbance

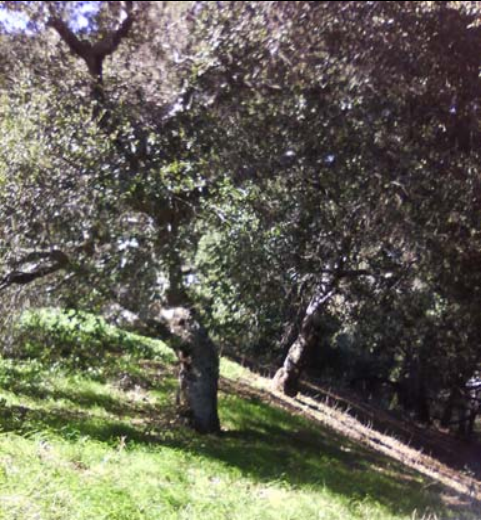
20	<i>Quercus agrifolia</i>	Coast live oak	23	358326.59, 3802239.00	Self corrected incline. 180 degree trunk growth then vertical scaffold growth into canopy.	Oak woodland transitioning to annual grassland.	<i>Bromus diandrus</i> <i>Silybum marianum</i>	Canopy reaches into the pad of Tower 6-5.	Tower replacement, vehicular traffic	Loss of canopy

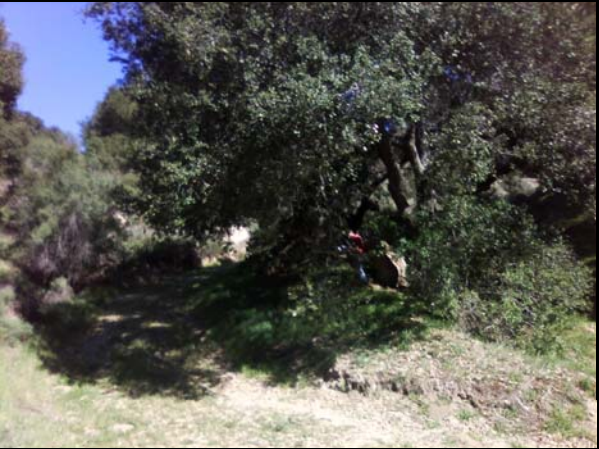
TAG NO	SCIENTIFIC NAME	COMMON NAME	DBH	UTM COORDINATES	GENERAL HEALTH NOTES	ASSOCIATED HABITAT	UNDERSTORY SPECIES	GENERAL NOTES	PROJECT ACTIVITY	POTENTIAL IMPACT	PHOTO
21	<i>Quercus agrifolia</i>	Coast live oak	26	358316.09, 3802241.25	Slight incline in trunk. Healthy scaffolding and dense canopy	Oak woodland	<i>Solanum douglasii</i> <i>Marah macrocarpa</i> <i>Sambucus mexicana</i> <i>Bromus diandrus</i> <i>Silybum marianum</i>	Canopy reaches into the access road. Will be potentially significantly impacted. Also reaches into access road.	Road widening, vehicular traffic	Loss of canopy, Root zone disturbance

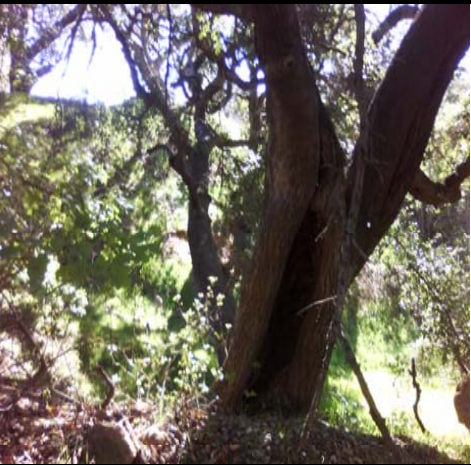
22	<i>Quercus agrifolia</i>	Coast live oak	19" @8", '9"@8"	358310.84, 3802243.75	Double trunked. 1st larger trunk senescent with significant cavities with calloused edges.	Oak woodland	<i>Toxicodendron diversilobum</i> <i>Solanum douglasii</i> <i>Bromus diandrus</i> <i>Phacelia ramosissima</i> <i>Marah macrocarpa</i>	Canopy within access road and turnaround. Wildlife tree-cavities.	Road widening, vehicular traffic	Root zone disturbance

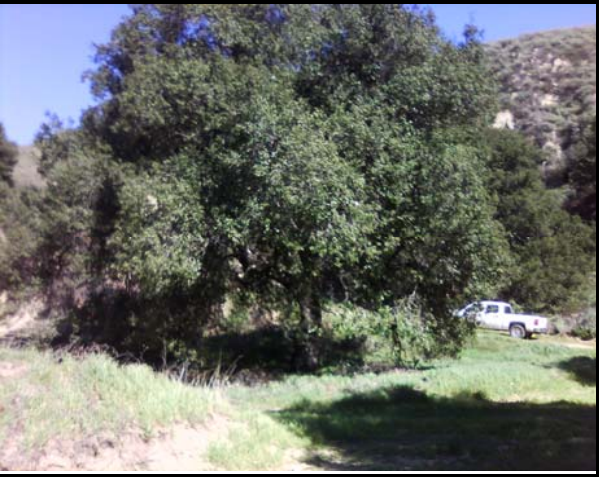
23	<i>Quercus agrifolia</i>	Coast live oak	30	358314.59, 3802236.50	Broken scaffold. Dead branches. Fully calloused former trunk. Some oak borer damage on lower N/W portion of trunk	Oak woodland	<i>Sambucus mexicana</i> <i>Silybum marianum</i> <i>Marah macrocarpa</i> <i>Bromus diandrus</i> <i>Marrubium vulgare</i> <i>Mimulus aurianticus</i>	Tree to be potentially impacted by access road as 2/3 of the canopy is within the access road. Wildlife tree (many large cavities).	Road widening, vehicular traffic	Root zone disturbance

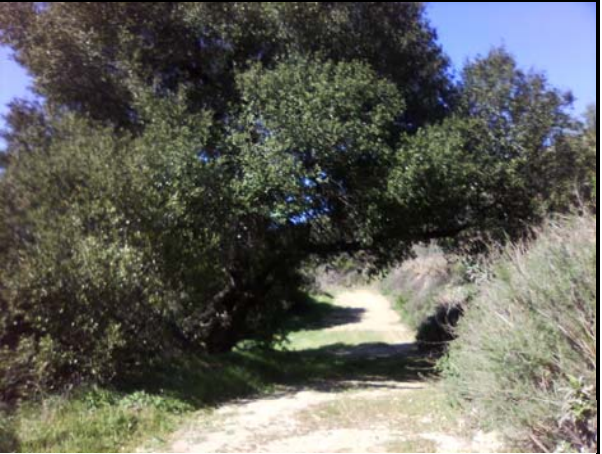
TAG NO	SCIENTIFIC NAME	COMMON NAME	DBH	UTM COORDINATES	GENERAL HEALTH NOTES	ASSOCIATED HABITAT	UNDERSTORY SPECIES	GENERAL NOTES	PROJECT ACTIVITY	POTENTIAL IMPACT	PHOTO
24	<i>Quercus agrifolia</i>	Coast live oak	35"	358306.63, 3802246.75	Some dead scaffolds. Pocket formation between 3 main scaffolds @ 15'. Dense canopy cover.	Oak woodland	<i>Bromus diandrus</i> <i>Silybum marianum</i> <i>Sambucus mexicana</i>	Removal of scaffold over the road would unbalance the tree, causing potential further structural failures on the oak.	Road widening, vehicular traffic	Loss of canopy, root zone disturbance

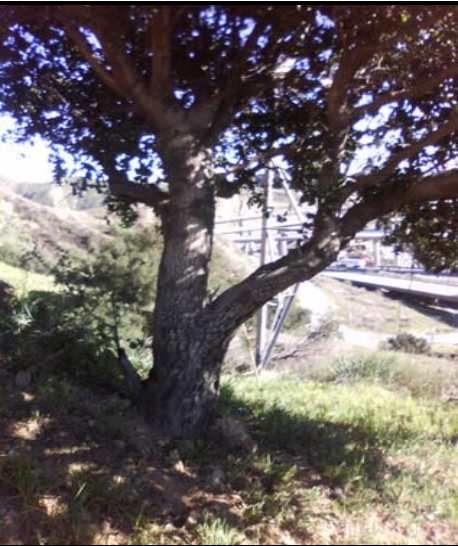
25	<i>Quercus agrifolia</i>	Coast live oak	10"@3', 11"@3'	358316.16, 3802249.75	Some dead limbs. Compact growth from exposed site (location).	Annual grassland/Venturan sage scrub remnants.	<i>Plagiobotrys</i> sp. <i>Avena barbata</i> <i>Eriogonum fasciculatum</i> <i>Solanum xantii</i> <i>Lupinus hirsutissimus</i> <i>Achnatherum coronatum</i> <i>Yucca whipplei</i> <i>Mirabilis californica</i>	Small tree on side of slope growing into the framework of Tower 7-5.	Tower replacement, vehicular traffic	Loss of canopy, root zone disturbance

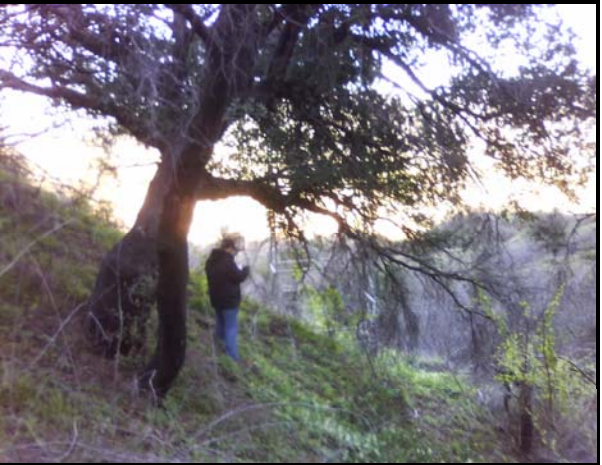
26	<i>Quercus agrifolia</i>	Coast live oak	25"	358318.81, 3802212.75	Epicormic growth on charred trunk from previous fire event. Tree is recovering.	oak-walnut woodland.	<i>Eucrypta minutiflora</i> <i>Marah macrocarpa</i> <i>Ribes aureum</i> <i>Claytonia</i> sp. <i>Galium aparine</i> <i>Galium officinal</i> <i>Silybum marianum</i> <i>Rhus ovata</i> <i>Bromus</i> sp.	Canopy reaches into Tower 14-3	Tower replacement	Loss of canopy, root zone disturbance

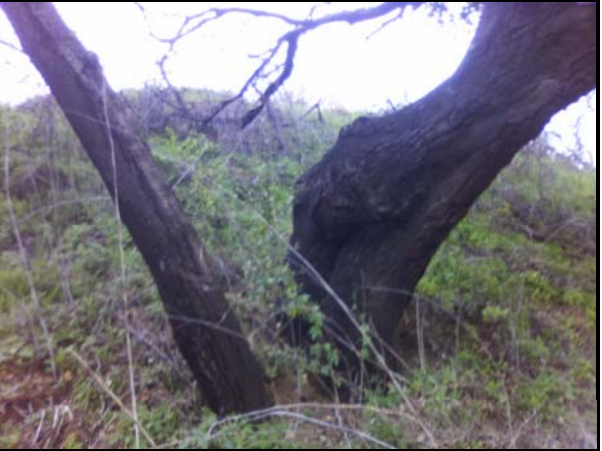
TAG NO	SCIENTIFIC NAME	COMMON NAME	DBH	UTM COORDINATES	GENERAL HEALTH NOTES	ASSOCIATED HABITAT	UNDERSTORY SPECIES	GENERAL NOTES	PROJECT ACTIVITY	POTENTIAL IMPACT	PHOTO
27	<i>Quercus agrifolia</i>	Coast live oak	10"	358313.09, 3802219.50	Partially suppressed by tree no. 26. Previous fire damage has spurred epicormic growth along scaffolds, branches, and the trunk.	oak-walnut woodland.	<i>Galium aparine</i> <i>Galium angustifolium</i> <i>Rhus ovata</i> <i>Claytonia</i> sp. <i>Marah macrocarpa</i> <i>Bromus</i> sp. <i>Eucrypta minutiflora</i>	Along with Tree 26, this oak forms part of a larger oak-walnut woodland along the ravine southward towards the 5 fwy interchange.	Tower replacement	Loss of canopy, root zone disturbance

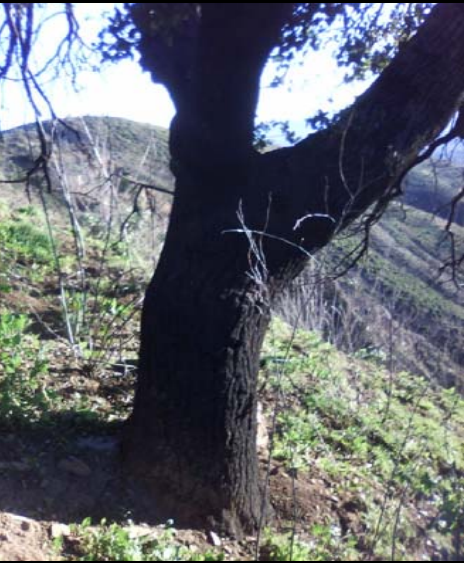
28	<i>Quercus agrifolia</i>	Coast live oak	21"	357155.69, 3797309.75	Heavily impacted by fire. Epicormic growth on trunk and scaffolds as it recovers.	Oak woodland-chaparral	<i>Melica imperfecta</i> <i>Rhapinus saetivus</i> <i>Phacelia imbricata</i> <i>Rhus ovata</i> <i>Bromus</i> sp. <i>Galium angustifolium</i>	Canopy formerly grew into the frame of Tower 14-1. Fire impacted.	Tower replacement, grading, vehicular traffic	Loss of canopy, root zone disturbance

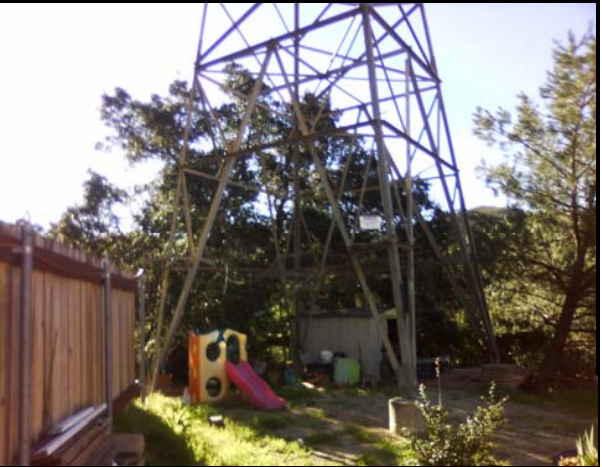
29	<i>Quercus agrifolia</i>	Coast live oak	23"	357164.16, 3797311.25	Healthy taper. Dense canopy.	Oak woodland adjacent to disturbed (mobile home park).	Oak duffus layer with intermittent <i>Marah macrocarpa</i>	Canopy growing into Tower 5-7 on north facing slope.	Tower replacement, grading, vehicular traffic	Loss of canopy

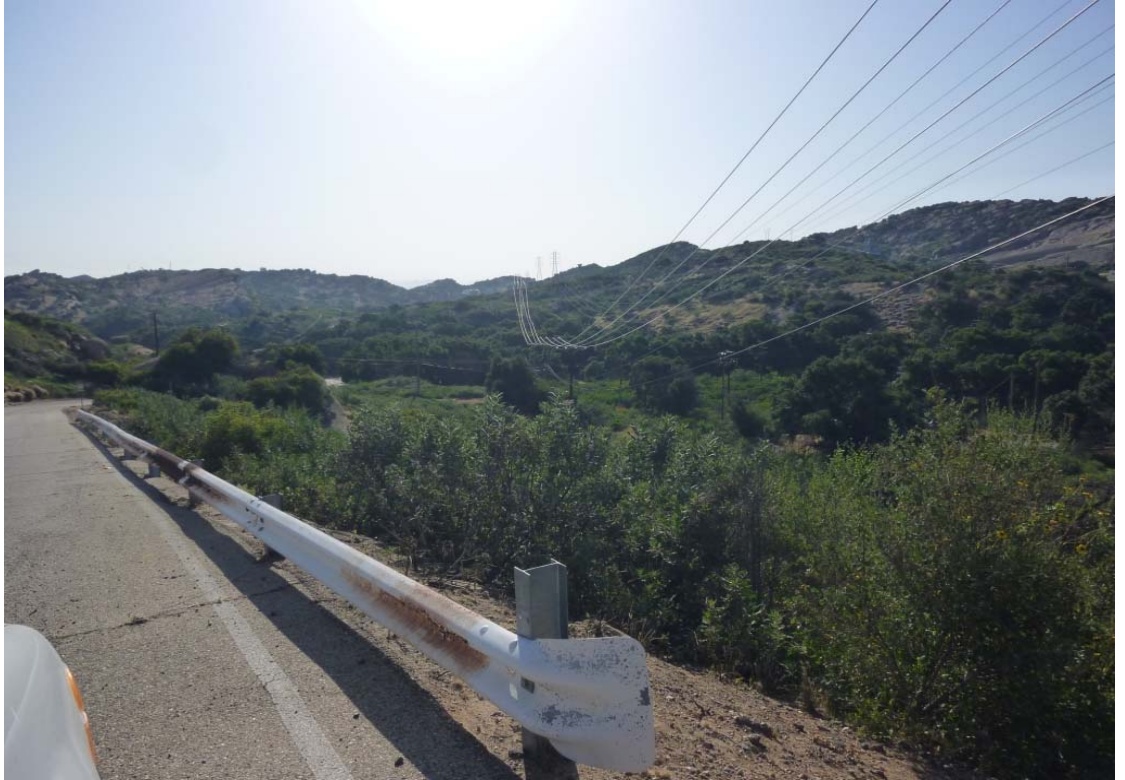
**Direction Photo
Taken: East**
East

Description:
Portion of CH-1 inside
Boeing Santa Susana
facility.
Note – Coastal Sage
Scrub (CSS) habitat and
coast live oak trees.

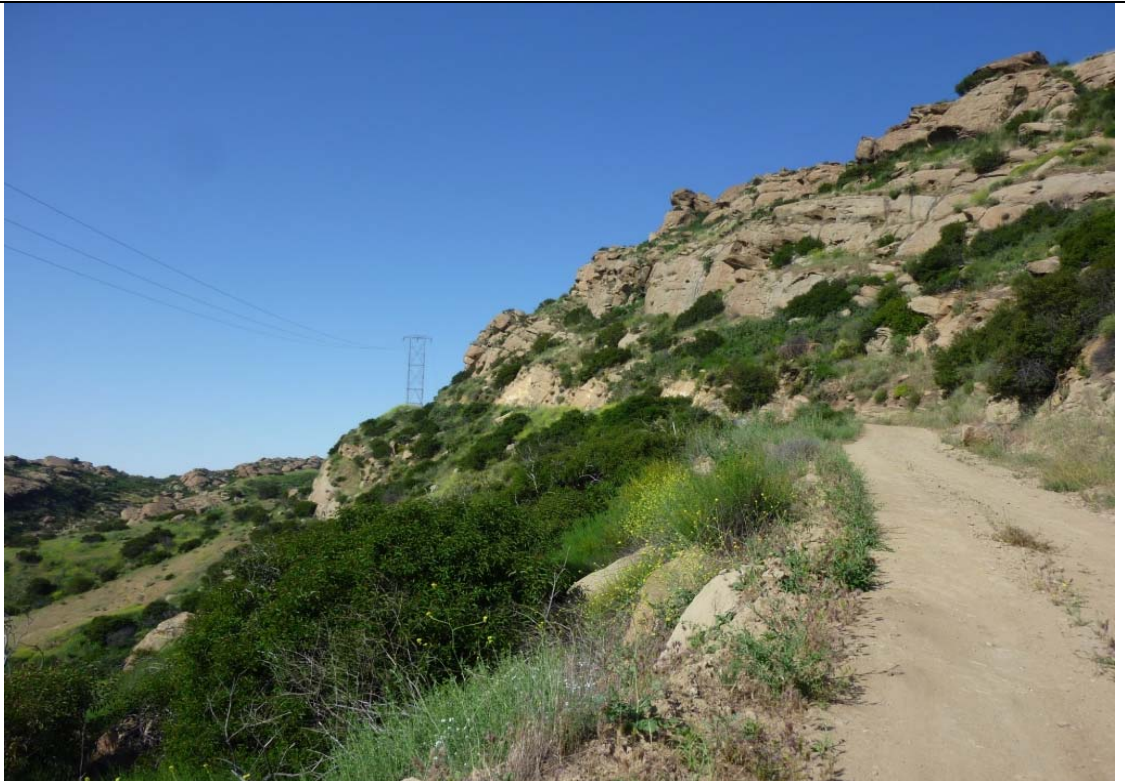
Photo No.
2

**Direction Photo
Taken:**
Southwest

Description:
Portion of CH-1 near
northern end of the
North American Cutoff.
Note – steep
topography and CSS
habitat.

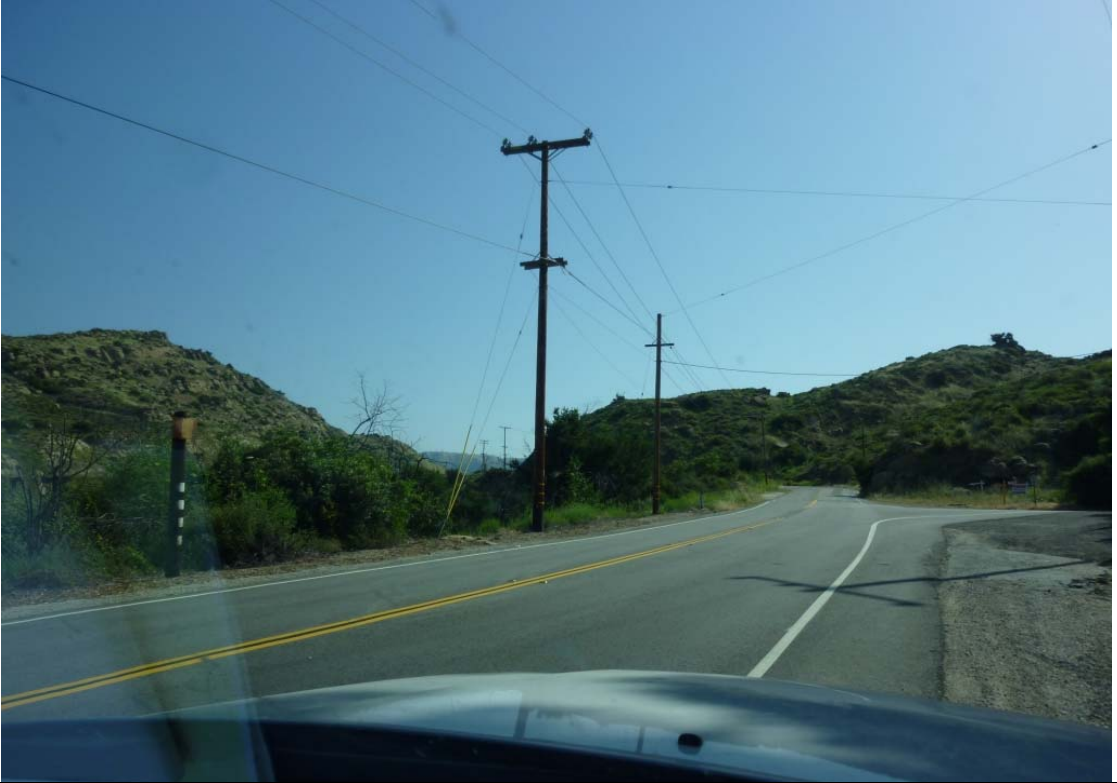
Direction Photo Taken: Northeast					
Description: Portion of CH-1 along Santa Susana Pass Road. Note – CSS habitat and coast live oak trees.					
Photo No. 4	Date: 5/5/11

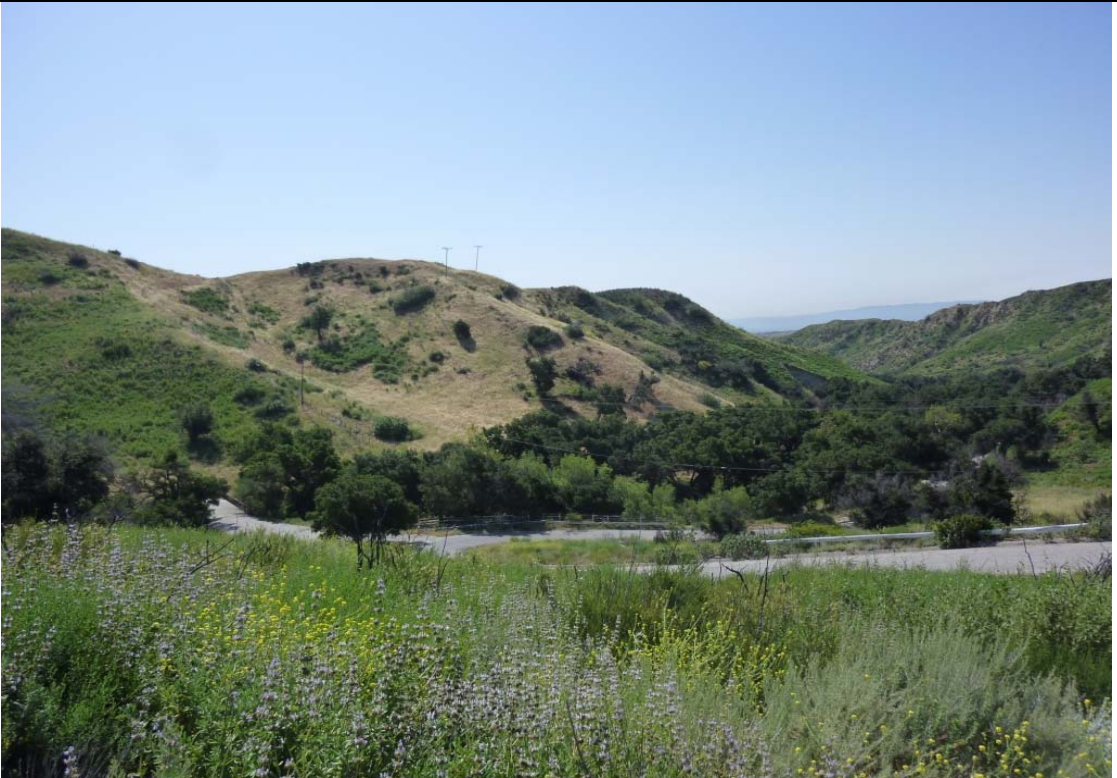
Direction Photo Taken: Southeast					
Description: From Brown's Canyon Road looking down Brown's Canyon at a portion of CH-2. Note – CSS habitat on hillsides and coast live oak woodland along bottom of canyon.

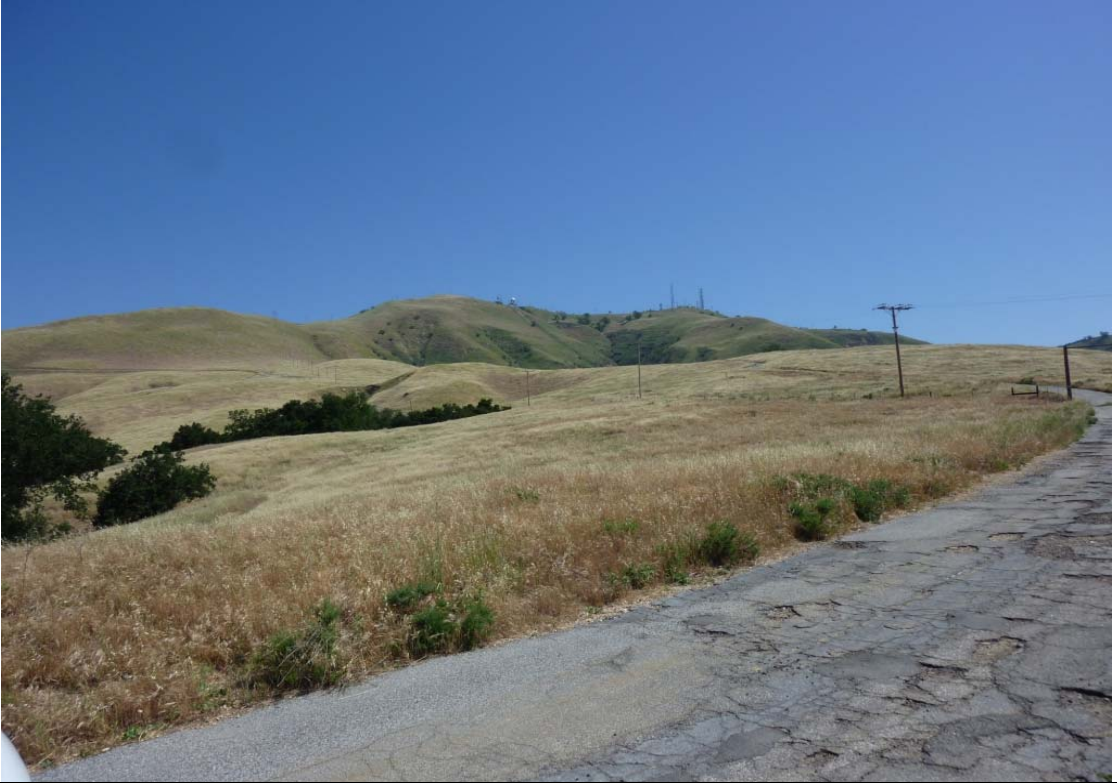
Direction Photo Taken: North			
Description: From Oat Mountain Highway looking at CH-2 as it ascends hillside to Oat Mountain. Note – Non-native Annual Grassland (NNAG) habitat with coast live oak trees in lower areas.			
Photo No. <div style="text-align: center; font-size: 1.2em; font-weight: bold;">6</div>	Date: <div style="text-align: center;">4/15/11</div>

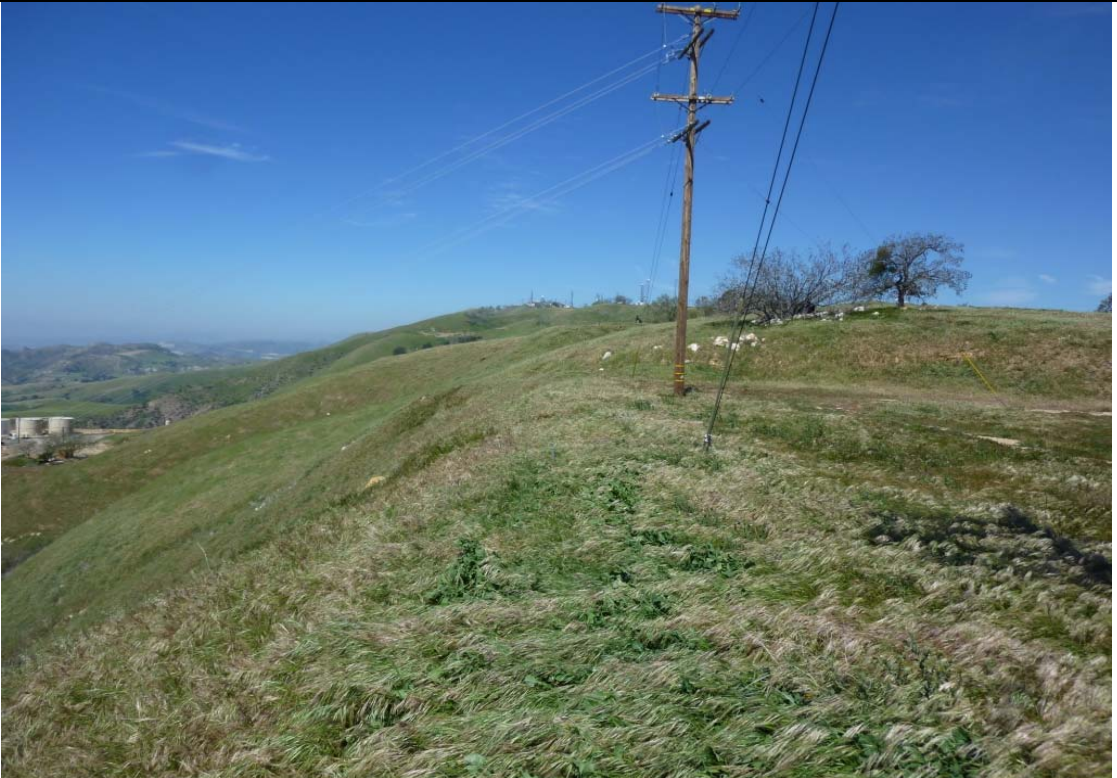
Direction Photo Taken: West			
Description: Portion of CH-3 inside SCG Aliso Canyon Storage Facility – looking along ridgeline towards Oat Mountain. Note – monotypic NNAG habitat.

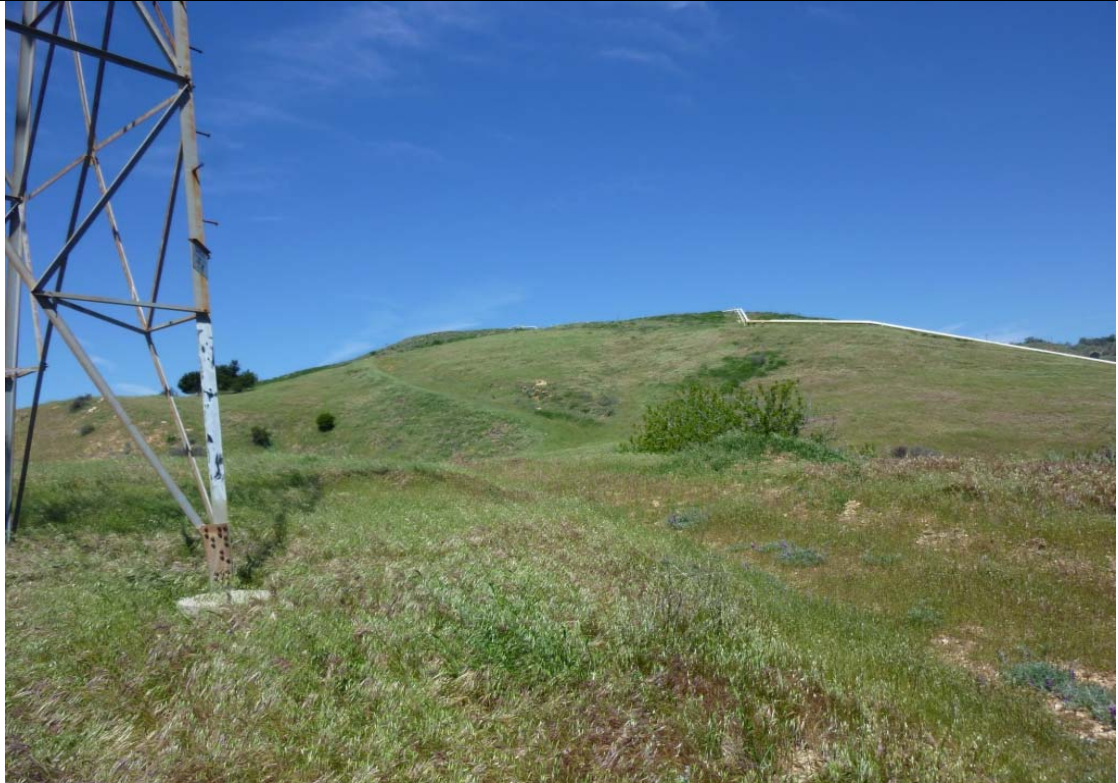
Direction Photo Taken: Northwest			
Description: From proposed Natural Substation site looking at portion of CH-4 that will enter the substation. Note – NNAG habitat.			
Photo No. 8	Date: 4/28/11

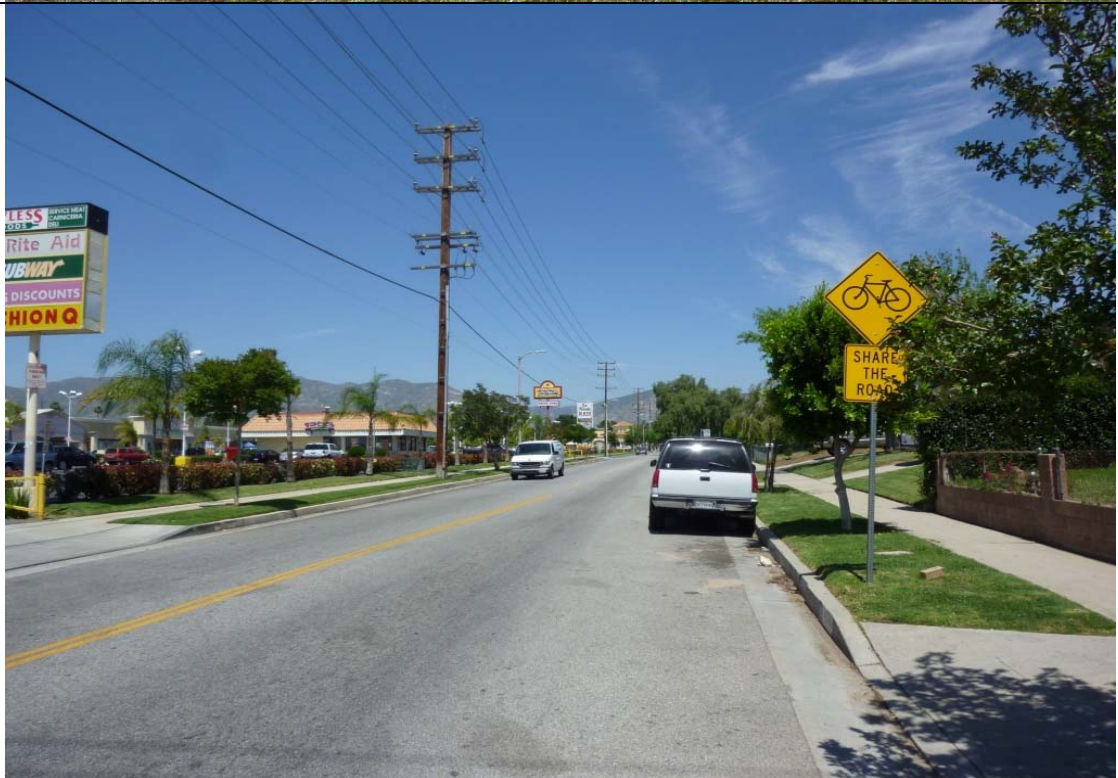
Direction Photo Taken: Northeast			
Description: Portion of SF line along Workman Street in San Fernando Valley. Note – urban setting.

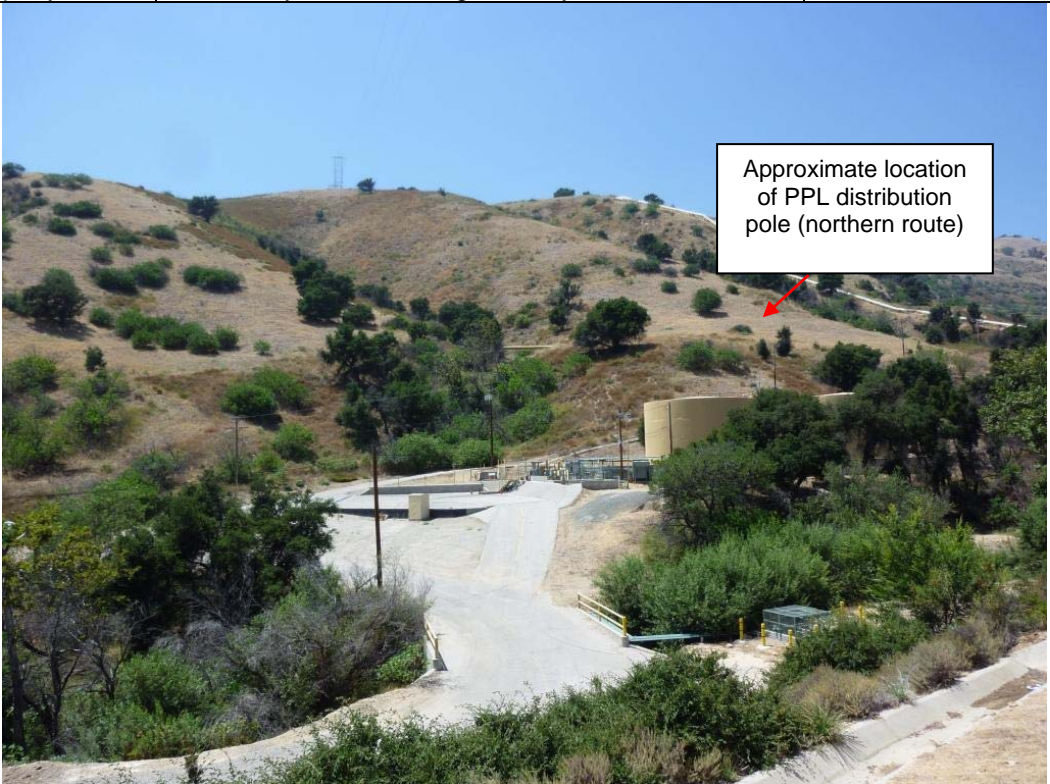
Client Name: Southern California Gas Company		Site Location: Aliso Canyon Gas Storage Facility	Project No. 60137730
Photo No. 1	Date: 7/28/11

Direction Photo Taken: Looking west			
Description: Looking toward hillside on which proposed PPL and access road will be built.			
Photo No. 2	Date: 7/28/11

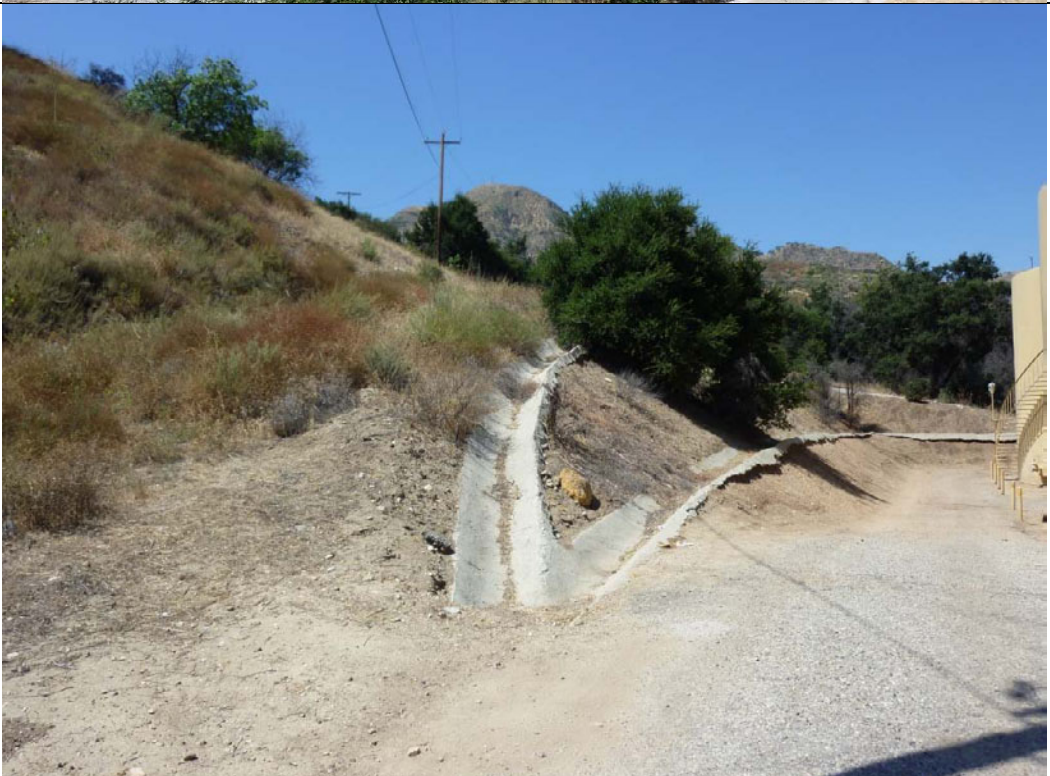
Direction Photo Taken: Looking north			
Description: Beginning of proposed PPL access road. The overhead lines in the photo are part of the existing Storage Field 16kV loop.

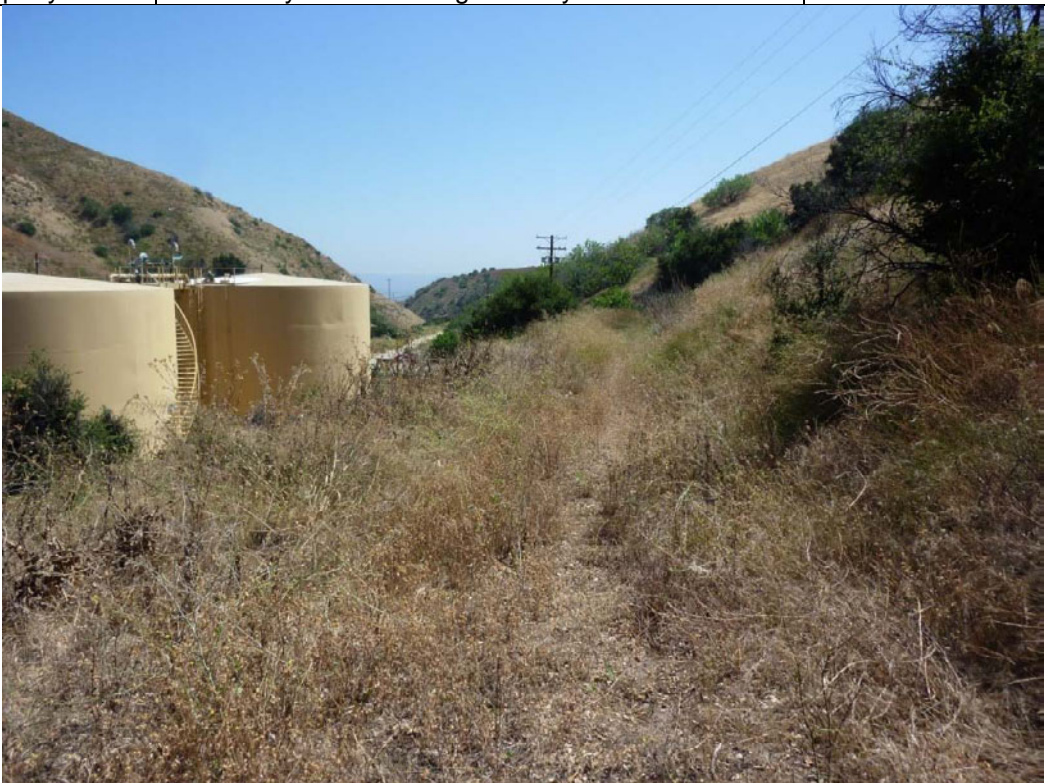
Client Name: Southern California Gas Company		Site Location: Aliso Canyon Gas Storage Facility	Project No. 60137730
Photo No. 3	Date: 7/28/11

Direction Photo Taken: Looking south			
Description: Lower portion of proposed PPL access road.			
Photo No. 4	Date: 7/28/11
