Biological Resources Studies (E1 to E8)

Appendix E1
Special Status Plant Species Report

Special-status Plant Species Report

Aliso Canyon Turbine Replacement Project
Los Angeles County, California

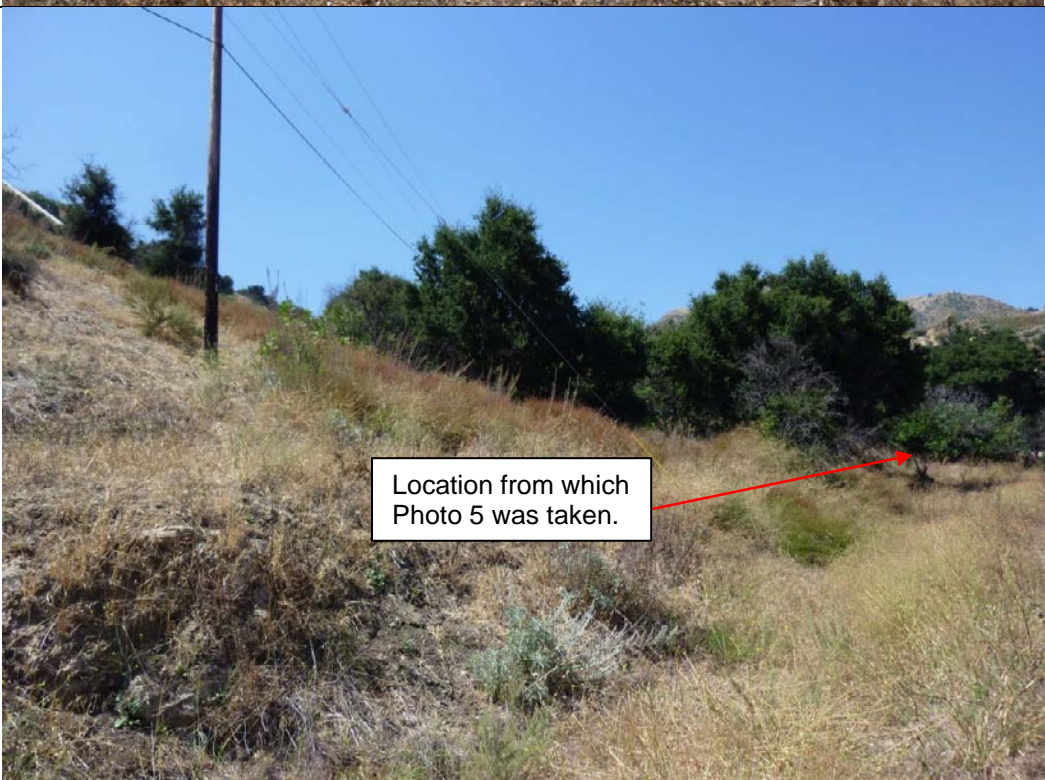
<div data-bbox="831 1581 1109 1663">Location from which Photo 5 was taken.</div>	
Direction Photo Taken: Looking northwest			
Description: Lower portion of proposed PPL access road, looking toward grove of coast live oak next to which the road will pass.

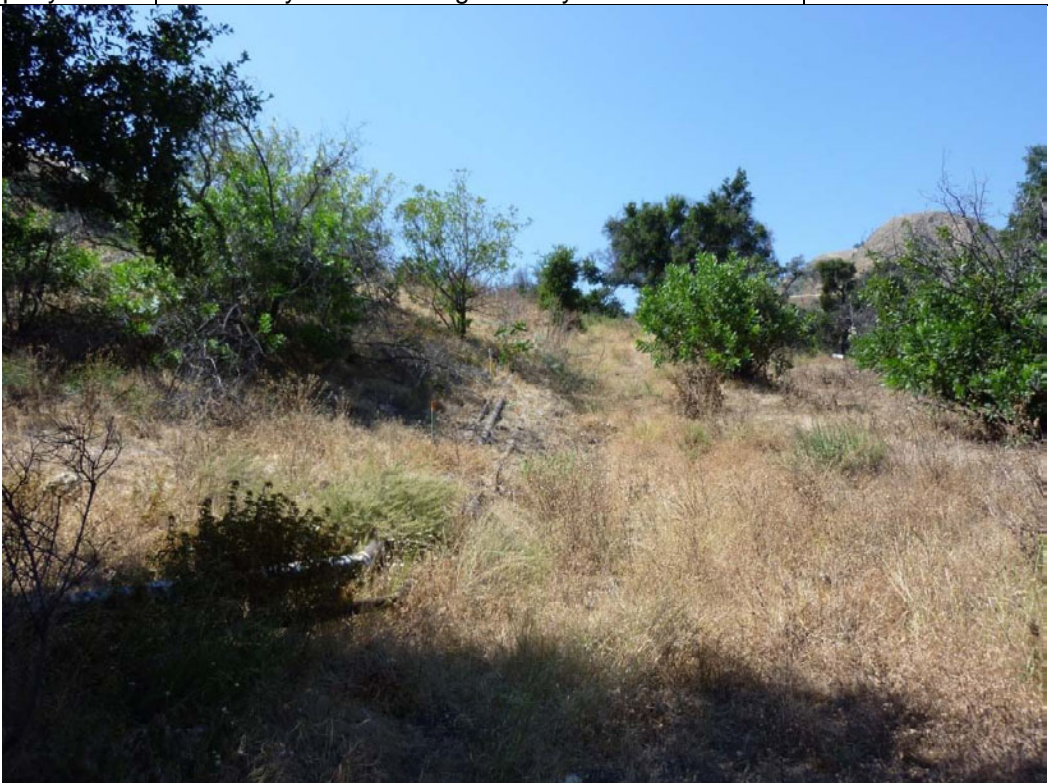
Direction Photo Taken: Looking northwest			
Description: Middle portion of proposed PPL access road. Photograph taken adjacent to coast live oak (left edge of frame) next to which road will pass.			
Photo No. 6	Date: 7/28/11

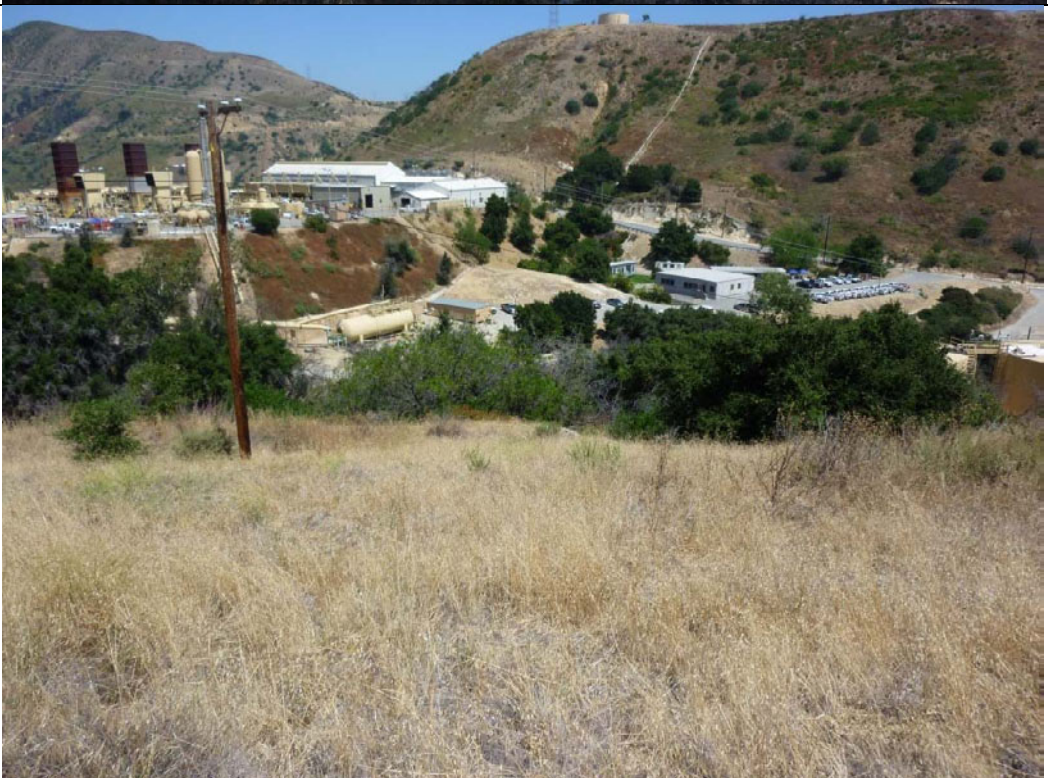
Direction Photo Taken: Looking east			
Description: Upper portion of proposed PPL access road, looking downhill toward coast live oak grove next to which road will pass.

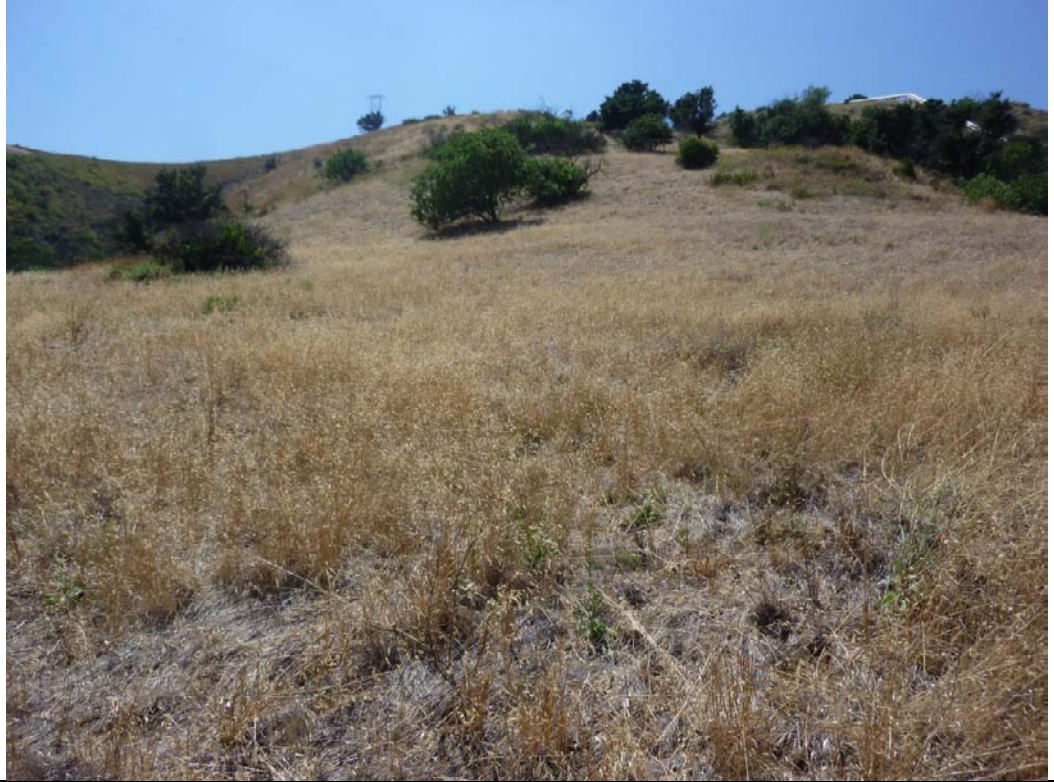
Photo No.
7

**Direction Photo
Taken:**
Looking west

Description:
Upper portion of proposed
PPL access road, looking
uphill toward proposed
tower location/road
turnaround.
