Pacific Gas and Electric Company Stantec Consulting, Inc.

File: Fulton-Fitch Mountain Reconductoring Date: June 27, 2018

Reference: Fulton-Fitch Mountain Reconductoring Project: Seasonal Watercourse Avoidance and

Crossing Plan

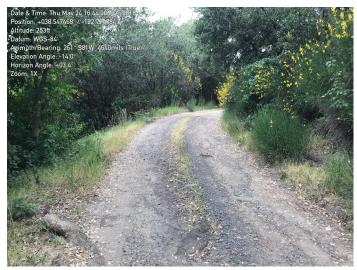
Photograph 1. FFX1 at SEW44 on Access Road A15.

| ISMND Crossing Number | SWACP Crossing Number | Crossed by | Nearest Project Impact Areas | Water Feature to be Crossed | Proposed Avoidance and Minimization Method |
|---|---|--|---|---|--|
| FFX1 | N/A | Access road 15 | Pole 42 | Seasonal watercourse (SEW44) | Existing culvert |

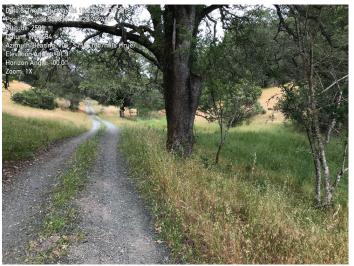
Photograph 3. FFX3 at SEW 7/C1 on Access Road 31.

| ISMND Crossing Number | SWACP Crossing Number | Crossed by | Nearest Project Impact Areas | Water Feature to be Crossed | Proposed Avoidance and Minimization Method |
|---|---|--|---|---|--|
| FFX3 | N/A | Access road 31 | Pole 58 | Seasonal watercourse (SEW7/C1) | Steel plate |

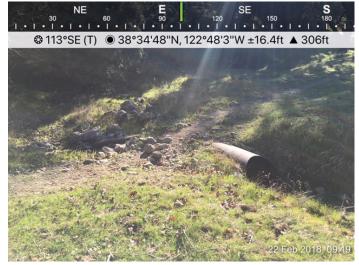
Photograph 5. FFX8 at SEW 3 on Access Road 36.

| ISMND Crossing Number | SWACP Crossing Number | Crossed by | Nearest Project Impact Areas | Water Feature to be Crossed | Proposed Avoidance and Minimization Method |
|---|---|--|---|---|--|
| FFX8 | N/A | Access road 36 | Pole 66 | Seasonal watercourse (SEW 3) | Existing culvert/steel plate |

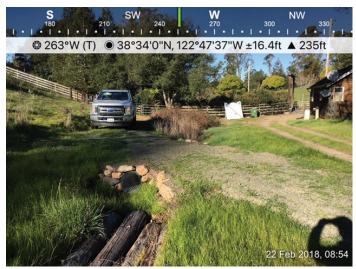
Photograph 2. FFX2 at SW1/MW0-01 on Access Road 31.

| ISMND Crossing Number | SWACP Crossing Number | Crossed by | Nearest Project Impact Areas | Water Feature to be Crossed | Proposed Avoidance and Minimization Method |
|---|---|--|---|---|--|
| FFX2 | N/A | Access road 31 | Pole 58 | Seasonal wetland (SW1/MW0-01) | Existing culvert |

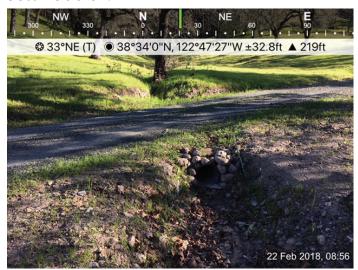
Photograph 4. FFX4 at SEW 7/C1 on Access Road 31.

| ISMND Crossing Number | SWACP Crossing Number | Crossed by | Nearest Project Impact Areas | Water Feature to be Crossed | Proposed Avoidance and Minimization Method |
|---|---|--|---|---|--|
| FFX4 | N/A | Access road 31 | Pole 58 | Seasonal watercourse (SEW 7) | Existing culvert |

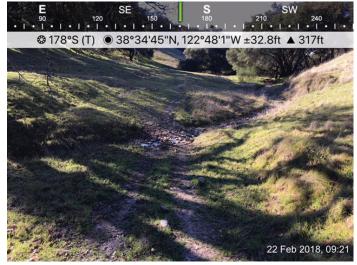
Photograph 6. FFX10 at SEW 3 on Access Road 36.

| ISMND Crossing Number | SWACP Crossing Number | Crossed by | Nearest Project Impact Areas | Water Feature to be Crossed | Proposed Avoidance and Minimization Method |
|---|---|--|---|---|--|
| FFX10 | N/A | Access road 36 | Pole 66 | Seasonal watercourse (SEW 3) | Steel plate |

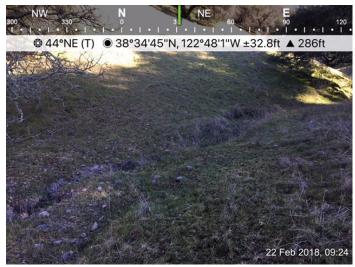
Photograph 7. FFX11 at SEW 2 on Access Road 35.

| ISMND Crossing Number | SWACP Crossing Number | Crossed by | Nearest Project Impact Areas | Water Feature to be Crossed | Proposed Avoidance and Minimization Method |
|---|---|--|---|---|--|
| FFX11 | N/A | Access road 35 | Pole 66 | Seasonal watercourse (SEW 2) | Steel plate |

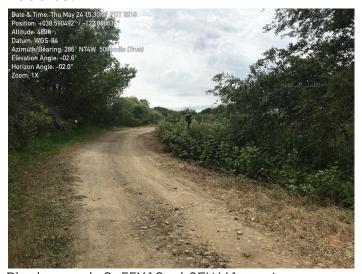
Photograph 9. FFX13 at SEW61 on Access Road 41.

| ISMND Crossing Number | SWACP Crossing Number | Crossed by | Nearest Project Impact Areas | Water Feature to be Crossed | Proposed Avoidance and Minimization Method |
|---|---|--|---|---|--|
| FFX13 | N/A | Access road 41 | Landing Zone-5 | Seasonal watercourse (SEW61) | Existing culvert |

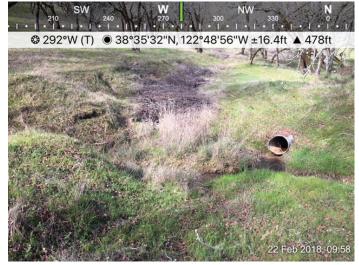
Photograph 11. FFX15 at SEW 8a on Access Road 46b.

| ISMND Crossing Number | SWACP Crossing Number | Crossed by | Nearest Project Impact Areas | Water Feature to be Crossed | Proposed Avoidance and Minimization Method |
|---|---|--|---|---|--|
| FFX15 | N/A | Access road 46b | Pole 74 | Seasonal watercourse (SEW 8a) | Steel plate |

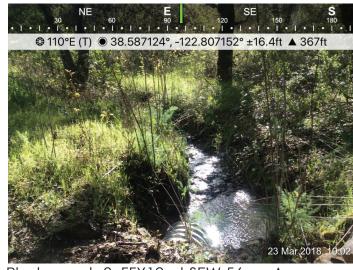
Photograph 8. FFX12 at SEW 56 on Access Road 39.

| ISMND Crossing Number | SWACP Crossing Number | Crossed by | Nearest Project Impact Areas | Water Feature to be Crossed | Proposed Avoidance and Minimization Method |
|---|---|--|---|---|--|
| FFX12 | N/A | Access road 39 | Pole 70 | Seasonal watercourse (SEW56) | Steel plate |

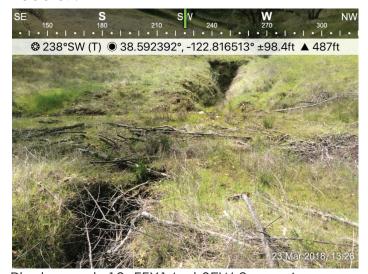
Photograph 10. FFX14 at SEW 8a on Access Road 46.

| ISMND Crossing Number | SWACP Crossing Number | Crossed by | Nearest Project Impact Areas | Water Feature to be Crossed | Proposed Avoidance and Minimization Method |
|---|---|--|---|---|--|
| FFX14 | N/A | Access road 46 | Pole 75 | Seasonal watercourse (SEW 8a) | Steel plate |

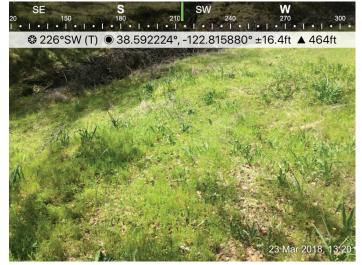
Photograph 12. FFX16 at SEW8A on Access Road 46.

| ISMND Crossing Number | SWACP Crossing Number | Crossed by | Nearest Project Impact Areas | Water Feature to be Crossed | Proposed Avoidance and Minimization Method |
|---|---|--|---|---|--|
| FFX16 | N/A | Access road 46 | Pole 74 | Seasonal watercourse (SEW8a) | Steel plate |

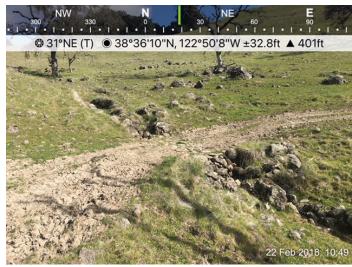
Photograph 13. FFX20 at SEW 6 on Access Road 54.

| FFX19 | N/A | Access road abandoned by project | Pole 77 | Seasonal watercourse (SEW54) | N/A |
|---|---|--|---|---|---|
| FFX20 | N/A | Access road 54 | Pole 87 | Seasonal watercourse (SEW 6) | Steel plate |

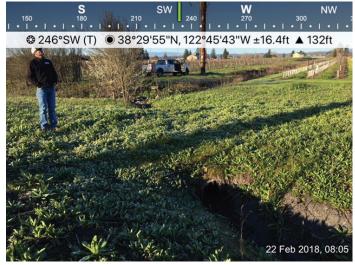
Photograph 17. WC-3 at D1 on Access Road B-01.

| FFX32 | N/A | Project does not cross feature; See Table 2 below | Pole 67 | Drainage Ditch (D6) | Flag and avoid, implement BMPs |
|---|---|---|---|---|---|
| N/A | WC-3 | Access road B01 | Pull Site-2, Pole 5 | Drainage ditch (D1) | Existing culvert |

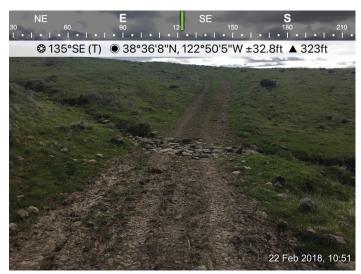
Photograph 14. FFX21 at SEW 5 on Access Road 54.

| FFX19 | N/A | Access road abandoned by project | Pole 77 | Seasonal watercourse (SEW54) | N/A |
|---|---|--|---|---|---|
| FFX21 | N/A | Access road 54 | Pole 86 | Seasonal watercourse (SEW 5) | Steel plate |

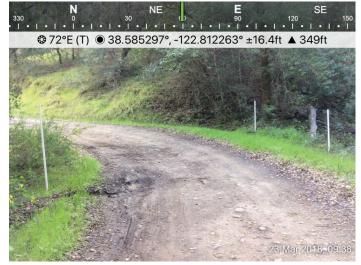
Photograph 18. WC-4 at unnamed seasonal watercourse on Access Road 39.

| FFX32 | N/A | Project does not cross feature; See Table 2 below | Pole 67 | Drainage Ditch (D6) | Flag and avoid, implement BMPs |
|---|---|---|---|---|---|
| N/A | WC-4 | Access road 39 | Pole 70 | N/A | Existing culvert |

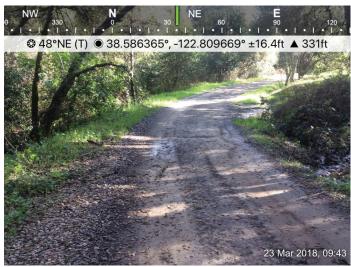
Photograph 19. WC-5 at unnamed seasonal watercourse on Access Road 39.

| FFX32 | N/A | Project does not cross feature; See Table 2 below | Pole 67 | Drainage Ditch (D6) | Flag and avoid, implement BMPs |
|---|---|---|---|---|---|
| N/A | WC-5 | Access road 39 | Pole 70 | N/A | Existing culvert |

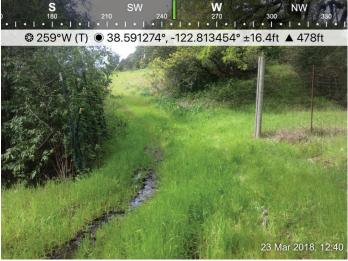
Photograph 21. WC-7 at SEW 33 on Access Road 44a.

| FFX32 | N/A | Project does not cross feature; See Table 2 below | Pole 67 | Drainage Ditch (D6) | Flag and avoid, implement BMPs |
|---|---|---|---|---|---|
| N/A | WC-7 | Access road 44a | Landing Zone-5 | Seasonal watercourse (SEW 33) | Existing culvert |

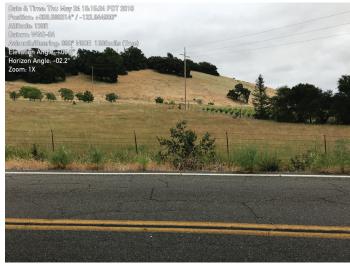
Photograph 23. WC-9 at C3 on new access to TAP staging area.

| FFX32 | N/A | Project does not cross feature; See Table 2 below | Pole 67 | Drainage Ditch (D6) | Flag and avoid, implement BMPs |
|---|---|---|---|---|---|
| N/A | WC-9 | New TAP AR | TAP Staging Area | Seasonal watercourse (C3) Steel plate | |

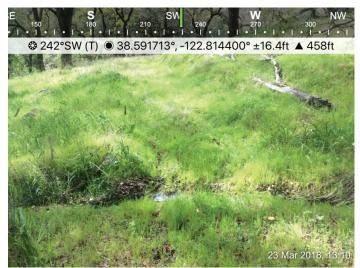
Photograph 22. WC-8 at SEW 34 on Access Road 44a.

| FFX32 | N/A | Project does not cross feature; See Table 2 below | Pole 67 | Drainage Ditch (D6) | Flag and avoid, implement BMPs |
|---|---|---|---|---|---|
| N/A | WC-8 | Access road 44a | Pole 74 | Seasonal watercourse (SEW 34) Steel plate | |
