## PROJECT MEMORANDUM PG&E ATLANTIC-DEL MAR REINFORCEMENT PROJECT

**Subject:** Weekly Report #38: January 1, 2006 – January 7, 2006

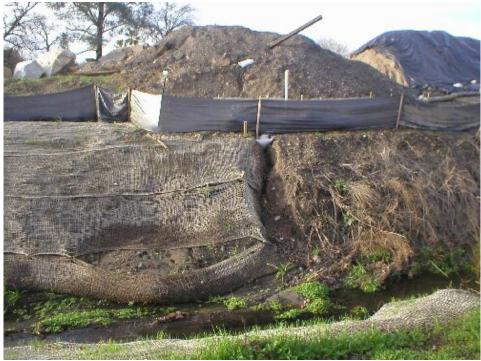
Erosion control in the vicinity of Seasonal Drainage #30 was in serious disrepair at the time of the CPUC EM site visit and silt from the nearby spoil piles was entering the resource, a CDFG jurisdictional drainage (see Figure 1). Erosion had occurred underneath the sediment fence which was installed at the bank line. Erosion extended from that point and all the way down the bank of the drainage. A Project Memorandum was issued to PG&E to document the occurrence and the close proximity of the spoil piles to Seasonal Drainage #30, which at some points are placed 10 to 12 feet from the top of the bank. In addition, a dewatering hole has been dug less than 35 feet from the drainage and surface and ground waters from areas covering the entire underground segment are being deposited into the hole. It was noted on Friday, January 6, that crews had made an effort to remedy the situation. Sediment fence was installed around some of the spoils piles closest to the drainage and sediment build-up at the existing sediment fence located at the bank line was removed. In addition, sand bags were placed within and around eroded areas inside the bank of Drainage #30 to prevent further erosion and hinder further sediment flow into the drainage (see Figure 2). Note that no equipment entered the drainage area and no earth moving occurred which is seasonally prohibited by the Project Streambed Alteration Agreement. Further repair is required.

Erosion control in the vicinity of Seasonal Drainage #30 was in serious disrepair at the time of the CPUC EM site visit and silt from the nearby spoil piles was entering the resource, a CDFG jurisdictional drainage. A Project Memorandum was issued to PG&E to document the occurrence and the close proximity of the spoil piles to Seasonal Drainage #30. It was noted on Friday, January 6, that crews had made an adequate effort to remedy the situation, although further repair is required.

Project Memo	1-6-06	Large spoil piles are being stored in close proximity to Seasonal Drainage #30 without adequate erosion control measures, which is a violation of APM 7-2. The erosion control along the drainage was in disrepair, which led to silt from the spoil piles being emptied into the CDFG drainage. Siltation entering the drainage is a violation of Condition #2 of the CDFG Streambed Alteration Agreement.	Crews reinforced the erosion control along Seasonal Drainage #30. The CDFG has been notified. A decision to move the spoil piles is being considered by PG&E.

**Figure 1** – Erosion at Seasonal Drainage #30, January 5, 2006.

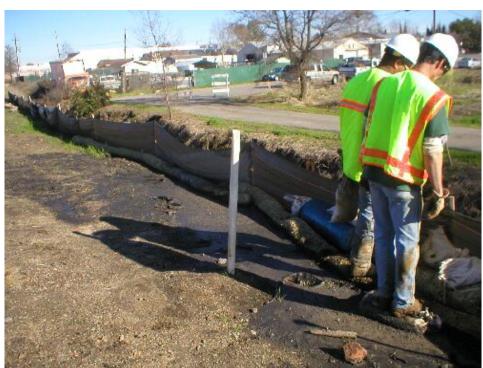
Figure 2 – Crews placing sand bags at Seasonal Drainage #30, January 6, 2006.
