# PROJECT MEMORANDUM PG&E ATLANTIC-DEL MAR REINFORCEMENT PROJECT

**Subject:** Weekly Report #54: April 23, 2006 – April 29, 2006

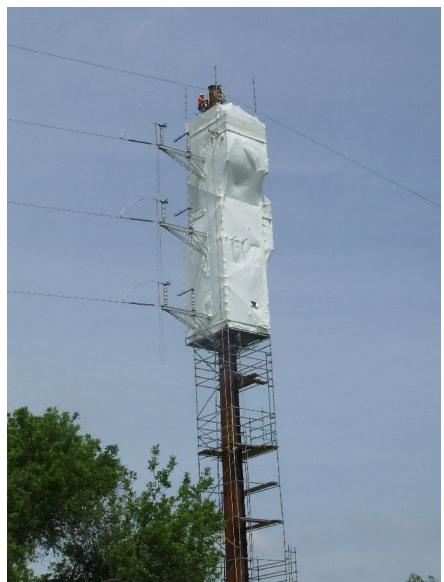
All overhead construction including pole, foundation, and line stringing work is being done by PG&E. During the subject week, the overhead crew strung a fiber optic cable between Transition Tower #10 and the Atlantic Substation (see Figure 1). The wire was put into place by using a helicopter to string a length of rope along pulleys situated on the top of the towers. Subsequently, the rope was used to pull and tighten the wire into place with trucks positioned at termination points. Crew members were placed on the towers using the helicopter.

Figure 1 – Wire-pulling at Transition Tower #10, April 25, 2006.
