**PROJECT MEMORANDUM
SCE TRANSMISSION PROJECTS, SEGMENTS 1 - 11**

To: John Boccio, Project Manager, CPUC
From: Vida Strong, Aspen Project Manager
Date: June 29, 2011
Subject: Weekly Reports 176 & 177, June 5 to June 18, 2011

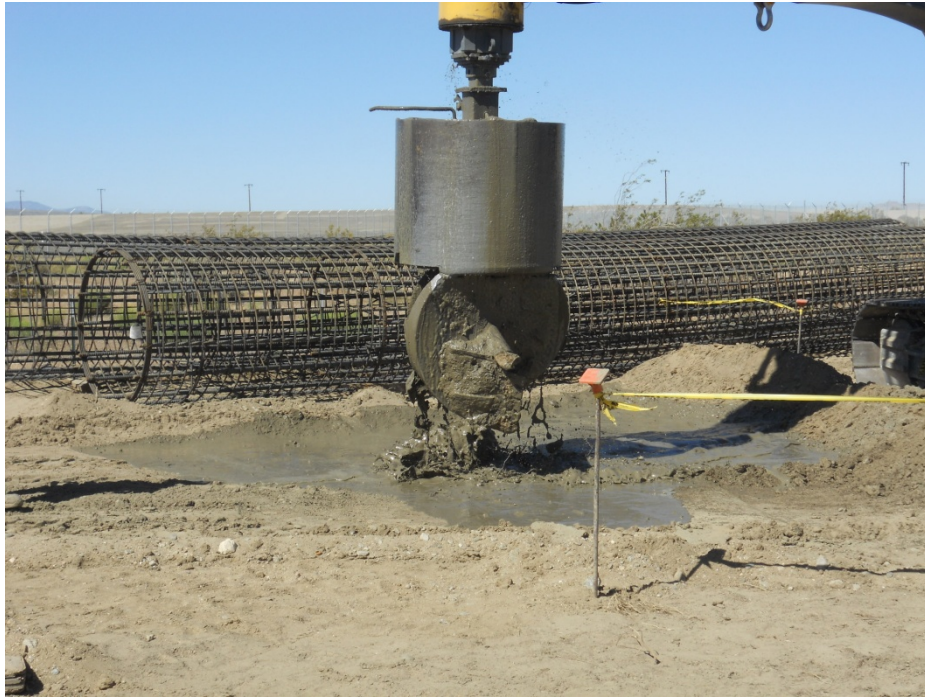
Figure 1: Drilling operation at Tower M74-T1X with the disposal of polymer, soil, and water mixture onsite, Segment 4.

2. Segment 4: KV Structures (drilling contractor) continued drilling, setting rebar cages using a spider jig for stub angle placement, and concrete pouring at Towers 1 and M74-T1X. They continued using Revert polymer during drilling operation of Tower M74-T1X due to unstable soils (see Figure 1). H&M steel crews continued tower assembly and erection work at various locations throughout the Segment. BMP's were maintained at various locations.

5. The Revert polymer mixture of soil and water was cleaned up, stockpiled on plastic sheeting and covered at Tower M74-T1X on Segment 4.
6. SCE received CDFG approval to water access roads through bird buffers.

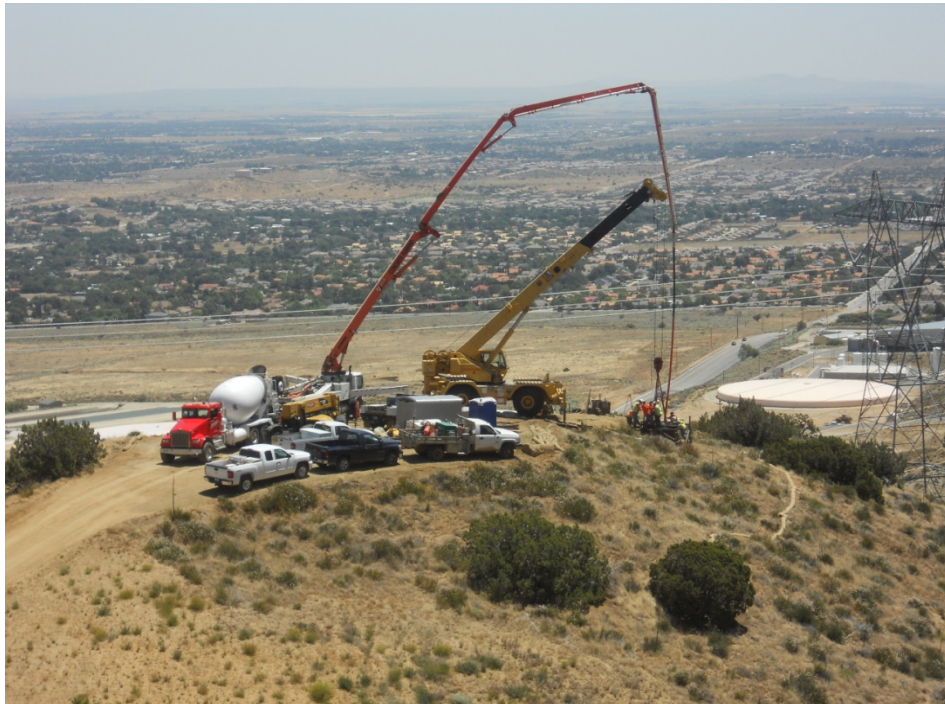
Figure 2: Woodward Brothers pouring concrete at Tower 18, Segment 5.

3. Segment 5: Woodward Brothers (drilling contractor) continued drilling, setting rebar cages, and concrete pouring at Towers 18, 20, 21, and 24 (see Figure 2). H&M steel crews continued tower assembly and erection work at various locations throughout the Segment. Tower pad re-contouring occurred at Tower 28A (see Figure 3). Removal of old steel and existing foundations from the 220 kV towers continued.

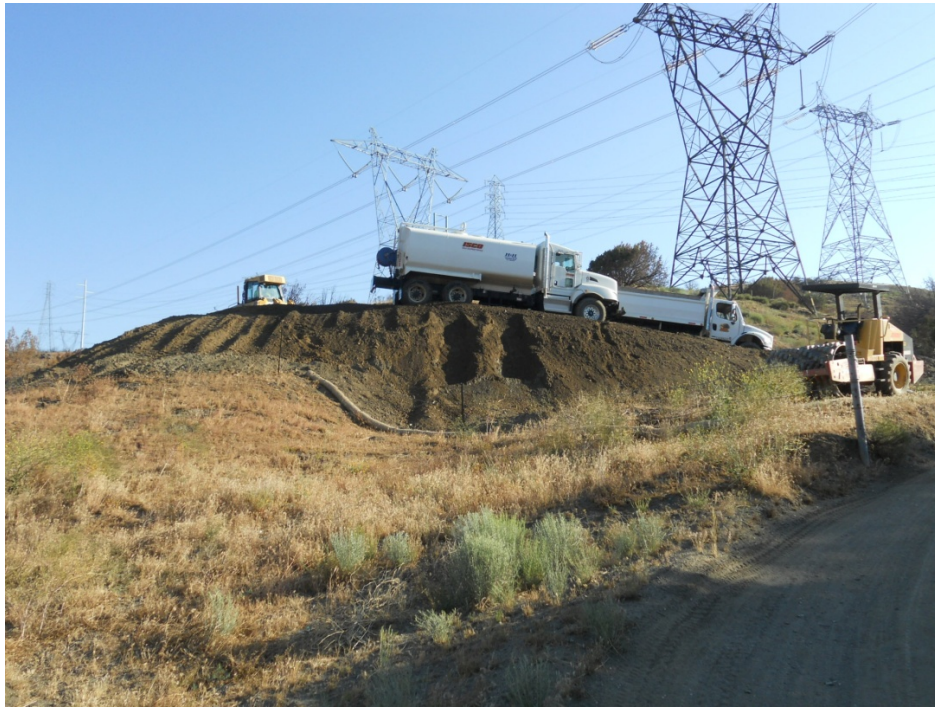
Figure 3: H&H Grading working on crane pad site at Tower 28A, Segment 5.

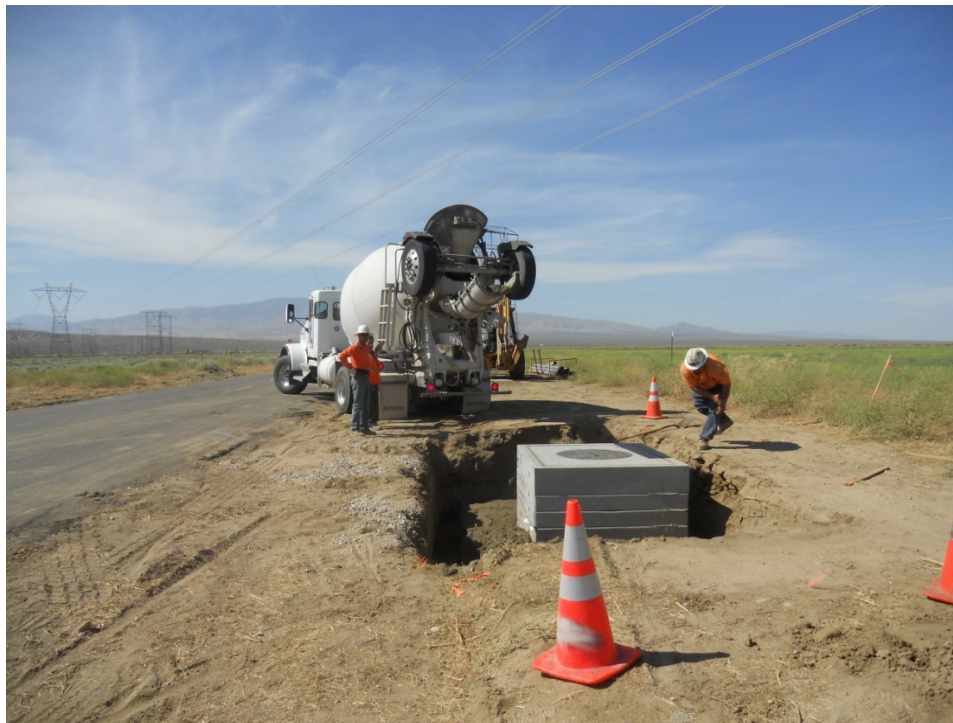
Figure 4: Tidwell pouring slurry around manhole on the east side of 170th Street, Segment 10 Telecom.

5. Segment 10 Telecom: Work continued on the 12 kV portion of the Segment from Whirlwind Substation to Gaskell Road. An SCE crew continued setting wood poles on the east side of 170th Street. Tidwell Excavation continued excavating and slurry placement in the manhole on the east side of 170th Street near Tower 5 on Segment 4 (see Figure 4). The crew also excavated and installed conduit

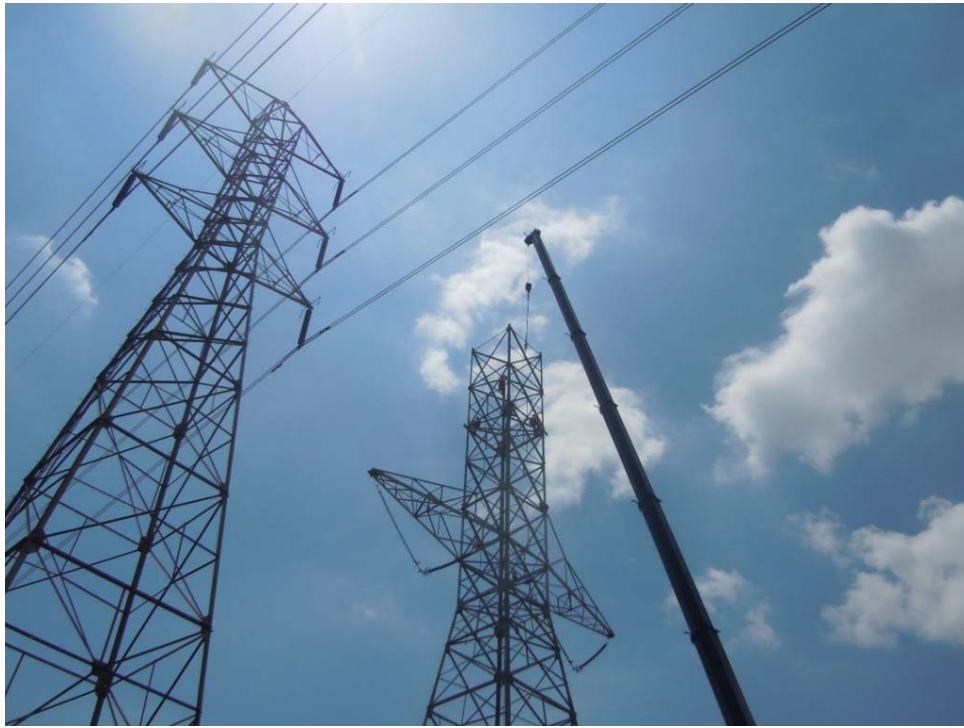
Figure 5: A Wilson crew assembles a tower, Segment 7

2. Segment 7: Wilson continued assembly on four towers within the Huntington Yard in the City of Duarte (see Figure 5). DCX and Tri-State continued drilling at four towers and excavated tower foundations at four locations (see Figure 6). Additionally, Wilson crews mowed tower sites and wire setup sites to keep environmental surveys active.

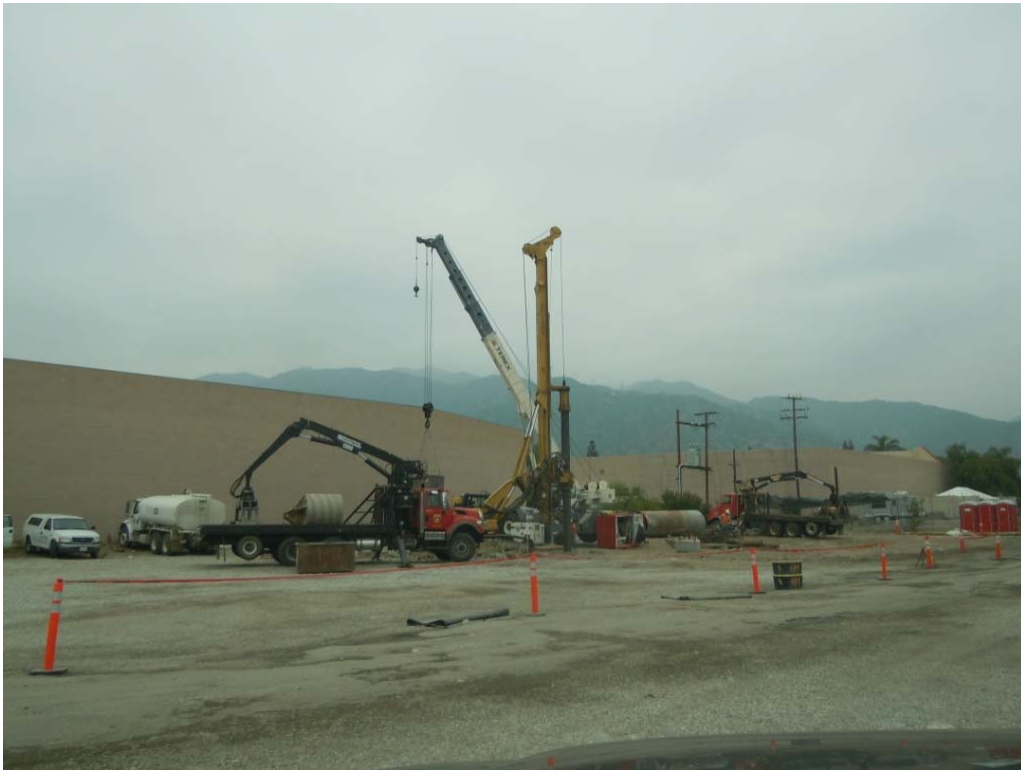
Figure 6: A Tri-State crew drills a foundation, Segment 7

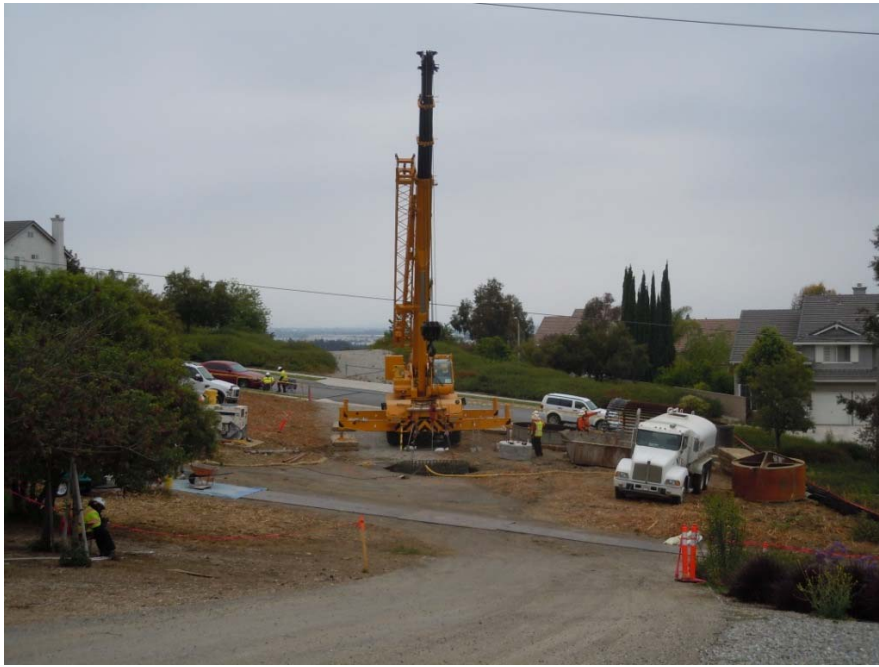
Figure 7: Crews drill a foundation for a TSP, Segment 8 Phase 1.

3. Segment 8, Phase 1: Wilson crews mowed and installed BMPs at tower sites and wire setup sites to keep environmental surveys active. Additionally, Wilson crews hauled steel for four tubular steel poles (TSPs) in Chino Hills and set one pole. Tri-State continued drilling at three pole sites (see Figure 7). No tower construction occurred in Tonner Canyon, City of Industry, due to biological resource restrictions (see #1 below).

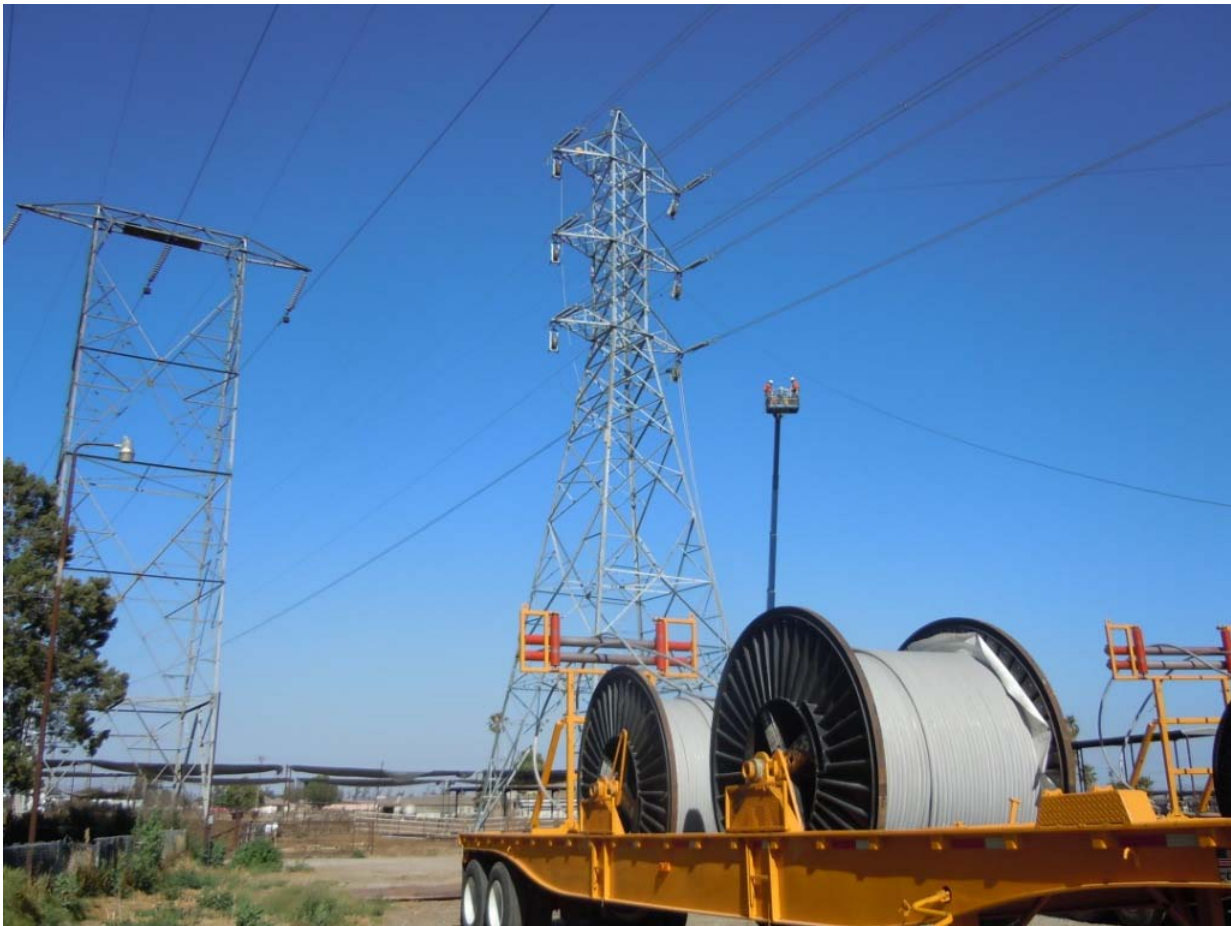
Figure 8: Crews string wire, Segment 8 Phase 2.

4. Segment 8, Phase 2: Wilson crews finished wire-stringing at Towers M2-T2 to M3-T2 on the Chino–Mira Loma No. 1 line (see Figure 8). The line was energized on Friday, June 17th.
