**PROJECT MEMORANDUM
SCE TRANSMISSION PROJECTS, SEGMENTS 1 - 11**

To: John Boccio, Project Manager, CPUC
From: Vida Strong, Aspen Project Manager
Date: October 14, 2011
Subject: Weekly Reports 190 and 191, September 11 to September 24, 2011

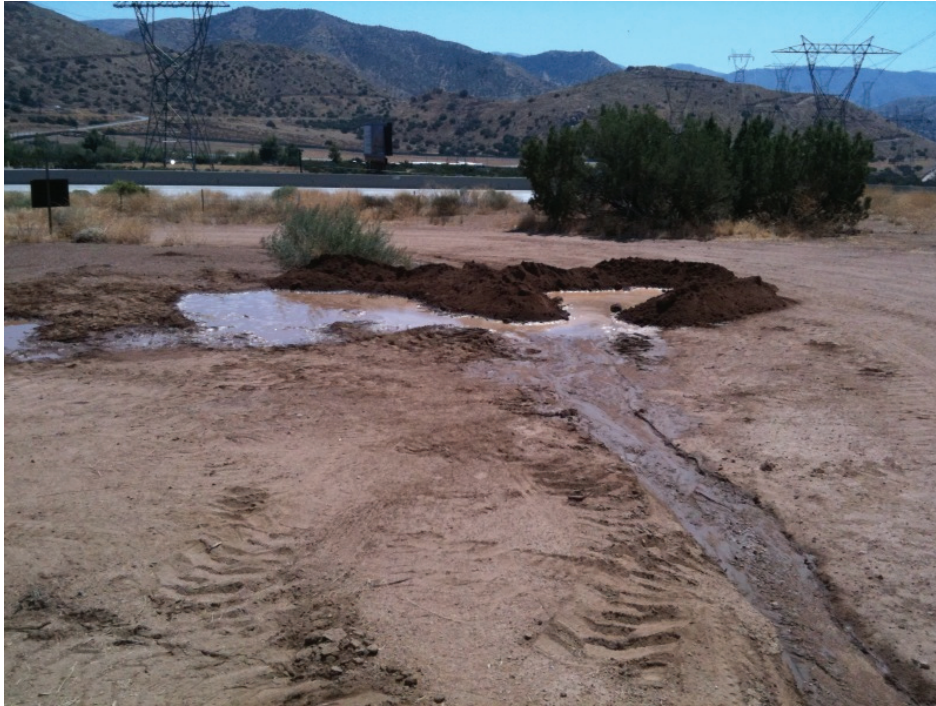
1. On September 12th, during a site visit, the CPUC EM was informed that the H&M underground fiber optic crew had pumped water from a trench onto the ground near Tower 63 on Segment 5. Water had collected in the trench from the weekend rain storm. The CPUC EM observed the ponded water at the end of a dirt access road (see Figure 1). The SCE Environmental Coordinator was notified of this occurrence. SCE was requested to provide details of the storm water discharge, including BMP's that were in place for erosion control/sedimentation and if any concrete had been recently poured in the trench. SCE provided a memorandum on September 17th detailing the discharge. Concrete had not been poured in the trench and there were a series of fiber rolls in place at the point of discharge, but subsequently, the water flowed onto the dirt access road.

Figure 1: Ponded storm water that was discharged from the trench near Towers 63 and 64, Segment 5.

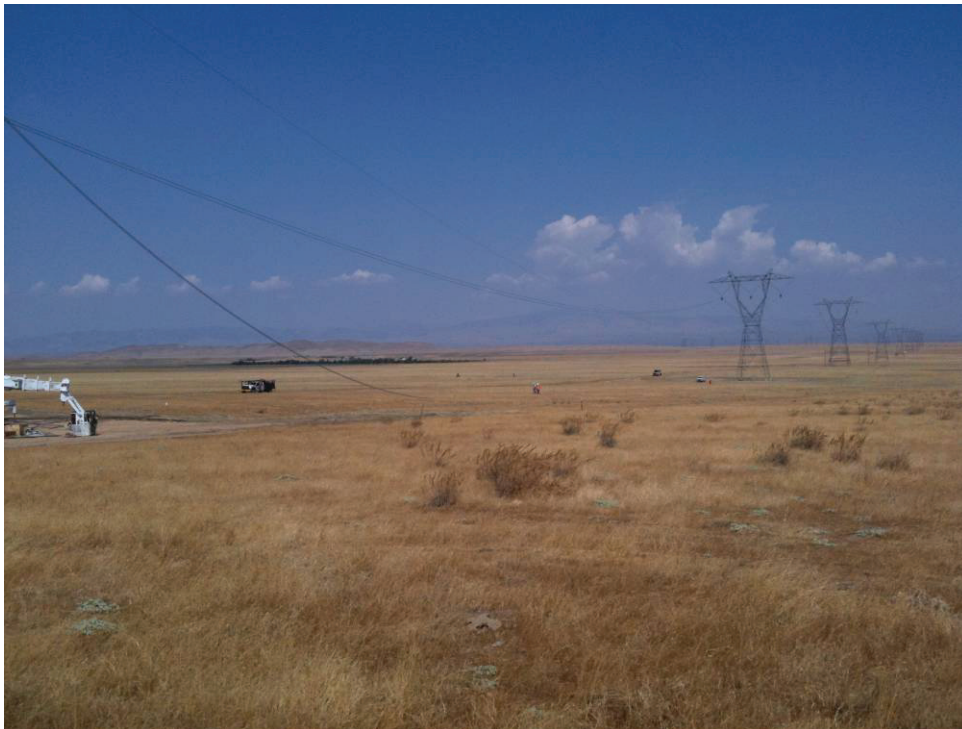
2. On September 14th, during wire stringing activity, the hard line broke approximately 80 feet from the puller site near Tower 39 on Segment 4. This caused the hard line and a portion of the conductor to fall to the ground between Towers 39 and 48 (see Figure 2). None of the line was on the ground across any public streets because these were guarded. But in order to secure the area and pull the line off the ground, equipment and trucks had to drive outside the approved disturbance areas near Towers 39, 47, and 48. Biological monitors were onsite to conduct a sweep of the newly impacted areas and observe activity. No cultural sites were located here and no biological Environmentally Sensitive Areas (ESAs) were impacted. SCE submitted written notification to CDFG for this incident.

Figure 2: View of conductor touching the ground north of Tower 48, Segment 4.

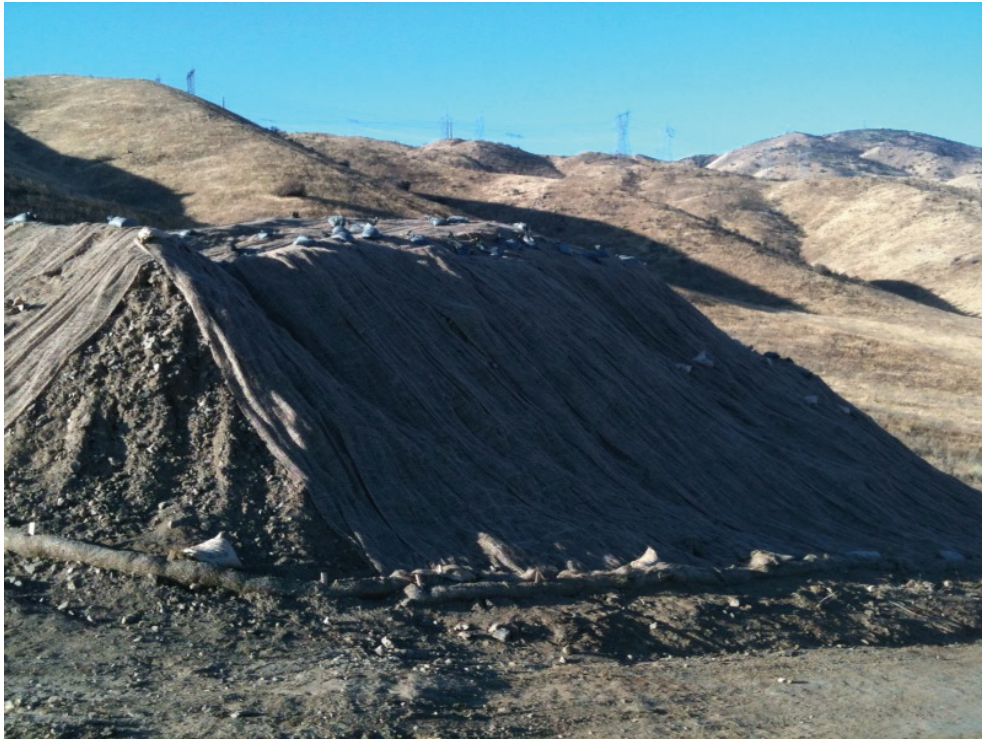
3. SCE submitted a request to CDFG and USFWS for approval to use an alternate tortoise gate on Segment 10.
4. The CPUC EM informed the SCE Environmental Coordinator that there are two inactive soil stockpiles near Towers 30 and 41 on Segment 5 that do not have BMP's installed. The contractor addressed both piles by installing fiber rolls around the perimeter and covering with jute netting (see Figure 3).

Figure 3: Covered soil stockpile near Tower 41, Segment 5.

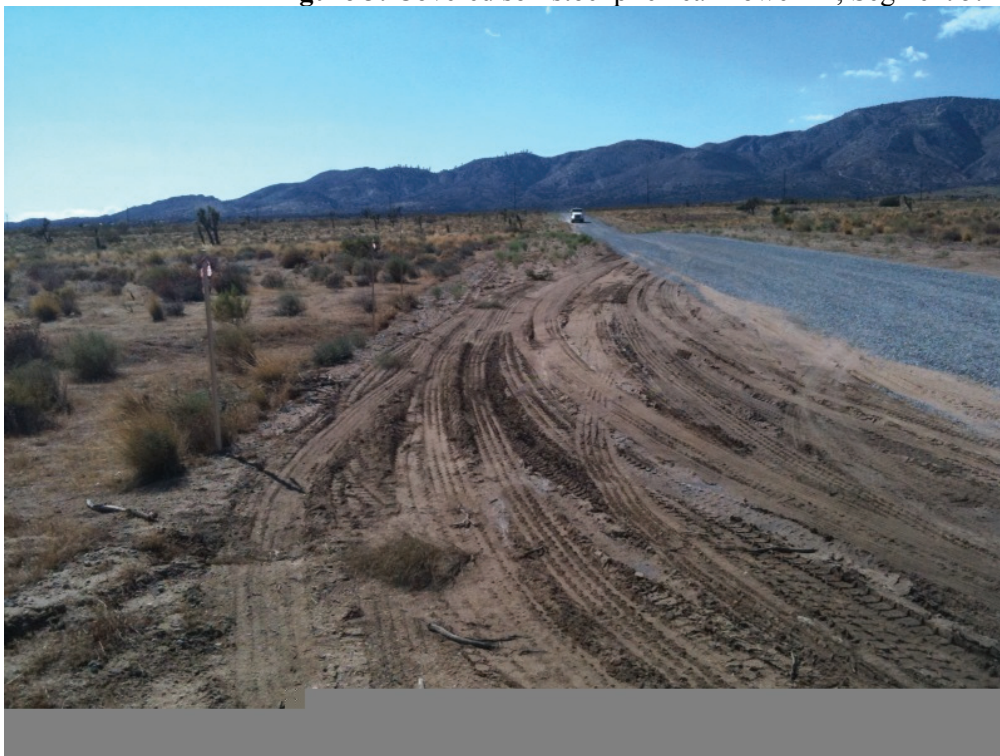
6. The CPUC EM expressed concern with concrete and water trucks making wide turns from Plum Road onto a spur road on Segment 10 (see Figure 4). Plum Road is a 22-foot gravel road and the trucks were

utilizing the adjacent dirt area. Because this dirt area was previously disturbed and is not considered desert tortoise and Mohave ground squirrel habitat, it will be restored after construction is completed.
