Southern California Edison's **Banducci Substation Project**

**Mitigation Monitoring, Compliance,
and Reporting Program**

FINAL CONSTRUCTION COMPLETION REPORT

June 2018

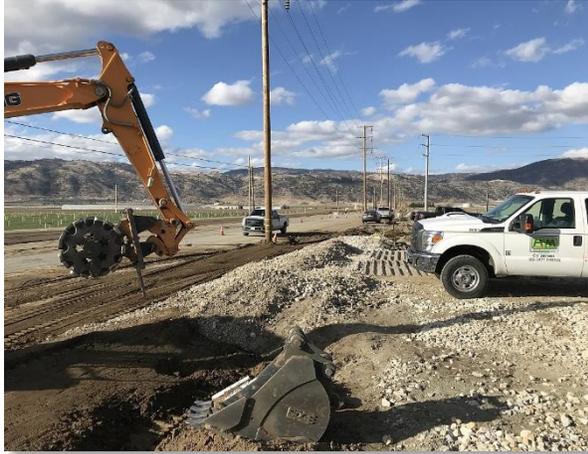
Figure 2. Construction of the stabilized construction entrance to the Banducci Substation built consistent with SWPPP requirements

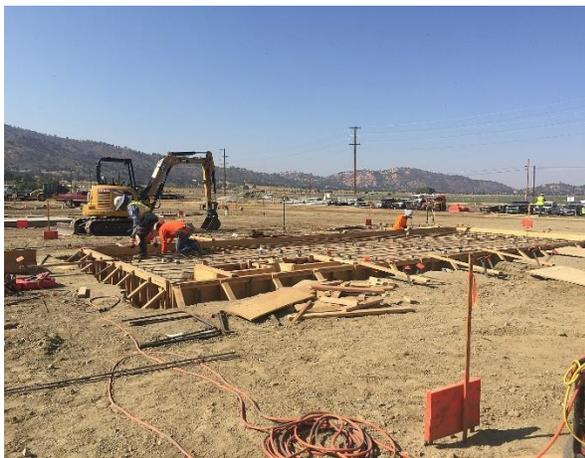
Figure 3. Foundation work inside of the Banducci Substation was conducted by Professional Engineering

Professional Engineering, the concrete contractor, built forms and set foundations throughout the substation site. Material for the perimeter wall was delivered and the block wall installation took place.

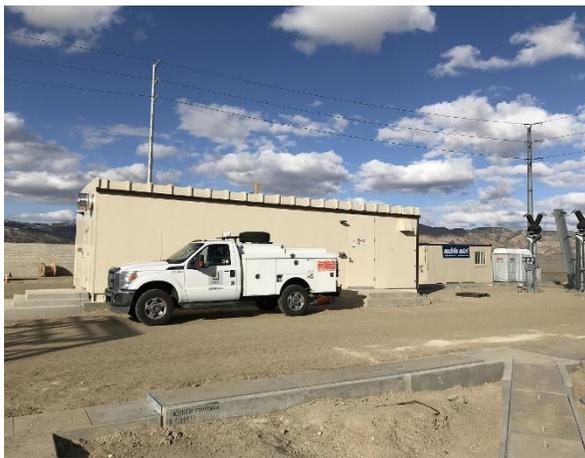
Figure 4. The MEER building at the Banducci Substation site

The MEER is a pre-fabricated structure approximately 10 feet high, 38 feet long, and 15 feet wide. The MEER is equipped with heating, ventilation, and air-conditioning (HVAC) units and houses protective relaying equipment, telecommunications equipment, substation automation and control equipment, batteries, and associated equipment. Control cables installed in trenches connect the MEER to the 66 kV and the 12 kV switchracks.

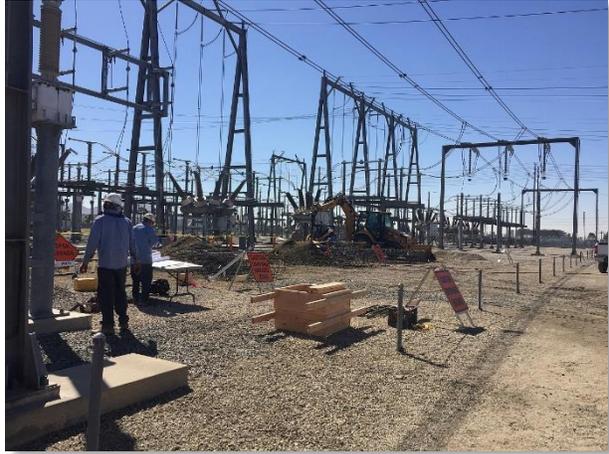
Figure 5. Bus structures and circuit breakers were installed at the Banducci Substation

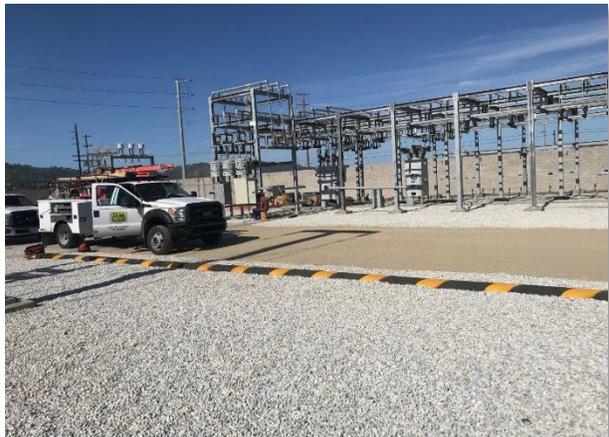
Figure 6. Base rock and rock driveway completed inside of the Banducci Substation (Photo courtesy of SCE)

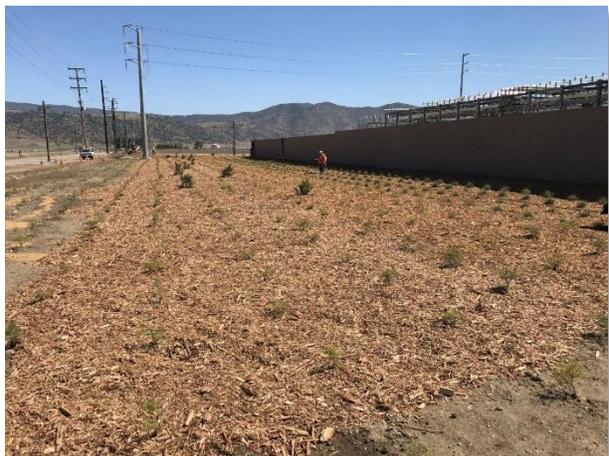
Figure 7. Landscaping and mulch was installed surrounding the Banducci Substation (Photo courtesy of SCE)

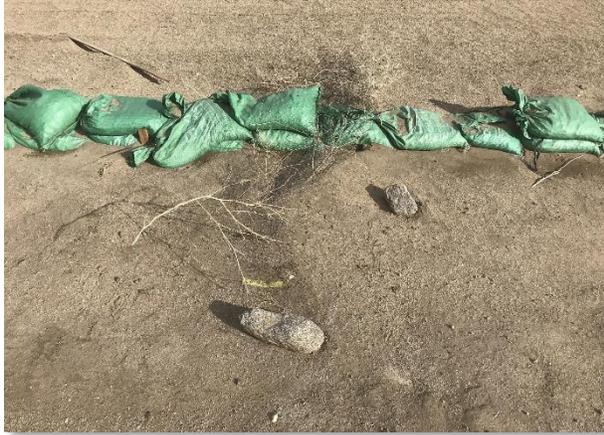
On February 13, the CPUC EM noted that sections of bird netting used to cover conduit was left on the ground unsecured. On February 14, two sections of bird netting were found caught in the perimeter sand bag berm surrounding the substation. The CPUC EM documented this as a Level B compliance incident, because of the threat to wildlife (entrapment) and also for microtrash (see Table 2).

Figure 8. Monofilament netting used to cover open pipes had become loose and blew to the edge of the substation site creating a wildlife entrapment hazard

Excavations and trenches were covered or wildlife escape ramps were installed at the end of each work day to prevent wildlife entrapment. Open pipes were covered using mesh netting to prevent wildlife from entering, consistent with permit conditions.

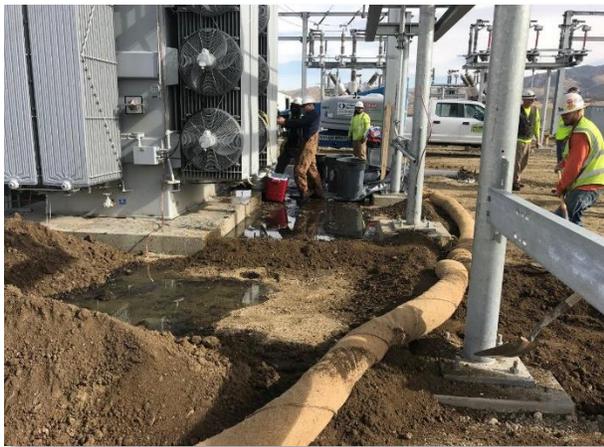
Figure 9. Spill and containment of the mineral oil spill from the damaged transformer

A major spill occurred on January 16 when a man-lift bumped into Transformer #1 at the Banducci Substation site. Approximately 125 gallons of mineral oil spilled out of the damaged transformer onto the ground. A professional environmental clean-up company was deployed to perform clean-up. The area contaminated was estimated to be 20-ft by 30-ft and impacted soil was removed. Repairs were made to the damaged transformer and additional mineral oil was added.

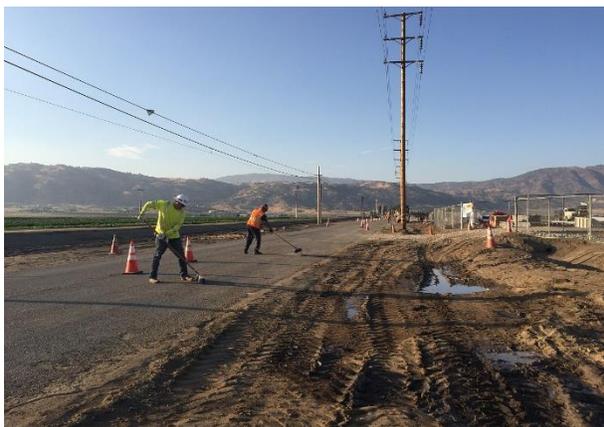
Figure 10. Crews swept any trackout from the substation site onto Pelliser Road

Dust suppression was implemented appropriately during grading activities. Stormwater BMPs were utilized appropriately to protect soil stockpiles and contain work areas. Driveway aprons were inspected for track-out and swept as needed. Spill kits were kept on site and all spills were reported, cleaned up, and disposed of properly. New equipment arriving on site was inspected for leaks and parked in the staging area or substation area. Concrete washouts were properly contained.

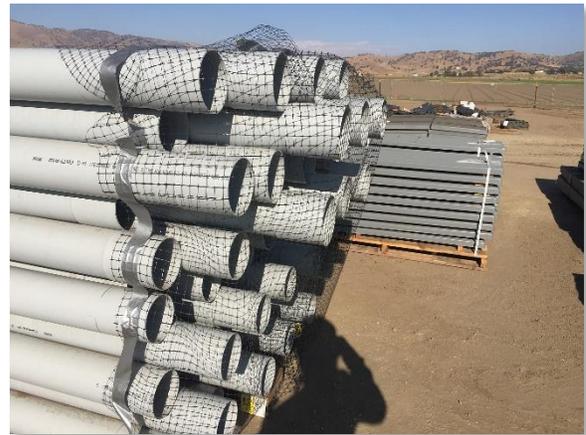
Figure 11. Open pipes were covered consistent with Mitigation Measure requirement to minimize wildlife entrapment

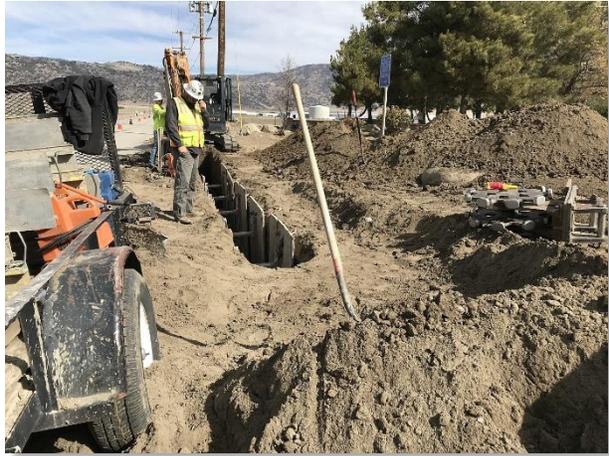
Figure 12. Crews installing conduit for the underground distribution line along Pelliser Road

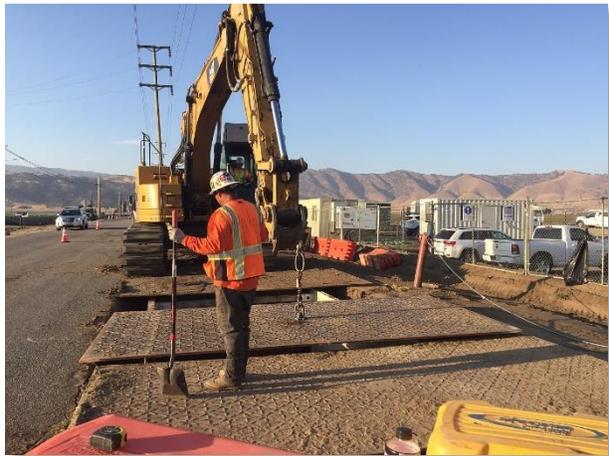
Figure 13. Steel plates were used to cover trench and vault excavations along Pelliser Road outside of the Banducci Substation

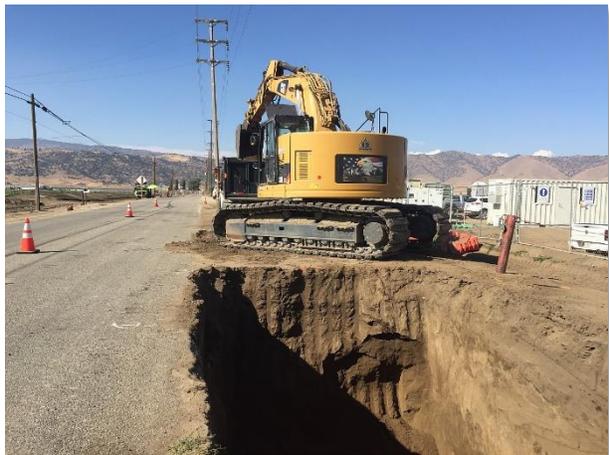
Figure 14. Traffic control was in place during vault excavation for the underground distribution work along Pelliser Road

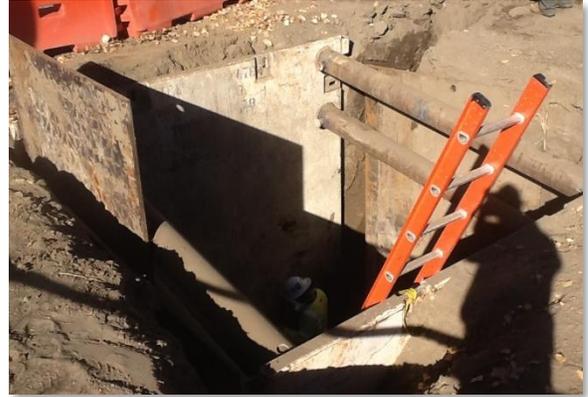
Figure 15. Bore pit for conduit installation under a culvert near Highline Road

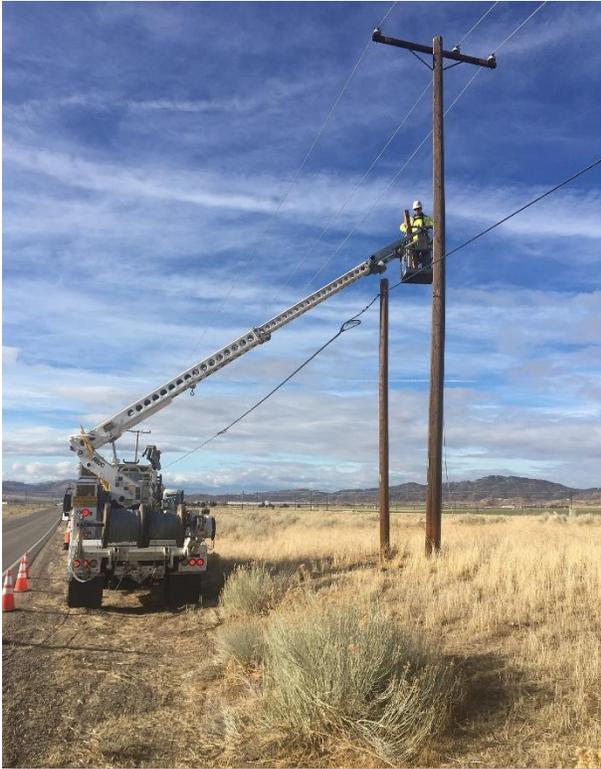
Figure 16. Henkels and McCoy telecom crews installing cable on existing wood poles along Highline Road near Tehachapi

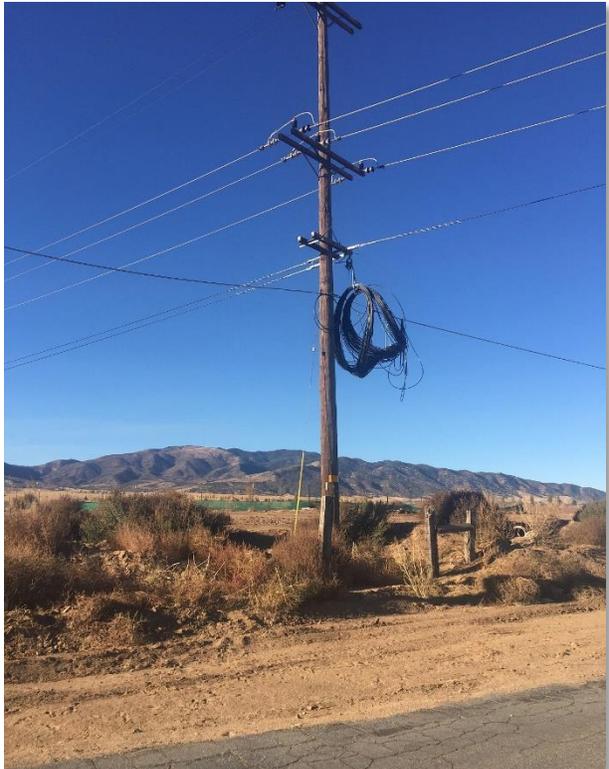
Figure 17. Telecom cable installed onto existing pole with excess cable ready for the Highway 58 Freeway crossing

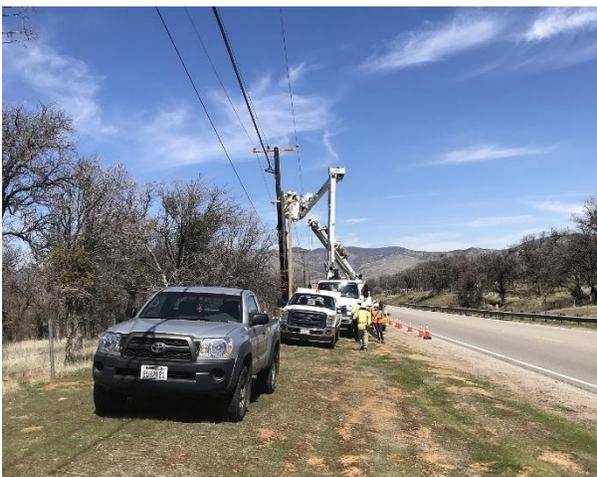
Figure 18. Distribution pole replacement along Highway 202 in Tehachapi

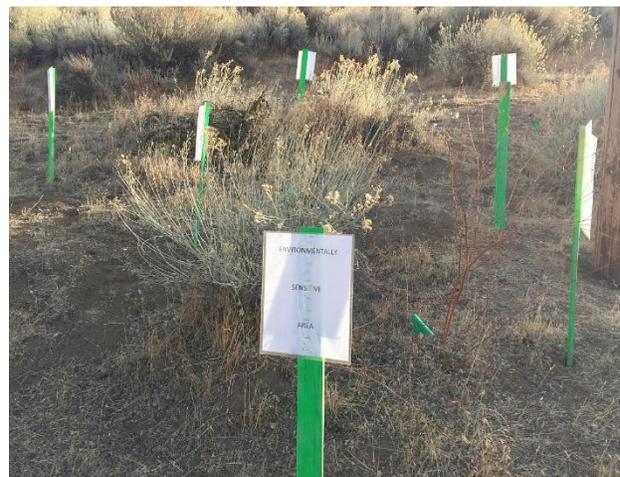
Figure 19. ESA avoidance signage surrounding CNPS List 4 plant population identified along the telecom route near the Prison

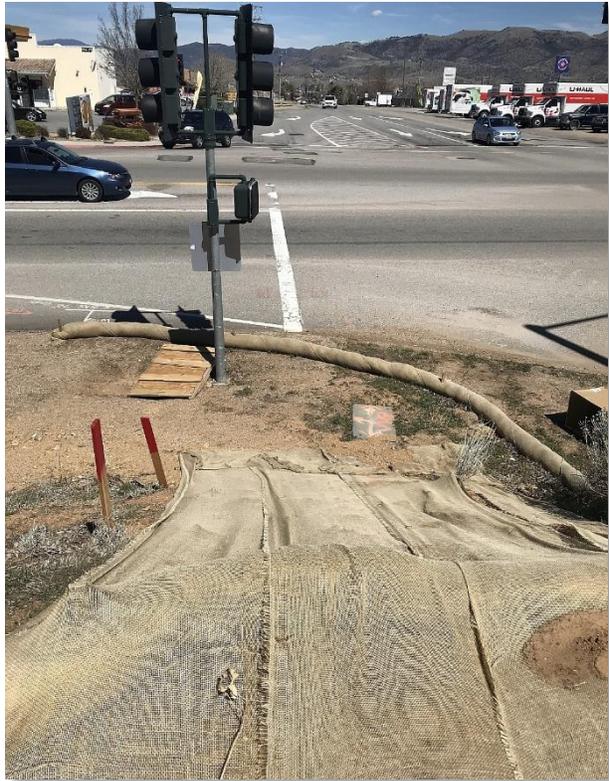
On February 7, during a final sweep of the work location near Tehachapi Woodford Road, the Project biologist noted that approximately 135 square feet of fresh ground disturbance was observed outside of the limits of disturbance. The impact occurred from back-dragging while backfilling an adjacent trench. No sensitive resources were impacted, and SCE documented this as a Level 1 non-compliance incident. Corrective actions were taken, including installation of additional signage and roping off the approved work limits. The disturbed area was stabilized with erosion control BMPs and ultimately sprayed with a hydroseed mix.

Figure 20. Areas disturbed during trenching activities were stabilized with erosion control blankets and later sprayed with hydroseed

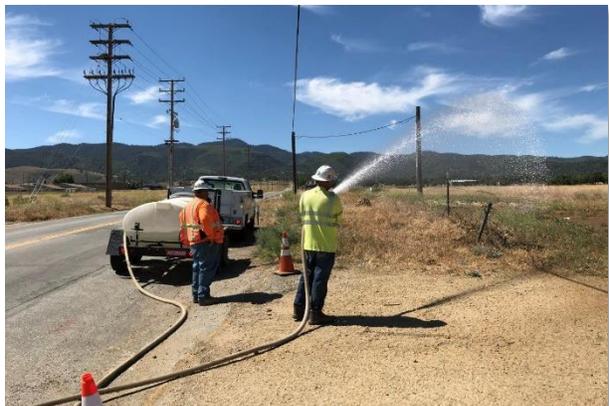
Figure 21. Watering hydroseeded area near Woodford Tehachapi Road (Photo courtesy of SCE)
