PROJECT MEMORANDUM
SCE BANDUCCI SUBSTATION PROJECT

To: Jensen Uchida, Project Manager, CPUC
From: Vida Strong, Aspen Project Manager
Date: October 31, 2017
Subject: Monitoring Report #4: September 24 to October 28, 2017

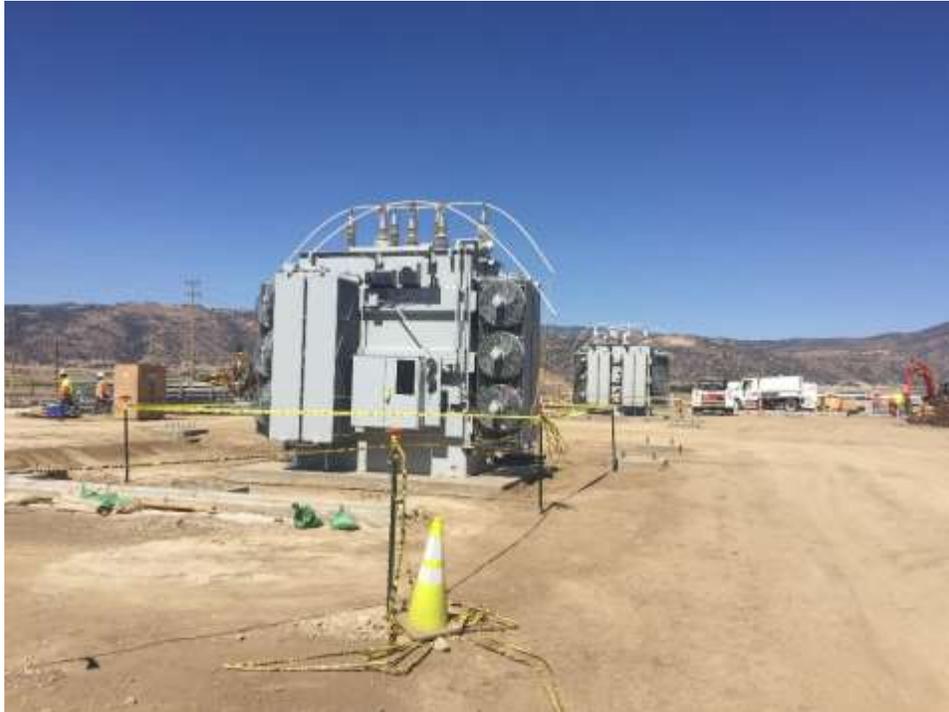
Figure 1 – Construction crews delivered and installed two transformers to the Banducci Substation site.

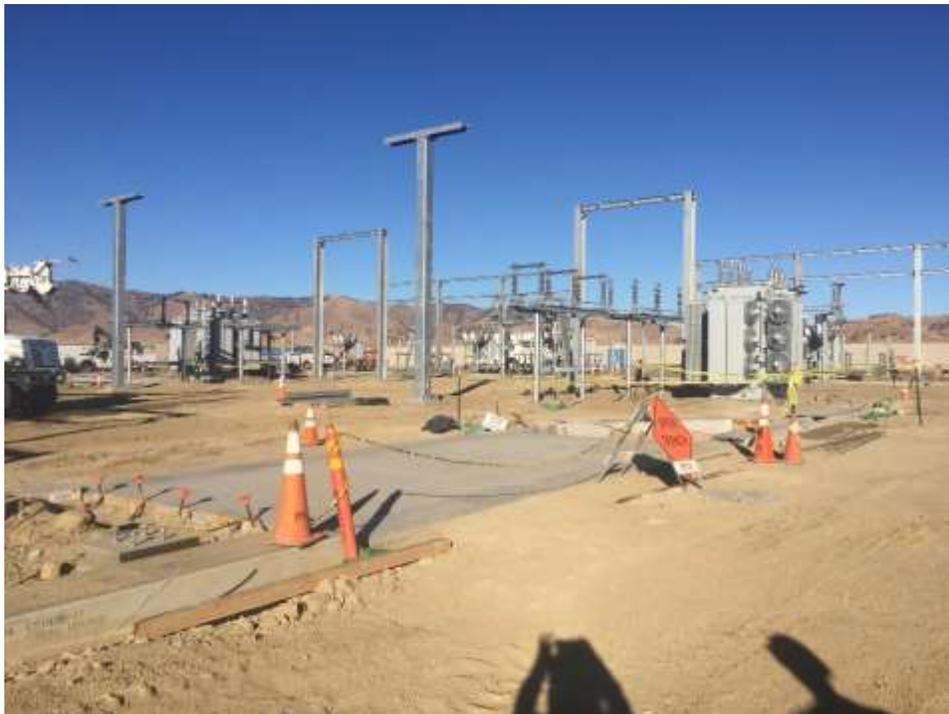
Figure 2 – Vertical steel infrastructure was erected at the Banducci Substation once foundations were completed.

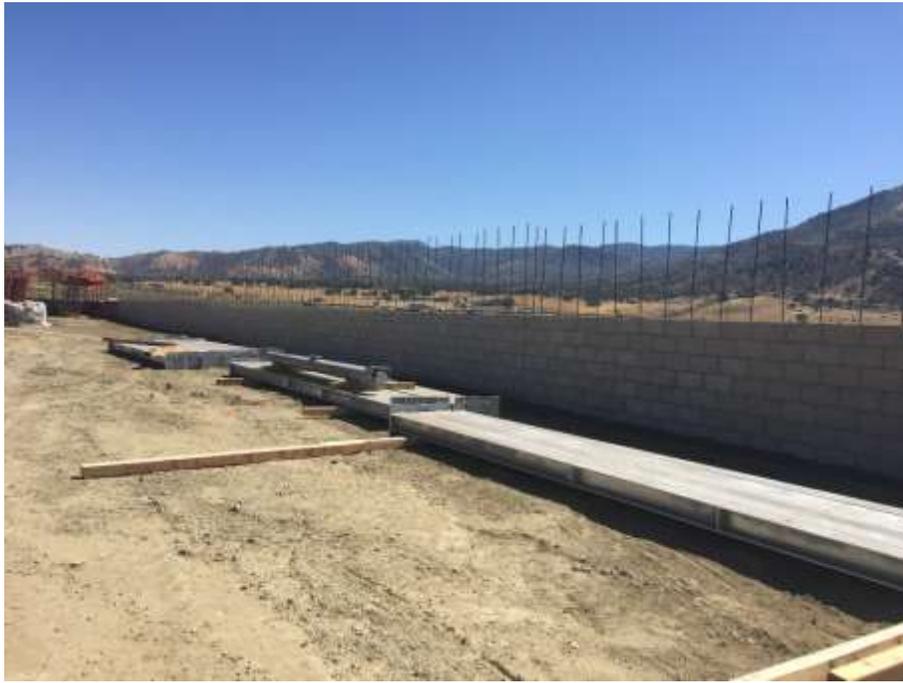
Figure 3 – Block wall installation surrounding the Banducci Substation.

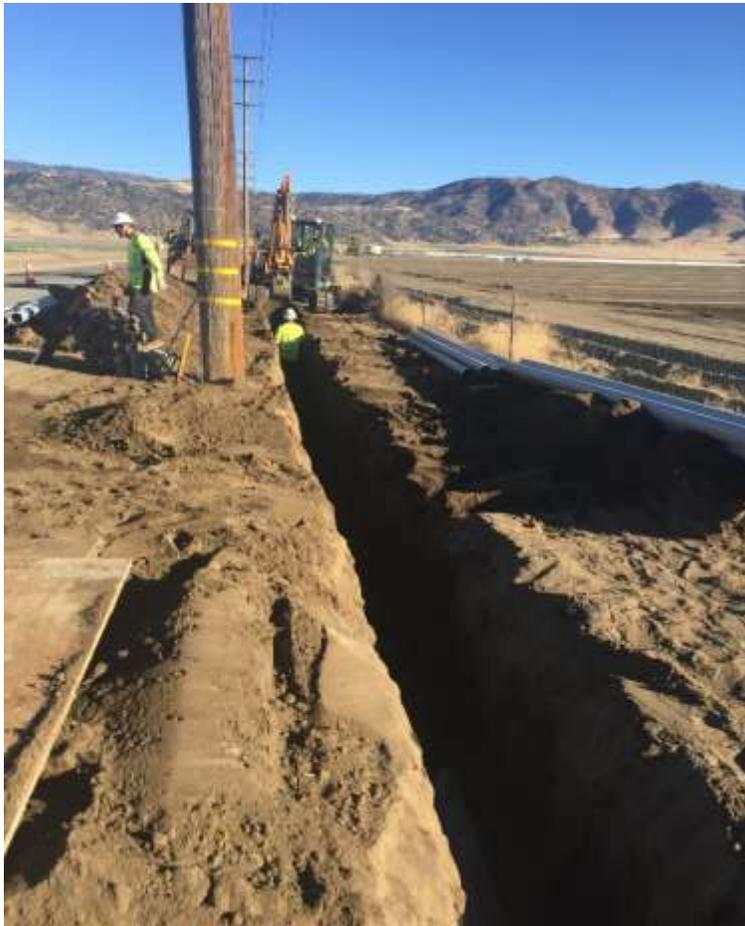
10. H&M crews conducted trench and vault excavation, vault placement, conduit installation, and backfilling activities along Pellisier and Highline Roads (see Figure 4).
11. Boring operations were completed and casing was filled with slurry.

Figure 4 – Conduit installation along Pellisier Road outside of the Banducci Substation.

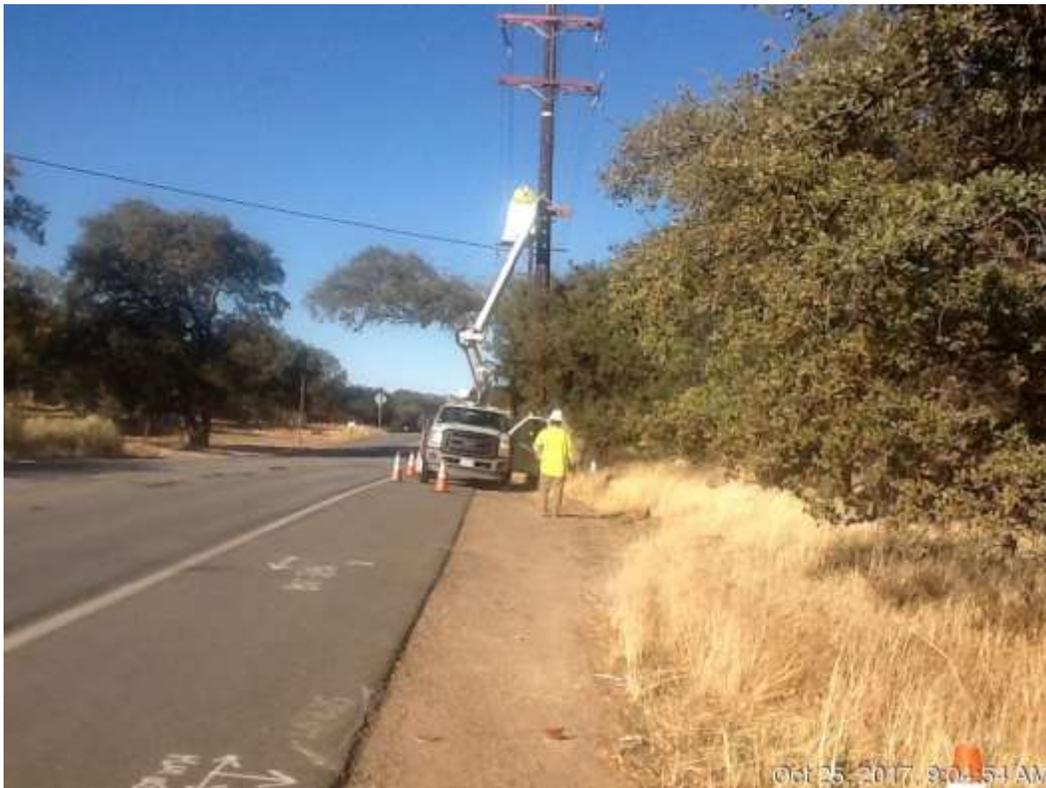
13. H&M crews began work on Routes 1 and 2 of the Telecommunication work on September 27.
14. Two crews conducted telecom cable installation, one on each route. Overhead cable was installed between the Highwind Yard and the Cummings Substation of Route 1 and underground fiber was installed on Route 2 between Monolith Substation and S. Curry Street (see Figure 5).

Figure 5 – Telecom installation on existing overhead wood poles took place along Highline Road near the Cummings Substation.

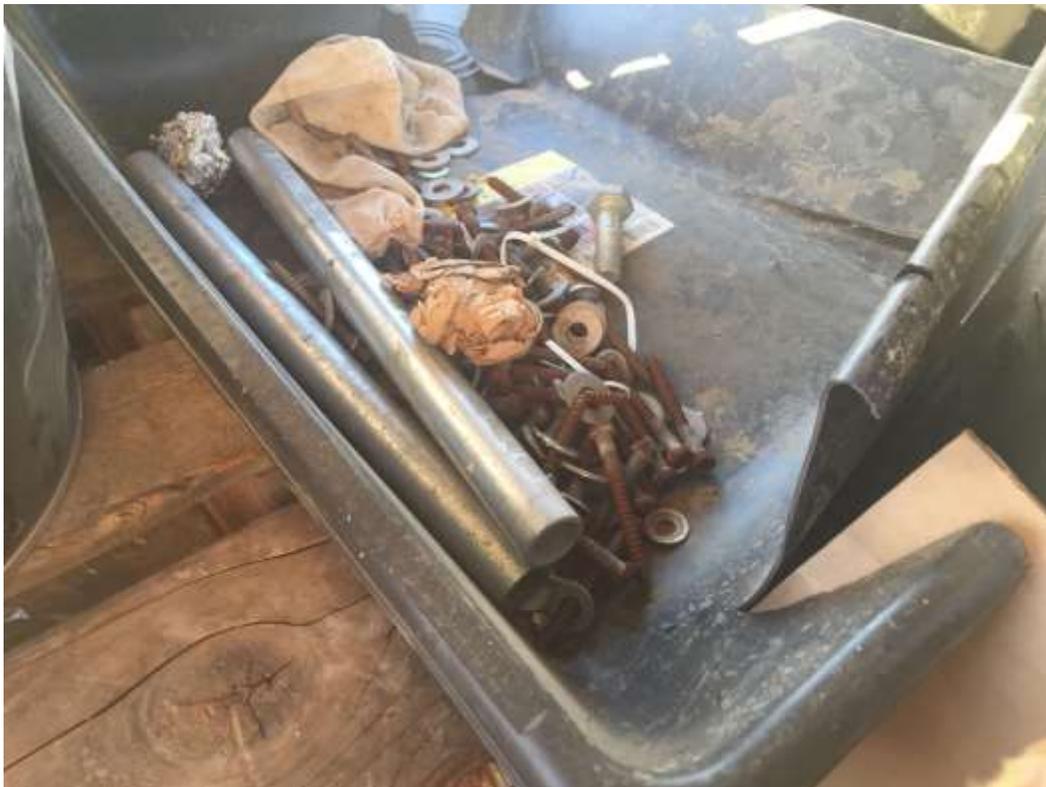
7. Compliance concerns identified by the CPUC EM during the subject period included leaking equipment, microtrash, trackout, and uncovered haul trucks (see Figure 6). Once reported to the site construction manager, all incidents were resolved in a timely manner.

Figure 6 – Microtrash observed after the work shift had ended at the Banducci Substation.
