PROJECT MEMORANDUM
SCE BANDUCCI SUBSTATION PROJECT

To: Jensen Uchida, Project Manager, CPUC
From: Vida Strong, Aspen Project Manager
Date: March 14, 2018
Subject: Monitoring Report #10: February 18 to March 10, 2018

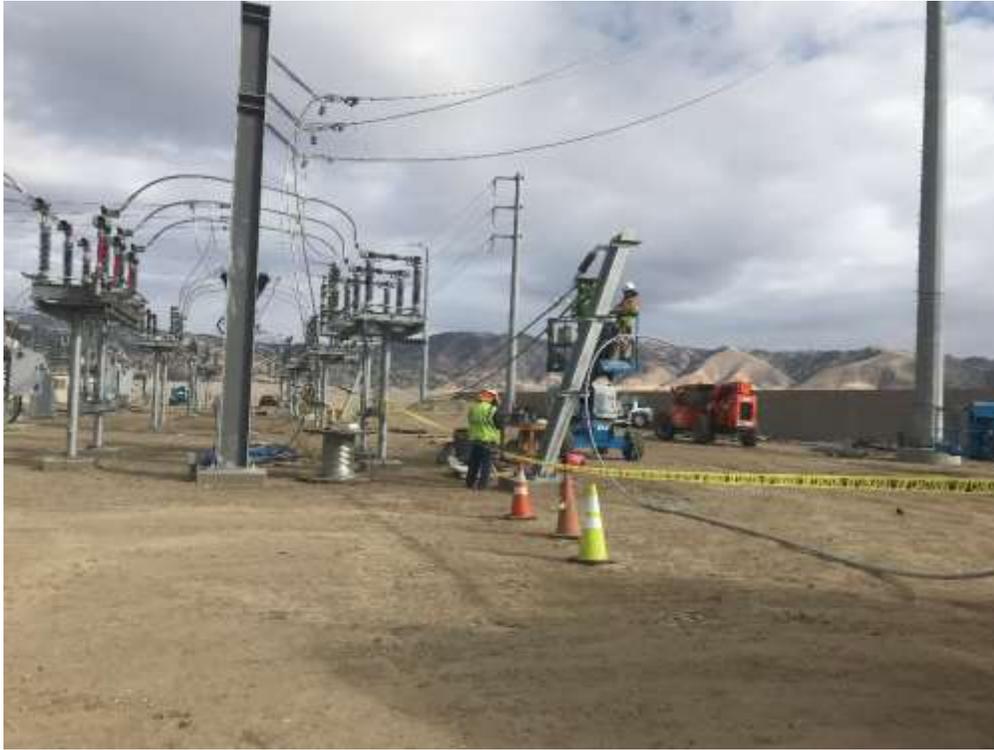
Figure 1 –H&M crew installing jumpers on the 66 kV rack.

2. Bus placement into the 12-kV rack took place and jumpers were installed for the 66-kV rack (see Figure 1).
3. Control wiring was installed and tested in the MEER building.
4. Erosion control BMPs were inspected and maintained at the Banducci Substation site.
5. Construction crews are trucking in non-potable water for dust control and compaction from an approved hydrant located near Highline Road.

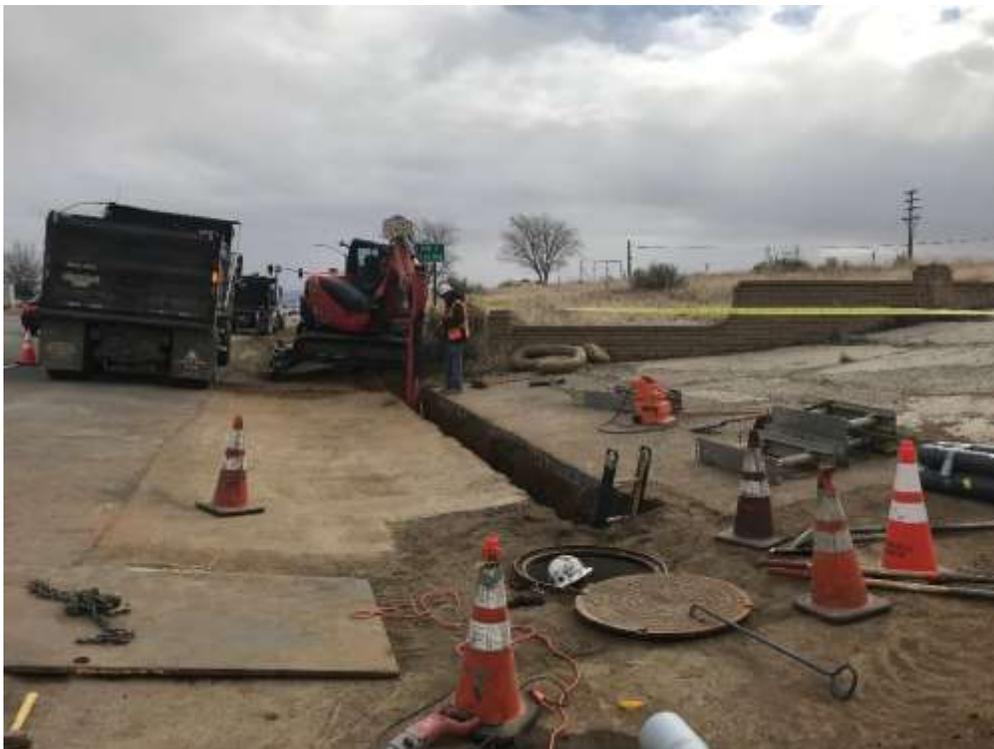
Figure 2 – Telecom underground crews trenching to tie in with overhead sections installed along Highway 202 and Woodford Tehachapi Road.

8. H&M crews began work on Routes 1 and 2 of the Telecommunication work on September 27, 2017.
9. H&M crews completed overhead fiber installation along Highway 202.
10. Telecom underground crews trenched and installed conduit to tie in with overhead sections installed along Highway 202 and Woodford Tehachapi Road (see Figure 2).

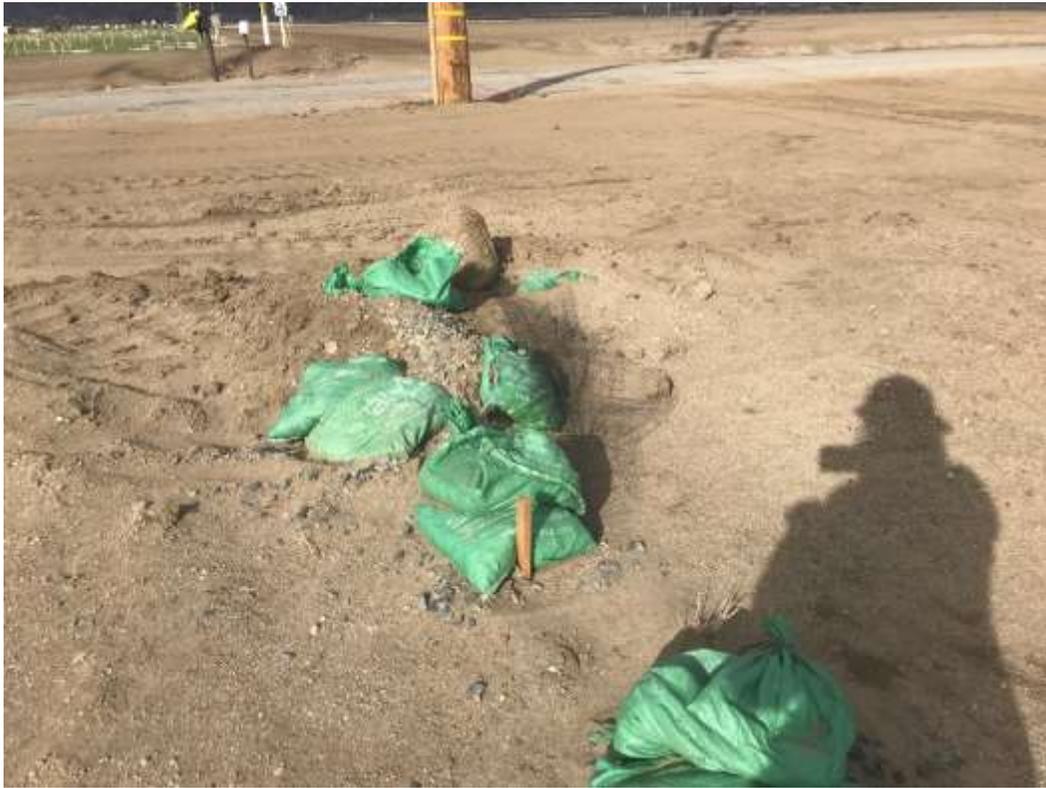
2. On February 13, the CPUC EM noted that sections of bird netting used to cover conduit was left on the ground unsecured. On February 14, two sections of bird netting were found caught in the perimeter sand bag berm surrounding the Substation (see Figure 3). The CPUC EM documented this as a Level B compliance incident, because of the threat to wildlife (entrapment) and also for microtrash (see Table 2).

Figure 3 – Bird netting used to cover ends of conduit was left unsecured and became caught in perimeter sandbag berm causing a microtrash and wildlife entrapment concern, as documented by the CPUC EM on Feb 14.

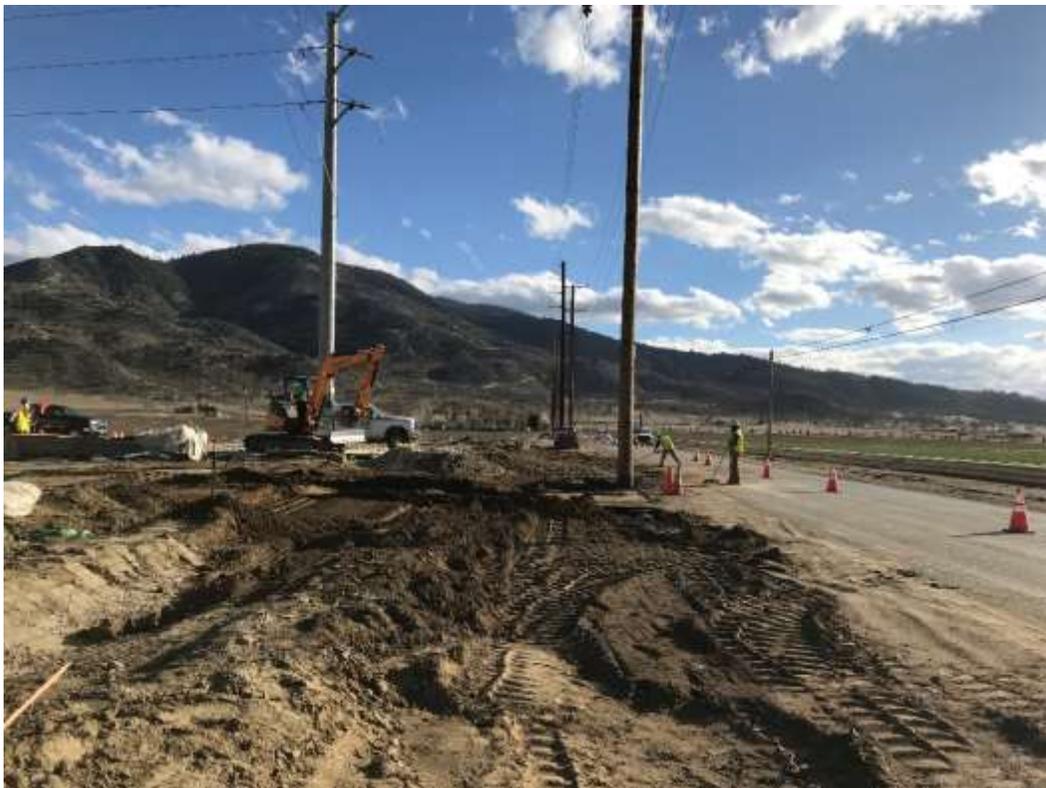
Figure 4 – Crews using brooms to clean off mud from the Substation entrance.

3. No paleontological monitoring took place during the monitoring period. To date, no paleontological resources have been identified.
4. Manual street sweeping is taking place as needed along Pellisier Road at the Substation entrance (see Figure 4).
