PROJECT MEMORANDUM
SCE BANDUCCI SUBSTATION PROJECT

To: Jensen Uchida, Project Manager, CPUC
From: Vida Strong, Aspen Project Manager
Date: April 16, 2018
Subject: Monitoring Report #11: March 11 to April 13, 2018

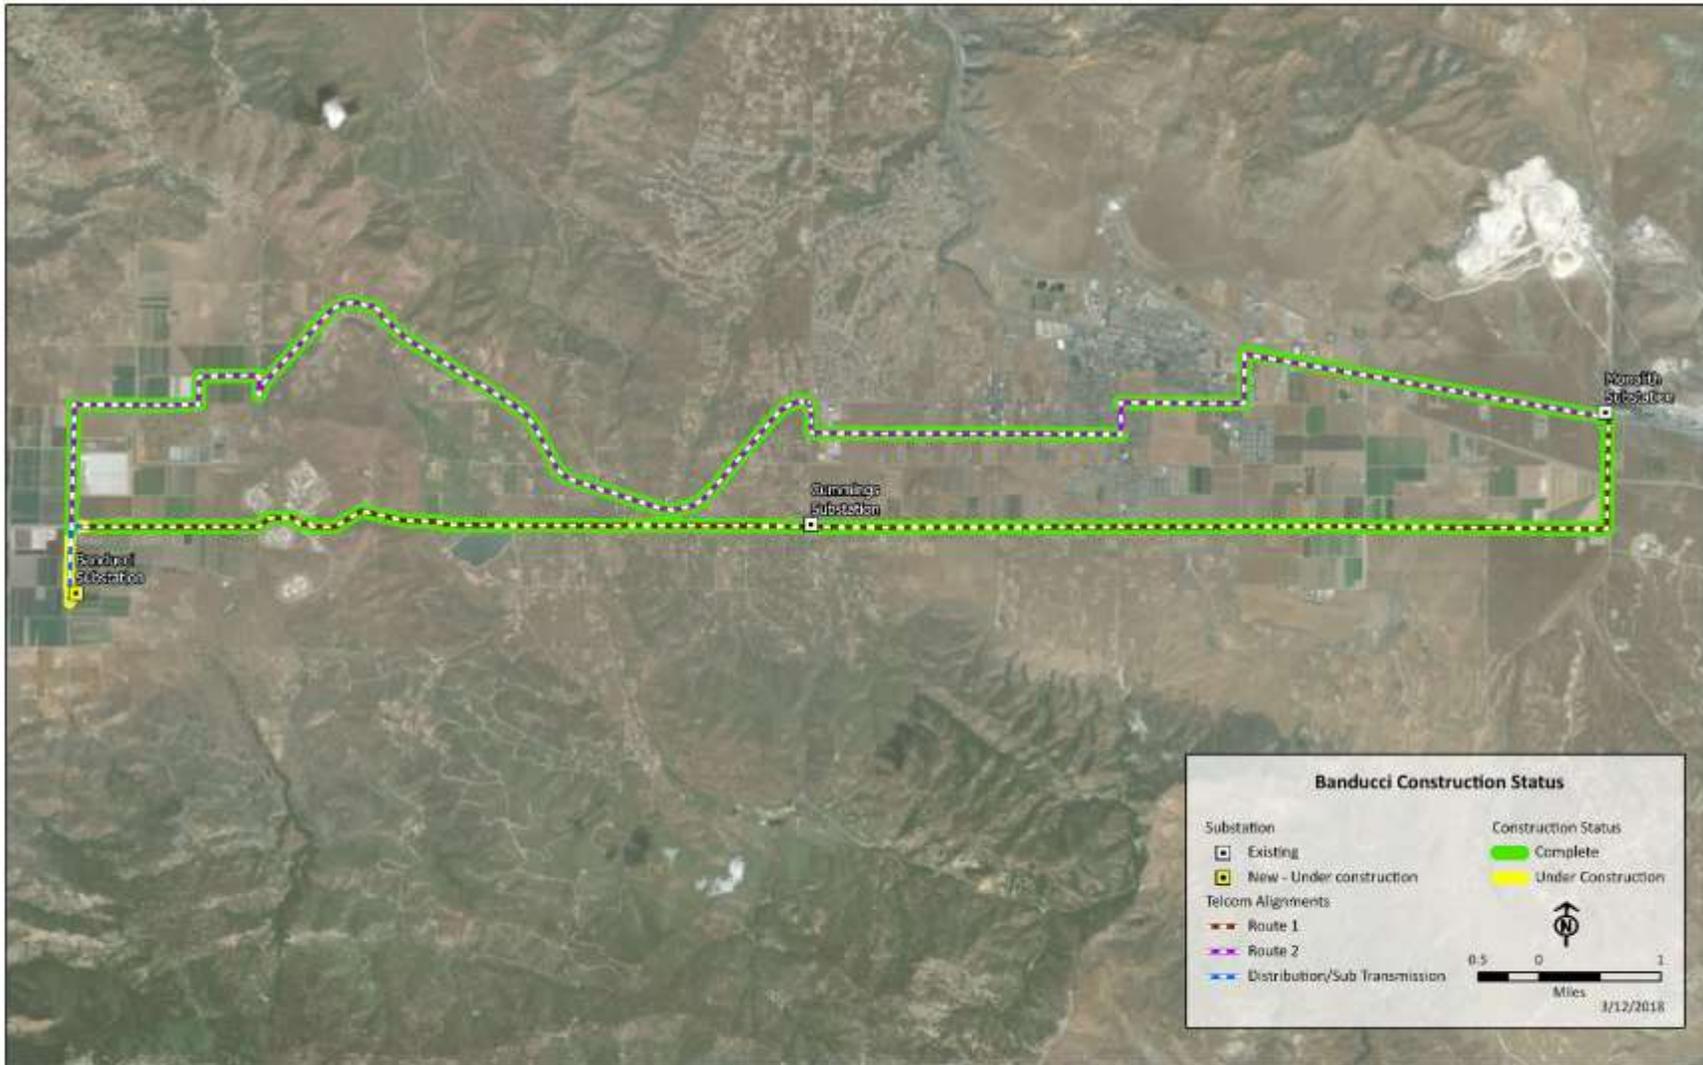
Exhibit A – Construction Status

Summary of Construction Activity: Please see Exhibit A

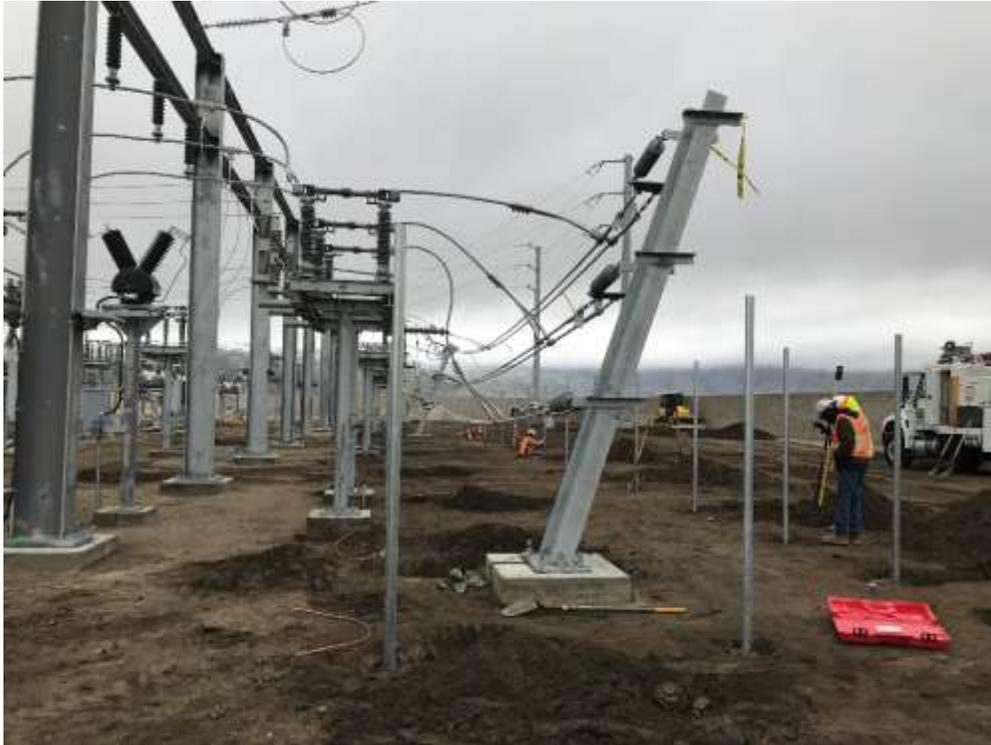
Figure 1 – H&M crew installing fencing and jumpers on the 66 kV rack.

1. Construction activities are being performed by Henkels and McCoy (H&M), and Professional Electrical Construction Services, and construction management is being conducted by TRC. Construction activities started on July 26, 2017.
2. Jumper installation continued into the 66 kV rack (see Figure 1).

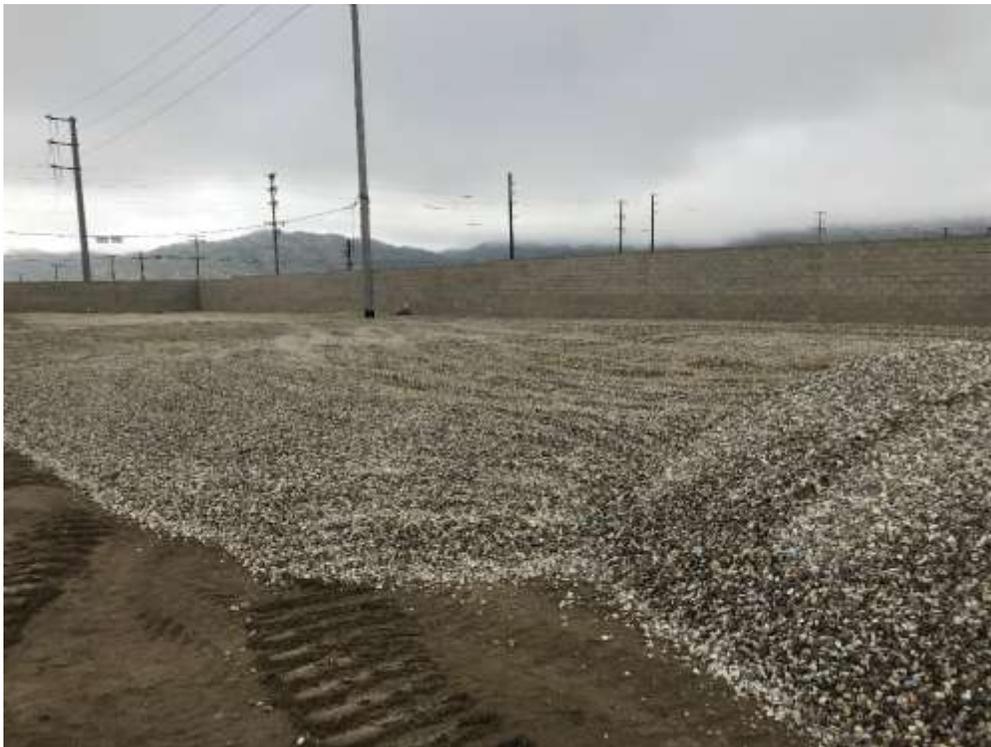
Figure 2 – Civil work including final grading and rock placement at the Banducci Substation.

3. Installation of the substation lighting components began and gate installation occurred.
4. Testing of the electrical components continued.
5. Repair of the damaged transformer radiator was completed.
6. Civil work for final grading and rock installation took place (see Figure 2).
7. Erosion control BMPs were inspected and maintained at the Banducci Substation site. Perimeter sandbags were removed, and soil binder was installed at some locations.
8. Construction crews are trucking in non-potable water for dust control and compaction from an approved hydrant located near Highline Road.

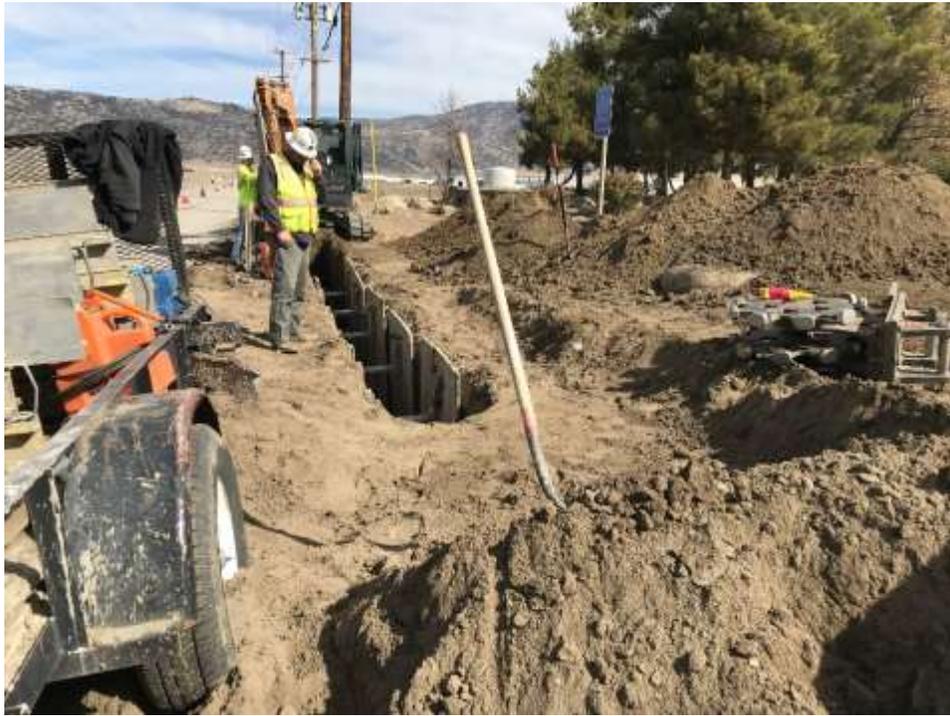
Figure 3 – The final section of 12 kV underground conduit was installed along Pellisier Road.

9. Tie-in trenching and conduit placement between manholes took place between Pellisier and Highline Roads (see Figure 3). All conduit is in place.
10. Conduit was proofed, and vaults and manholes were cleaned. Vault lids were adjusted to grade and grouted.

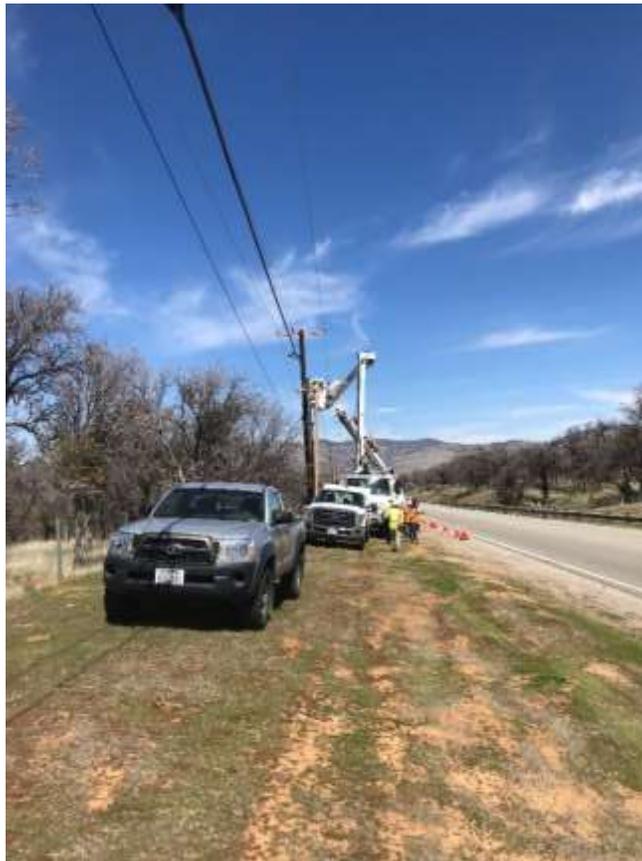
Figure 4 – H&M crews conducting pole replacement along Highway 202.

12. H&M crews began work on Routes 1 and 2 of the Telecommunication work on September 27, 2017. Both telecom routes are essentially complete.
13. Pole replacement along the telecom routes began (see Figure 4). Crews can replace one pole each work day, if weather conditions allow.

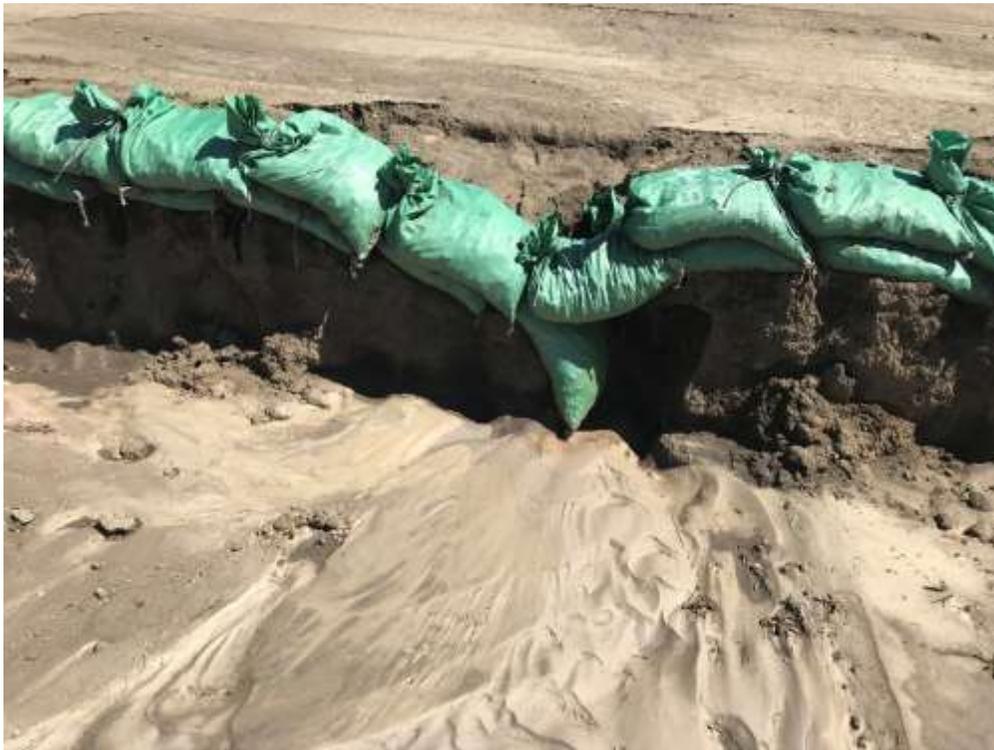
8. Excavations and trenches are covered, or wildlife escape ramps are installed after work is completed.
9. Weekly SWPPP inspections are taking place at both the Substation and telecom work sites, and additional inspections are performed prior to and after rain events. Concerns noted during the subject period included items needing secondary containment, maintenance to the construction entrance, perimeter BMP replacement and regrading to prevent run-on, and stabilization of inactive construction areas (soil binder and erosion control blanket) (see Figures 5 and 6).

Figure 5 – Run-on from adjacent farm land occurred during a storm event. A discrepancy between the elevation of the adjacent farm field and the substation channel feature is being evaluated by SCE to avoid this becoming a continual problem.

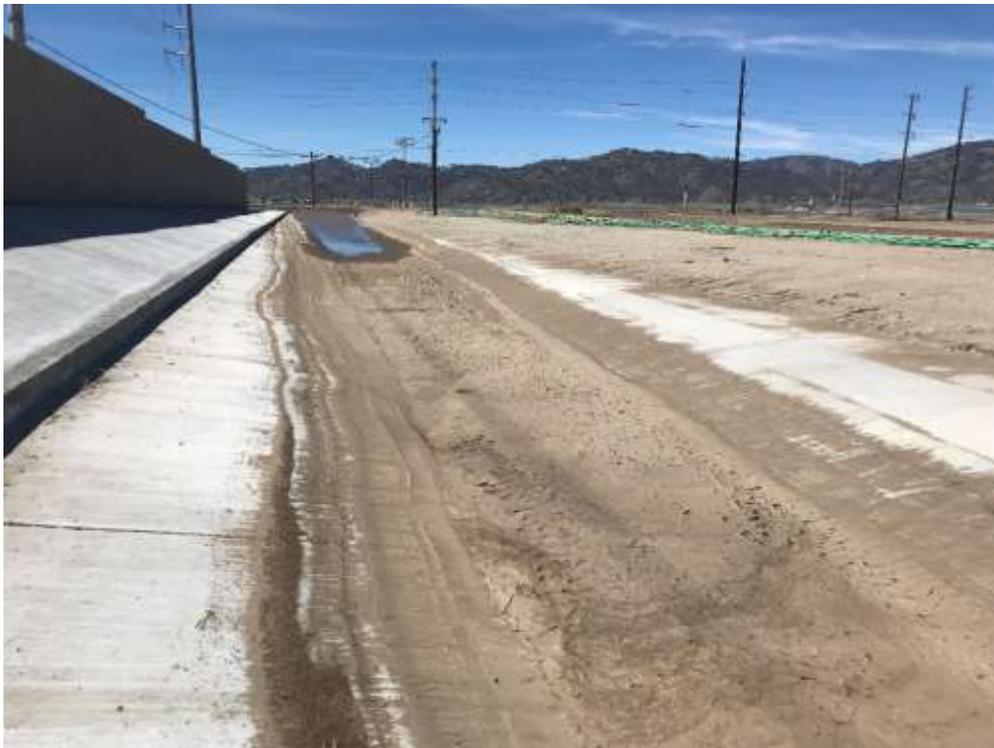
Figure 6 – Run-on from the adjacent farming operations. Sediment collected in the perimeter concrete channel.
