## PROJECT MEMORANDUM SCE DPV2 TRANSMISSION PROJECT

**To:** Billie Blanchard, Project Manager, CPUC  
**From:** Vida Strong, Aspen Project Manager  
**Date:** May 29, 2012  
**Subject:** Weekly Report 42, April 30 to May 06, 2012

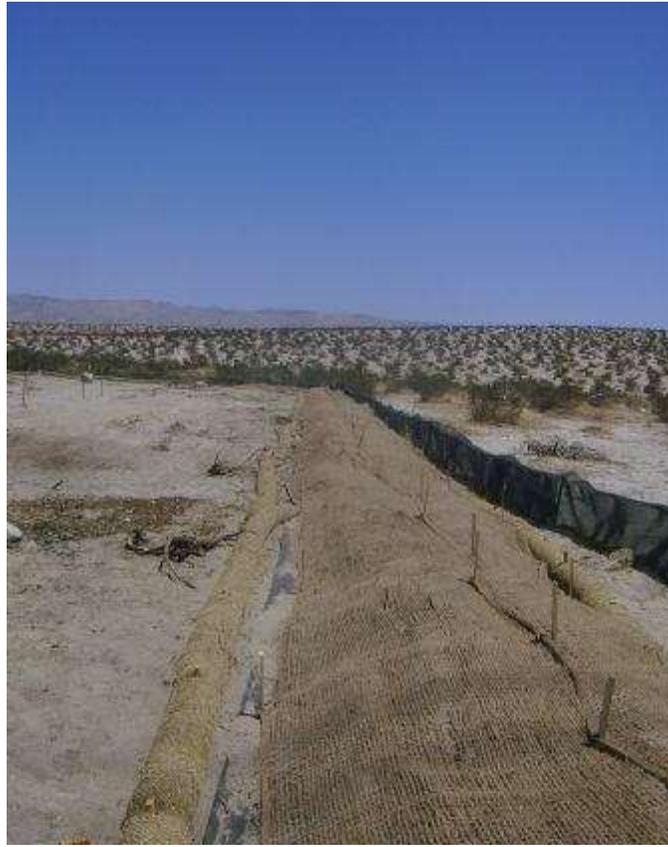
- Topsoil salvage occurred at Tower 2020 and 2511 (see Figure 1).
- Spur road and crane pad grading occurred at Towers 2001, 2002, 2003, 2004, 2005, 2007, 2009, 2100, 2352, 2353, 2402, 2426, 2510, 2512, 2513, 2514, 2516, 2518, 2519, 2520, 2521, 2522, 2523, 2524, 2526, 2529, 2531, and 2532.

**Figure 1.** Topsoil salvage for Coachella Valley Milk-vetch at Tower 2020.

- Coachella Valley milk-vetch approved biologists conducted biological sweeps for Coachella Valley Milk-vetch prior to construction at all applicable tower sites and monitored topsoil salvage at Tower 2020.

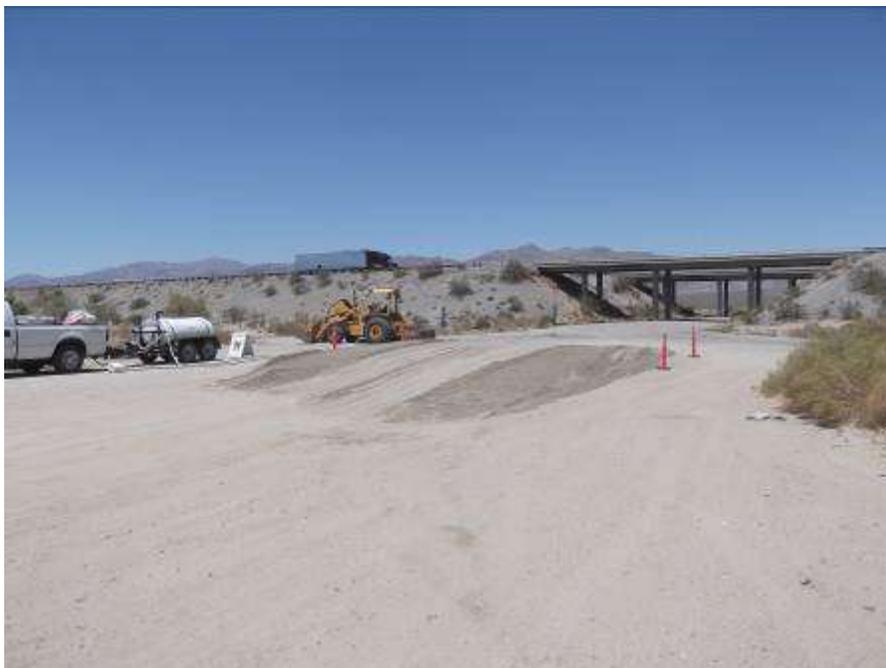
- Tower assembly and steel deliveries occurred at Towers RB1-3E and RB2-3W.
- Potholing occurred on the access road near Towers 2112, 2122, 2124, and 2127.
- Sensitive cactus transplanting occurred at Towers 2248, 2260, 2264, 2307, 2315, 2317, 2322, and 2325.
- Road stabilization activities, including the installation of shaker plates, were conducted near the intersection of the ROW access road and Red Cloud Road (see Figure 2).

**Figure 2.** Road stabilization for fiber optic line near Red Cloud Road.

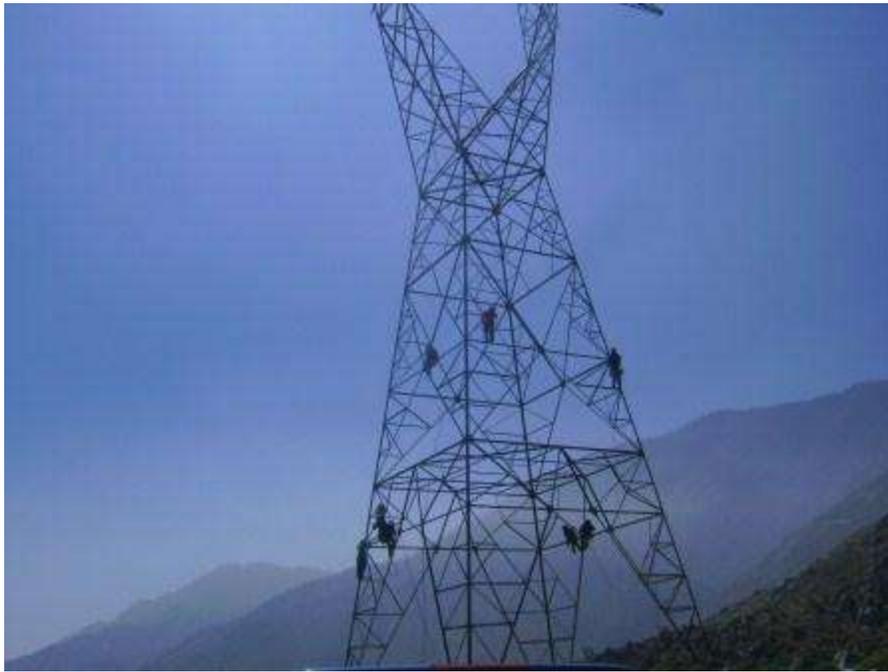
- BMPs were installed at Tower 1021.
- Tower foundation drilling occurred at Towers 1010 and 1015.
- Tower foundation concrete pouring activities occurred at Towers 1010, 1015, 1021 and 1022.
- Tower assembly and steel deliveries occurred at Towers 1021, 1028, 1052, 1053, 1054, 1055, 1057, 1059, and 1060 (see Figure 3).

**Figure 3.** Tower assembly (crews backbolting) at Tower 1057.

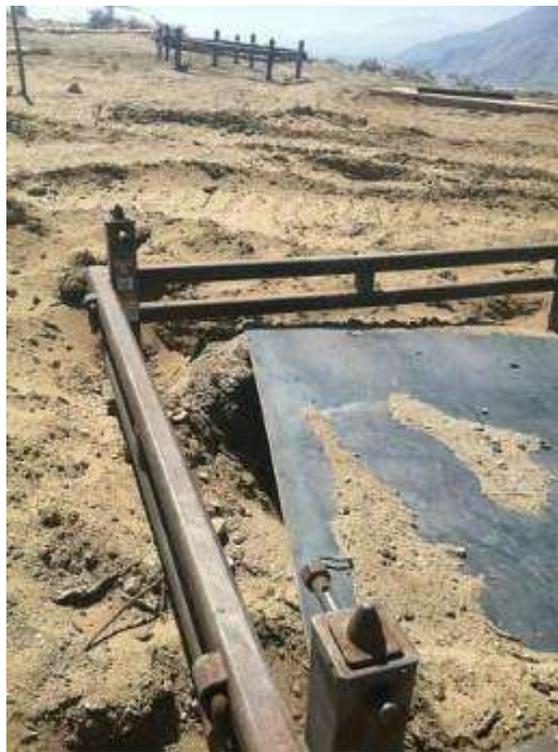
- The CPUC EMs identified several locations during the subject period where foundation holes had been inadequately covered (see Figure 4). All foundation holes must be completely covered when a site is not unattended to prevent accidental death or injury to wildlife. The Contractor was informed by SCE to notify foundation crews that auger holes must be completely covered when a site is left unattended.

**Figure 4.** Foundation excavation inadequately covered at Tower 1015 (Photo taken from FRED Incident Report).

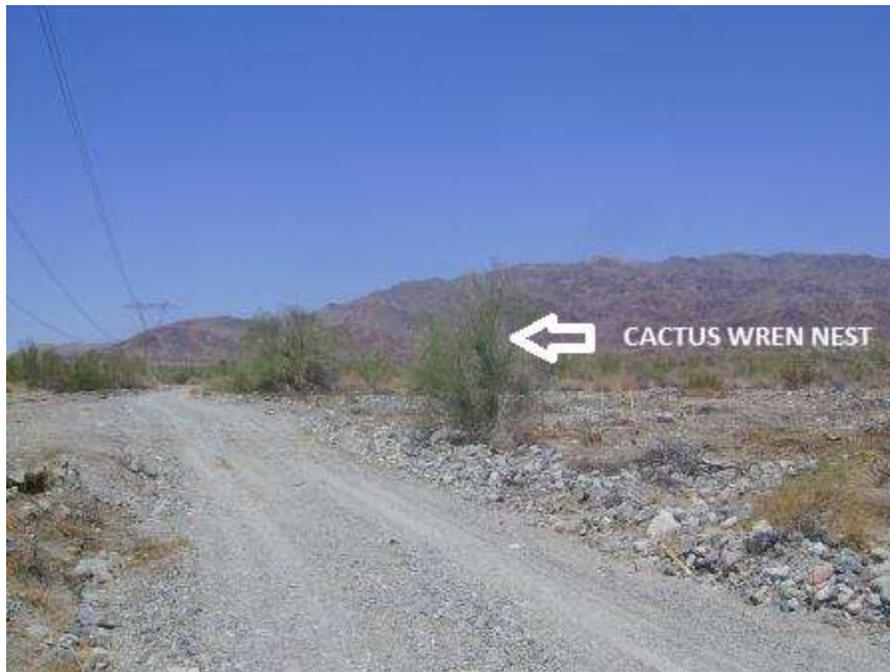
- On May 1, vegetation clearing occurred at Tower 2330 within the buffer of an active nest (ID 1526). The cactus wren nest was reported as an inactive nest within the disturbance area. When the CPUC EM asked the onsite Biological Monitor about its protection the onsite monitor stated it would be observed for an hour to determine if it was inactive. Vegetation clearing activities occurred at the site prior to ensuring the nest was inactive. When the crew left for the day the cactus wren returned to the nest and the nest was then determined to be active. A 300 foot buffer was then established at the site (see Figure 5).

**Figure 5.** Vegetation clearing activities occurring within 300 feet of an active cactus wren nest at Tower 2330.

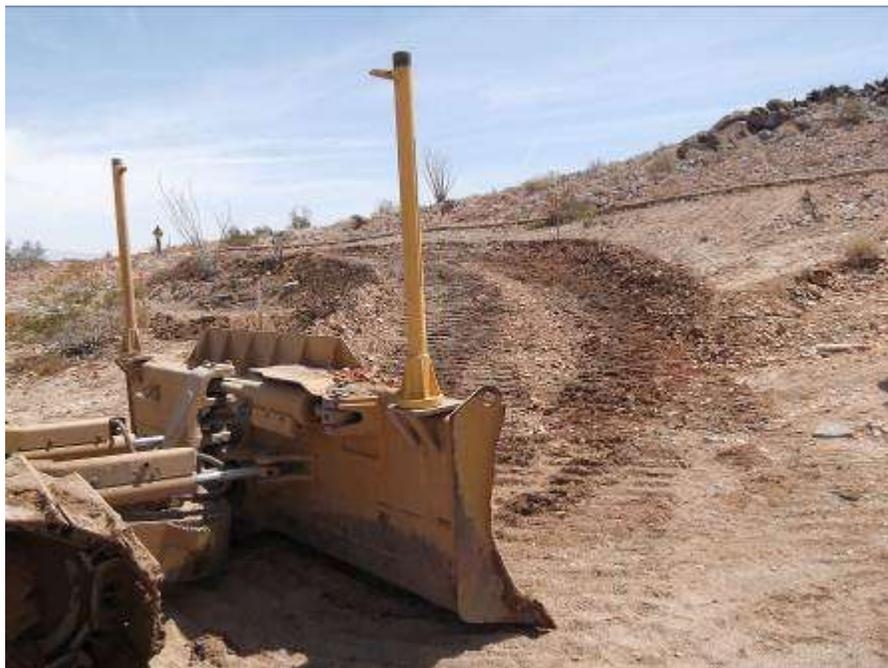
- Grading activities were conducted at Tower 2518 on May 3 (see Figure 6). This location was previously defined as a topsoil salvage site and all grading activities occurred without any topsoil salvage. Due to this oversight, SCE will add all disturbed acreage that was designated for topsoil salvage to mitigation/compensation totals.

**Figure 6.** Grading activities initiated prior to topsoil salvage at Tower 2518. The blade mark is located within the area designated for salvage.

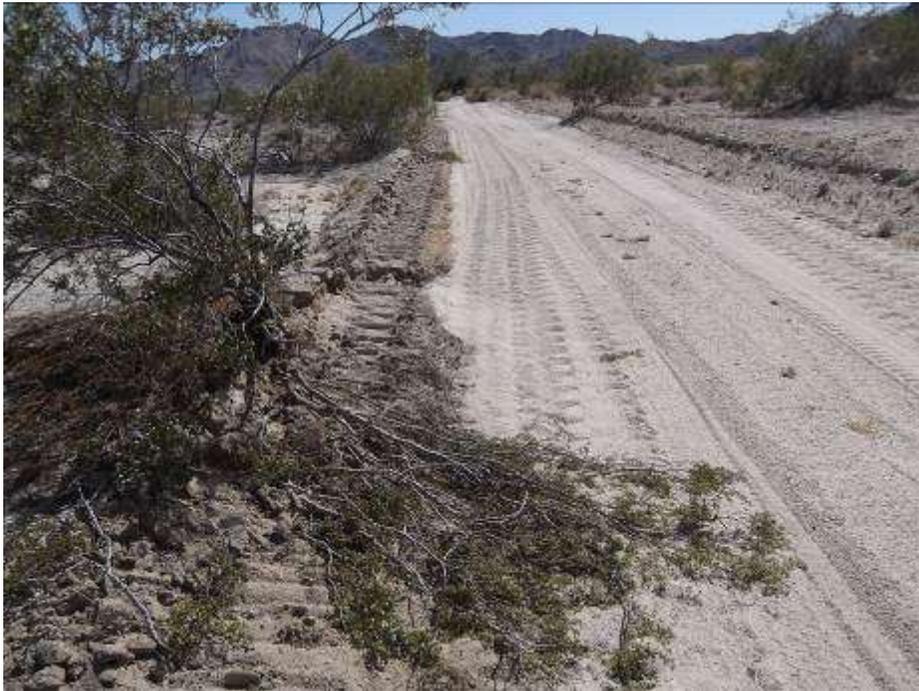
- While driving the access road between Towers 2433 and 2434 on May 3, the CPUC EM observed heavy equipment tracks outside of the defined road limits. As a result of traveling outside the roadbed, several creosote bushes were crushed (see Figure 7).

**Figure 7.** Heavy equipment tracks outside road limits between Towers 2433 and 2434 resulting in several crushed creosote bushes.

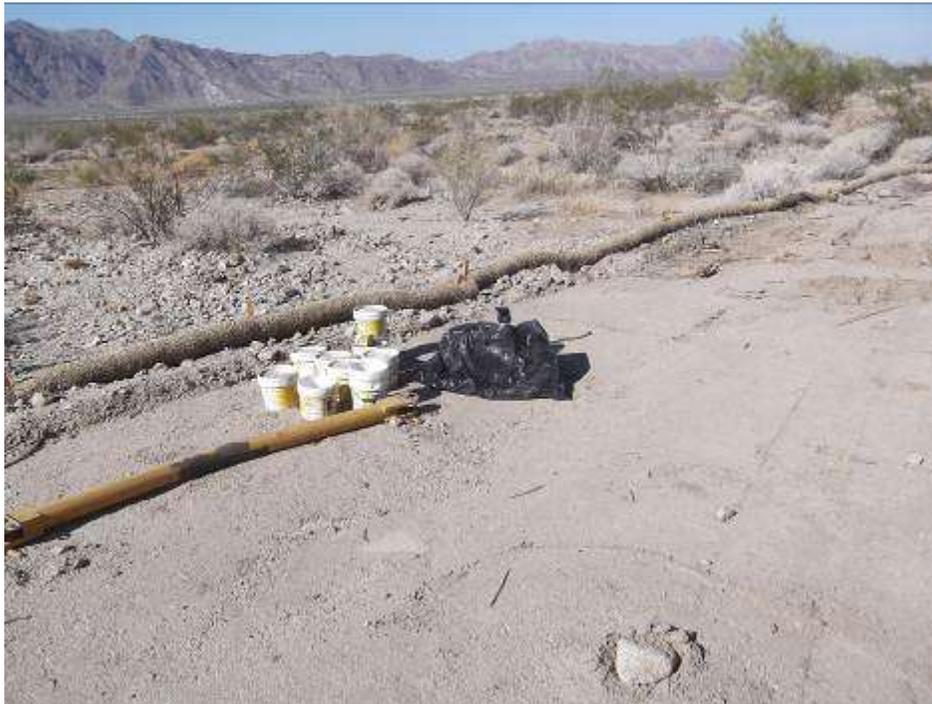
- The CPUC EM notified the SCE General Monitor of an uncontained plastic trash bag that had been left in the disturbance area of Tower 2426 on May 3 (see Figure 8). The SCE General Monitor informed the contractor and the bag was removed from the site the same day.

**Figure 8.** Uncontained trash bag observed by CPUC EM at Tower 2426.

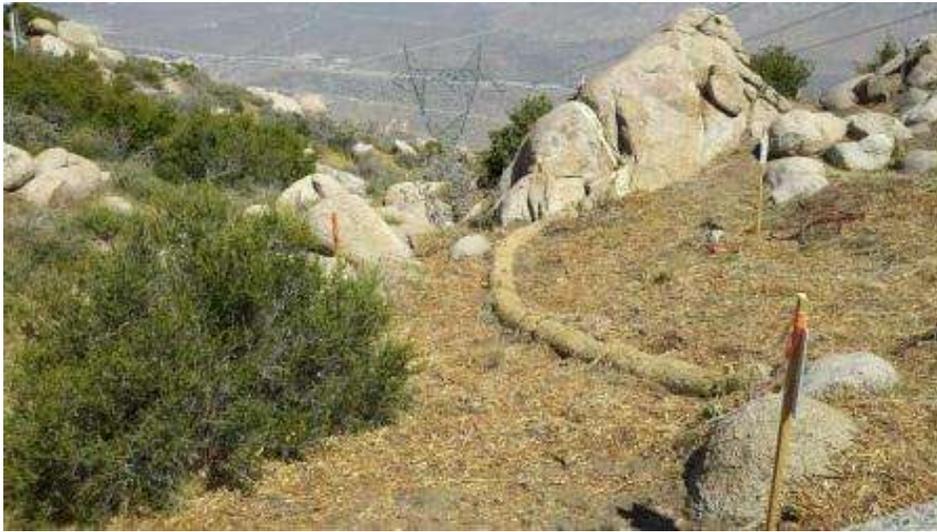
- The USFS delineated a section of an erosional feature to the west of the Tower 1047 temporary work limits as a Riparian Conservation Area (RCA). The RCA intersects and overlaps the site at the west corner. The area was not clearly symbolized in early project mapping or SWPPP drawings. As such, construction activities including BMP installation and vegetation clearing took place within the RCA (and other areas outside of the temporary work limits) from April 20 to April 27. The SCE Field Lead and Environmental Coordinator observed that minor impacts including installation of fiber roll BMPs, clearing of vegetation, and spreading of subsequent mulch had taken place within the RCA (see Figure 9). A walking path from the temporary helipad to the north west of the site crosses the RCA. The contractor was informed that continued construction activities within the RCA would result in a higher level non-compliance. Determinations of corrective action would require further investigation of the impacts and consultation with SCE. On May 5, the SCE Field Lead returned to the site to map the non-compliance area with a Trimble featuring sub-meter accuracy. A GIS analysis was conducted. It was determined that a 0.0338 acre area was impacted outside of the approved temporary work limits. That area includes 0.0316 acres of impact to the RCA, 0.0020 acres of impacts to jurisdictional waters (flow line of RCA), and 0.0022 acres of impact to an area (California buckwheat (*Erigonum fasciculatum*) scrub) both outside of the RCA and outside of the temporary work limits. ESA signage was installed on both sides of the RCA where it intersects the walking path. SCE has recommended relocation of the BMPs to the edge of the RCA where it intersects the temporary work limits, removal of mulch remaining in the RCA, and relocation of the walking path to avoid the RCA. The contractor has reported that these actions have been completed. Due to high winds and limitations on helicopter access, SCE has been unable to confirm as of May 23.

**Figure 9.** Impacts to RCA at Tower 1047. Stakes with white signs on the right side of the photo delineate the edge of the RCA (Photo taken from FRED Incident Report).
