PROJECT MEMORANDUM SDG&E – MIGUEL-MISSION 230 kV #2 PROJECT

To: Michael Rosauer, CPUC
From: Vida Strong, Aspen Project Manager
Date: August 30, 2004
Subject: Weekly Report #4: August 22, 2004 – August 28, 2004
CPUC Environmental Monitor (EM): Christopher Meyer

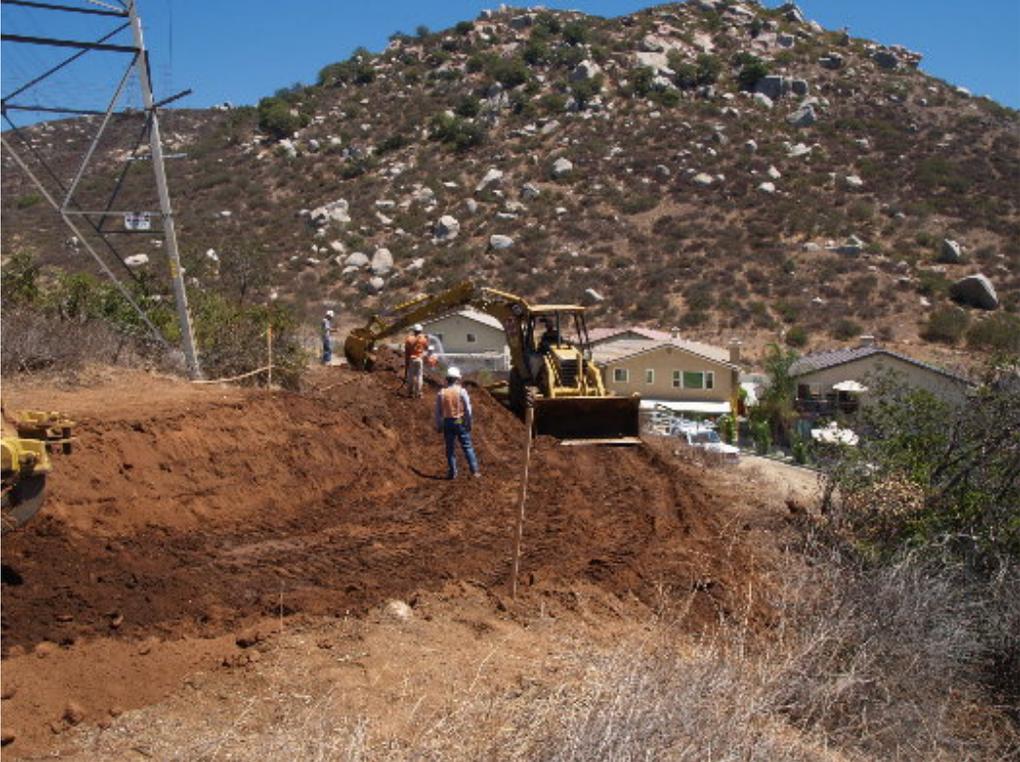
Figure 1 – Crew cutting and grading pad at Magnolia.

The crew worked a backhoe, loader, D4 bulldozer, and vibrating roller to build the pad location. A small D4 bulldozer and a backhoe were used to cut the pad on the side slope (see Figure 1). A small vibrating roller was used to compact the pad once the grade had been achieved (see Figure 2). Due to the side slope, the crew used the bulldozer to further compact the slope after the backhoe finished with the roller attachment (see Figure 3). A geotechnical inspector was on-site to test compaction and soil moisture.

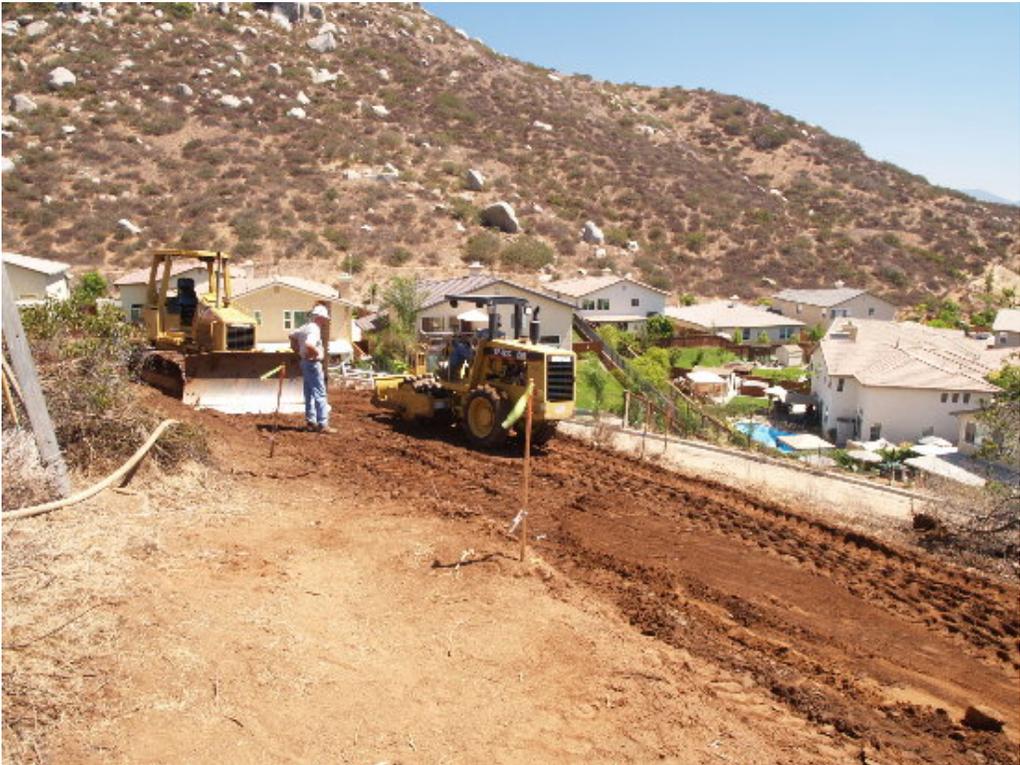
Figure 2 – A small vibrating roller was brought in to compact the narrow pad.

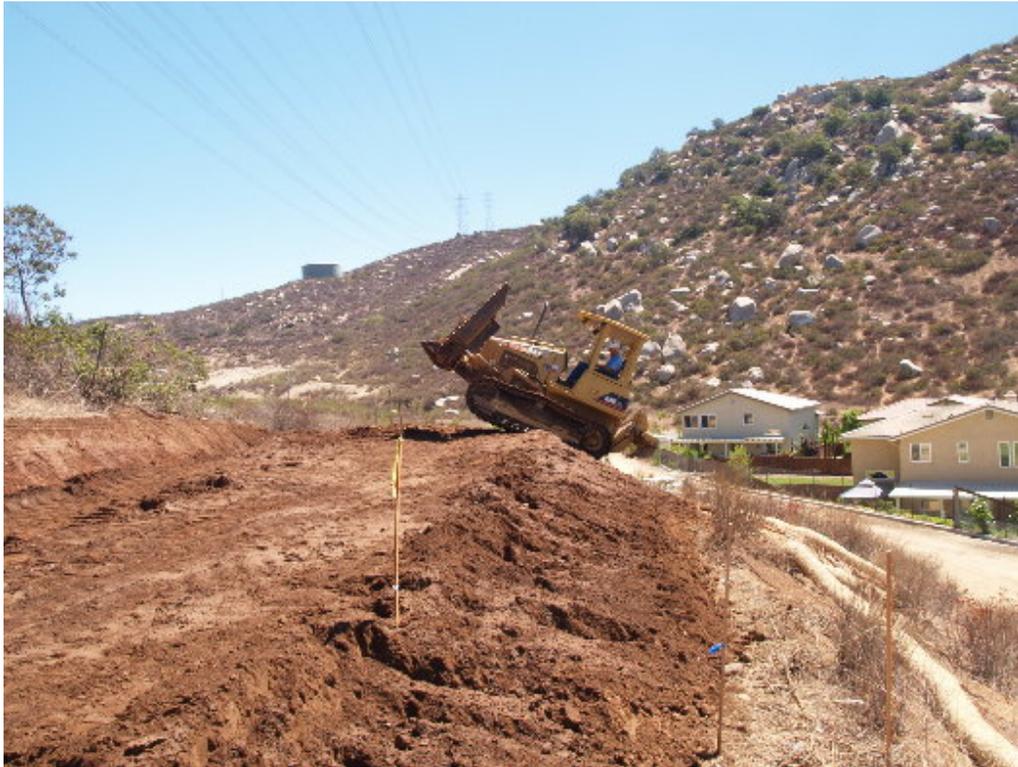
Figure 3 – Small D4 bulldozer compacting side slope at Magnolia.
Note the BMPs installed on the slope.

A water truck was on-site at the grading location to address fugitive dust and provide moisture for soil compaction. At the request of the Essex EI, the crew moved the water truck away farther away from the houses due to the noise from the power-take off (PTO) pump. Temporary Best Management Practices (BMPs) were installed around the pad location.

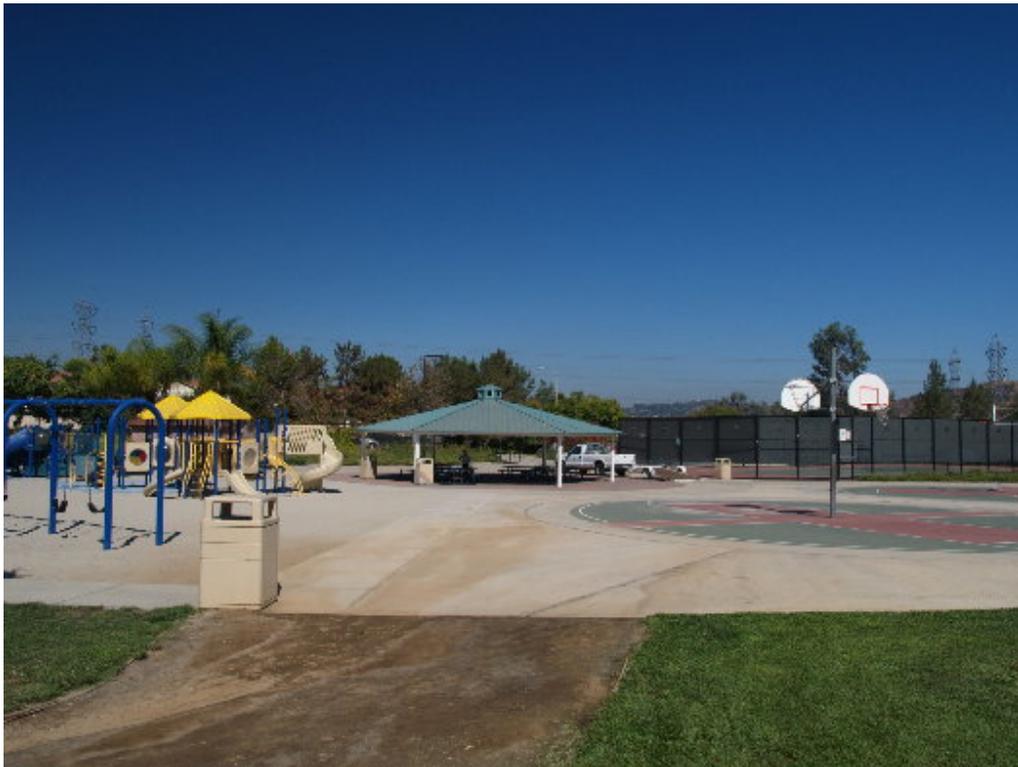
Figure 4 – Steele Canyon County Park with transmission line shown in background.
Project activity on weekends should not impact parking, access, or use of the park..

The CPUC EM conducted site visits on August 24 and 25. The CPUC EM reviewed the distance between the right-of-way and Steele Canyon County Park to determine if work day restrictions are required. The right-of-way is away from the park and across a street and weekend work should pose no problem with recreational use (see Figure 4).
