PROJECT MEMORANDUM SDG&E – MIGUEL-MISSION 230 kV #2 PROJECT

To: Michael Rosauer, CPUC
From: Vida Strong, Aspen Project Manager
Date: September 15, 2004
Subject: Weekly Report #6: September 5, 2004 – September 11, 2004
CPUC Environmental Monitor (EM): Christopher Meyer

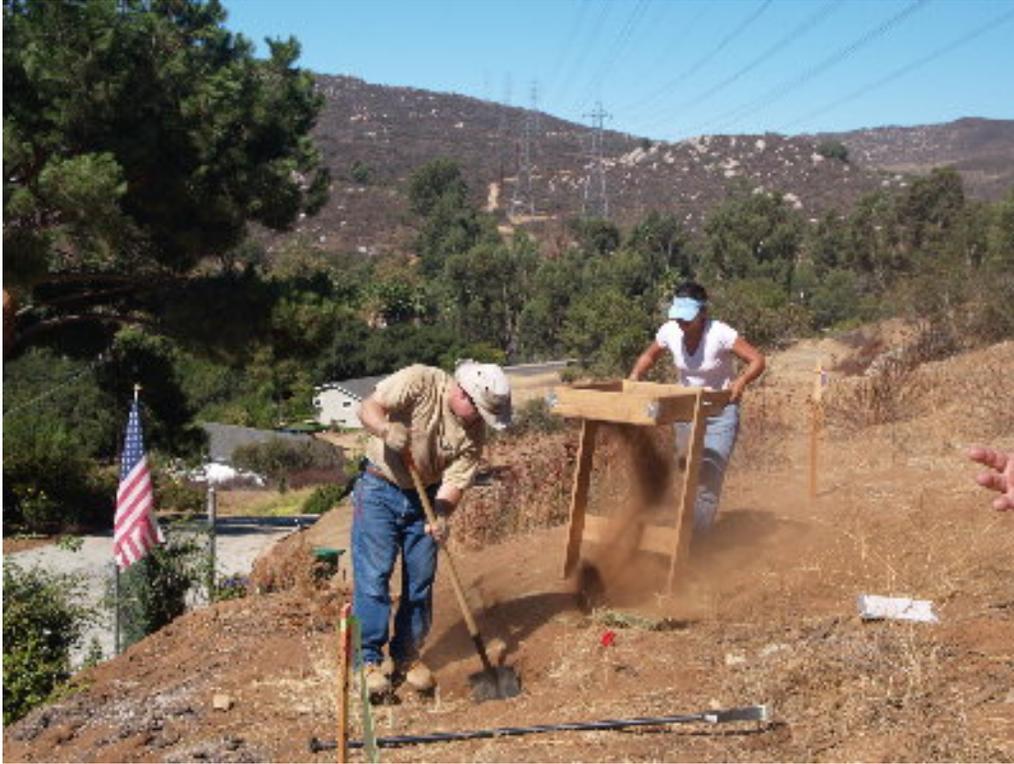
Figure 1 – A cultural testing crew worked at Site 1270 to complete the archaeological testing plan.

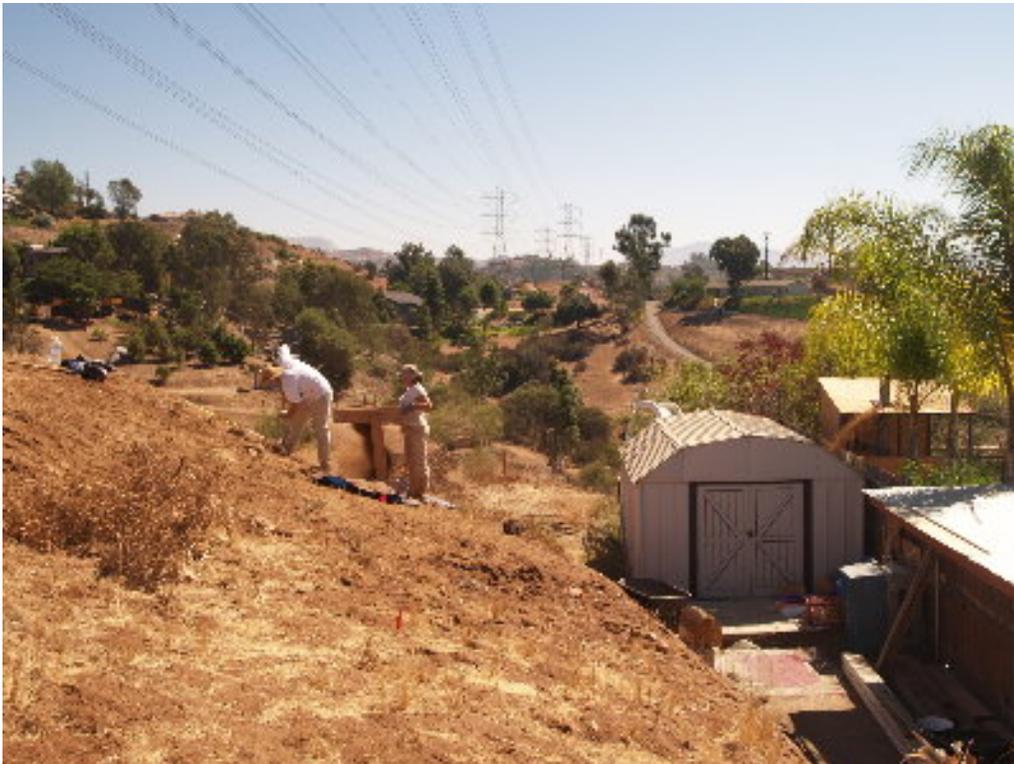
A small cultural resources crew was conducting testing at Site 1270 (see Figure 1). An Essex Environmental Inspector (EI) was on-site with the testing crew. No cultural materials had been discovered at the time the CPUC EM was on-site. The property owner at Site 1270 expressed concerns over the proximity of the proposed pole location to the carport (see Figure 2). Due to a recent purchase of the house, the current owners are not on the SDG&E notification list and have not received information on the project from SDG&E. The Essex EI took the property owner's contact information so SDG&E can address her concerns.

Figure 2 – New property owner concerned about location of proposed tower at Site 1270. The tower will be placed in the clear area on the bottom of the photograph.

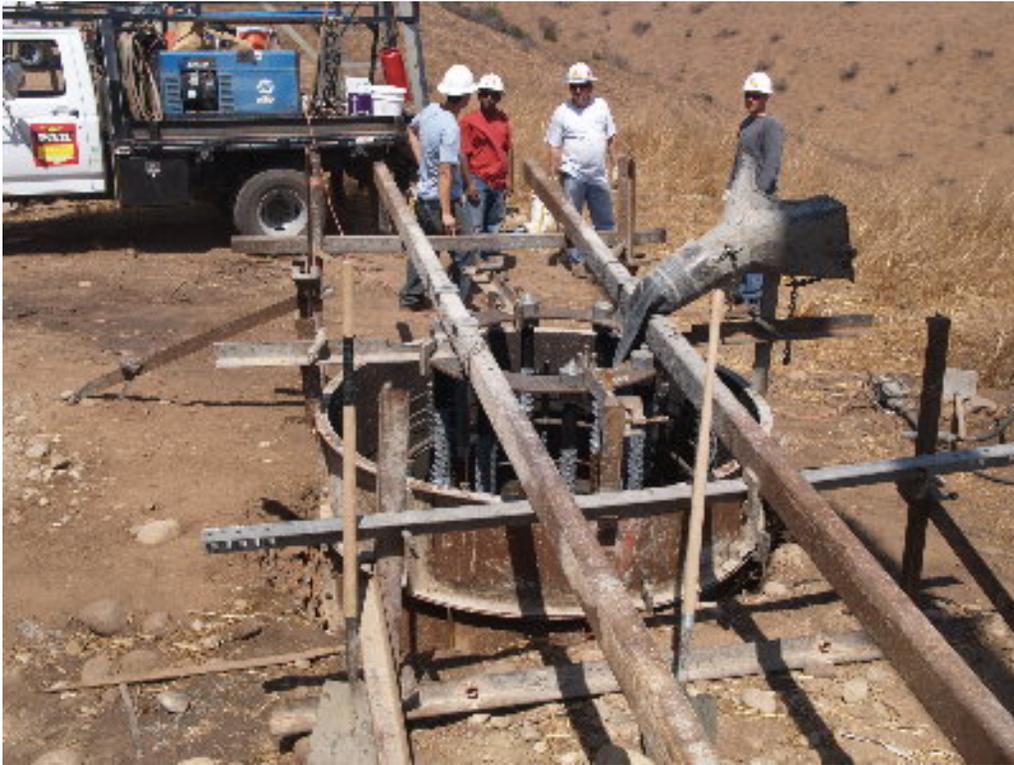
The transmission line contractor, PAR, continued working on foundations during the subject week. A boring crew completed excavation of the bore hole for the tower foundation at Site 1350 and moved to the next location to reset. Another PAR crew worked on setting the anchor bolts and pouring concrete at Site 1400 (see Figure 3). The drill tailings pile was lined and used as a washout station for the concrete trucks (see Figure 4). No sensitive water resources are located near the tower location. An Essex EI was on-site with the PAR crew for the pour.

Figure 3 – Anchor bolts in place for concrete pour at Site 1400.

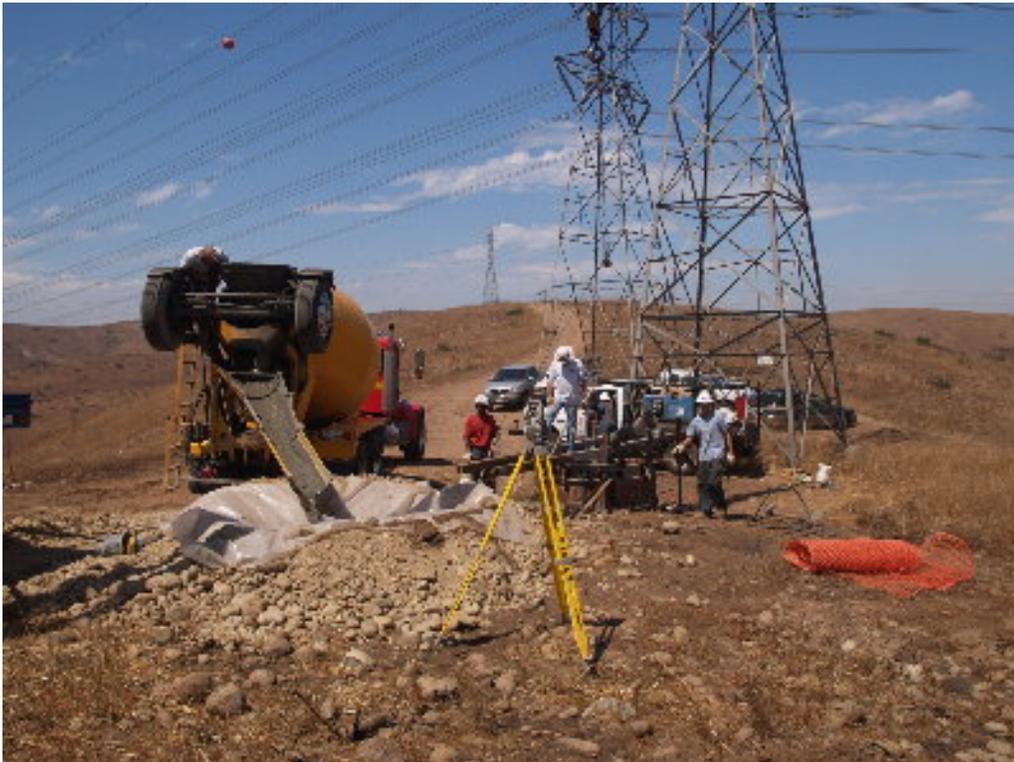
Figure 4 – The PAR crew at Site 1400 constructed an effective concrete washout station for the concrete trucks.

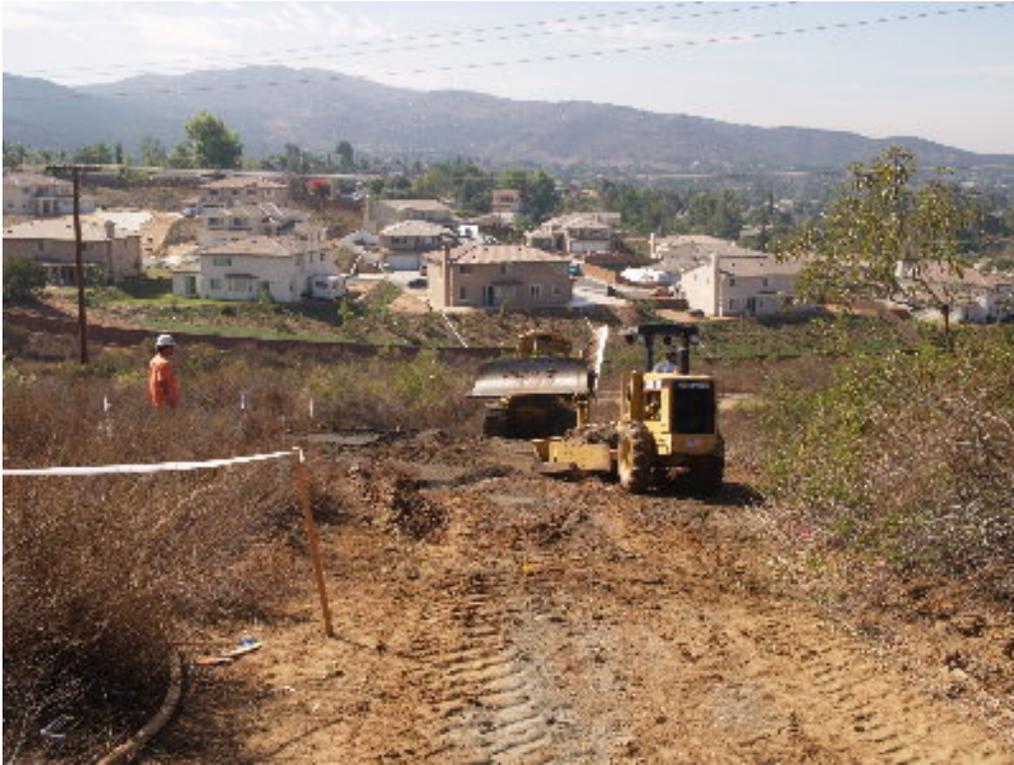
The clearing crew worked on Site 932 to prepare for grading activities. The grading crews moved to Site 1090 and placed additional material on the site after initial grading to build the pad (see Figure 5). Grading was completed at Site 1101 and temporary erosion control devices have been installed around the site (see Figure 6).

Figure 5 – Operators placing and compacting imported fill at Site 1090 to bring pad up to engineered grade.

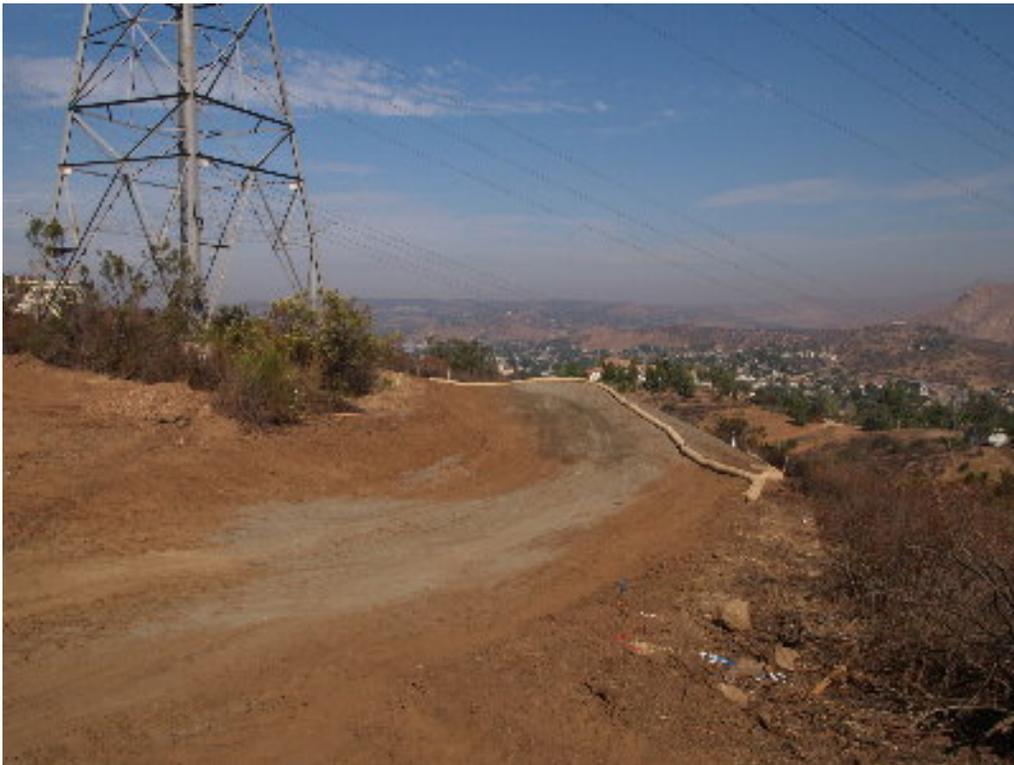
Figure 6 – Pad completed with imported fill at Site 1101. Erosion control devices have been installed at the completed site.
