Moraga-Oakland X 115 kV Rebuild Project, Contra Costa and Alameda Counties, California

Aquatic Resources Delineation Report

July 2024

Pacific Gas and Electric Company

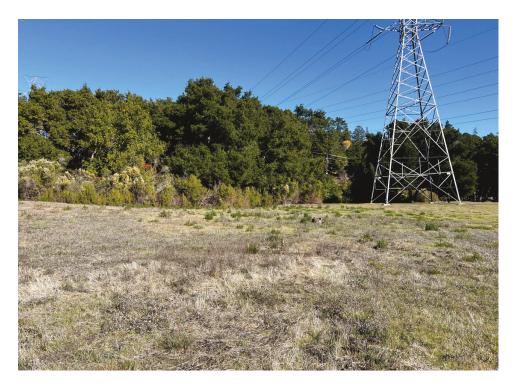
Photo 1. Area on the east side of Moraga Substation where the National Hydrography Dataset (NHD) and National Wetlands Inventory (NWI) show a riverine feature; no aquatic resources were observed in this area. Photo taken facing northeast on December 12, 2023.

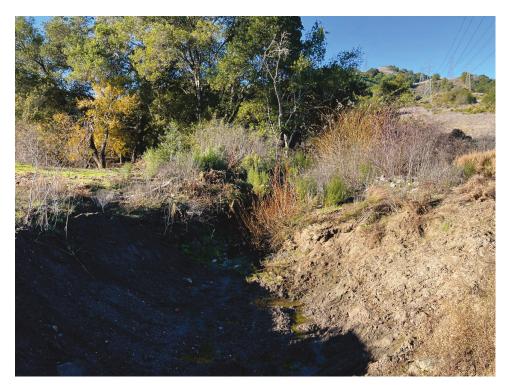
Photo 2. Ordinary high water mark (OHWM)-1 data point at feature R-2 southeast of Moraga Substation. Photo taken facing west/upstream on December 12, 2023.

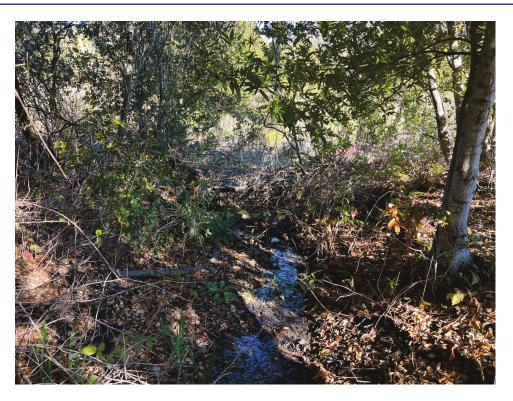
Photo 3. R-3 along the boundary of the Study Area northwest of Moraga Substation, facing west on December 12, 2023.

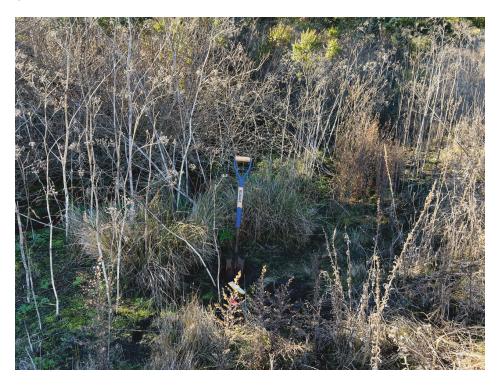
Photo 4. Sample point (SP)-1 located in a swale with hydrophytic vegetation. The sample point lacked wetland hydrology and hydric soils; therefore, no wetlands were delineated. Photo taken facing south on December 12, 2023.

SP-1 was established east of Moraga Substation (Figure 5, Map 2; Appendix C, Photo 4). The area was dominated by hydrophytes including poison hemlock (*Conium maculatum*) and spreading rush. However, there was no evidence of hydric soils or wetland hydrology; therefore, no aquatic resources were delineated at this location and the feature was determined to be an upland swale.

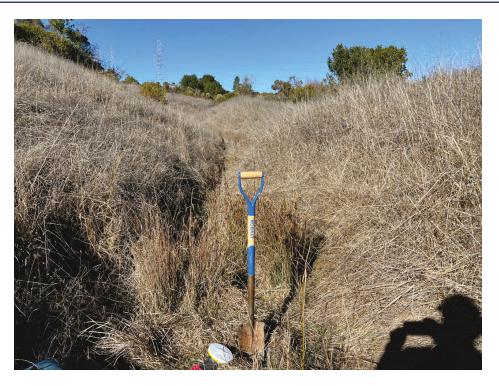
Photo 5. SP-2 located in a swale with hydrophytic vegetation. The sample point lacked wetland hydrology and hydric soils; therefore, no wetlands were delineated. Photo taken facing northwest on December 12, 2023.

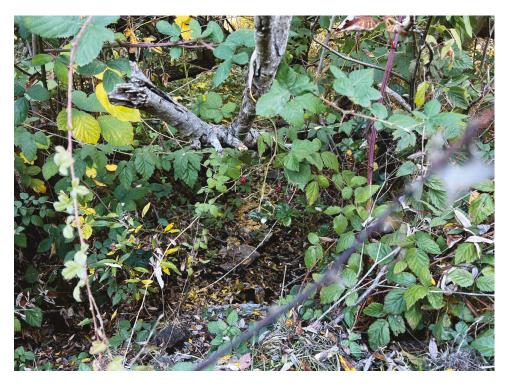
Photo 6. OHWM-2 data point taken at R-4 along access route southeast of Edgewood Road. Photo taken facing east on December 12, 2023.

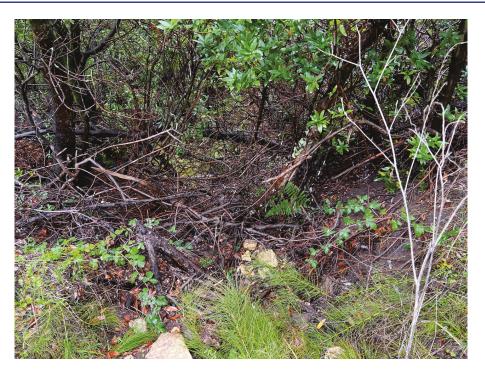
Photo 7. OHWM-4 data point taken at R-6 along access route southeast of the proposed staging area on Wilder Road. Photo taken facing east/downstream on December 29, 2023.

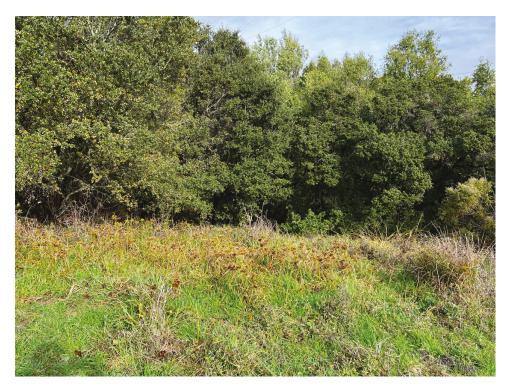
Photo 8. Wetland W-01a along access route on Edgewood Road. Photo taken facing northeast on December 12, 2023.

Feature ID	Cowardin Codeª	Latitude, Longitude	Approximate Area (acres)	Length (linear feet)	Figure 5 Mapbook Page	Description
WETLANDS				1	-	
Wetlands						
W-01a	PEM	37.852134, - 122.170409	0.035	-	4	Wetlands W-01a, W-01b, and W-01c are three separate features that form a wetland complex (Appendix C, Photo 8).
W-01b	PEM	37.852097, - 122.170484	0.015	-	4	This wetland complex was delineated along Edgewood Road east of the proposed staging area on Wilder Road. These wetlands are situated on flat to slightly concave terrain. They
W-01c	PEM	37.852314, - 122.170912	0.045	-	4	are formed by groundwater discharge at the base of a hillslope. Vegetation was dominated by tall flatsedge and soils met the Depleted Matrix (F3) hydric soil indicator. Wetland hydrology present were Saturation (A3) and Oxidized Rhizospheres along Living Roots (C3).
W-02	PEM	37.843238, - 122.177197	0.010	-	7	Wetlands W-02 and W-03 are seep wetlands formed on hillslopes adjacent to the proposed staging area just

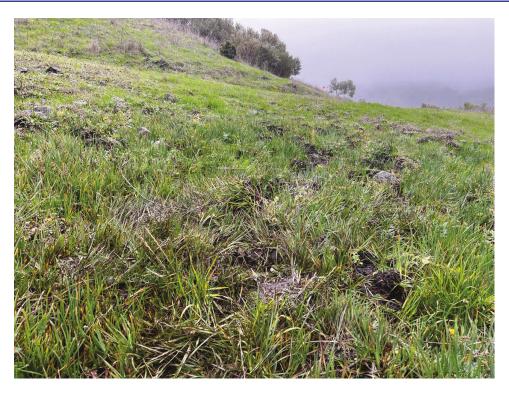
Photo 9. Wetland W-02 northeast of the proposed staging area southeast of the proposed overhead structures RN8 and RS8. Photo taken facing southwest on December 28, 2023.

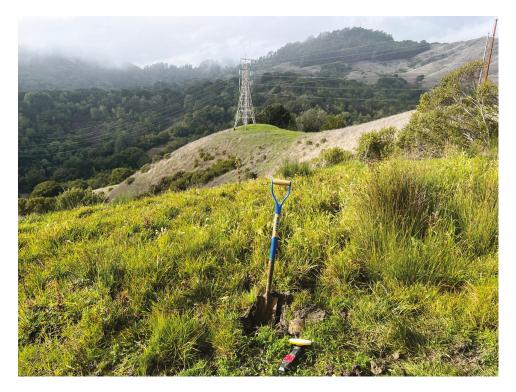
Photo 10. SP-4a taken at wetland W-03 southwest of the proposed staging area southeast of the proposed overhead structures RN8 and RS8. Photo taken facing northeast on December 28, 2023.

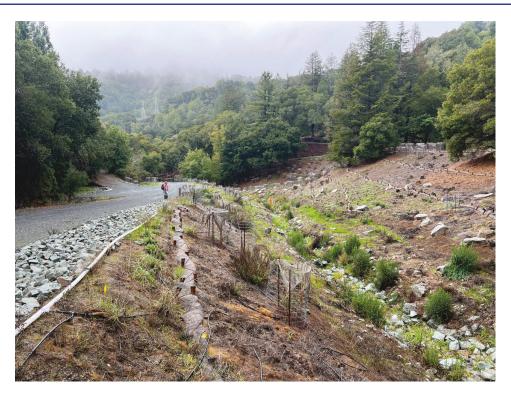
Photo 11. Alder Creek along access route within EBRPD Wilcox Staging Station Staging Area. Photo taken facing northeast on December 28, 2023.

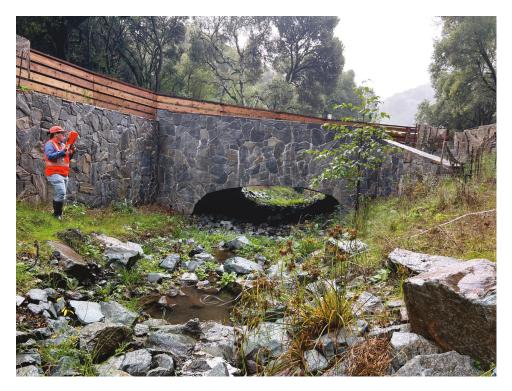
Photo 12. OHWM-3 data point at Alder Creek (R-8) along access route at EBRPD Wilcox Station Staging Area. Photo taken facing south on December 28, 2023.

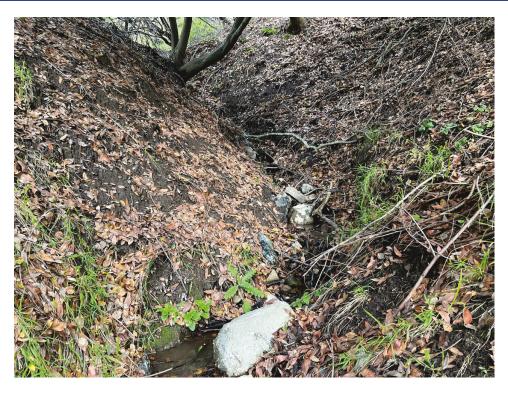
Photo 13. OHWM-6 data point taken at R-10 west of the proposed overhead structures RN12 and RS12. Photo taken facing north/upstream on January 12, 2024.

R-10	R4SB	37.835736, - 122.191000	0.006	83	10	Stream is approximately 3 feet wide on a hillslope, draining to CW-7 and into Shephard Creek (Appendix C, Photo 13). The feature was not mapped by the NHD but NWI identified the feature as a riverine, intermittent, streambed.
R-12	R4SB	37.825569, - 122.201999	0.064	608	12	Stream is identified by the NHD as Shephard Creek. The width of this drainage varies from 3 to 7 feet wide at the OHWM (Appendix C, Photo 16). This feature is not mapped on NWI.
R-13	R4SB	37.821866, - 122.205169	0.067	243	13	Stream is tributary to Shephard Creek. Approximately 12 feet wide (Appendix C, Photo 17) at OHWM. The stream is identified by the NWI as a riverine, intermittent, streambed feature but is not identified by the NHD.
R-14	RS4SB	37.818747, - 122.207186	0.087	394	14	Stream is approximately 8 feet wide at the OHWM. Stream is identified by the NHD as two blueline streams, Palo Seco Creek and Shephard Creek, and NWI identifies the feature as riverine, intermittent, streambed (Appendix C, Photo 18 and 19). The southeastern portion of the stream is part of Palo Seco Creek associated with CW-8 that drains into Sausal Creek.

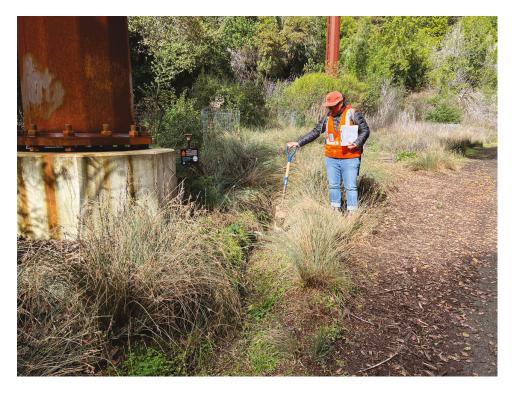
Photo 14. OHWM-8 data point taken at R-11 adjacent to a managed native plant garden along access route on Montclair Railroad Trail. Photo taken facing northwest on January 12, 2023.

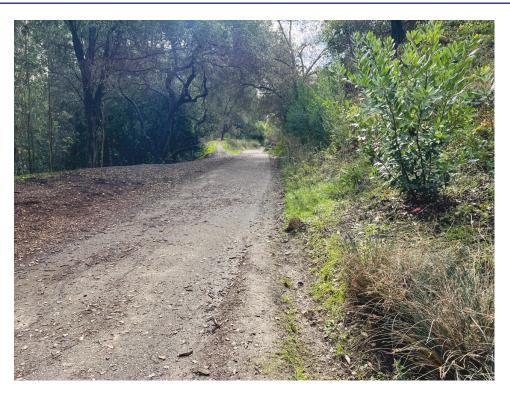
Photo 15. R-11 ends and sheetflows along trail on access route on Montclair Railroad Trai. Photo taken facing southwest on January 12, 2024.

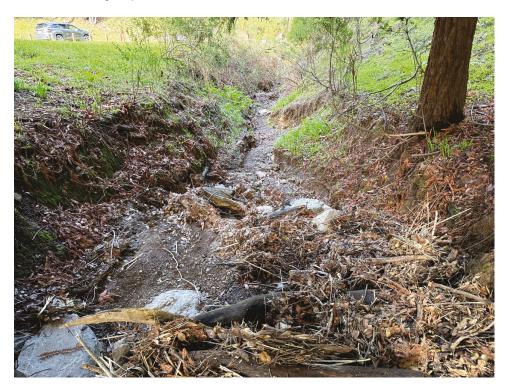
Photo 16. OHWM-7 data point taken at Shephard Creek (R-12) east of proposed staging area at Shepherd Canyon Park. Photo taken facing north on January 12, 2024.

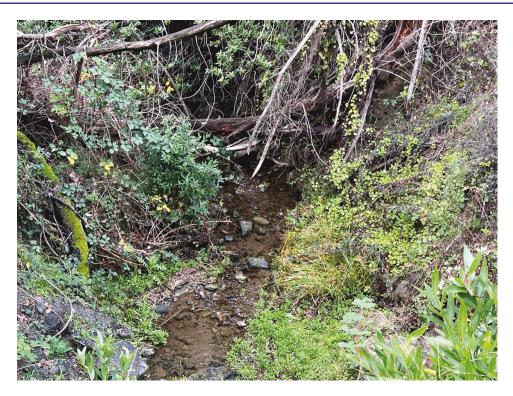
Photo 17. R-13 north of the tension pull site north of Mountain Boulevard. Photo taken facing west on January 12, 2024.

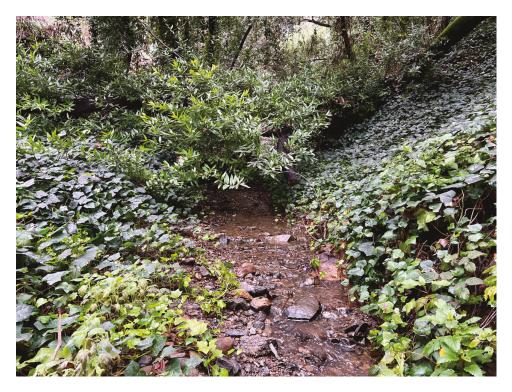
Photo 18. OHWM-5 data point taken at Palo Seco Creek section of R-14 east of the staging area at Montclair Golf Course. Photo taken facing west and downstream on December 29, 2023.

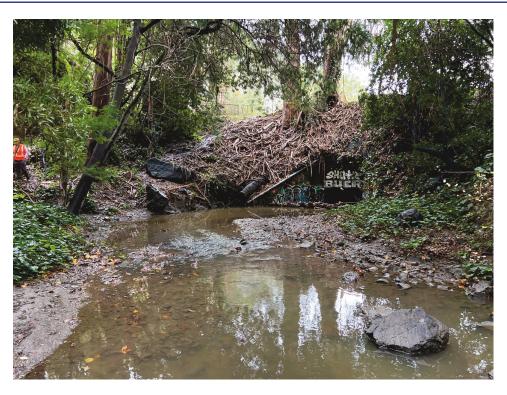
Photo 19. R-14 at the confluence of Shephard Creek and Palo Seco Creek northeast of the staging area at Montclair Golf Course. Photo taken facing southwest on December 29, 2023.

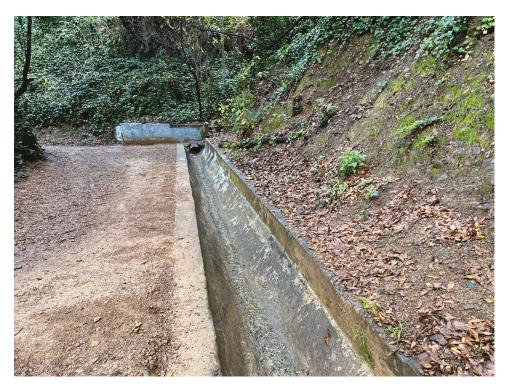
Photo 20. Concrete-lined ditch connecting to steep ephemeral waters (R-15) northeast of the proposed overhead structures RN24 and RS24. Photo taken facing east on December 29, 2023.

R-15	R6	37.816887, - 122.209666	0.001	50	14	Feature is in a 1-foot-wide concrete-lined ditch draining that conveys flow to CW-10 (Appendix C, Photo 20).
Approximate To	tal Ephemeral R	Riverine Waters	0.029	465		
Culverted Water	s					
CW-1	R4r	37.847694, - 122.160625	-	771	1	Culvert conveys flow from R-2 through Moraga Substation then drains into San Pablo Creek.
CW-2	R6r	37.849553, - 122.163171	-	13	1	Culvert conveys flow from R-3 through a 24-inch corrugated metal pipe (CMP) then drains into San Pablo Creek.
CW-3	R4r	37.850393, - 122.169473	-	19	4	Culvert conveys flow from R-4 through a 36-inch CMP which then drains into San Pablo Creek.
