Aspen Environmental Group

PROJECT MEMORANDUM PG&E – TRI-VALLEY 2002 CAPACITY INCREASE PROJECT

Subject: Weekly Report #29: March 31, 2003 – April 6, 2003

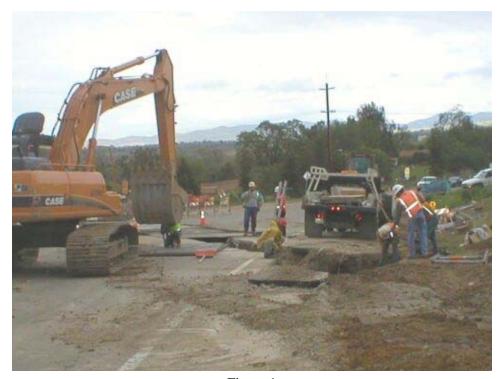
Trenching and conduit installation continued along New Vineyard Road westward from the Vault 14A and 14B location and across the intersection with "Old" Vineyard Avenue (see Figure 1). Crews also continued with trenching and installation within "Old" Vineyard Avenue from the Vault 15A and 15B location eastward toward the intersection. Crews continued with trenching and conduit installation from the Vault 16A and 16B location to the Vault 17A and 17B location, and from the Vault 17A and 17B location to south of the Arroyo del Valle. At the end of each workday all open trench was covered with steel plates and the areas swept clean. Throughout the "Old" Vineyard Avenue area, crews continued restoration along the right-of-way. Completed street trench areas were re-paved and off pavement trench line was restored and grapevine rows were extended. Traffic Control Plans were implemented.

Figure 1
Trenching and conduit installation east of the Vault 15 location across "Old" Vineyard Avenue.

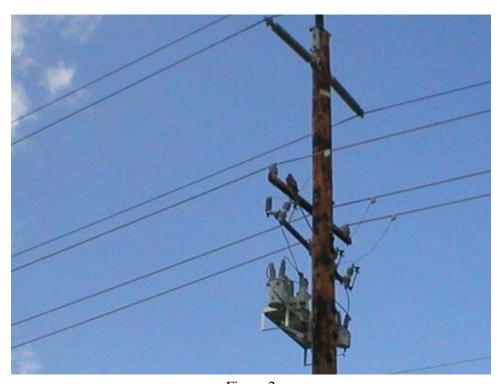
On March 24, the Essex EI contacted the CPUC EM with information that a Red Tail Hawk was spotted in a nest along "Old" Vineyard Avenue adjacent to the Vault 10 area (see Figure 2). Construction

including conduit installation, restoration and grapevine row extensions has already been completed through this area. No exclusion signs had been posted by April 3. While on-site, the CPUC EM saw a Mueller restoration crew doing right-of way clean-up closely approaching the nest exclusion area. The Essex EI was immediately contacted who then met the crew and diverted them around the exclusion area. The Essex EI later installed exclusion signs (see Figure 3). The PG&E biologist has been called to do a survey of the nest area. Grapevine re-planting is planned through the area. The CDFG will be consulted if and when any additional work within the 250-foot buffer should need to occur.

Figure 2
Red Tail Hawk spotted (located on the second bar from the top and left of the pole) on a utility pole across the street ("Old" Vineyard Avenue) from its nest location.

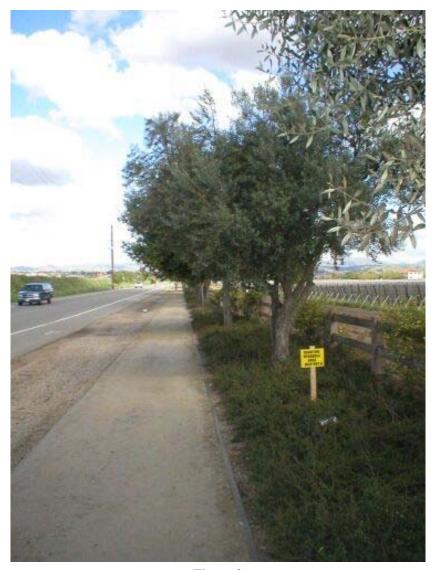
Figure 3
Exclusion signs were placed at the 250-foot exclusion boundaries of the active Red Tailed Hawk nest location.

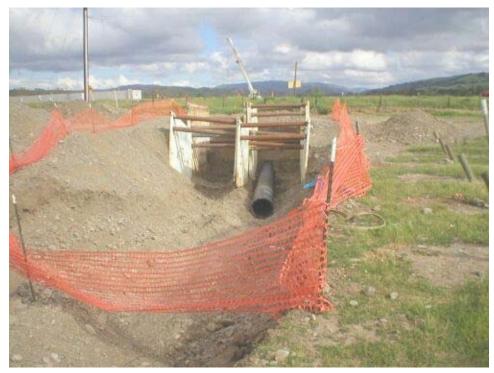
Boring operations continue at the Highway 84 bore. The first of the two bores was completed by the end of the subject week. HDPE casing was pulled through the bore hole (see Figure 4). Overland dewatering continues as defined in the Regional Water Quality Control Board (RWQCB) approved plan. The water has effectively peculated though the basin area without overflow.

Figure 4
The first of the two bores under Highway 84 has been completed.

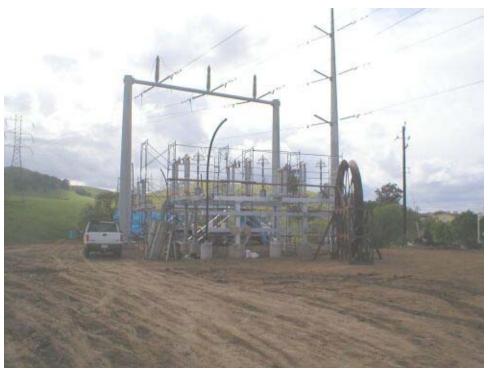
At the Transition Station, connections to the existing Contra Costa-Newark transmission line, which overhangs the station area, have been made to the erected station poles. Crews have installed switching equipment and have begun conduit stringing from the underground installation up the pole supports (see Figure 5). The CPUC EM checked erosion controls at the site, which appeared in good repair. Trucks and applicable equipment were being kept outside of exclusion boundaries at the Station site.

Figure 5
Continued work at the Transition Station, crews were on-site stringing conduit from the underground section to the above ground installation.
