## PROJECT MEMORANDUM PG&E – TRI-VALLEY 2002 CAPACITY INCREASE PROJECT

To: Roosevelt Grant, CPUC
From: Vida Strong, Aspen Project Manager
Date: August 28, 2003
Subject: Weekly Report #49: August 18, 2003 – August 24, 2003
CPUC Environmental Monitor (EM): Anne Sweet and Jenny Slaughter

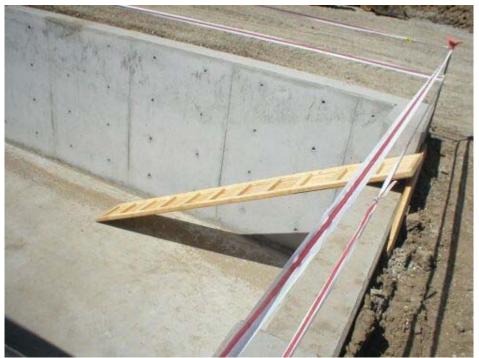
Figure 1 – Ramp installed for San Joaquin Kit Fox and other wildlife protection within the SPCC pond built at the Cayetano Substation, Phase Two.

At the Cayetano Substation site, crews have completed grading operations. A water sweeper is being used to clean the roadway outside of the substation. The contractor continued foundation work for footing installation. Approximately 25 deep holes have been drilled and steel cages are being inserted and set in concrete. At the end of each workday all open holes are being covered by plywood to avoid entrapment of wildlife. The SPCC pond has been completed at the southwest corner of the substation. Within the depression, a ramp was installed and maintained throughout construction of the feature to prevent wildlife entrapment including the San Joaquin Kit Fox (see Figure 1). The perimeter of silt fencing is being maintained around the substation site.

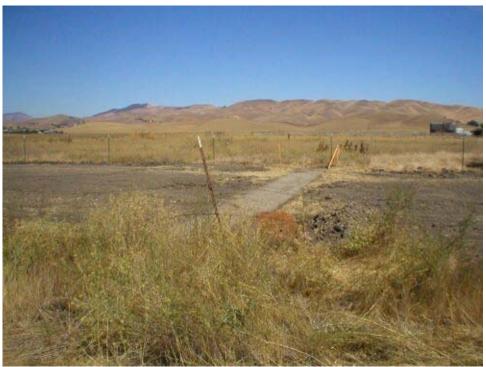
Figure 2 – Trenching and conduit installation under the UAD along May School Road is complete. The contractor has backfilled soil up to the cultural resource , Phase Two.

On July 29, an unanticipated cultural discovery was made on the right-of-way adjacent to the historic May School cultural resource site. A concrete walkway was identified during clearing of the alignment area at Station 88+00. The CPUC EM and Lead EM were immediately notified of the find. After review

of the consultation report submitted, a NTP was issued by the CPUC on August 4 to continue work in the area of the unanticipated discovery. An archaeological monitor was onsite for the duration of the construction in the resource area and also monitored the backfill of the trench (see Figure 2).

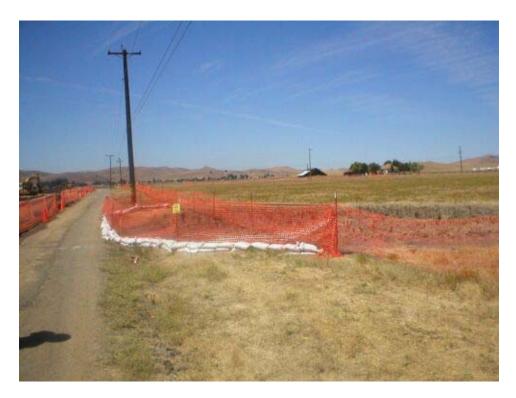
Figure 3 – Reduced buffer zone for wetland habitat along the North side of the access road between Dagnino Road and the Transition Station, Phase Two. The PG&E trench line is on the opposite side of the access road from the resource.

Crews also continued trenching northbound along Dagnino Road and on August 23, crews began trenching east along the access road, which follows the alignment to the Transition Station, part of which lies within a wetland exclusion buffer and future wetland mitigation site for the Dublin Ranch Development. Based on documentation submitted by PG&E stating that the seasonal wetland east of Dagnino Road did not provide suitable habitat for sensitive species and the subject area will be graded for the creation of the Dublin Ranch Development mitigation site, the required 100-foot buffer was reduced. However, exclusion fencing was installed to prevent any construction activity from entering the mitigation site and subject seasonal wetland area. As an added protection measure, sandbags were also placed around the site (see Figure 3).
