PROJECT MEMORANDUMPG&E - TRI-VALLEY 2002 CAPACITY INCREASE PROJECTTo:Jensen Uchida, CPUCFrom:Vida Strong, Aspen Project ManagerDate:August 18, 2005Subject:Weekly Report #71: August 8, 2005 – August 12, 2005CPUC Environmental Monitors (EMs):Anne Sweet and Jenny Slaughter

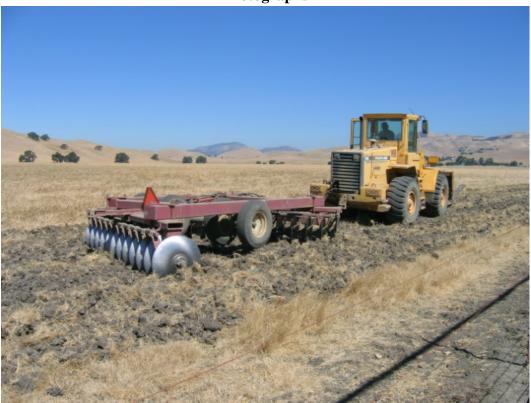
On August 17th, construction of the underground portion began just north of the Cayetano Substation on North Livermore Avenue (see Figure 1). Crews initially used a disk to break up the soil and then were able to strip the top soil and stockpile it along the side of the right-of-way. Excavation is being conducted using a trencher.

Figure 1 – Construction of the underground portion began August 10, 2005.

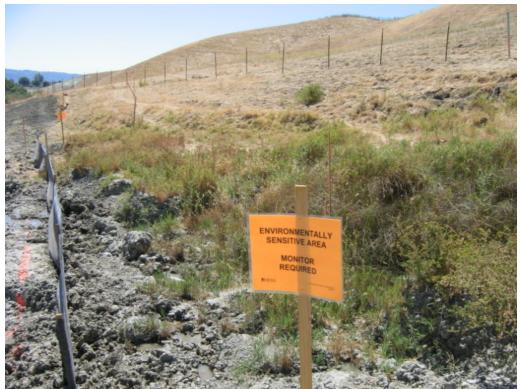
Ten sightings of California red legged frogs were reported along Moller Road during the week. In one case, a frog was found immediately adjacent to construction and was relocated out of the work area (see Figure 2). The other sightings were outside of the work area. USFWS and CDFG were notified of the sightings.

Figure 2 – A California red legged frog was found in the project area and relocated along Moller Road, August 10, 2005.
