PROJECT MEMORANDUM
SDG&E VINE 69/12-KV SUBSTATION PROJECT

To: Eric Chiang, Project Manager, CPUC
From: Vida Strong, Aspen Project Manager
Date: May 20, 2017
Subject: Monitoring Report #13: April 9 to May 19, 2017

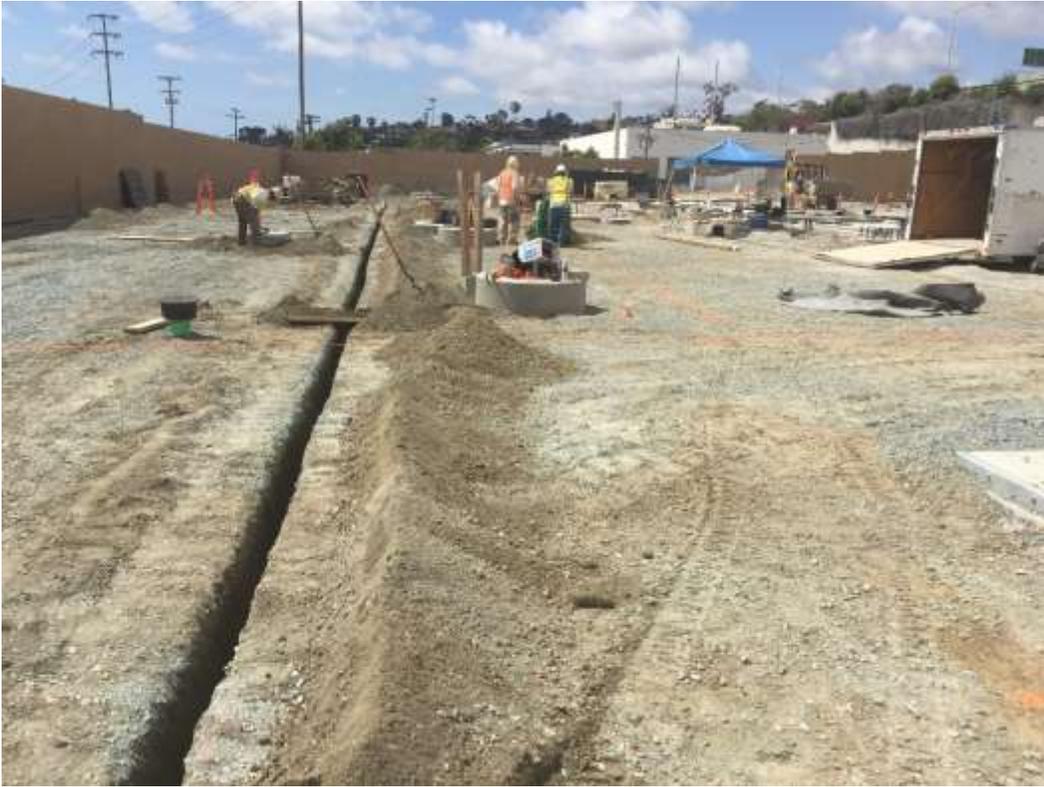
2. DCX continued with substation component construction including the control building, ground grid, and pull box installation (see Figure 1).
3. Stockpiled soils from the excavated trenches and foundations were hauled off site.

Figure 1 – DCX crews continued with the installation of the substation ground grid.

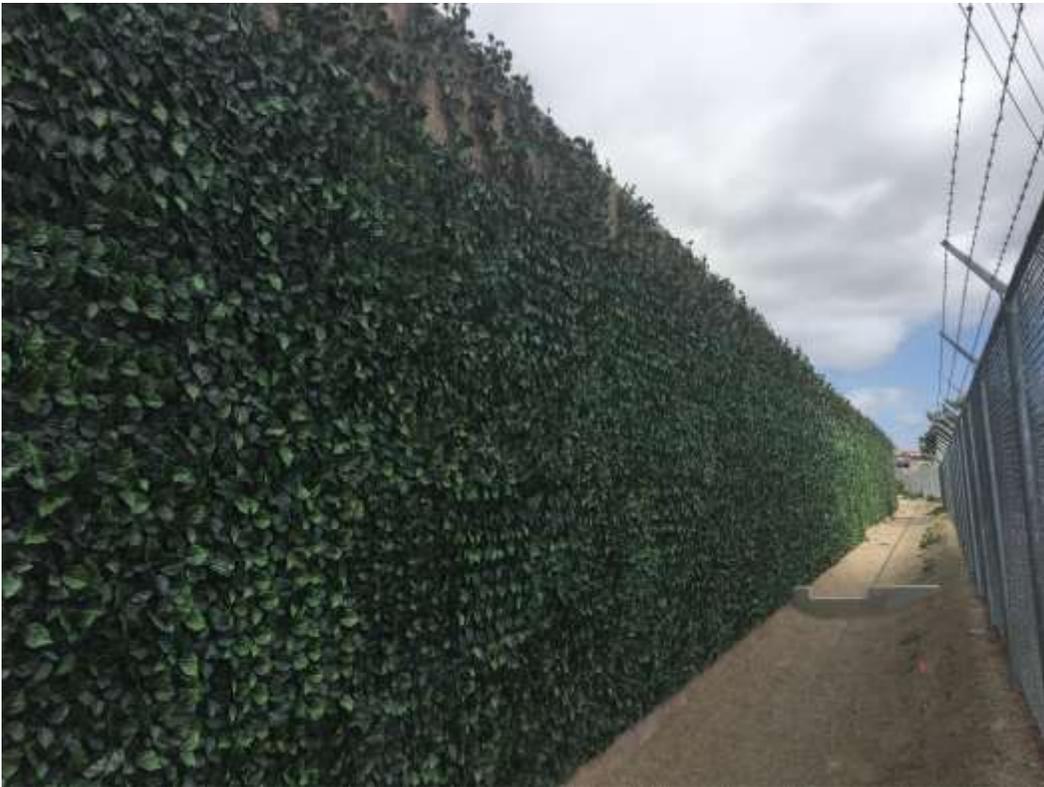
4. Artificial ivy installation occurred on the outside of the western boundary wall (see Figure 2). Due to graffiti concerns, SDG&E is proposing to cover the other walls with the artificial ivy. SDG&E is in discussions with the City of San Diego to determine if updates to the Landscape Plan will be necessary.

Figure 2 – Artificial ivy installation was installed on the outside western perimeter wall to prevent graffiti.

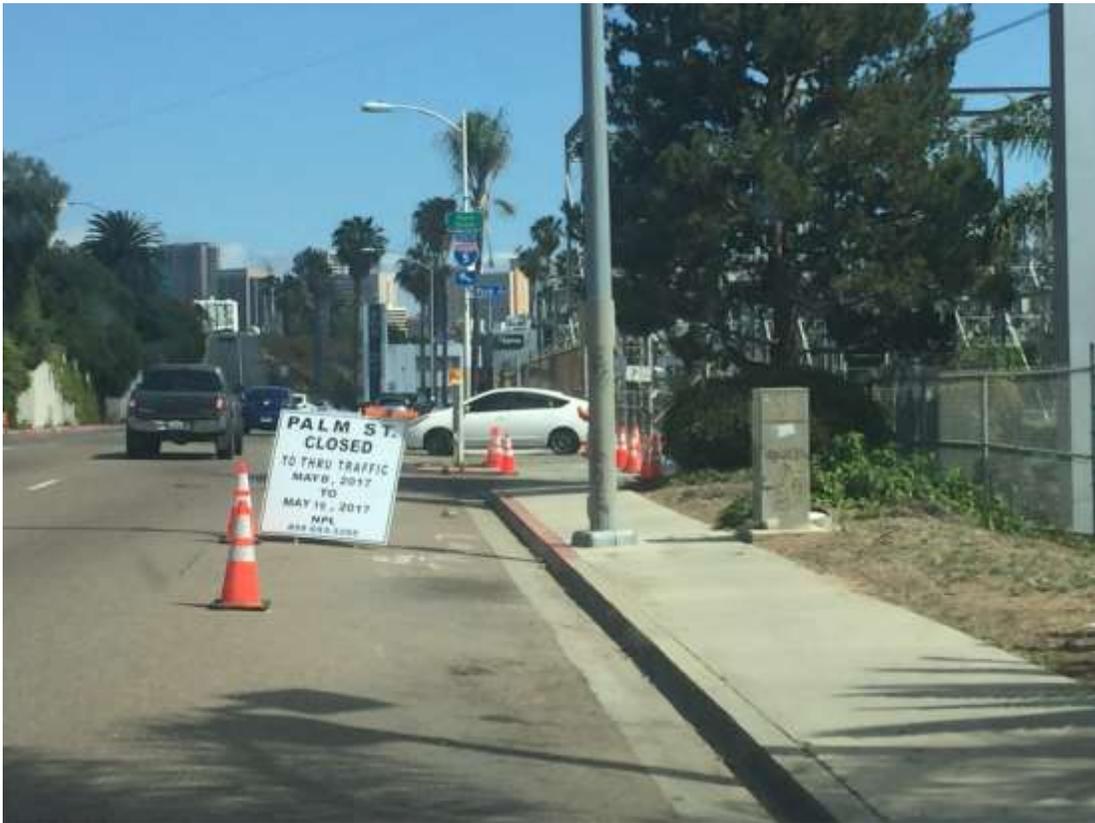
5. Construction of the 12 kV underground portion resumed on May 8 at the Palm Street railroad crossing. Underground distribution work is being conducted by NPL. NPL and their subcontractor mobilized equipment to the work location on Palm Street. Traffic control for the 24-hour lane closure was in place (see Figure 3).

Figure 3 – Street closure signage in place for the jack and bore work. One lane of traffic is closed 24 hours a day during construction.

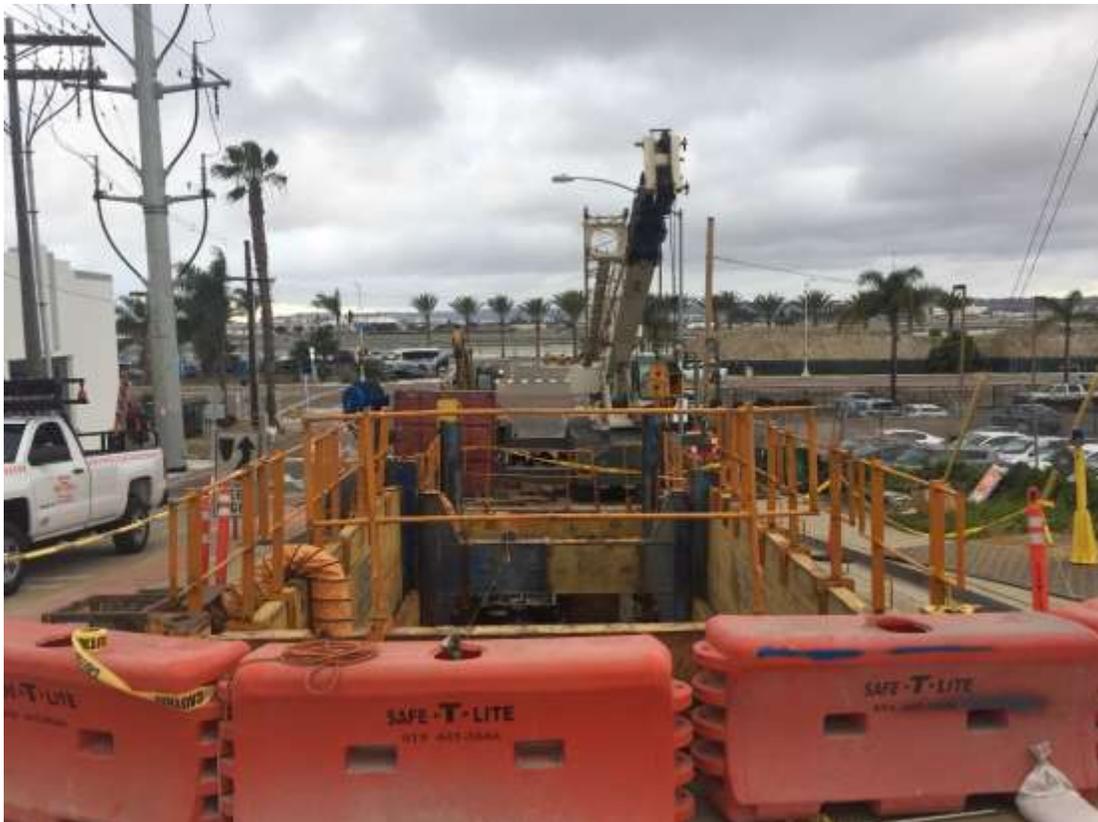
6. Saw cutting and excavation of the entry and exit bore pits were completed (see Figure 4). Boring began until the crews discovered a concrete wall in the way of the drill bit. Additional equipment is being delivered to assist in breaking up the concrete wall.

Figure 4 – Equipment set up and entry pit of the jack and bore work along Palm Street.

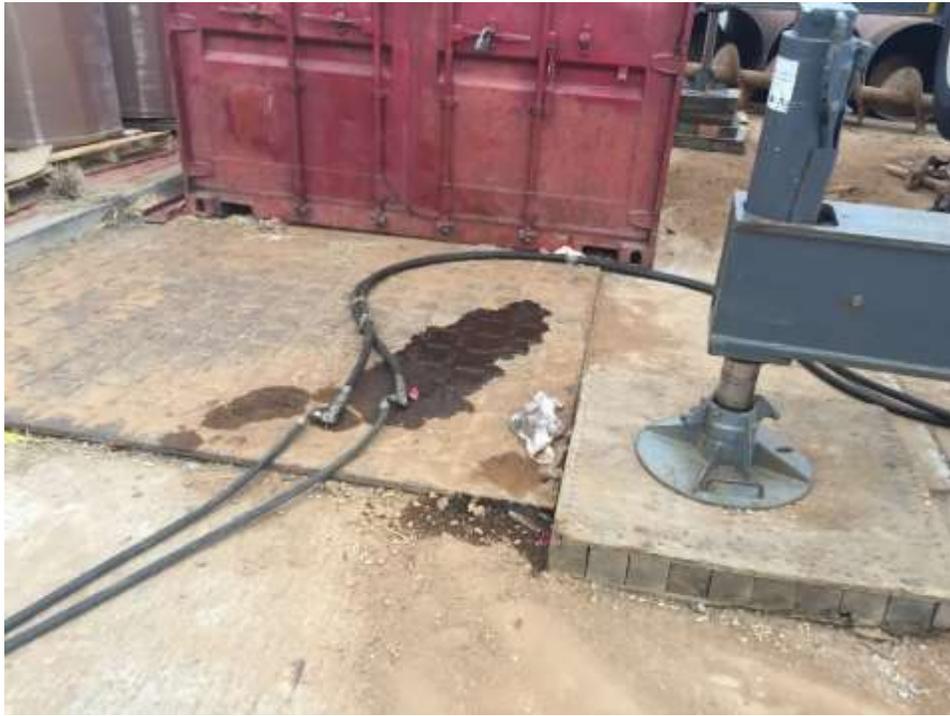
1. On May 17, project Environmental Inspectors conducted a site inspection at the jack and bore location and observed two leaking hydraulic hoses lying on a steel plate on the ground. The crane staged at this location was also observed to be staged without secondary containment. Both items were brought to NPL's attention at the weekly construction meeting the same day. On May 18, the CPUC EM checked the site to see if these items had been addressed. The hydraulic hoses were still leaking and dirt was used to soak up the fluid and contain it. No drip pans were underneath the crane. The CPUC EM documented the improper containment and spill clean-up of the hydraulic fluid in an incident report to SDG&E. SDG&E's Environmental Inspectors also issued two Level B Non-Compliances for this and for not having complete spill containment kits available on site. Photos showing the proper containment and clean up were provided to the CPUC EM (see Figures 5-7)

Figure 5 – Leaking hydraulic hoses at the jack and bore site with no spill containment as observed on May 17.

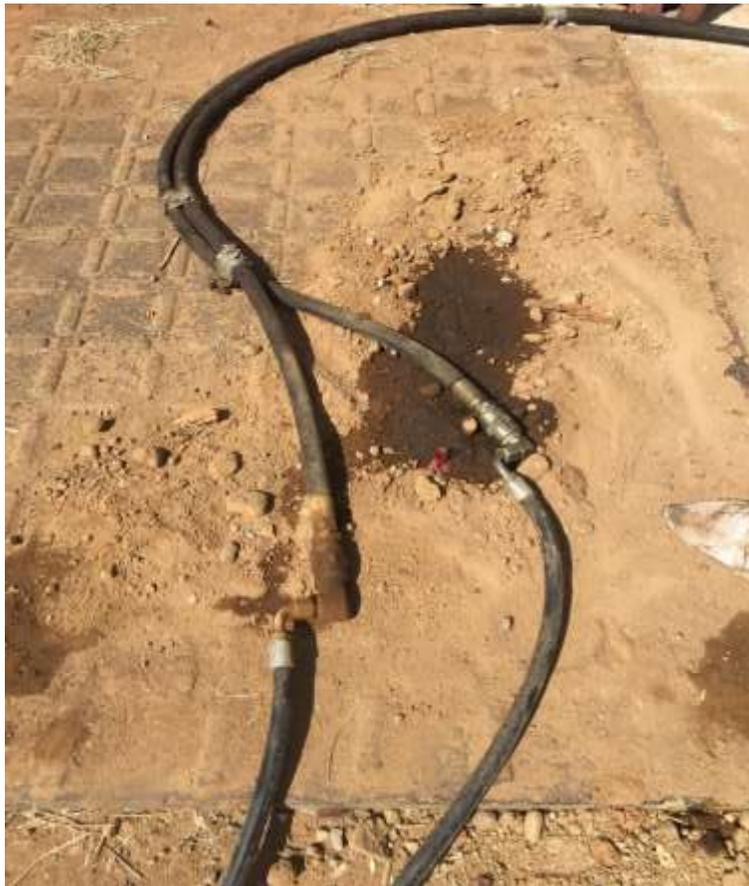
Figure 6 – Same hydraulic leak observed the morning of May 18 after crews had used dirt to contain and soak up the spill.

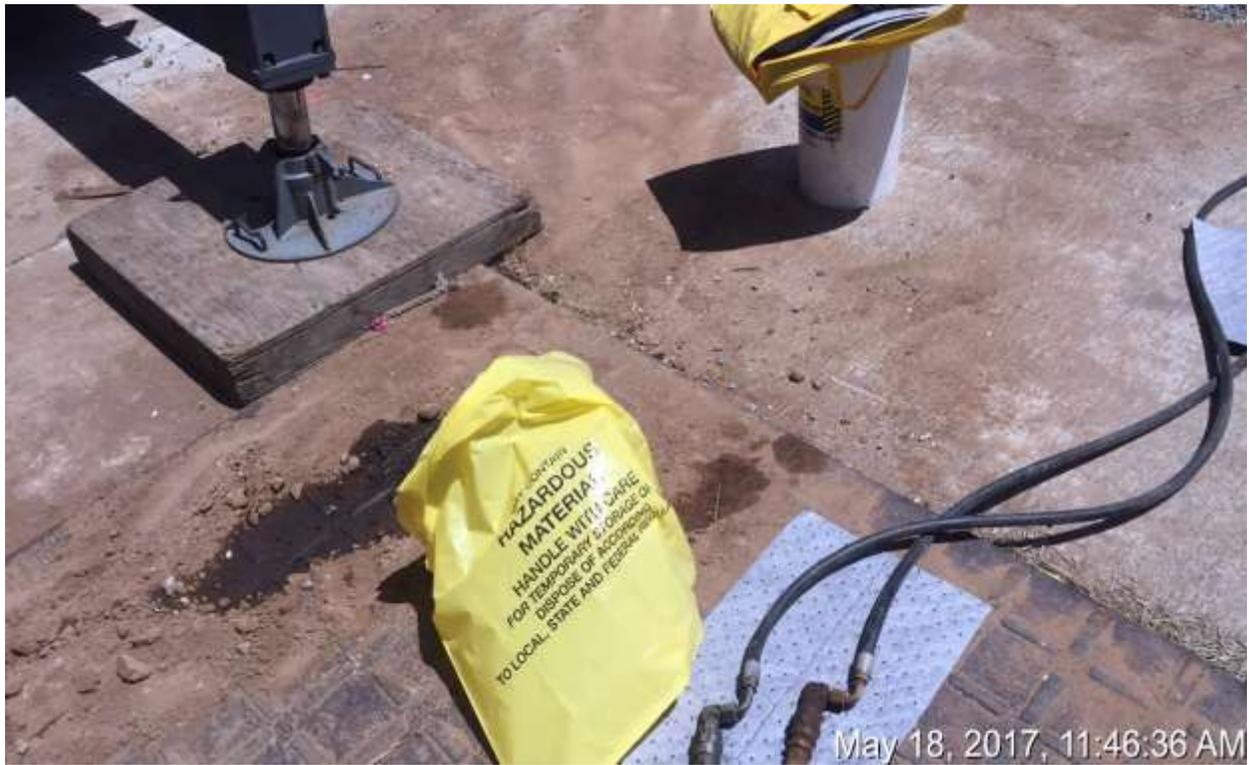
Figure 7 – Proper clean-up of the hydraulic leak was documented by SDG&E’s Environmental Inspectors on May 18 (photo courtesy of SDG&E).
