Environmental Minor Project Refinement Form

Project Name: West of Devers Upgrade Project **Request Prepared By:** Sylvia Granados

Date Approval Required: 7/24/2020 **Variance Request No.:** 39

Southern California Edison
West of Devers Upgrade Project
Proposed Work Areas
MPR #39

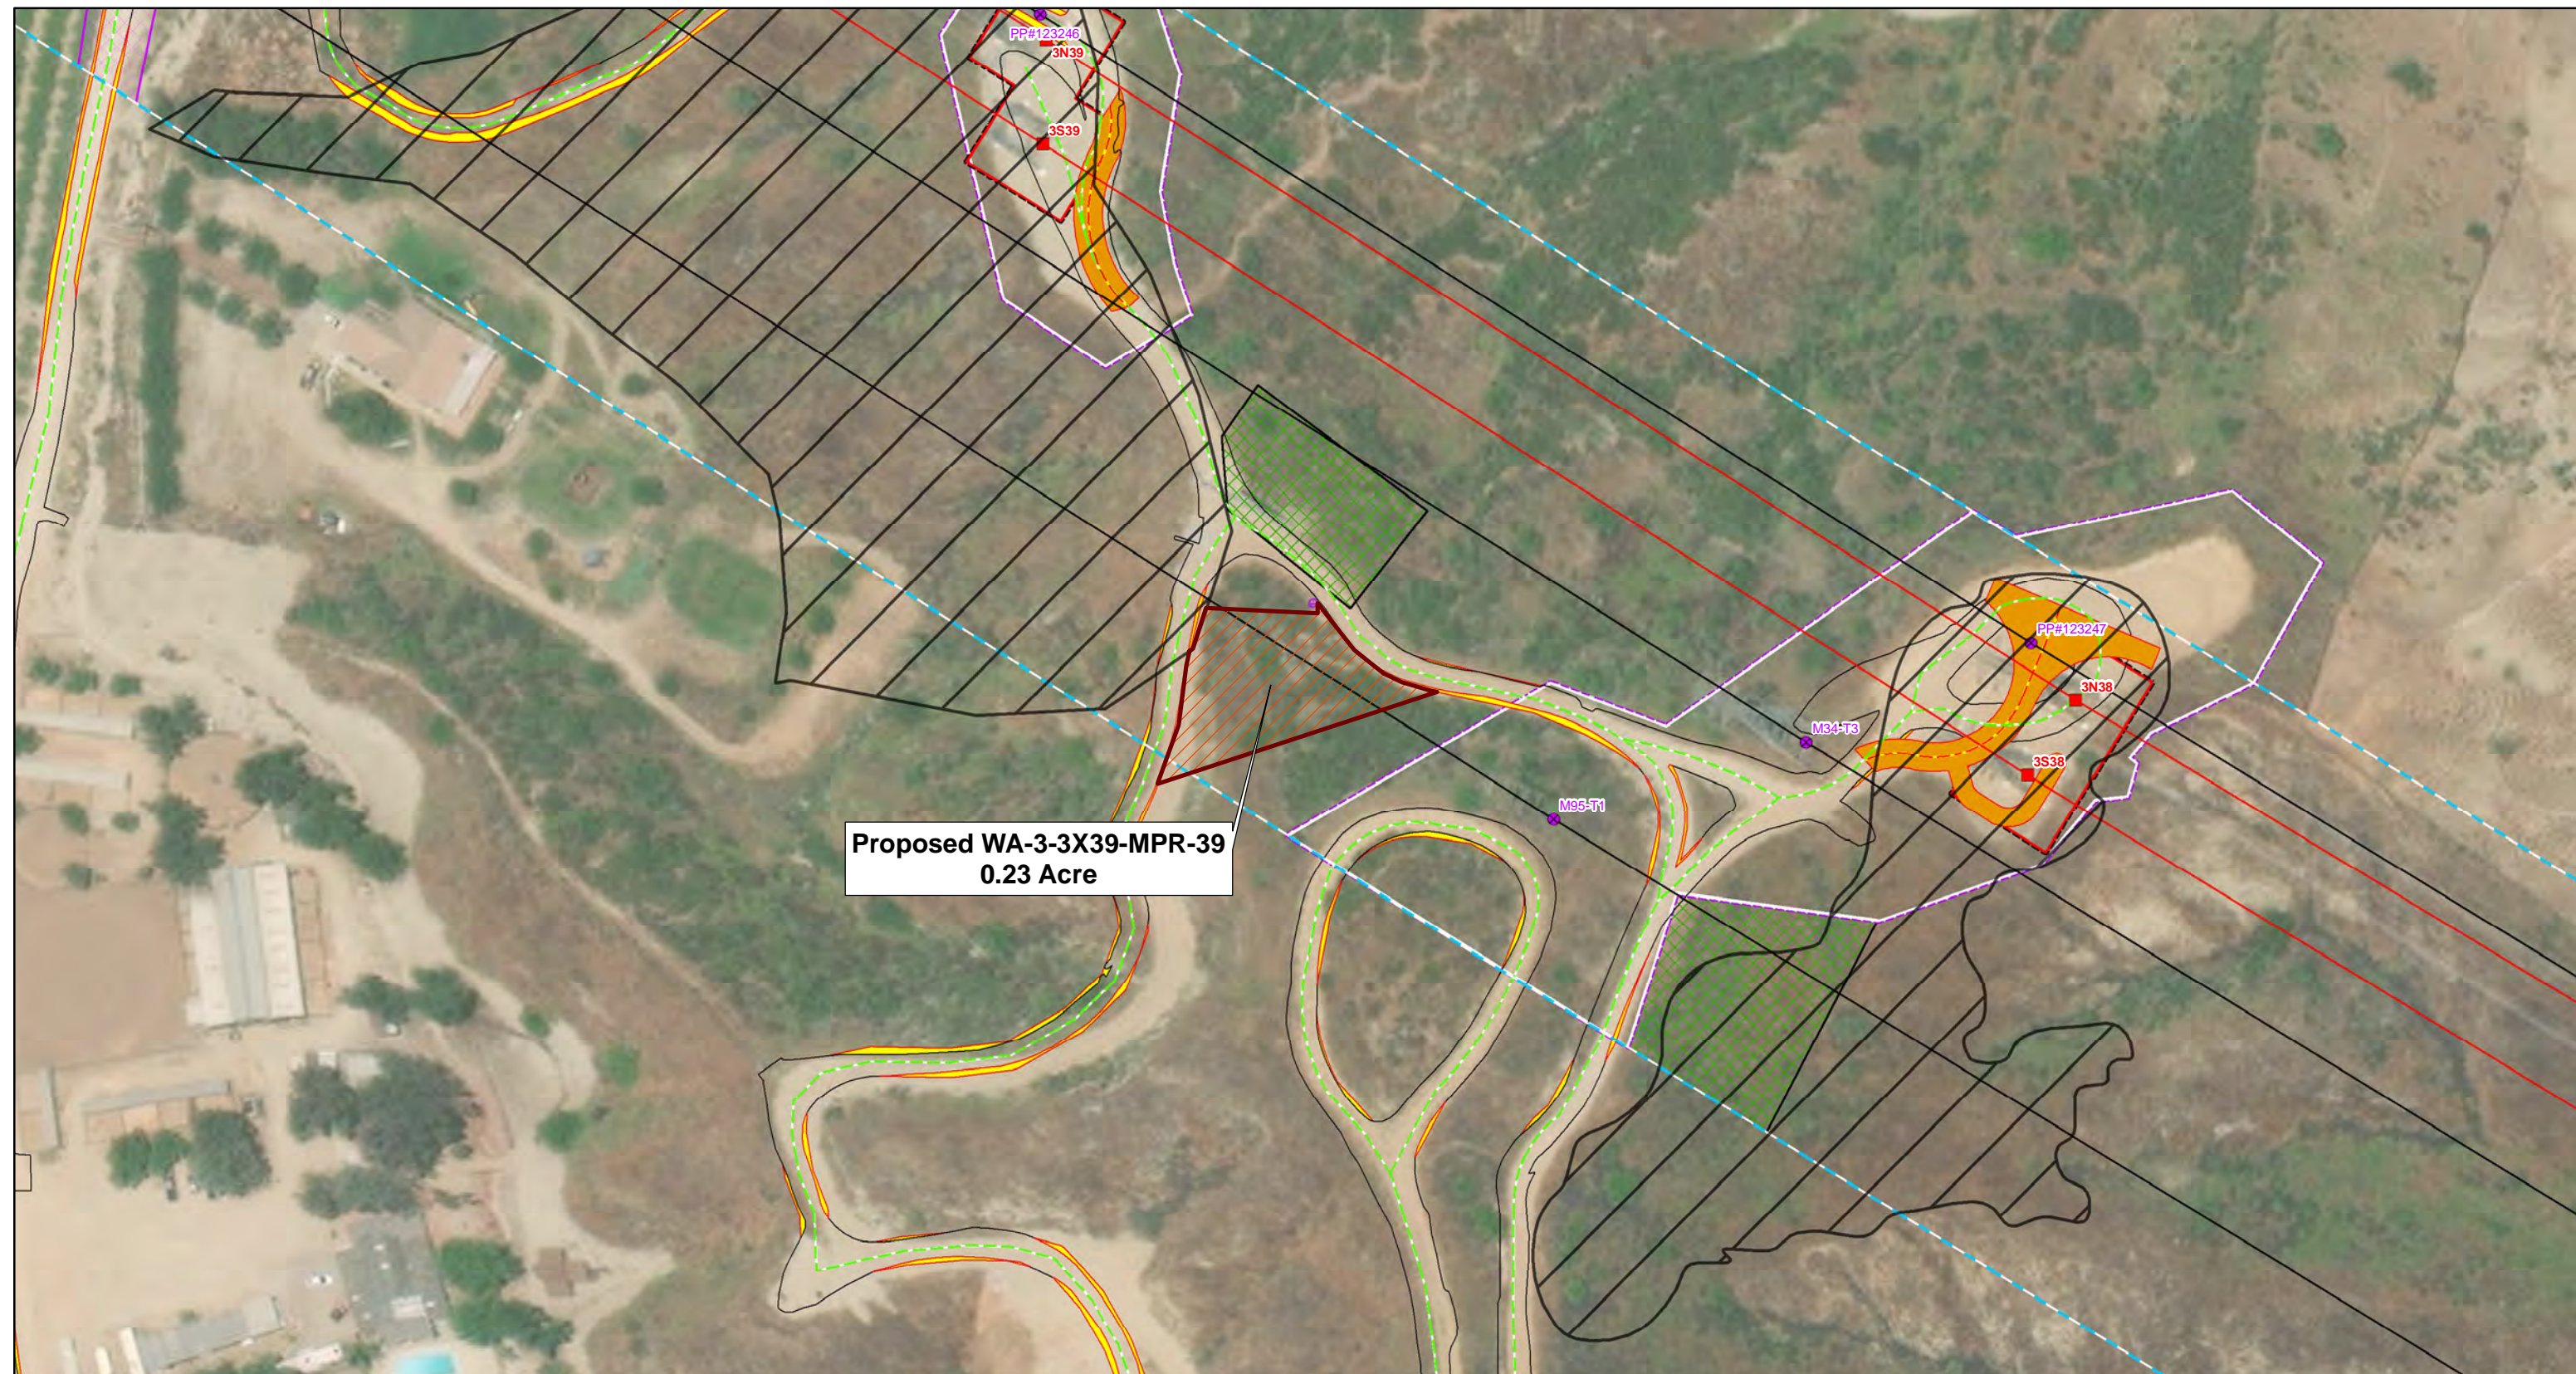
WA-3-3X39-MPR-39 (Figure 1, page 5)

A new temporary 0.23-acre work area is required to safely stage a crane and other material and equipment associated with the shoofly wire installation and wire wreck-out activities associated with SF-3-SF305, as shown on Figure 1, page 5. The new work area will be cleared and leveled prior to use and will be accessed from existing access roads.

The total temporary disturbance area is privately owned and consists of approximately 0.23-acre of coastal sage scrub located within the SCE transmission line right-of-way, in the City of Redlands.

Stephens' Kangaroo Rat – None of the new work areas intersect suitable SKR habitat, however suitable SKR habitat is mapped northwest of WSS-4-4X56-MPR-39 (Figure 1, page 1) and northwest of WA-3-3X39-MPR-39 (Figure 1, page 5). A habitat assessment, pedestrian surveys, and several consecutive years of trapping surveys have been conducted within the SKR suitable habitat areas of the Project. Based on a lack of historic data, habitat conditions, and negative results over several years of surveys, SKR are not expected. With implementation of mitigation measures and biological monitoring during construction, no impacts to SKR are anticipated.

MPR-39 along the access road during focused surveys in 2017 (Figure 1, page 5). No sign of the target species was observed in either area during subsequent preconstruction surveys of the areas. No special-status plants were observed in the vicinity of the other new work areas.
