# Environmental Minor Project Refinement Form

Project Name: West of Devers Upgrade Project Request Prepared By: Sylvia GranadosDate Approval Required: March 21, 2022 Variance Request No.: 54Date Submitted: March 14, 2022 Location: Supersite 3X48 in Redlands, San Bernardino County; Supersite 3X64 in Loma Linda, San Bernardino County; Supersite 4X34 in Beaumont, Riverside County; Supersite 4X52 in Beaumont, Riverside County; Supersite 6X35 in Whitewater, Riverside County.**Landowners and Associated Parcel Numbers:**

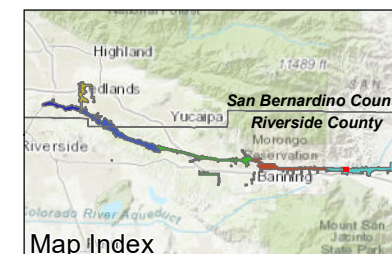
Southern California Edison  
West of Devers Upgrade Project  
**Proposed Work Area**  
MPR #54  
WA-6-6X35-MPR-54 Work Area

WA-6-6X35-MPR-54 is located within modeled desert tortoise (DETO) habitat; however, no DETO or sign have been observed in the vicinity (Figure 1, page 5). With monitoring, no impacts are anticipated.

Modeled habitat for Coachella Valley milk-vetch (*Astragalus lentiginosus* var. *coachellae* [CVMV]; FE, CRPR 1B.2) is located adjacent to WA-6-6X35-MPR-54 (Figure 1, page 5). The other proposed work areas do not intersect special-status plant habitat. No CVMV or other special-status plants have been observed in or near the four proposed work areas over several
