Pacific Gas & Electric Company's
Windsor Substation Project

**Mitigation Monitoring, Compliance,
and Reporting Program**

FINAL REPORT

Prepared for
California Public Utilities Commission

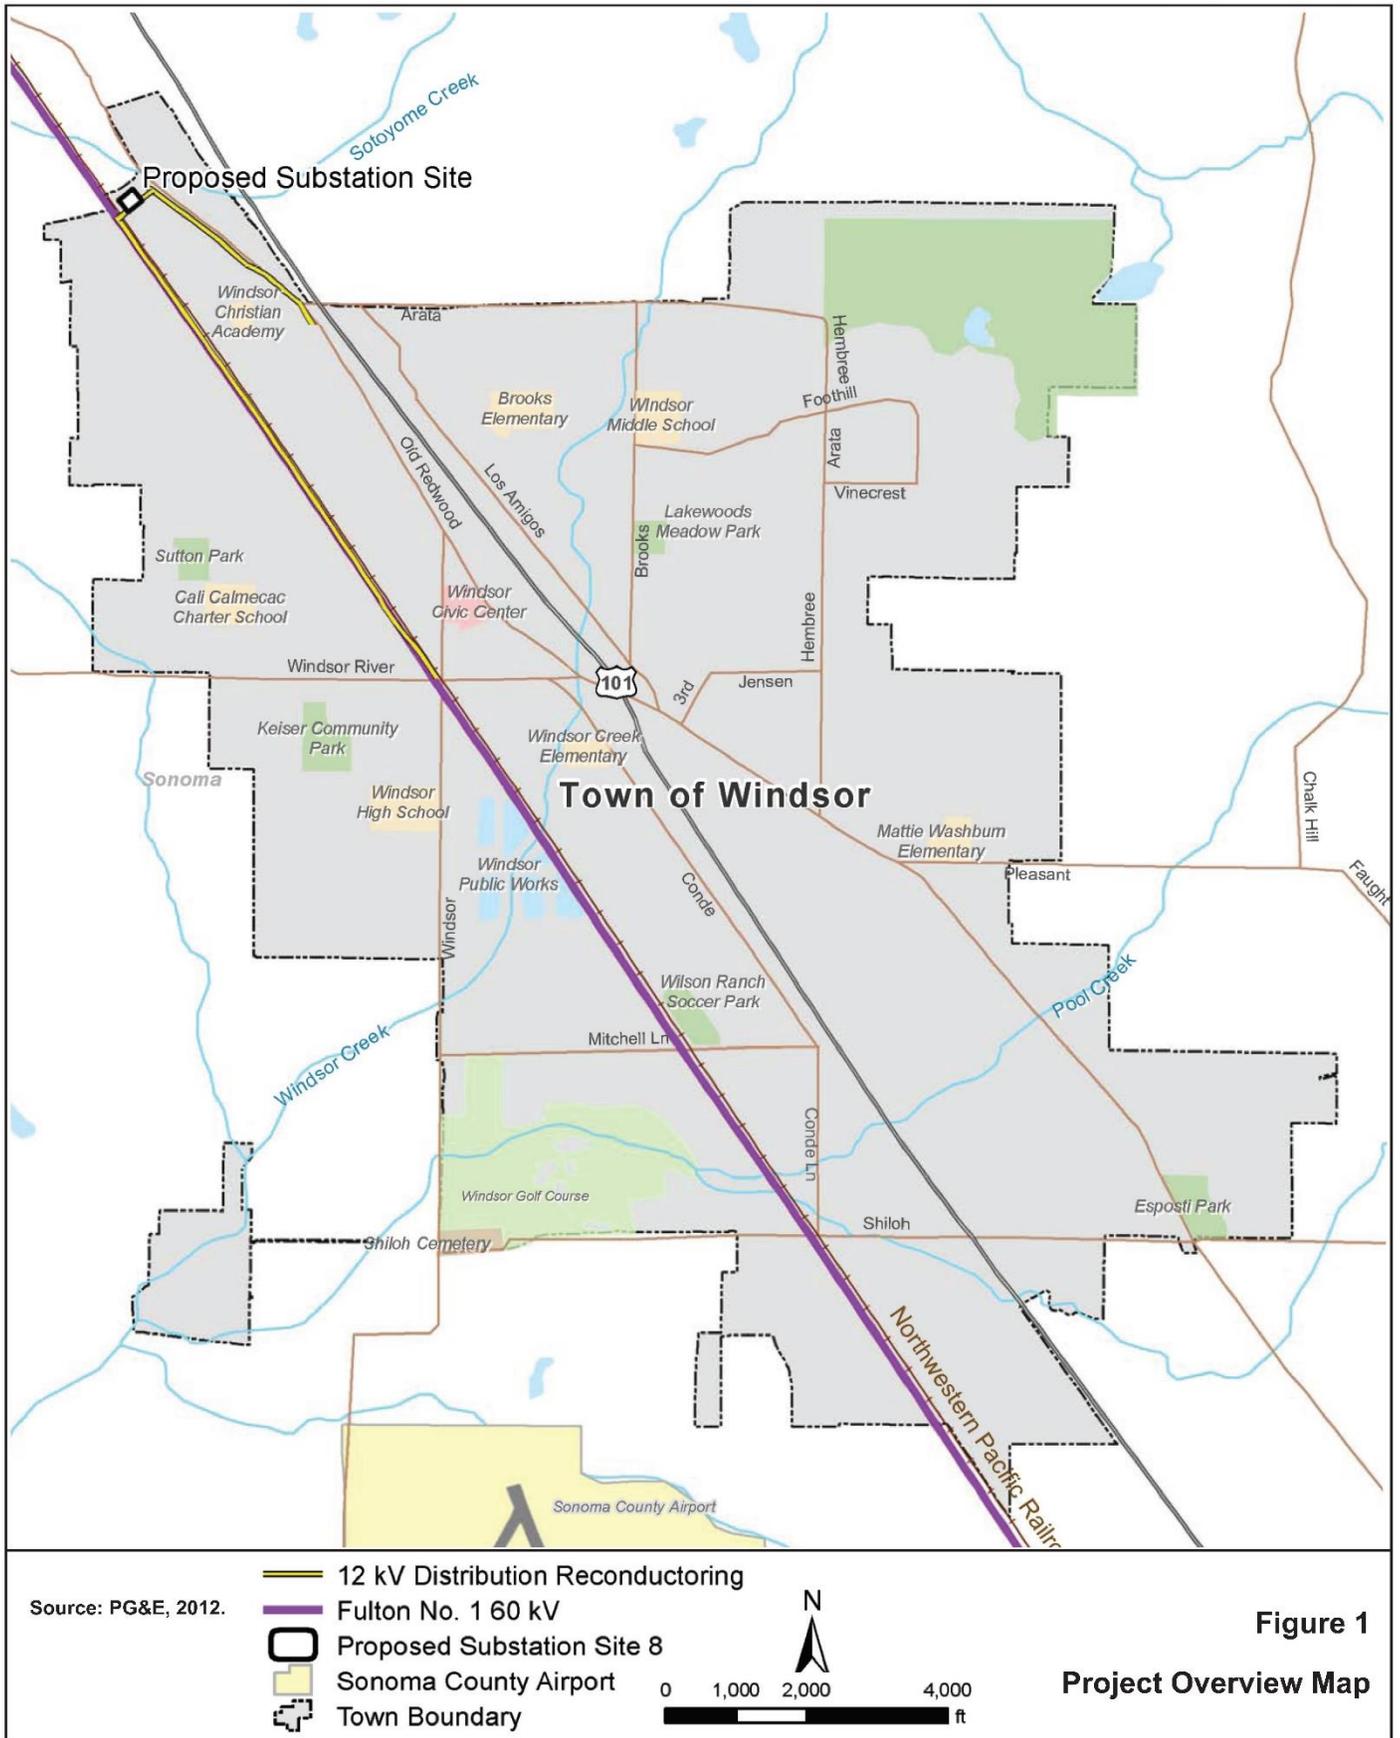
Figure 1

Project Overview Map

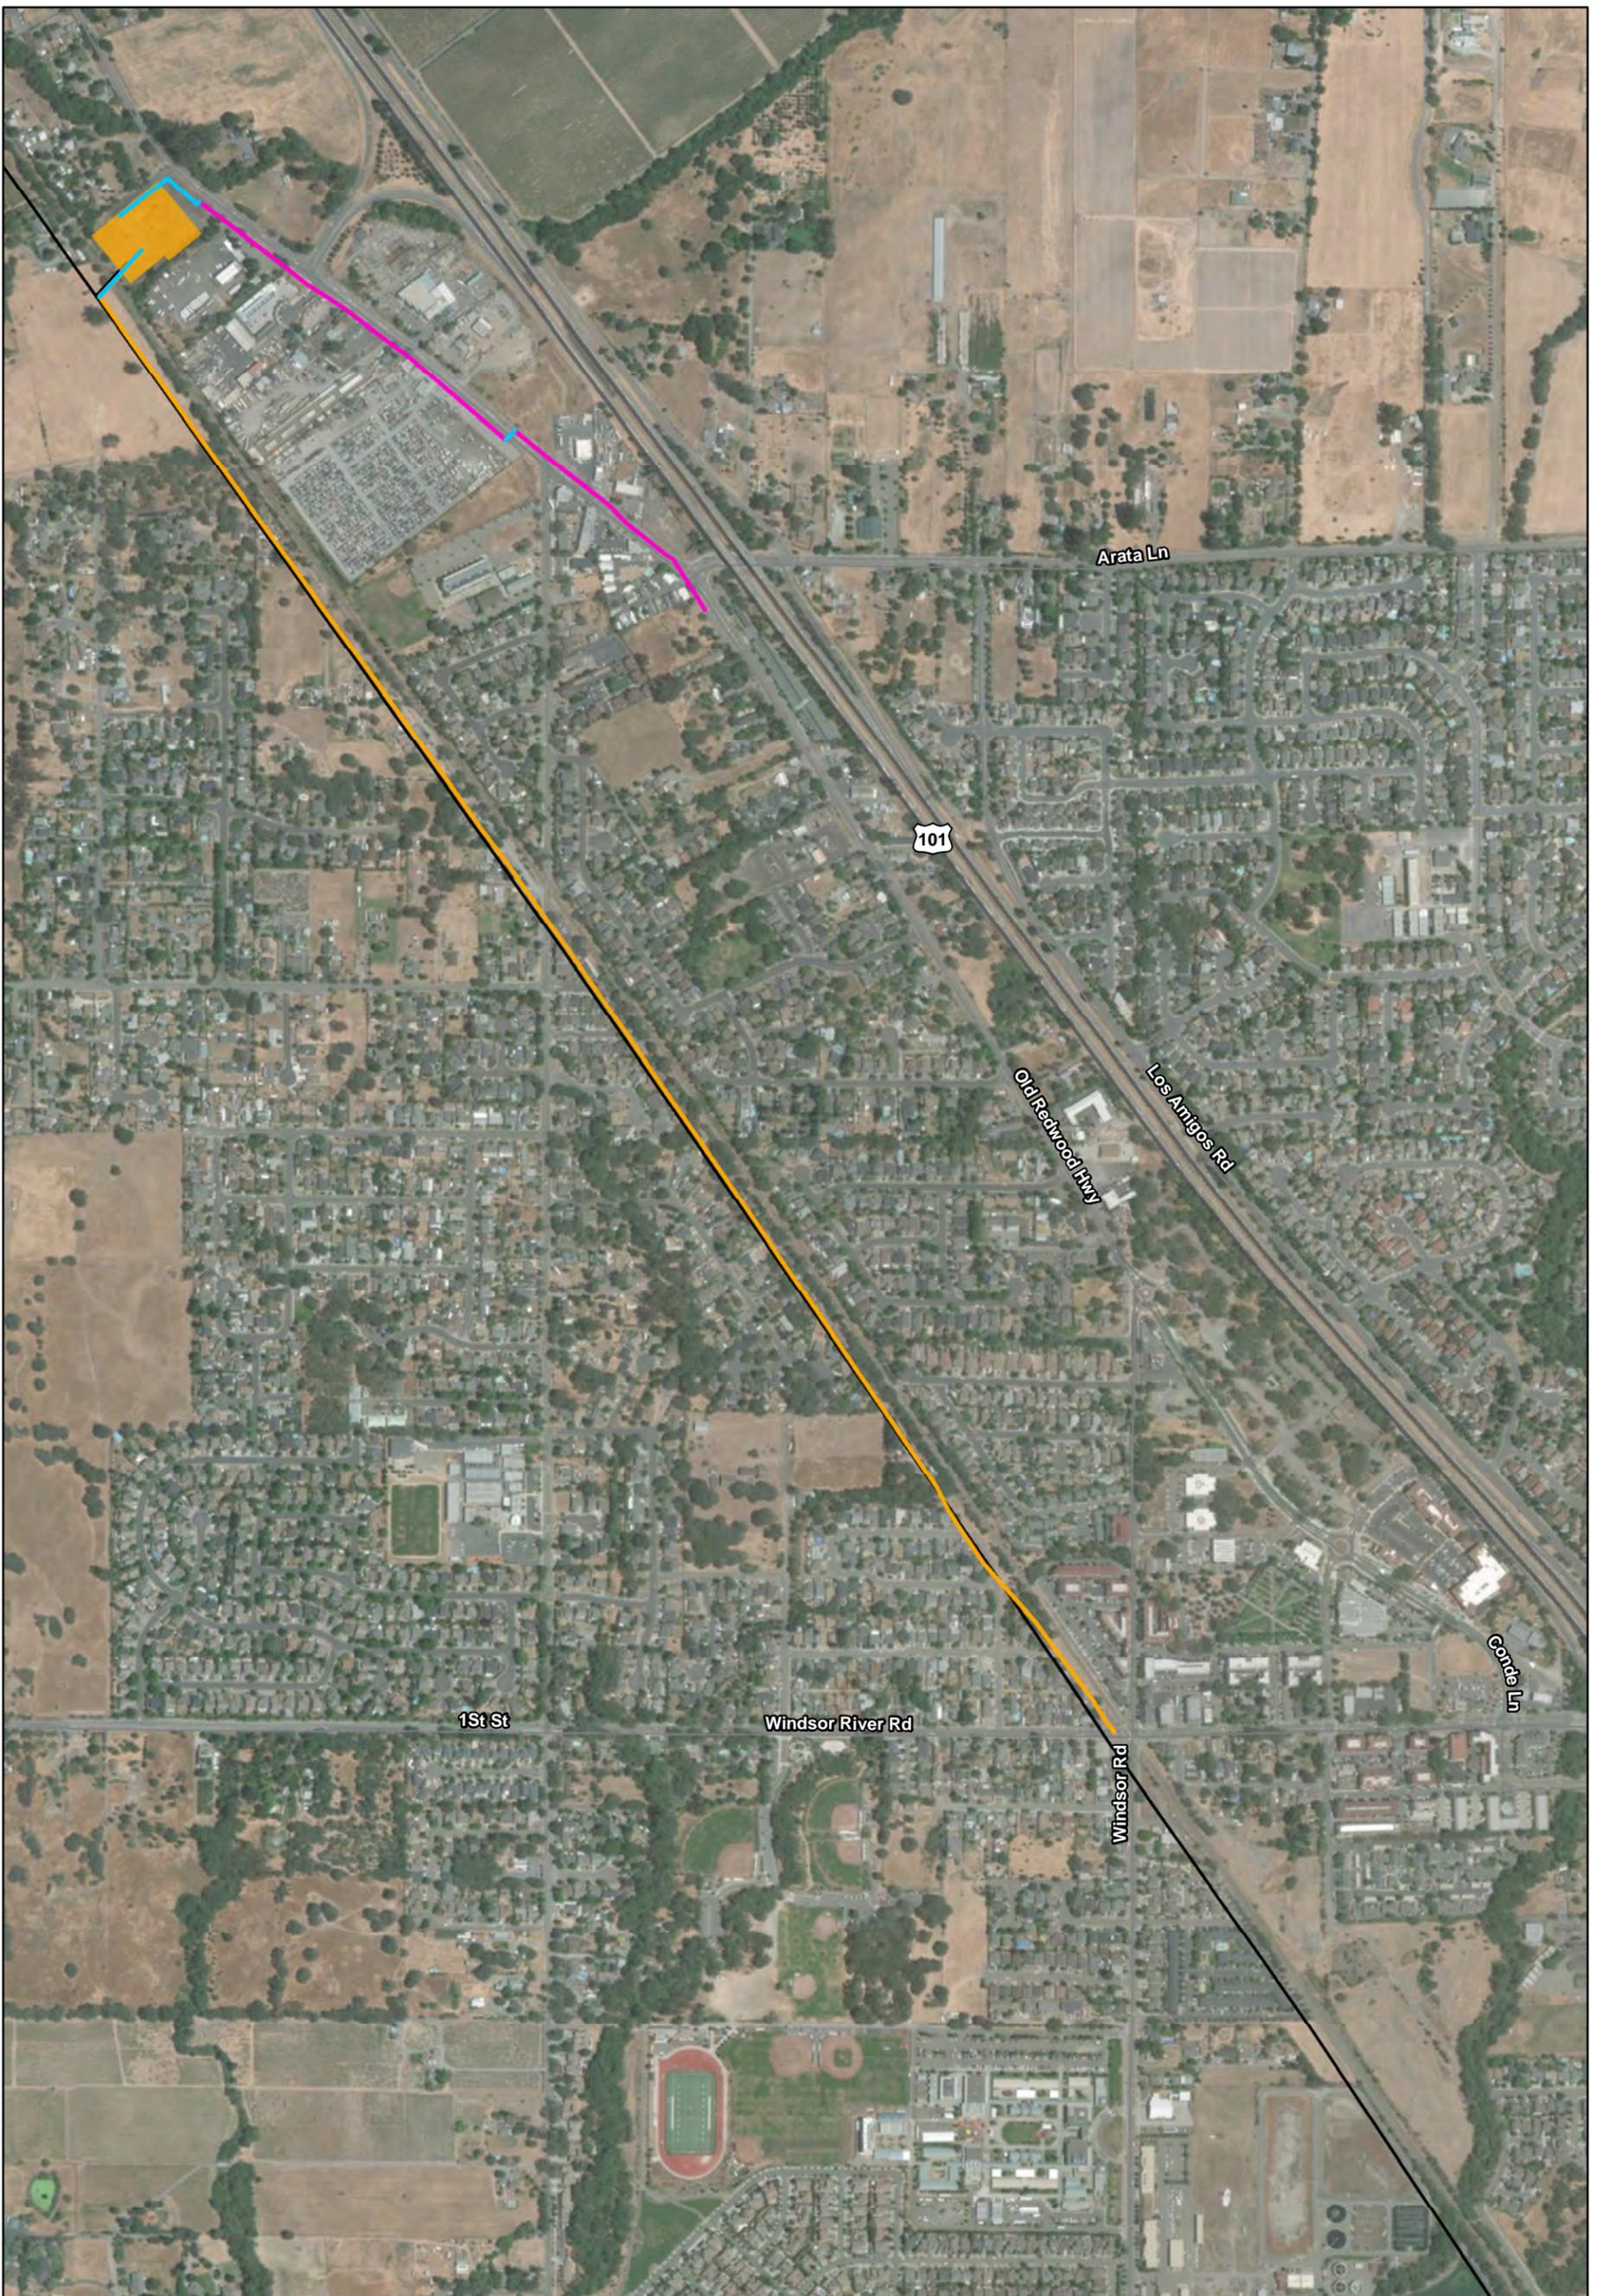
- Fulton No. 1 60kV
- Windsor Substation Site
- Overhead Double Circuit 12 kV Distribution Line Underbuild
- Overhead Double Circuit Reconductoring of Existing 12 kV Distribution Line
- 3 Underground Double Circuit 12 kV Distribution Line

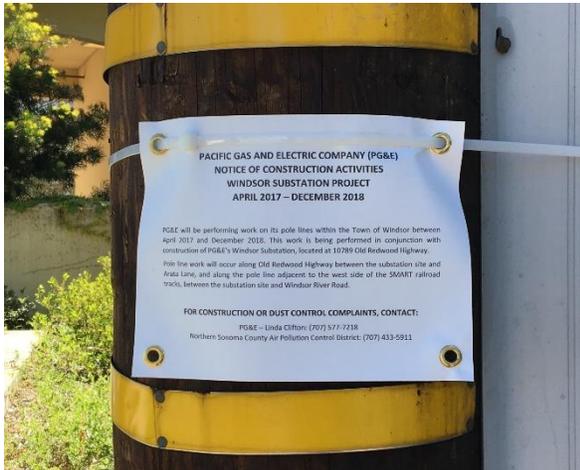
Figure 3. Public notice of Project and contact info for construction or dust complaints, view west, April 20, 2017

Air Quality. PG&E was required to post publicly visible signs at the Substation site and along the distribution and reconductoring right-of-way with telephone number and person to contact at PG&E regarding dust complaints, as well as the Northern Sonoma County Air Pollution District phone number (see Figure 3). PG&E was required to respond to complaints and take corrective action within 48 hours. PG&E was also to report to the CPUC within one week regarding complaints and corrective action taken.

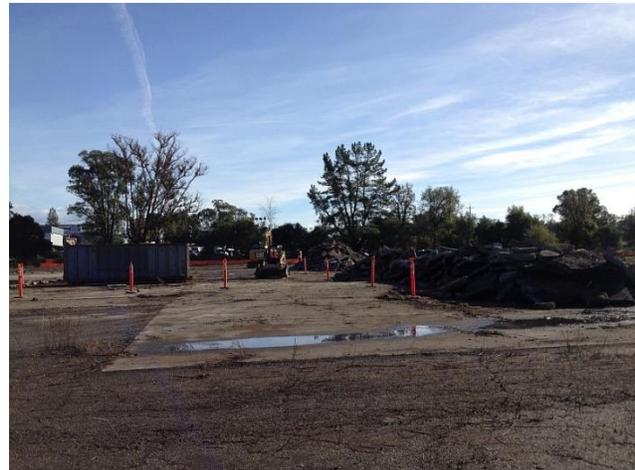
Figure 4. Demo of concrete pad at Substation site, view south, November 28, 2016

Biological Resources. The Windsor Substation site is relatively flat and was dominated by concrete foundations, asphalt, and gravel (see Figure 4). The western and southern portions of the site contain ruderal/disturbed vegetation. There are mature trees along the northern, southern, and western property lines. There is a seasonal swale along parts of the southern and western boundaries, which was protected by silt fence and Environmentally Sensitive Area (ESA) fencing during construction (see Figure 5); and a small drainage ditch and two inlets along the northern boundary (see Figure 6), which was protected by sandbags and fiber rolls. There is also a roadside ditch at the eastern edge of the property along Old Redwood Highway. Some tree trimming and removal was conducted within the Substation site and around the perimeter of the site.

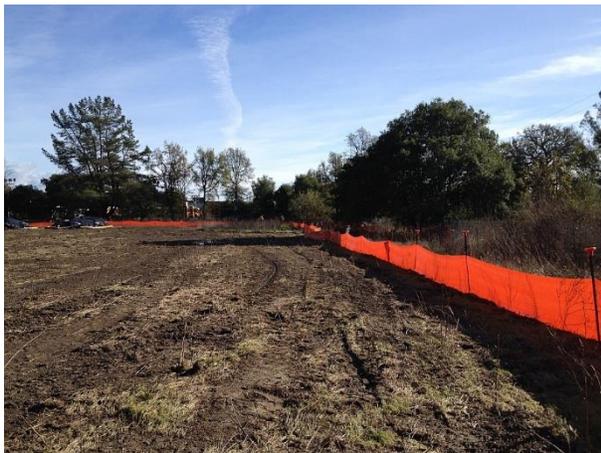
Figure 5. Silt fence-ESA fence installed on west and south sides, view south, November 28, 2016

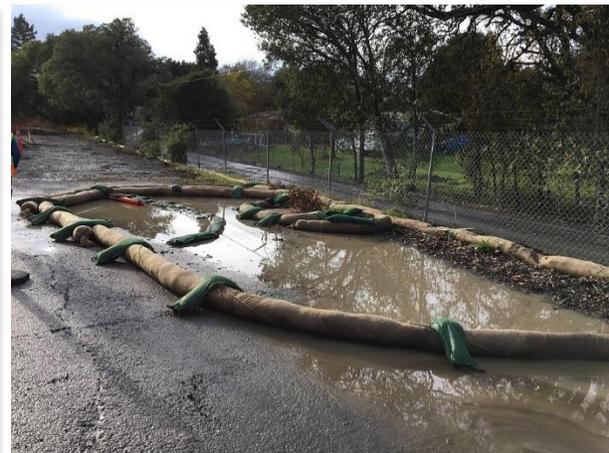
Figure 6. Drainage inlets on north side of site, view west, December 9, 2016

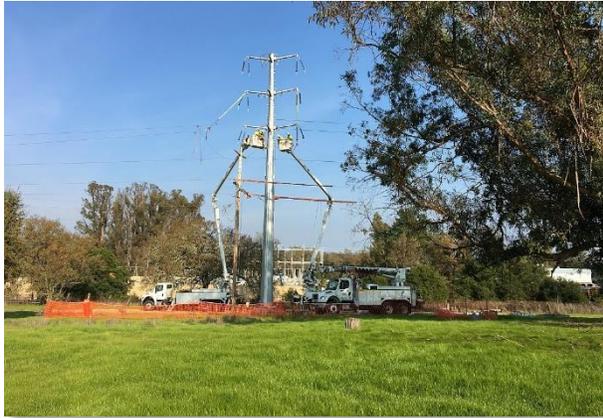
Figure 7. TSP installation on property west of Substation site, view east, December 13, 2017

During the week of December 11–17, 2017, on the property west of the Substation across from the railroad tracks, crews erected the TSP and completed conductor work. All six phases of conductor were pulled into the TSP from the Substation. Distribution lines were moved to the TSP, the existing wood pole (Pole a1) was removed, and the hole was backfilled with gravel to within two feet of the ground surface, with the remaining portion backfilled with soil. All vehicles and equipment stayed on mats while in the work area and along the access route.

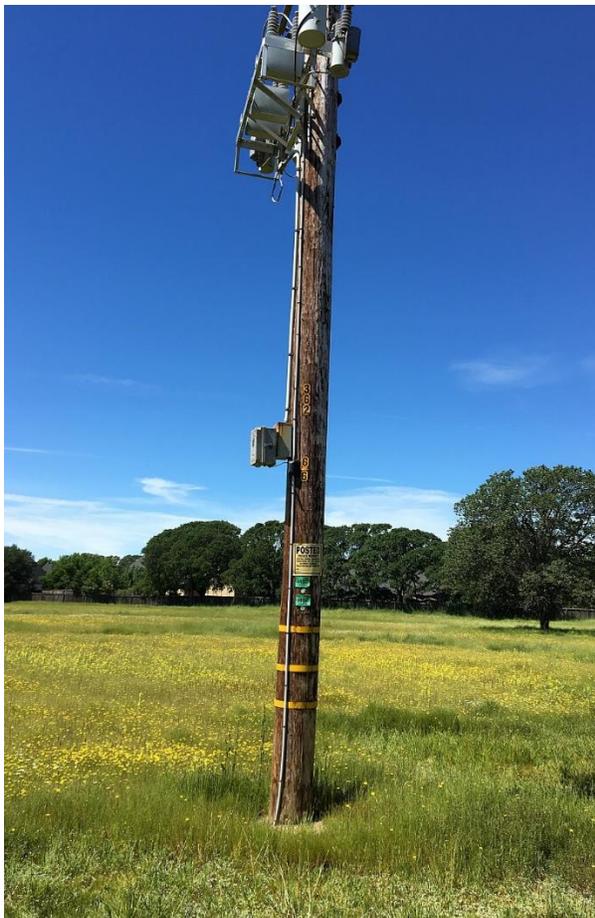
Figure 9. Pole a10 adjacent to vernal pool, view southwest, May 4, 2017

avoidance measure was required at Pole a10 replacement, which was located immediately adjacent to a vernal pool and included: (1) Filling of the exposed hole from the removed pole with a clay material that supports vernal pool re-establishment; and (2) Installation of the new pole as far outside the vernal pool area as feasible (see Figures 9 through 11).

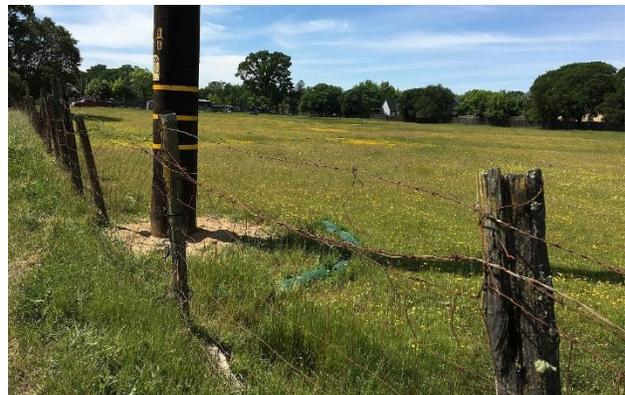
Figure 10. Pole a10 new location away from vernal pool, view southwest, May 4, 2018

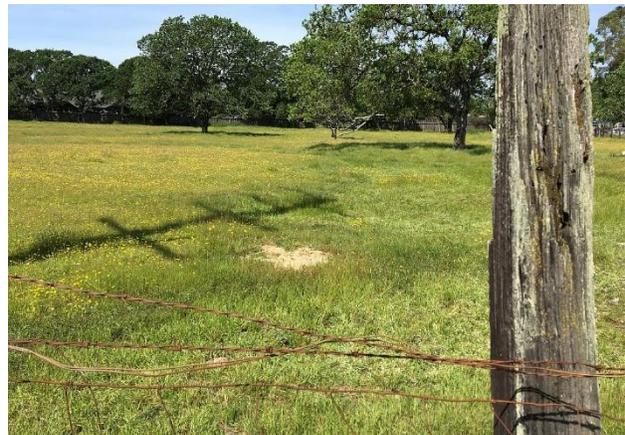
Figure 11. Location where Pole a10 was removed from adjacent vernal pool, view northwest, May 4, 2018

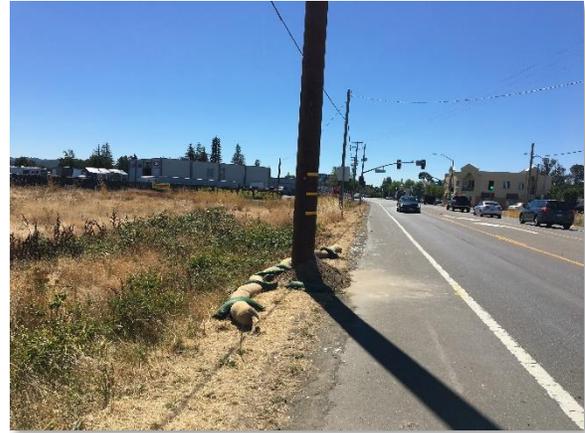
Figure 12. Old Redwood Highway reconductoring alignment, view south, July 6, 2017

The area along the Old Redwood Highway 12 kV distribution line between the Substation and just south of Arata Lane is a mix of light industrial, commercial, and residential, with a few vacant lots. Habitat along this alignment includes ruderal, grassland, and developed areas (see Figure 12). The line spans and or is adjacent to numerous roadside ditches, several drainage ditches and swales, and Starr Creek.

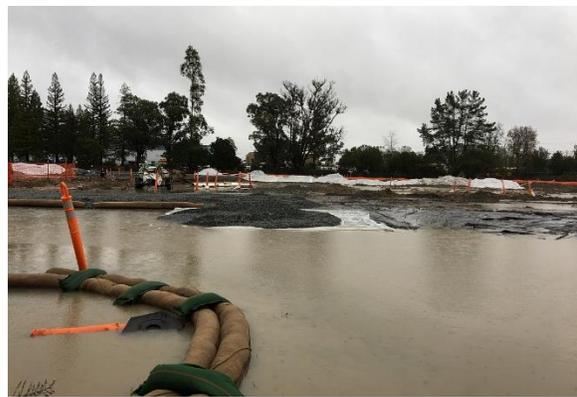
was a concern and two Baker tanks with secondary containment were delivered in late December to temporarily store stormwater. Frequent SWPPP inspections were conducted by PG&E's SWPPP contractor AHTNA. Construction activities started back up in April 2017. Grading activities and base rock continued to be delivered, spread, and compacted to build up the Substation pad. Kleinfelder performed compaction testing of the soil. As the days got warmer, a water truck was used for dust control and to facilitate compaction.

Figure 13. Stormwater at Windsor Substation site, view south, December 15, 2016

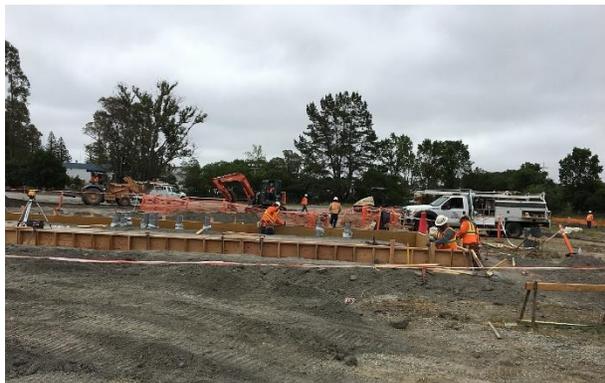
Figure 14. Foundation work at Windsor Substation, view south, May 10, 2017

for the switchgear foundations (see Figure 14). Excavation for the breaker foundation began mid-May 2017 and foundation work followed. Also, pier foundation holes were drilled and groundwater encountered at 12 feet was pumped through a filter bag and into the Baker tank. Concrete was then poured for the pier foundations. All holes not poured with concrete were covered at the end of the day with plywood and surrounded by sandbags to prevent wildlife entrapment. Foundation work for pull boxes and began mid-May 2017 and included excavating, installing forms, installing rebar, pouring cement, and stripping forms. Conduit trenches were also excavated throughout the site, conduit installed, and the trenches backfilled. When not completed the same day, 2x8 ramps were placed in each excavation to avoid wildlife entrapment and the excavation was surrounded by orange construction fencing. Beginning in June 2017, the locations for the perimeter wall foundation were laid out, holes were augured, forms were set, and concrete poured (see Figure 15). Foundation work for the perimeter wall piers was completed in early August 2017. Kleinfelder performed all concrete testing. PG&E delivered and set up two office and supply trailers at the east perimeter in early June 2017. The switchgear building was delivered and set on June 12, 2017 and crews worked on assembly and welding. Work

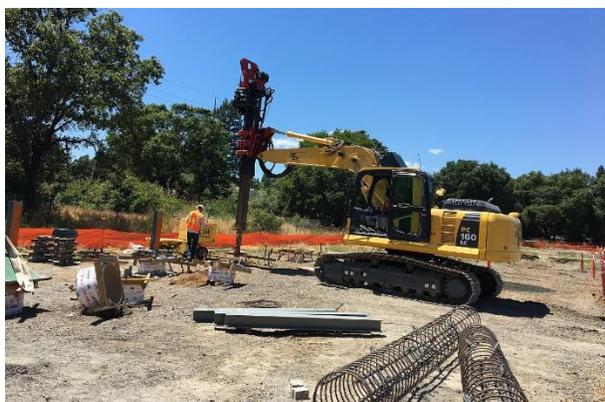
Figure 15. Augering holes for perimeter wall piers at Substation, view northwest, June 13, 2017

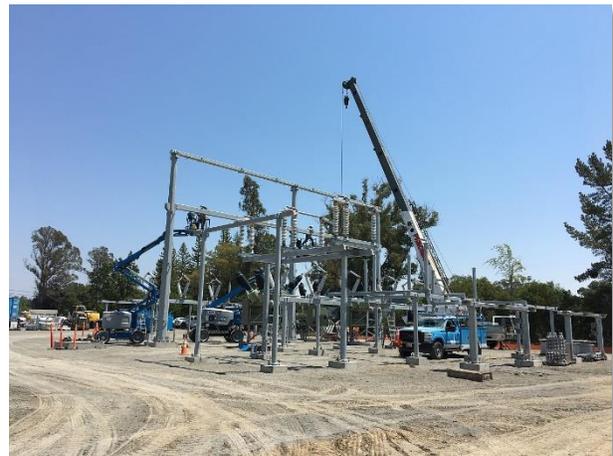
After the concrete foundations cured, the aboveground steel structures began to be erected in late July 2017, followed by installation of circuit breakers, switches, buses, dead ends, and other electrical equipment, including associated control system hardware (see Figure 16). This work continued into October 2017.

Figure 16. Erecting steel structures, installing insulators and switches, view southeast, August 1, 2017

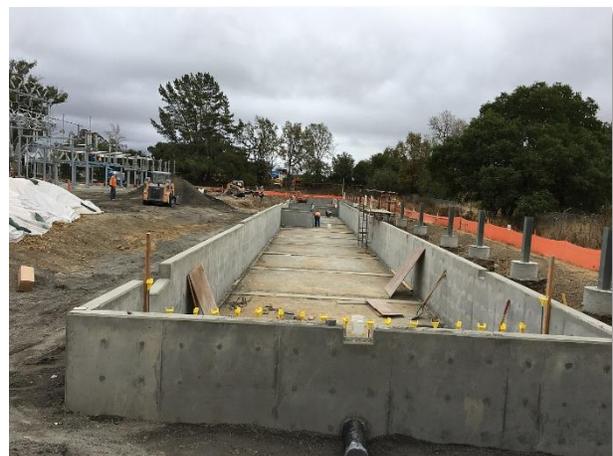
No work was conducted the week of October 9–15, 2017 due to wildfires in the area. Construction resumed on October 17, 2017 at the Substation. Work included excavating conduit trenches for the distribution lines, installing conduit in pull boxes, backfilling trenches, spreading and grading base rock to build up Substation pad and backfilling around the SPCC pond, pouring concrete for the SPCC pond, installation of transmission switches and insulators on dead-end structures, and work inside the switchgear building (see Figure 17).

Figure 17. Working on SPCC pond, view south, October 19, 2017

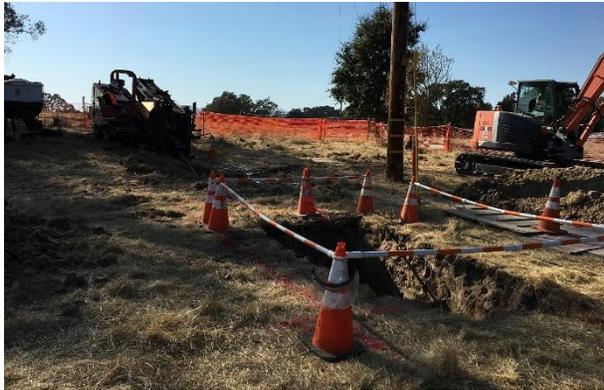
On October 30, 2017, VPI mobilized equipment for the horizontal directional drill (HDD) under the railroad tracks to connect the Substation to the Fulton No. 1 line, including two vacuum trucks, and excavator, a dump truck, and a flatbed truck. Hotline coordinated with the PG&E EI in placing delineators along the access route to the west side of the railroad tracks so that vernal pools at the southern boundary of the property (adjacent to the Kerry Conservation Site) were avoided. VPI potholed to locate the gas transmission line and fiber optic line adjacent to the railroad tracks, and excavated the entrance pit for the bore. The exit pit was excavated on the east side of the SPCC pond. All excavations were covered with plywood and surrounded by cones at the end of the day. From October 31 through November 2, 2017, boring, reaming, and pulling conduit was conducted and completed for three sets of underground conduit (see Figures 18 and 19). Mud from the bore

Figure 18. Horizontal Directional Drilling in field west of Substation, view west, October 31, 2017

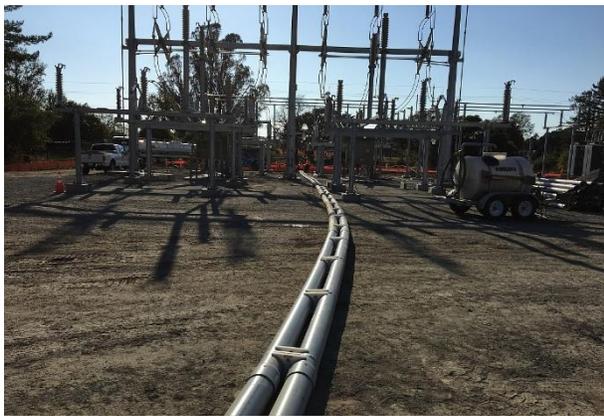
Figure 19. HDD conduit ready to be pulled back through hole, view west, October 31, 2017

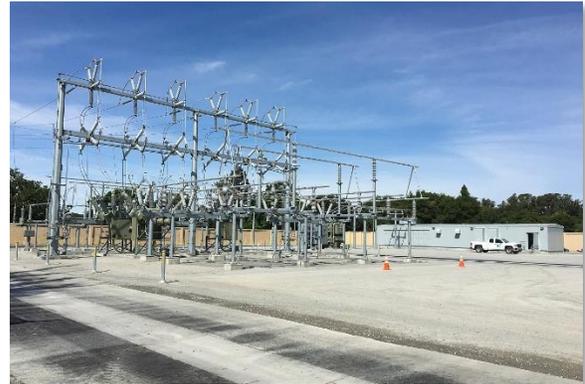
The CPUC EM conducted a final inspection within the Windsor Substation site on May 4, 2018 (see Figure 20). The CPUC EM observed that the site was neat and clean. At that time, remaining work within the Substation included installing a pump in the storm-water retention pond, removing PG&E's office trailers, and work within the electrical building.

Figure 20. Final inspection of Substation, view northwest, May 4, 2018

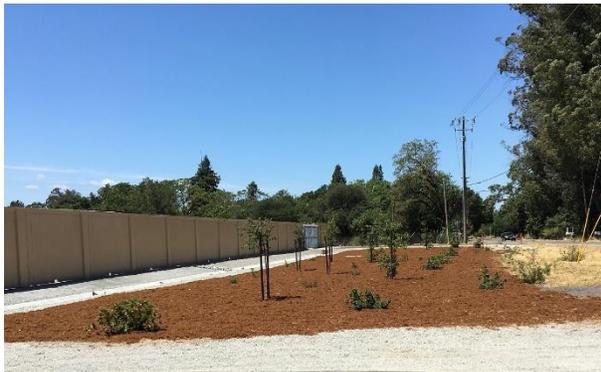
On May 21, 2018, the CPUC EM conducted a final inspection of the landscaping outside the Substation walls on the east and north sides (see Figures 21 and 22). The CPUC EM reviewed the approved conceptual Landscape Plan against what was planted. PG&E planted seven valley oak (*Quercus lobata*), 17 coast live oak (*Quercus agrifolia*), seven more than was in their conceptual Landscape Plan), and 60 evergreen native shrubs (five less than was in their conceptual Landscape Plan). The extra coast live oaks make up for the reduced number of evergreen shrubs and are evergreen trees. Irrigation was also installed, despite MPC #2 request to not install irrigation. Redwood bark was spread within the landscaped area, which will help retain soil moisture and prevent weed growth.

Figure 21. Landscaping in front of Substation on east side along Old Redwood Highway, view north, May 21, 2018

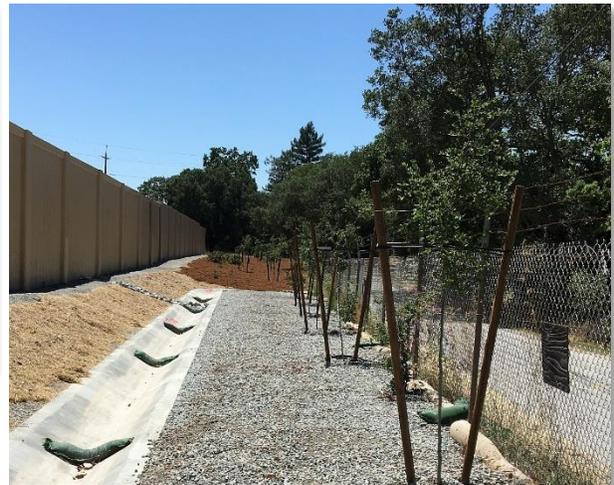
Figure 22. Landscaping on north side of Substation along Herb Road, view west, May 21, 2018

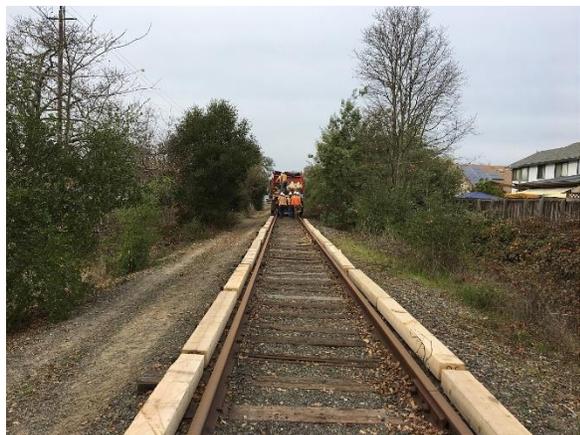
Figure 23. Laying down planks along railroad tracks for crane to drive over, view north, December 19, 2017

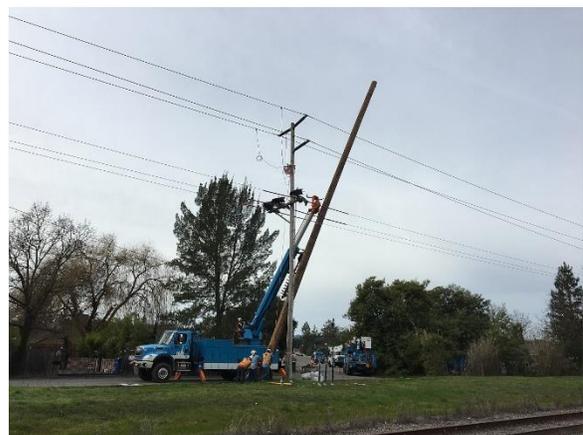
During the week of January 29–February 4, 2018, crews excavated pole holes with a vac-truck and replaced seven poles along the Fulton No. 1 alignment (see Figure 24). The pole replacements were north of Starr Road on Wilcox Road, and north of Windsor River Road on Wild Oak Drive.

Figure 24. Replacing pole along Fulton No. 1 line, view west, January 29, 2018

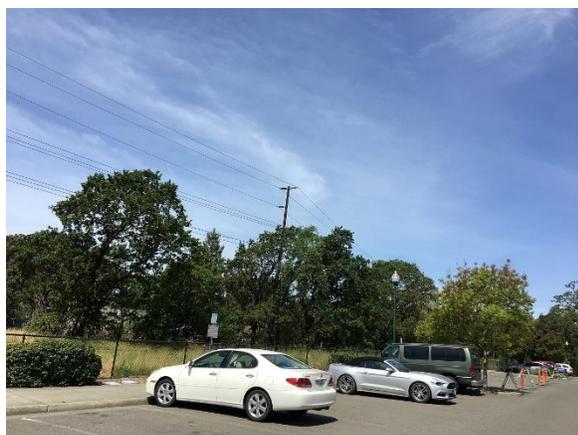
PG&E identified that the replacement pole for Pole a35 on the Fulton alignment needed to be approximately 76 feet tall. The reason this pole needed to be taller was that along this portion of the power line the framing transitions between types of framing, and the span length between the poles was such that the shorter pole would not provide sufficient separation distance [vertically] between the conductors.

Figure 25. Pole a35 approved under MPC 11, view northwest, May 4, 2018

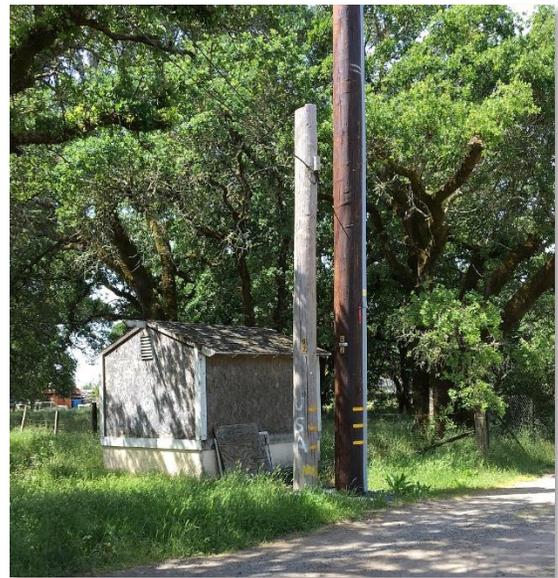
The CPUC EM conducted a final inspection of the Fulton No. 1 line and Old Redwood Highway alignment work areas on May 4, 2018. All BMPs had been removed, pole areas stabilized, and the work areas were left neat and clean (see Figure 26).

Figure 26. Final inspection of Fulton No. 1 pole replacements, view northwest, May 4, 2018
