PROJECT MEMORANDUM
PG&E WINDSOR SUBSTATION PROJECT

To: Eric Chiang, Project Manager, CPUC
From: Vida Strong, Aspen Project Manager
Date: July 12, 2017
Subject: Monitoring Report #23 – July 3, 2017 to July 9, 2017

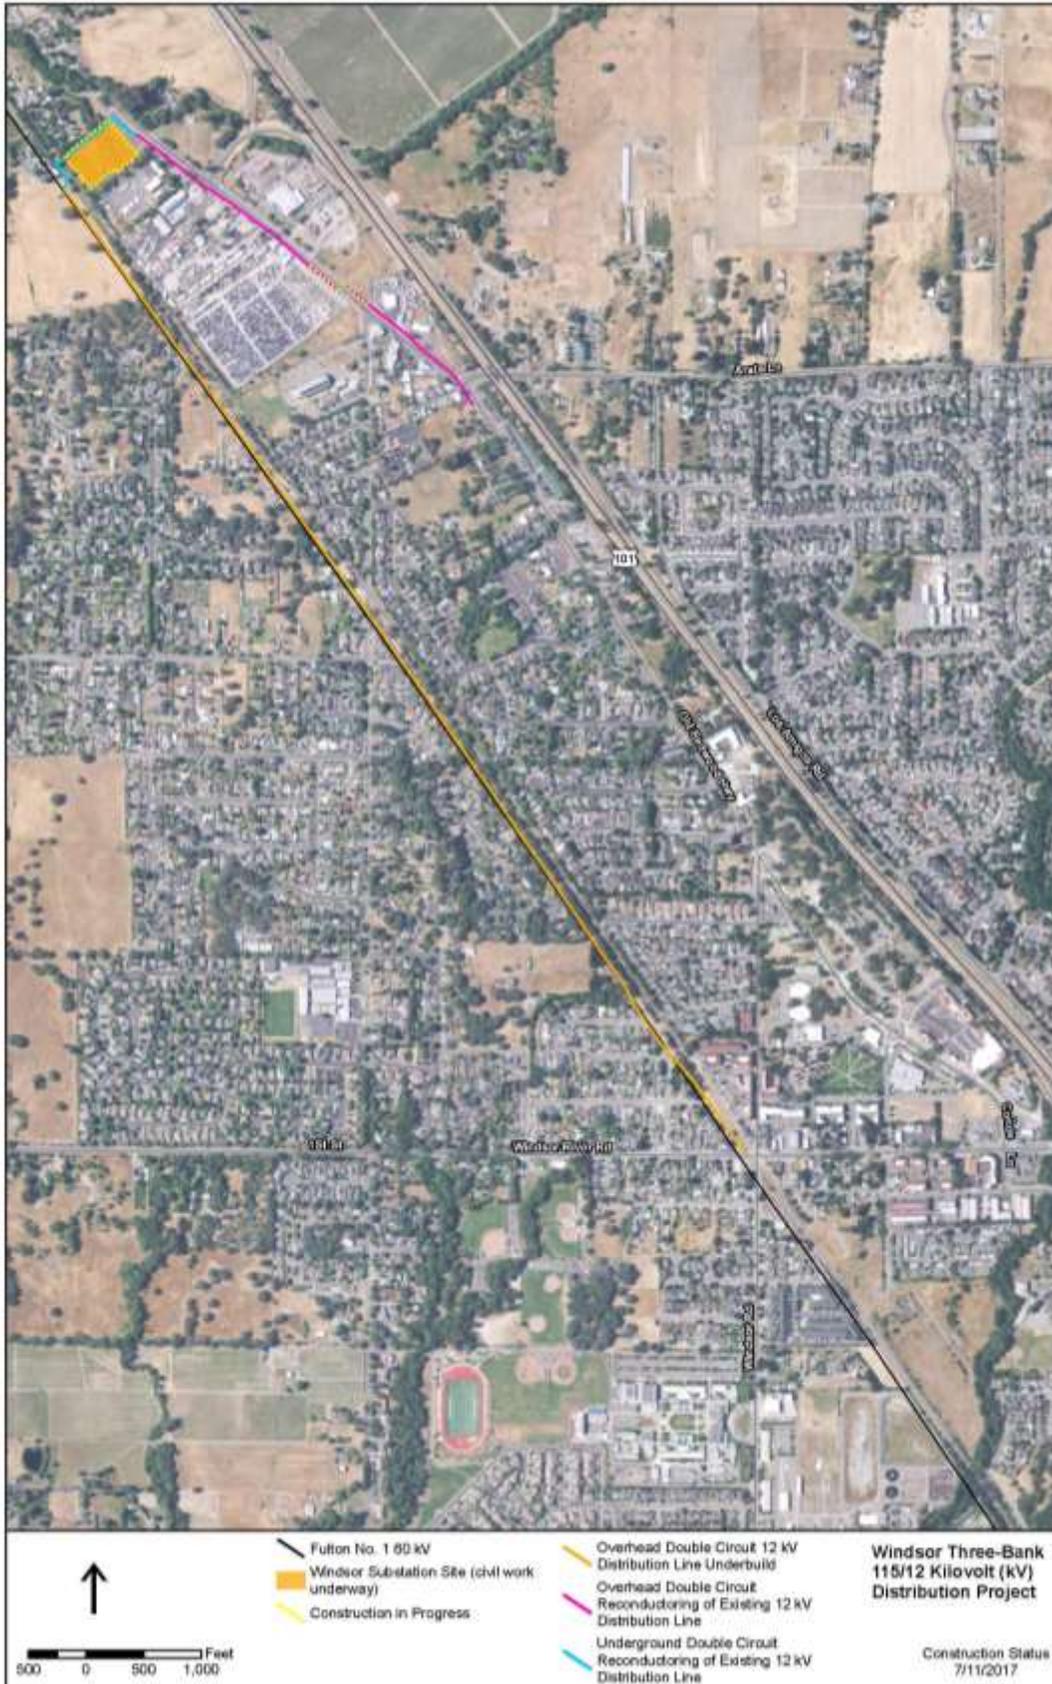
EXHIBIT A – CONSTRUCTION STATUS

This report provides a summary of the construction and compliance activities associated with the PG&E Windsor Substation Project which includes the construction of the Windsor Substation, as well as 12 kV distribution line underbuild and reconductoring work (see Exhibit A).

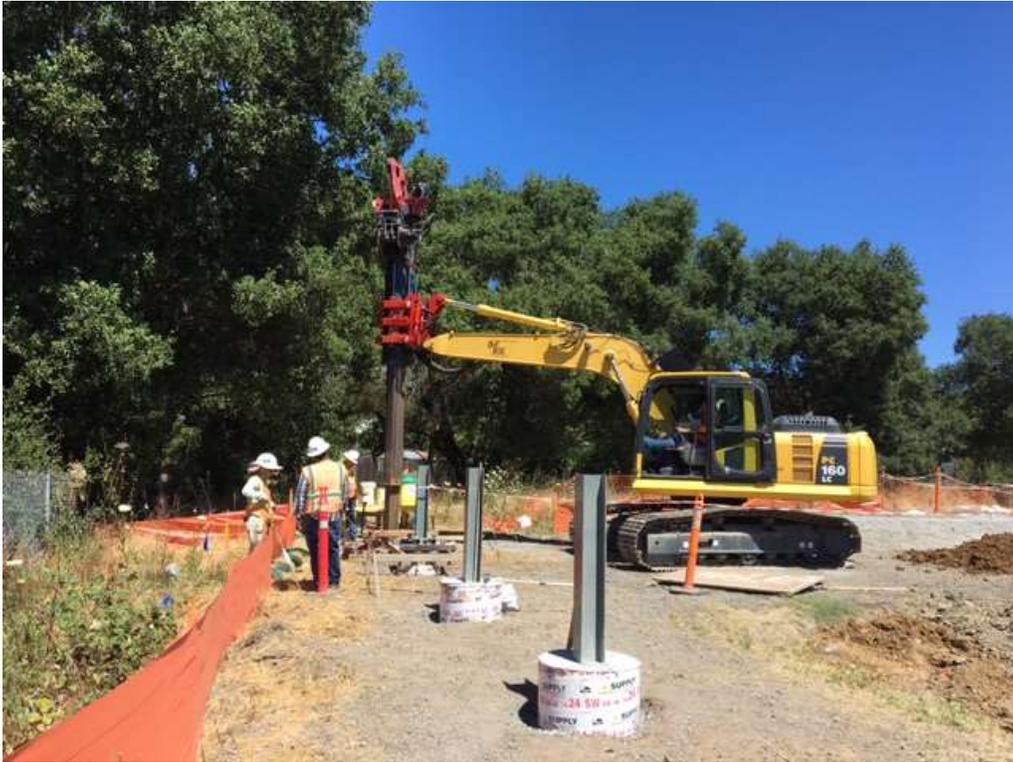
At the time of the CPUC EM's site visit on July 6, crews were conducting foundation work, excavating, drilling holes for perimeter wall, and working on the transformer (see Figures 1 and 2).

Figure 1 – Drilling foundation holes for perimeter wall piers in northwest corner of substation – view north, July 6, 2017.

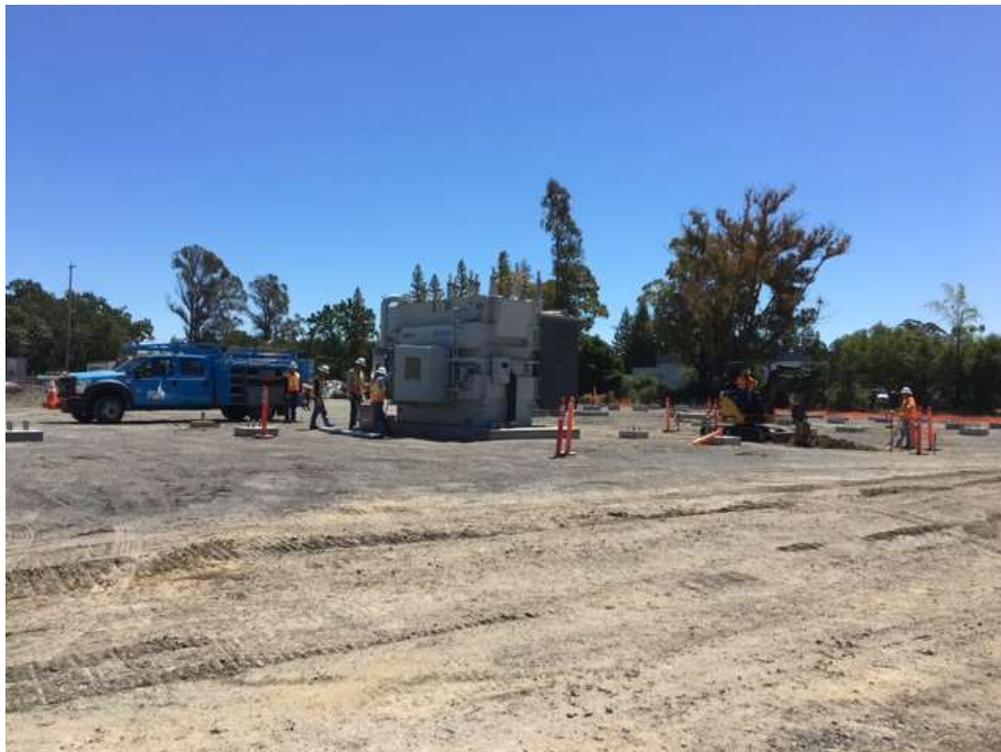
Figure 2 – Transformer and foundation work – view southeast, July 6, 2017.

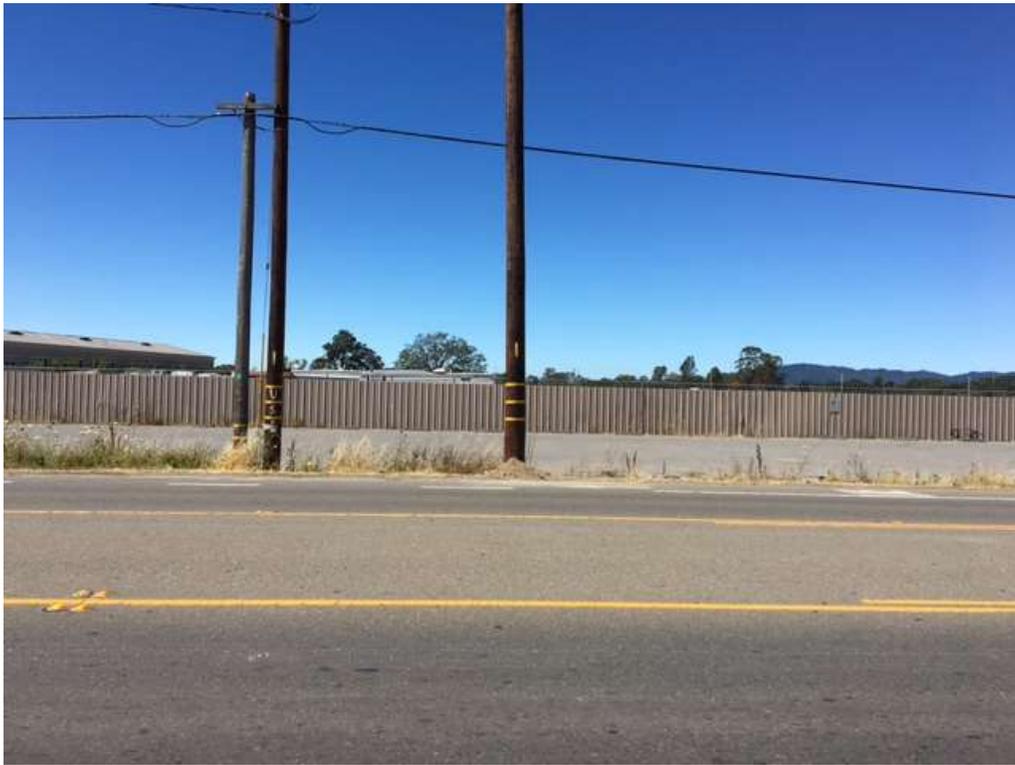
Construction activities during the subject week included pole work on Old Redwood Highway. On July 5, a new crew augured and set replacement pole b9 and an anchor on the west side of Old Redwood Highway just north of Starr Road (see Figure 3). On July 6, they installed a new pole (b9a) and anchor on the east side of Old Redwood Highway, directly across from pole b9 (see Figure 4). To prevent dirt spoils from entering the adjacent ditch, a straw fiber roll and gravel bags were placed around the excavation, and dirt spoils were spun from the auger into a bag and hauled offsite.

Figure 3 – Replacement Pole b9 on west side of Old Redwood Highway – view west, July 6, 2017.

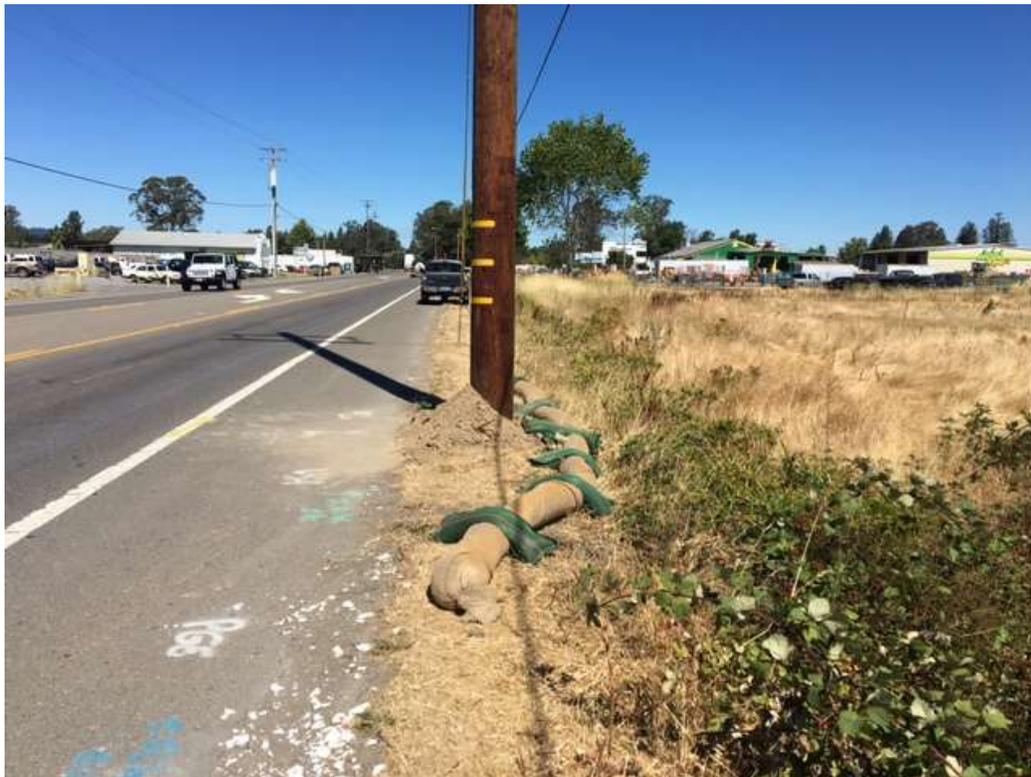
Figure 4 – New Pole b9a installed on east side of Old Redwood Highway – view north, July 6, 2017.
