<p>California Public Utilities Commission <i>Mitigation Monitoring, Compliance, and Reporting</i> <i>Program</i></p>
	<p>Cleveland National Forest Power Line Replacement Projects</p> <p>Compliance Status Report: 068</p> <p>May 5, 2019</p>

This compliance status report covers construction activities from April 22, 2019 through May 5, 2019.

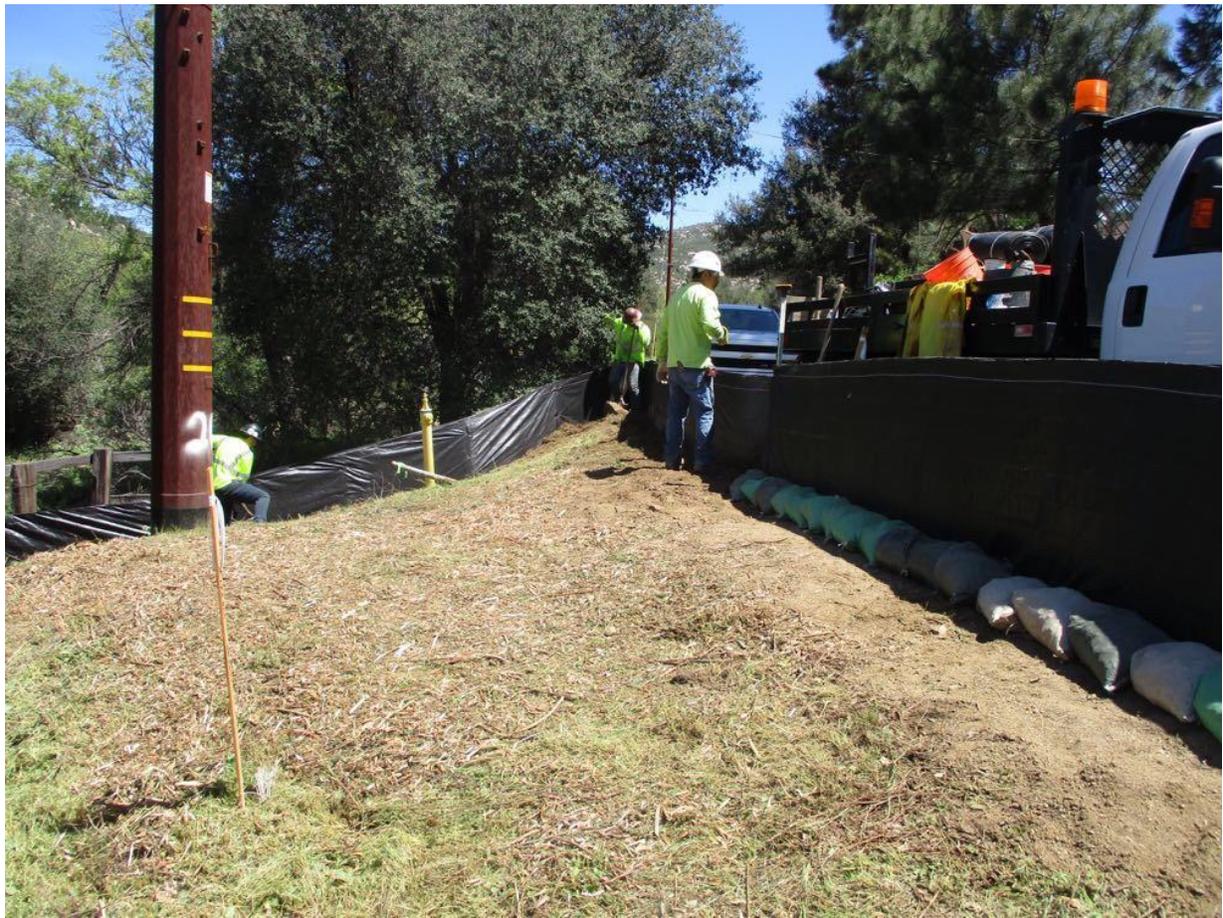
Photo 1: A construction crew was observed installing silt fence at Pole Z172800 (TL 629A) in accordance with the Erosion Control Plan (MM HYD-1) and was installed under the supervision of the Authorized Biologist per the recommended impact avoidance and minimization measures for the line.

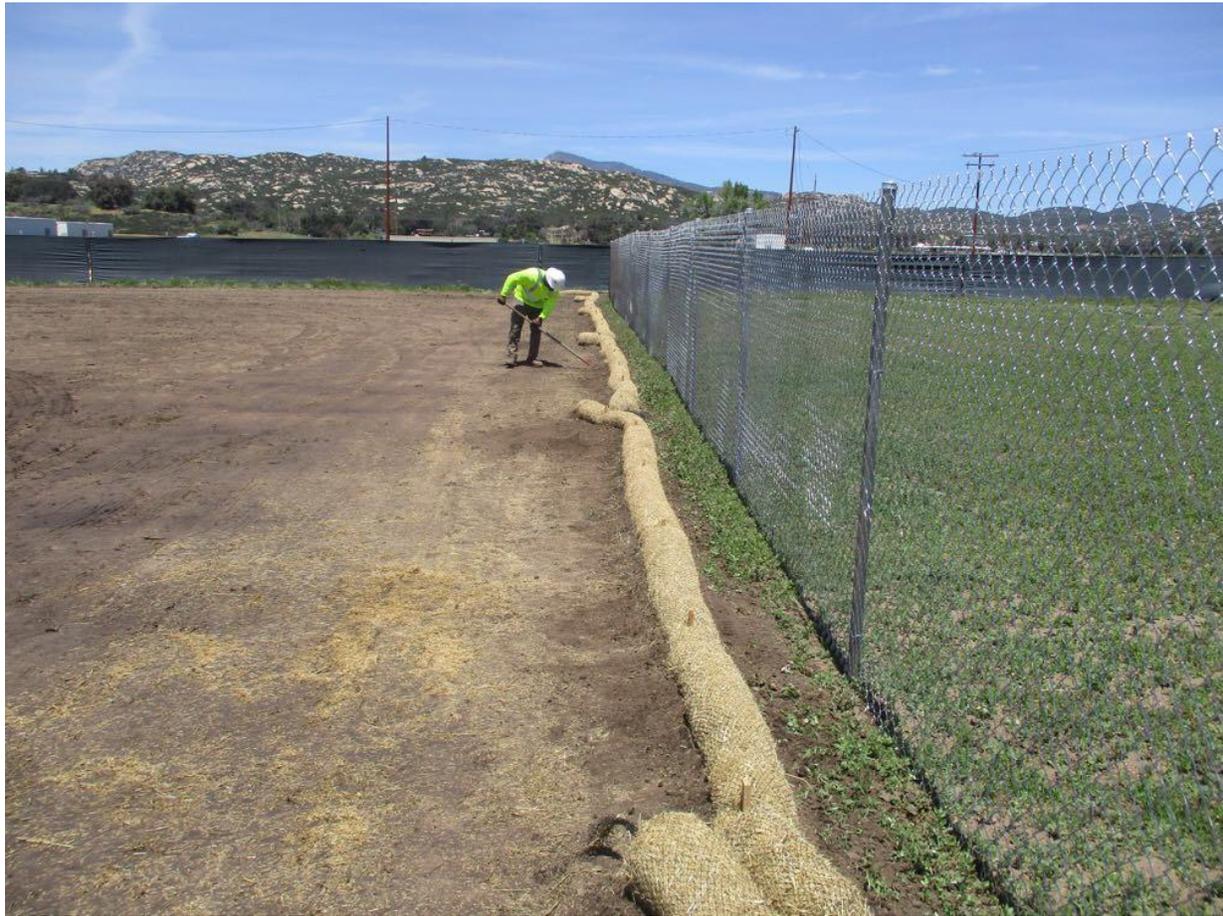
Photo 2: A crew member was observed finishing the installation of BMPs (straw wattles) along the perimeter of Merrigan Staging Yard expansion on TL 629A in accordance with the Erosion Control Plan and SWPPP. Opaque visual screening fencing was observed installed at the Merrigan Staging Yard (TL 629A) in accordance with APM VIS-02.

In accordance with APM VIS-02 and VIS-03, opaque fencing was observed installed around the newly established Merrigan Staging Yard expansion (see Photo 2 – Attachment A).

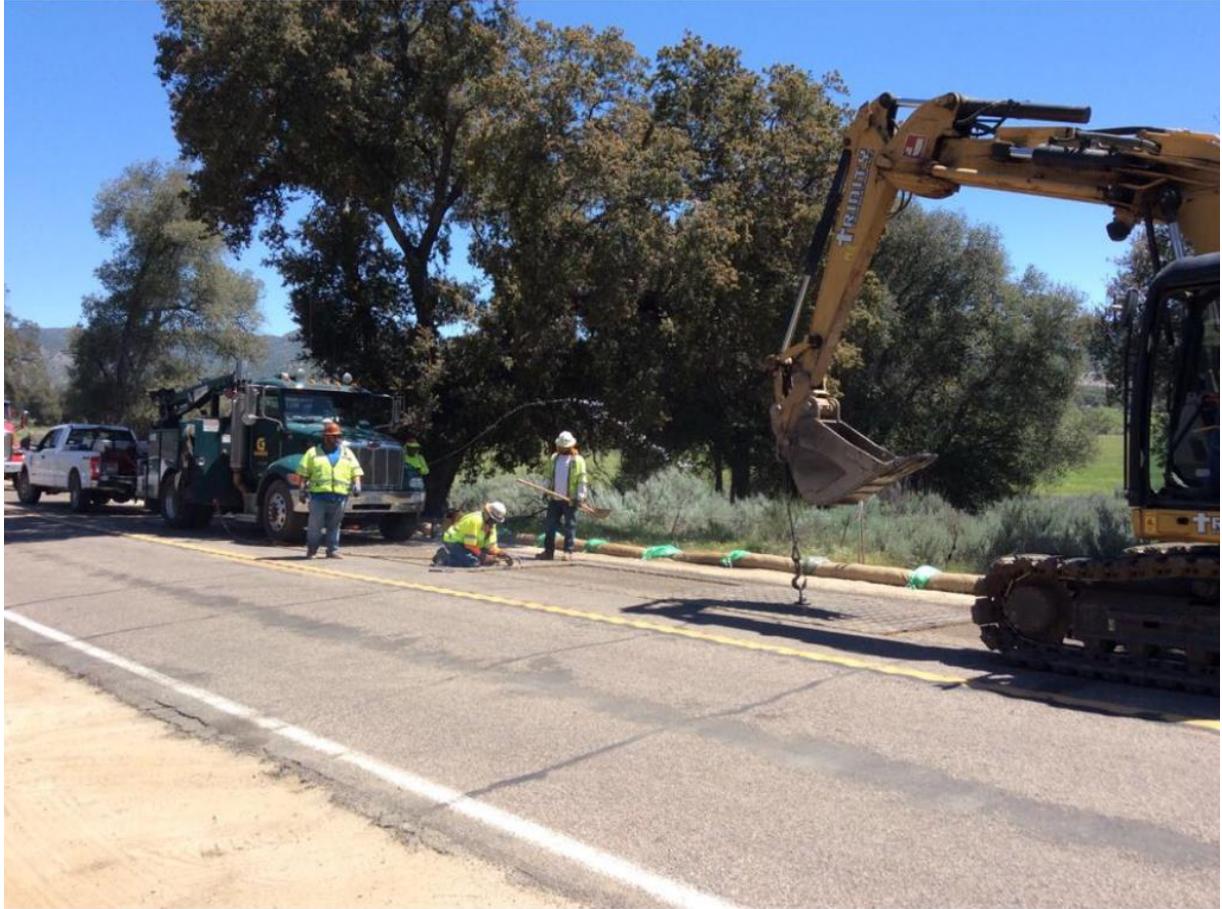
Photo 3: A dedicated fire patrol was observed wetting down the area surrounding hot work near along C449 and a complete set of fire tools was staged on site (5-gallon backpack pump, round point shovel, Pulaski, and 2A10BC fire extinguisher) in accordance with the CFPPP (MM FF-1).

In accordance with the Construction Fire Protection/Prevention Plan (CFPPP) (MM FF-1), all project-related vehicles and equipment were observed carrying the required set of fire tools (including a 5 gallon backpack pump, round point shovel, Pulaski, and 2A10BC fire extinguisher) and these tools were observed within 50 feet of work activities. Designated fire patrols were observed monitoring and wetting areas around hot work activities along C449 accordance with the CFPPP (see Photo 3 – Attachment A).

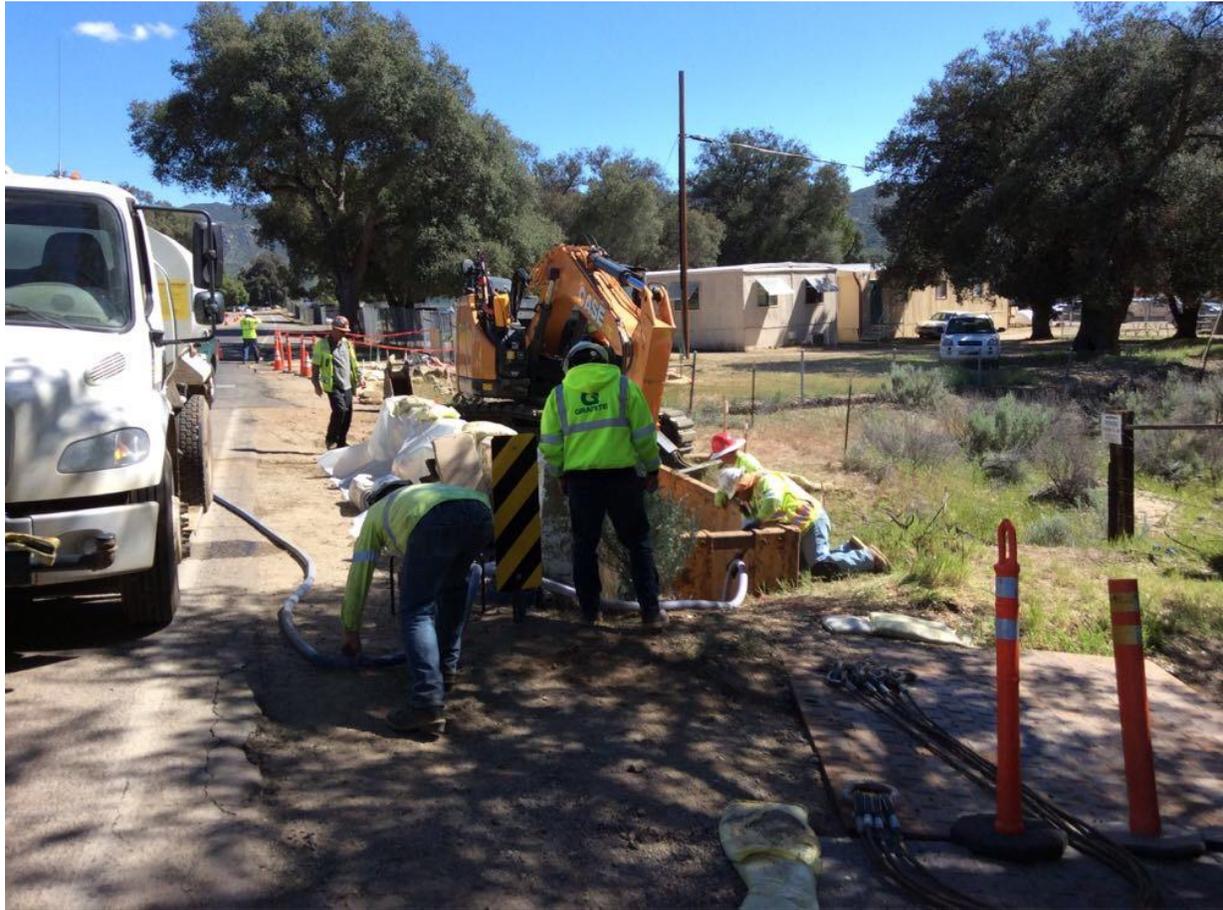
Photo 4: Groundwater encountered in the ephemeral stream channel near 19+96 was pumped into a water truck and later dispersed onto Morena Stokes Road on C 449 in accordance with APM HYD-08 and MM BIO-1.

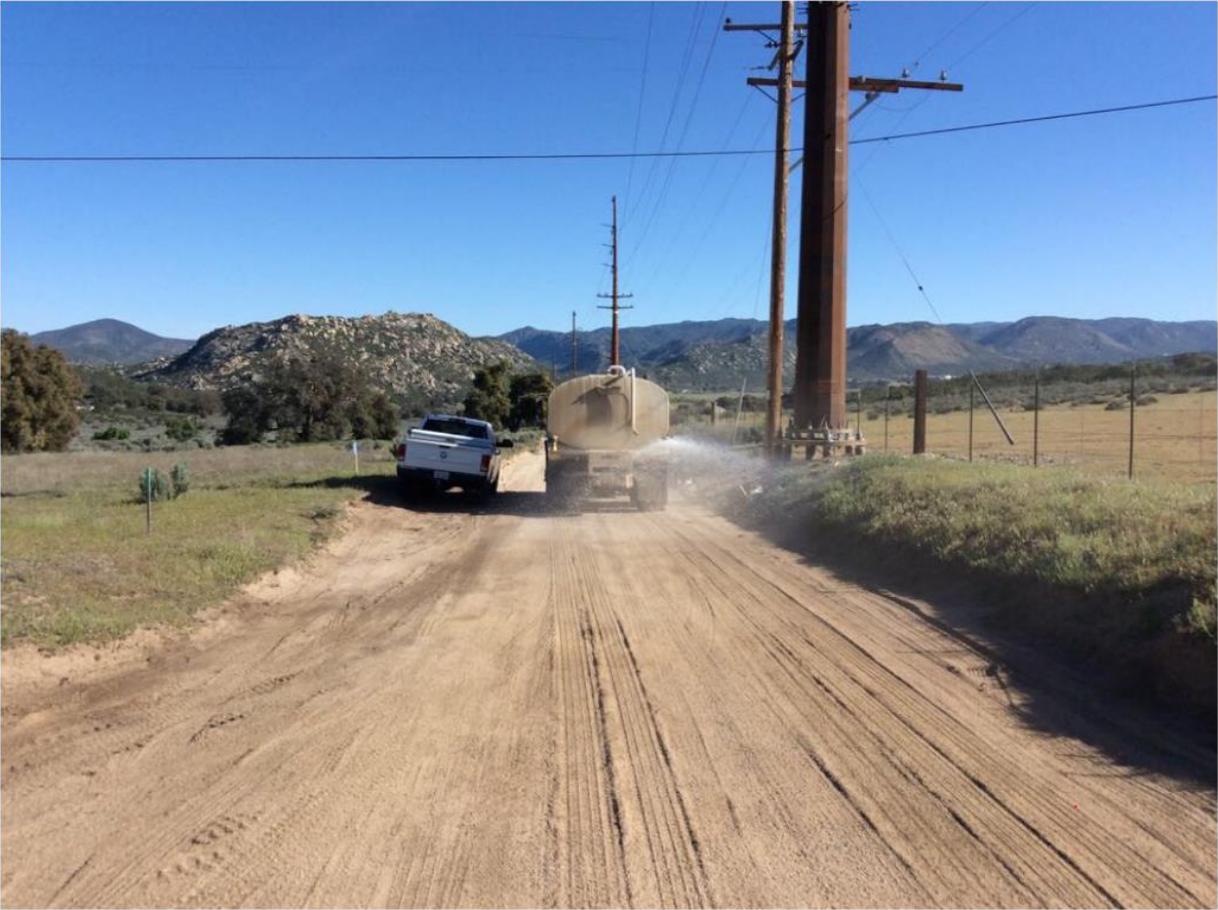
Photo 5: A water tender was observed applying water to the access road along TL 6958 to minimize dust emissions in accordance with APM AIR-02.

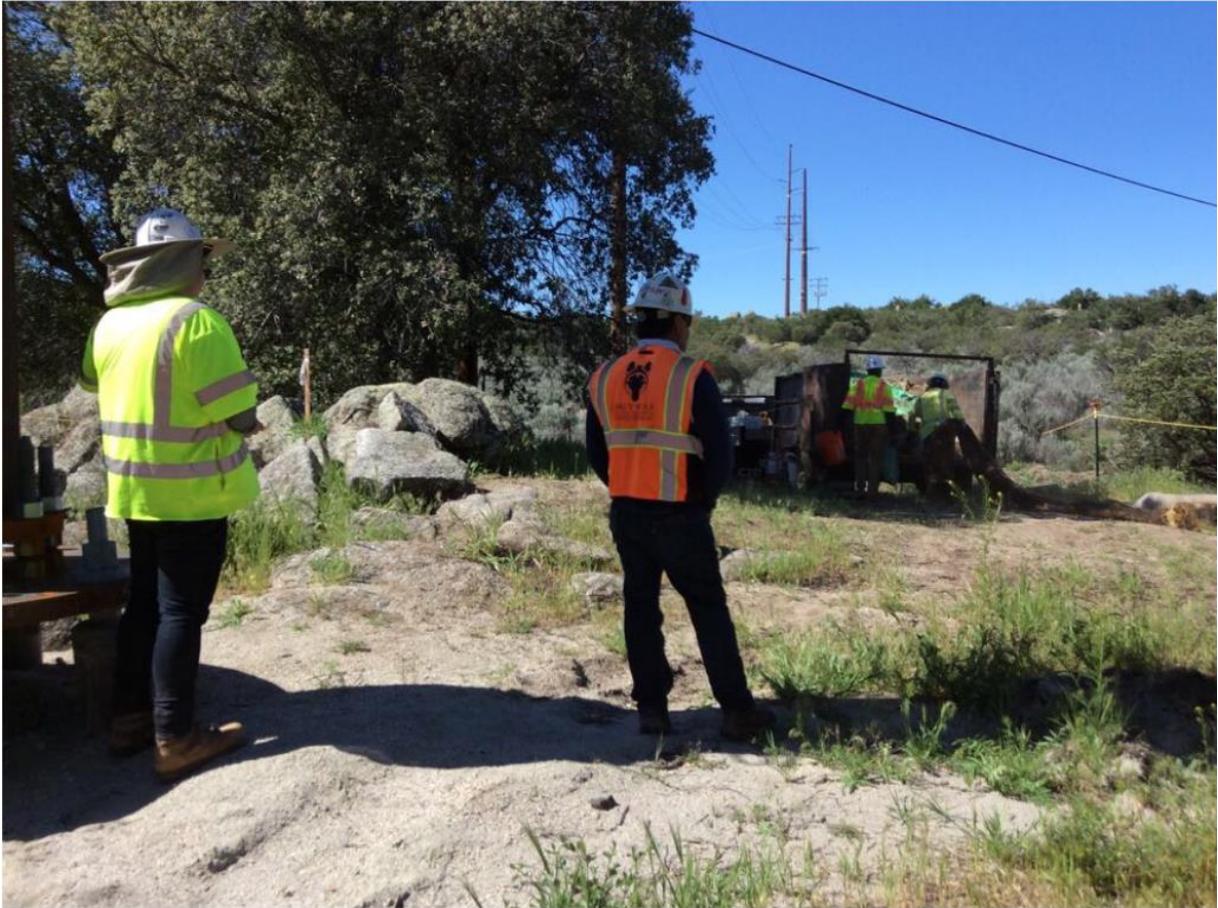
Photo 6: Archaeological and Cultural Monitors were observed monitoring BMP removal along TL 629C in accordance with the HPMP, APM CUL-04, and MM CUL-1.
