California Public Utilities Commission <i>Mitigation Monitoring, Compliance, and Reporting</i> <i>Program</i>
	Cleveland National Forest Power Line Replacement Projects Compliance Status Report: 098 June 28, 2020

This compliance status report covers construction activities from June 15 through June 28, 2020.

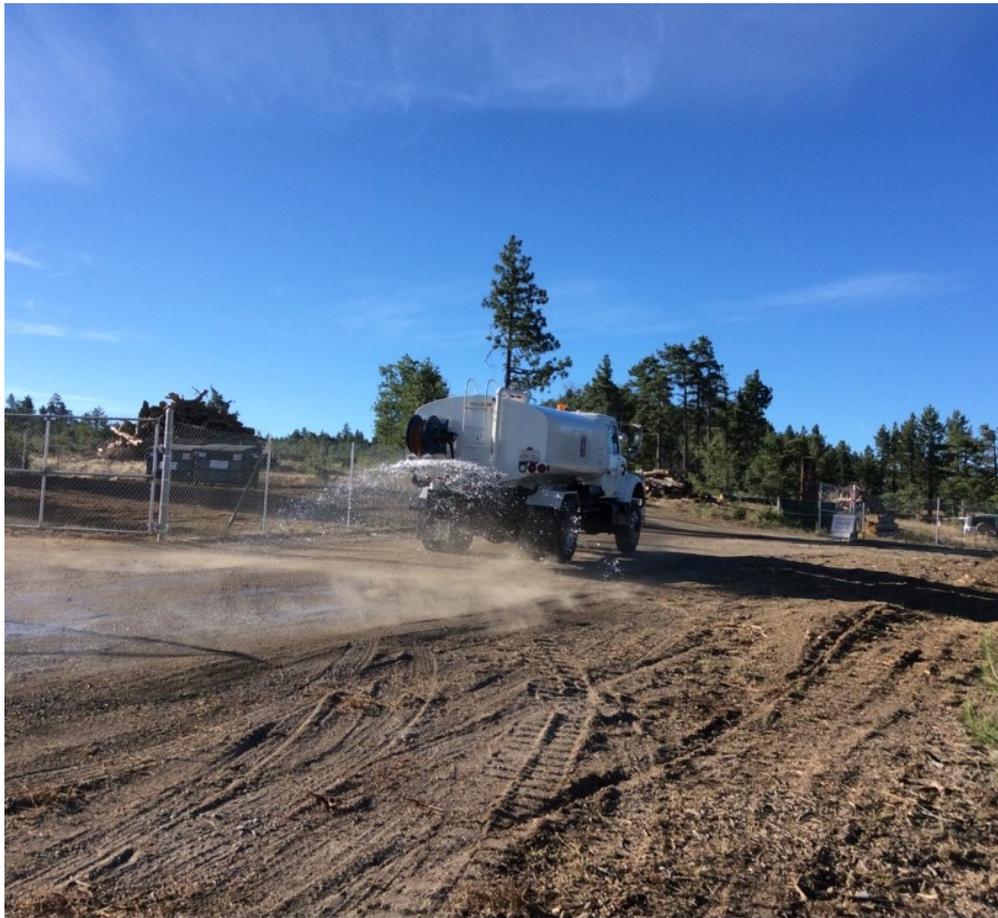
Photo 1: A water tender was observed applying water to the access road near Shrine Camp Staging Yard (C 440 Phase II) after the morning tailboard to minimize dust emissions during crew egress in accordance with APM AIR-02.

To prevent fugitive dust emissions during project activities, crews were observed applying water to prevent fugitive dust along unpaved access roads and in work areas in accordance with APM AIR-02 (see Photo 1 – Attachment A). Haul trucks used for dirt export were observed utilizing load covers to prevent dust emissions in accordance with APM AIR-02, and construction personnel were observed maintaining posted speeds of 15 miles per hour on unpaved access roads in accordance with APM AIR-03 and MM BIO-24. Construction crews were observed removing track-out from paved access roads in accordance with APM AIR-05.

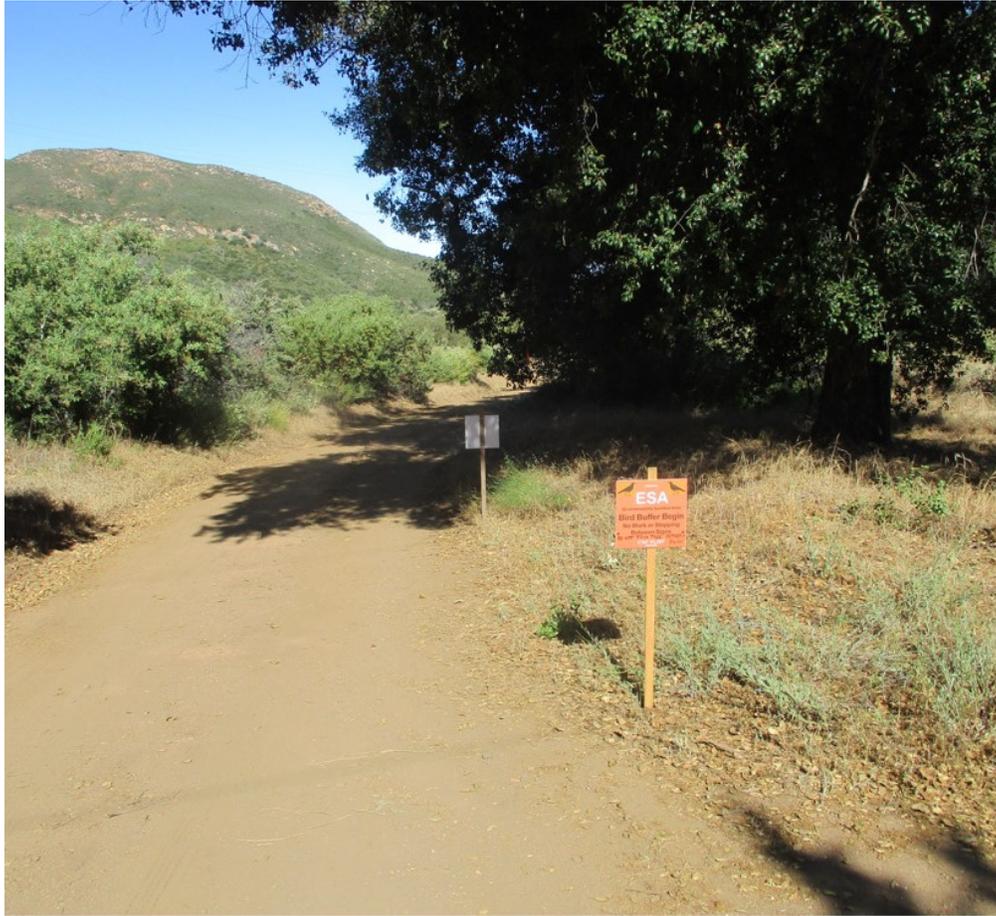
Photo 2: A “drive-through only” avian nest buffer/ESA was documented along the access road to P258481 (TL 626/C 79B) in accordance with the APP/NBMP (MM BIO-28).

Approved workspaces were observed delineated with staking and flagging, and work crews were observed adhering to work space limits and staying on approved access roads in accordance with MM BIO-1. Workers were observed having completed the Worker Environmental Awareness Program (WEAP), as shown by project hard hat stickers in accordance with MM BIO-2. Biological monitors were observed conducting full-time monitoring of initial ground-disturbing activities such as vegetation removal in accordance with MM BIO-3, and monitoring all other construction activities to ensure compliance with mitigation measures, applicant proposed measures, and permit conditions in accordance with MM BIO-22. In accordance with MM BIO-14 and MM BIO-16, Environmentally Sensitive Area (ESA) signs and flagging were observed installed around areas with special-status species, and ESAs were observed being avoided by crews. Excavations were observed covered to prevent wildlife entrapment in accordance with MM BIO-23, and crews were observed containing trash at work areas in accordance with MM BIO-26. Avian biologists were observed conducting nesting bird surveys and were present to monitor bird nests during construction activities in accordance with the Avian Protection Plan/Nesting Bird Management Plan (APP/NBMP) and MM BIO-28 (see Photo 2 – Attachment A).

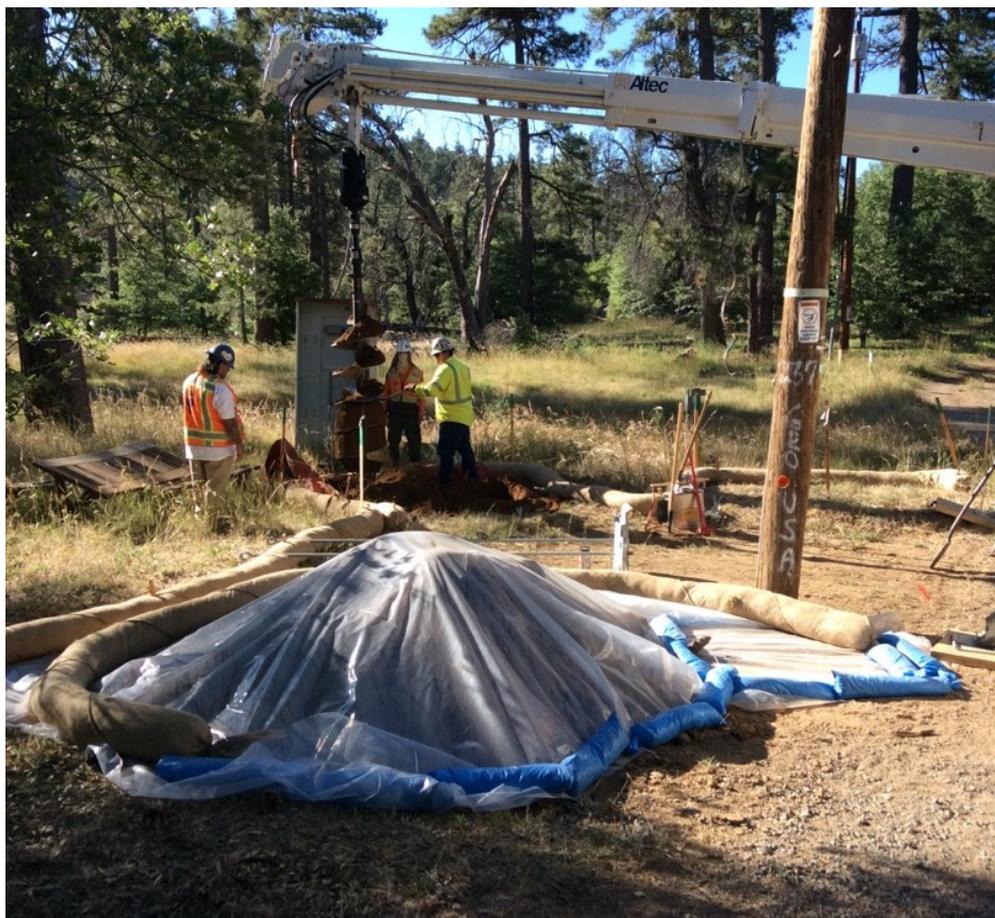
Photo 3: Archaeological and Cultural Monitors were observed monitoring anchor excavation and inspecting spoils for sensitive resources along C 440 Phase II in accordance with the HPMP, APM CUL-04, and MM CUL-1. In addition, the pole hole and spoils stockpile were observed to be covered in accordance with MM BIO-23, the ECP (MM HYD-1), and the SWPPP (MM HYD-1, MM BIO-7).

CPUC ECMs observed cultural resource monitors, including archaeological and Native American monitors, monitoring construction activities that occurred within or adjacent to identified archaeological or cultural resource site boundaries in accordance with the Historic Properties Management Plan (HPMP), MM CUL-1, MM CUL-3, and APM CUL-04 (see Photo 3 – Attachment A). Cultural ESAs were marked to prevent construction access to areas with cultural and/or historical resources in accordance with the

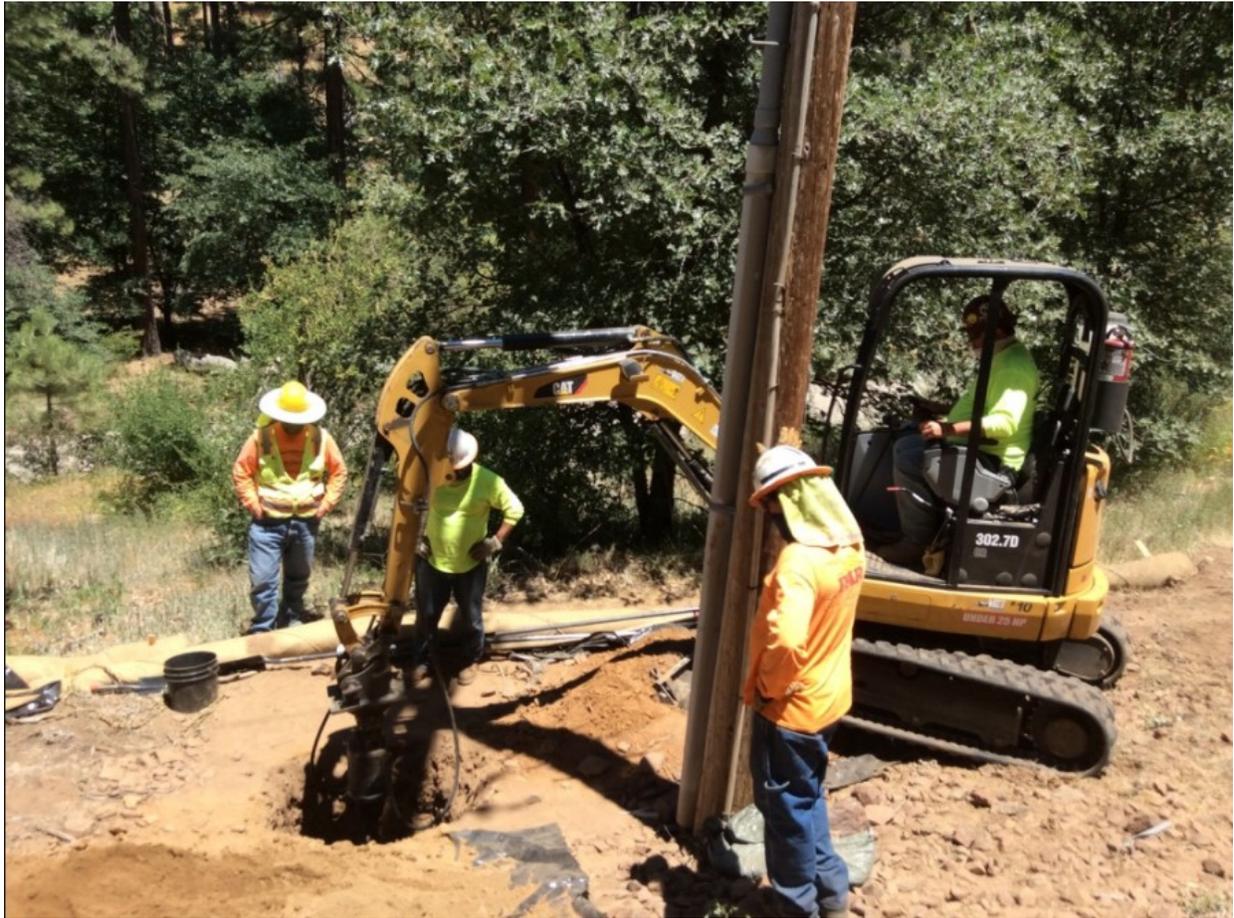
Photo 4: A Paleontological Monitor was observed monitoring pole hole digging along C 440 Phase II in accordance with APM CUL-08.

HPMP, and work crews were observed respecting cultural ESA boundaries. Paleontological monitoring was observed at work locations in accordance with the Paleontological Monitoring and Treatment Plan (APM CUL-08) (see Photo 4 – Attachment A).

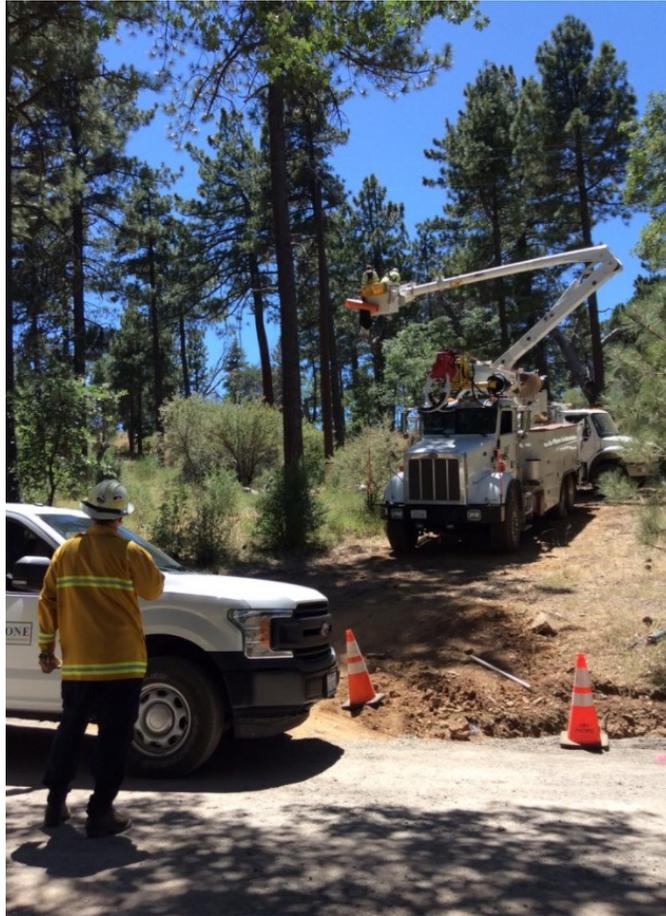
Photo 5: A Designated Fire Patrol was observed monitoring conductor work with de-energized lines at P260436 (C 440 Phase II) in accordance with the CFPPP Fire Prevention Matrix for the activity on USFS land with a PAL D (MM FF-1). A Project WEAP sticker was observed on the Fire Patrol's hard hat in accordance with MM BIO-2.

In accordance with the Construction Fire Prevention/Protection Plan (CFPPP) (MM FF-1), San Diego Gas & Electric (SDG&E) and their construction contractors were observed communicating Fire Potential Index (FPI) and Project Activity Levels (PALs) to work crews at daily tailboard meetings, during which daily fire requirements and restrictions for work on private land and on National Forest System (NFS) land were discussed. All project-related vehicles and equipment were observed carrying the required set of fire tools (each set containing a 5-gallon backpack pump, round point shovel, Pulaski, and 2A10BC fire extinguisher). Construction crews were observed staging a set of fire tools within 50 feet of work activities as required by APM HAZ-04 and other tools as required by the CFPPP (see Photo 5 – Attachment A). Fire boxes were observed at staging yards and stocked with the required firefighting tools.

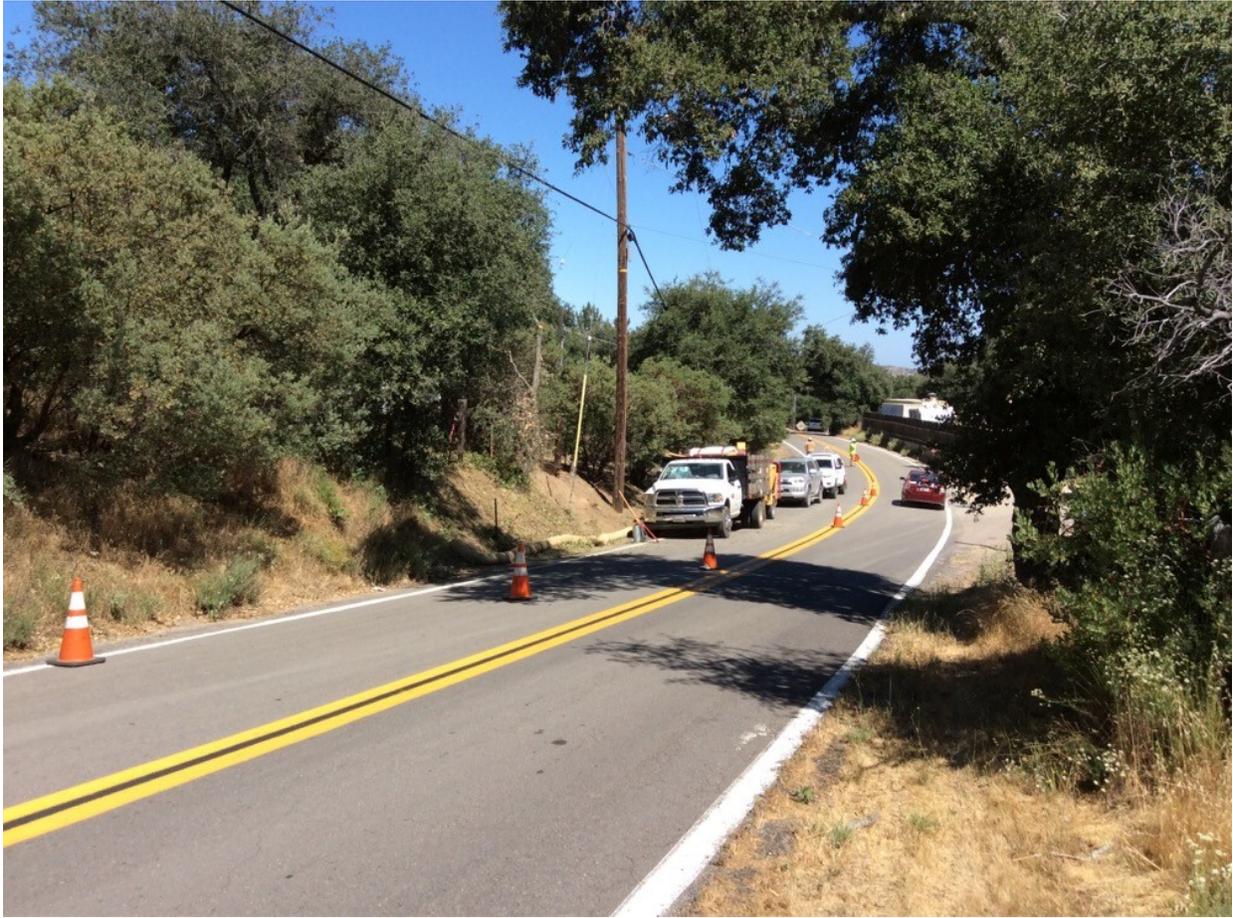
Photo 6: Cones, signage, and flagpersons were used to direct one-way traffic around the work area for Vault 71 and P259843 and P259844 (C 440) in accordance with the Traffic Control Plan (APM TRANS-05) and APM TRANS-02.

Traffic control measures were observed being implemented in accordance with APM TRANS-01 through APM TRANS-05 during this reporting period (see Photo 6 – Attachment A).
