<p>California Public Utilities Commission <i>Mitigation Monitoring, Compliance, and Reporting Program</i></p>
	<p>East County (ECO) Substation Project</p> <p>Compliance Status Report: 013</p> <p>September 29, 2013</p>

The California Public Utilities Commission (CPUC) is responsible for overseeing implementation of the mitigation measures set forth in the Final Environmental Impact Report/Environmental Impact Statement (FEIR/EIS) for the East County (ECO) Substation Project. The CPUC has established a third-party monitoring program and adopted a Mitigation Monitoring, Compliance, and Reporting Program (MMCRP) to ensure that measures approved in the FEIR/EIS to mitigate or avoid significant impacts are implemented in the field. This MMCRP status report is intended to provide a description of construction activities on the project, a summary of site inspections conducted by the CPUC’s third-party monitors, the compliance status of mitigation measures required by the MMCRP, and anticipated construction activities. This compliance status report covers construction activities from September 16 to September 29, 2013.

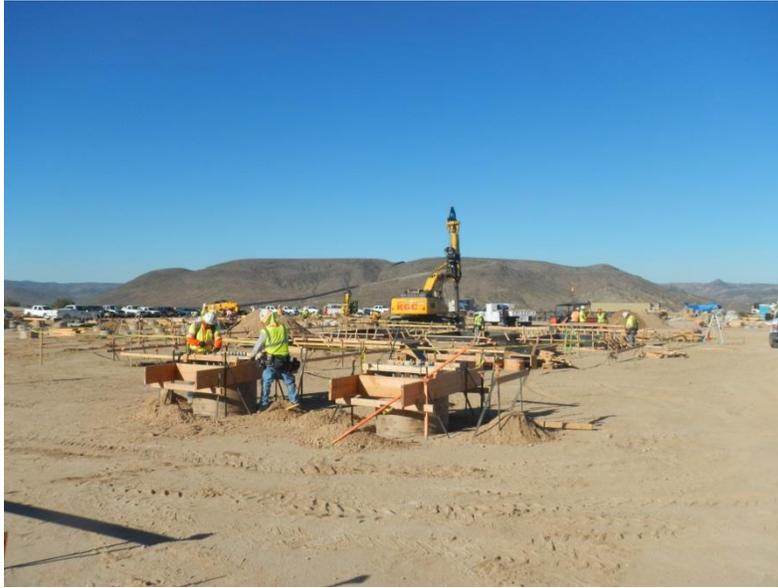
Construction activities at the ECO Substation site primarily consisted of excavating and pouring concrete foundations for substation components at the 138/230 kV ECO Substation Pad site (see Attachment A –Photo 1). CPUC issued an approval letter on September 24th to authorize SDG&E to continue construction activities associated with rough grading as required in Non-Compliance

Photo 1: Construction crews completing concrete foundations for substation components at the 138/230 kV ECO Substation pad.

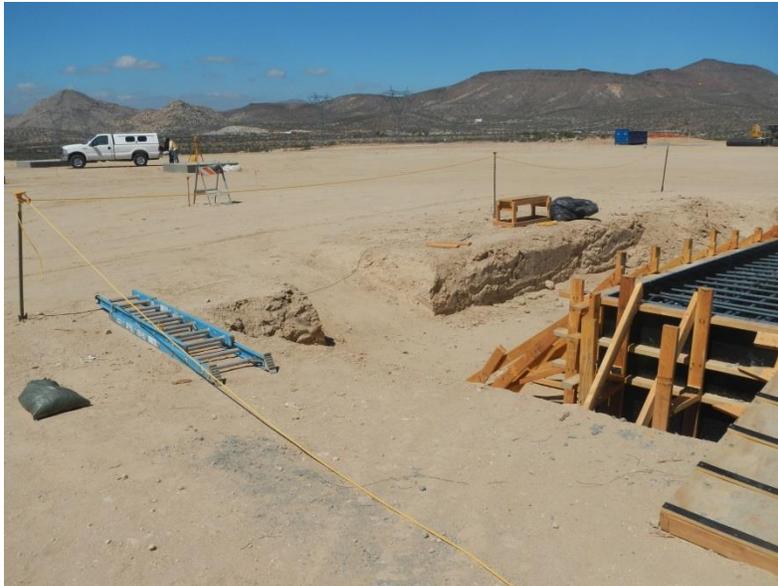
Construction crews were observed placing all trash debris in sealed storage containers in accordance with MM-BIO-7D. Wildlife escape ramps were installed with a gradient ratio of no greater than two to one to prevent wildlife entrapment in accordance with MM-BIO-7A at excavations within the 138/230 KV Substation Pad (see Attachment A –Photo 2).

Photo 2: Wildlife escape ramps being utilized at the 138/230 kV ECO Substation pad site to prevent wildlife entrapment in accordance with MM-BIO-7A.

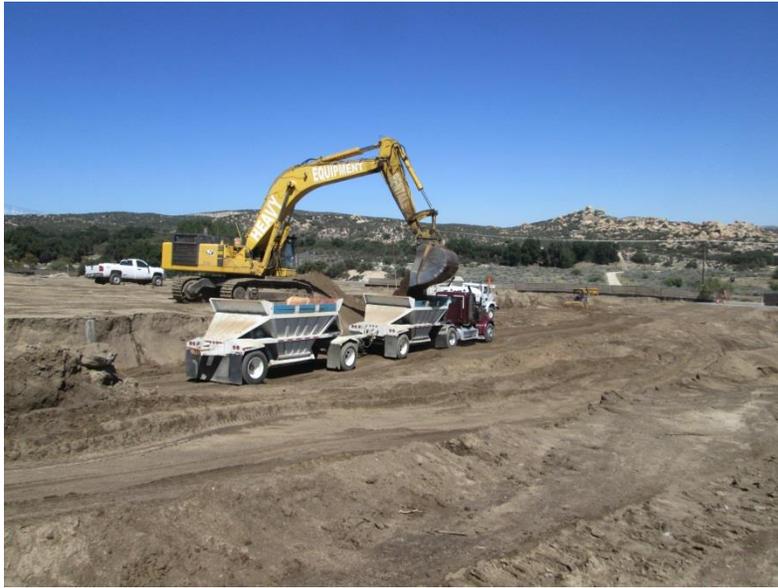
Construction activities at the Boulevard Rebuild Site consisted of rough grading and excavation of soils to establish the Boulevard Rebuild Substation pad site. Soils excavated from the project site were transported to the ECO Substation located to the east (see Attachment A –Photo 3). Construction is approximately 10% complete and is anticipated to be completed in November 2014.

Photo 3: An excavator is utilized to load haul trucks to export soil from the Boulevard Substation Rebuild Site.

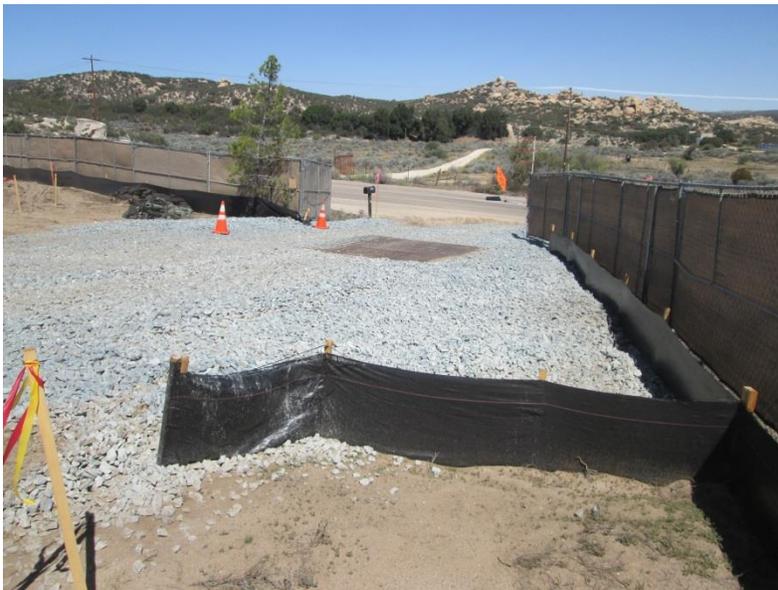
routine inspections to ensure BMP's were being maintained. Trac-out measures consisting of a rattle plate and rock apron have been installed at the point of ingress/egress to the Boulevard Substation Rebuild Site to minimize the potential for trac-out along Old Highway 80 (see Attachment A –Photo 4).

Photo 4: Trac-out measures consisting of a rattle plate and rock apron are being maintained at the point of ingress/egress to the Boulevard Substation Rebuild Site along Old Highway 80.

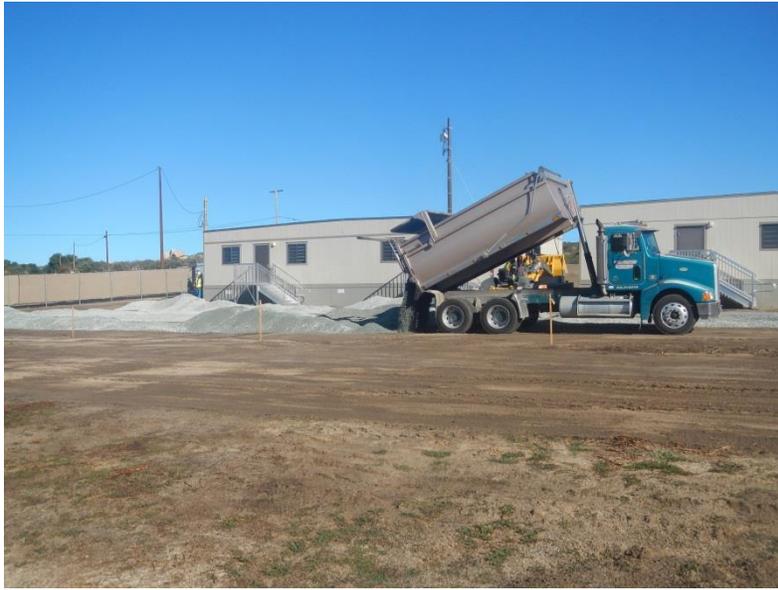
Construction crews continued to mobilize construction materials to the Carrizo Gorge Construction Yard and Jewel Valley Construction Yard during this reporting period. Gravel base was observed being placed at the Jewel Valley Construction Yard (see Attachment A –Photo 5). Clearing of vegetation at the Domingo Lake Construction Yard commenced during the reporting period. A biological monitor was present overseeing vegetation removal in accordance with MM-VEG-1C (see Attachment A –Photo 6). A Non-Compliance was reported by SDG&E on September 24, 2013 as a result of construction crews clearing vegetation beyond the approved work limits at the Domingo Lake Construction Yard (see Compliance section below).

Photo 5: Gravel base being delivered to the Jewel Valley Construction Yard that will be utilized to stage construction equipment and materials.

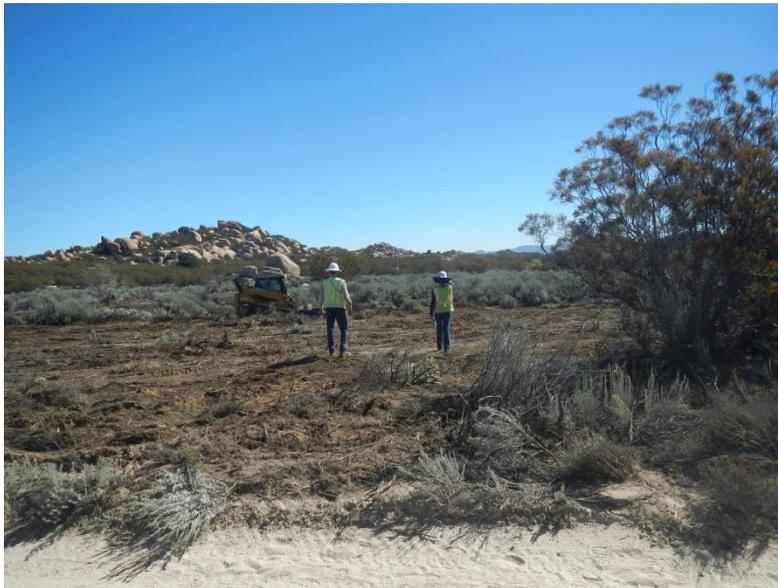
Photo 6: Biological monitors present during vegetation clearing at the Domingo Lake Construction Yard in accordance with MM-BIO-1C.

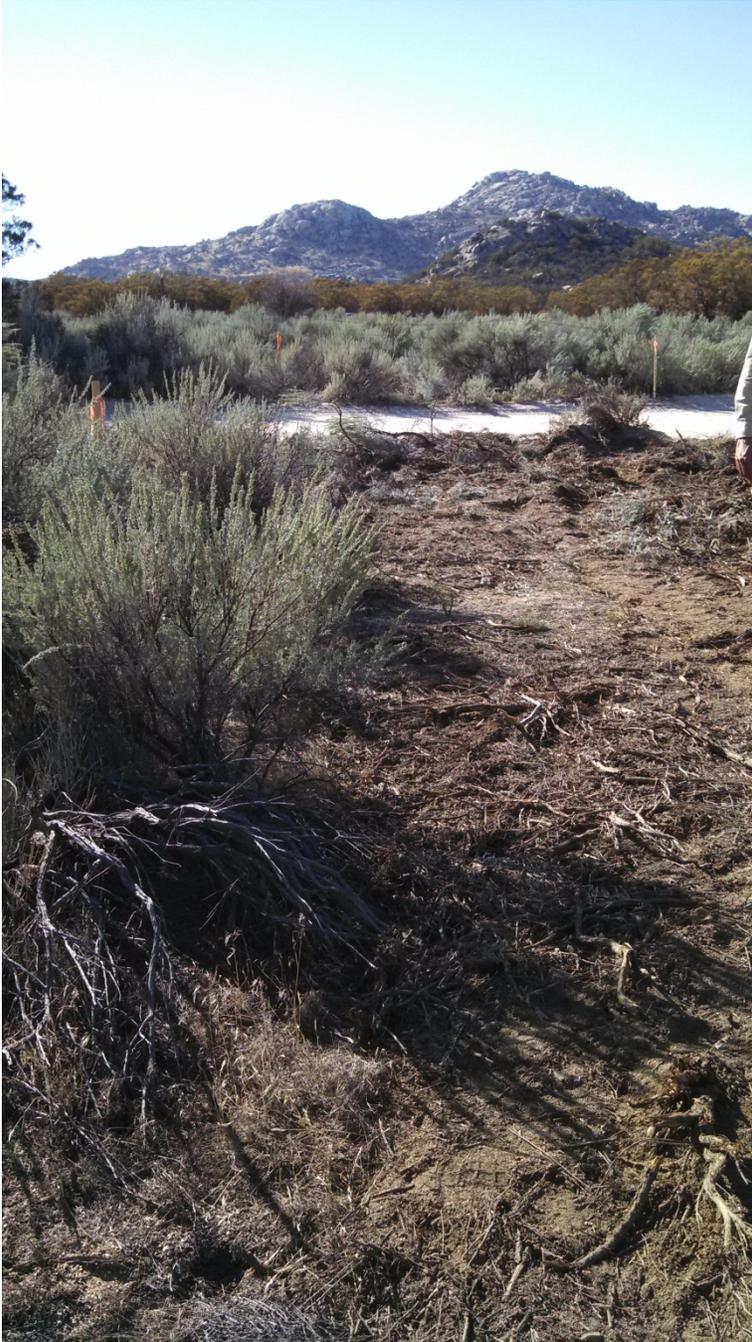
The EFS and LEI met with Kirstie Reynolds (Environmental Compliance Lead, SDG&E) at approximately 1650 to discuss the incident. It was determined that the Section 1 ROW limits and the Yard limits were staked and flagged with the same color ribbon causing the equipment operator to misinterpret the staked limits for the yard with the staked limits for the Section 1 underground alignment. In addition, offset staking was utilized as a portion of the yard overlaps with the adjacent dirt access road. Offset staking was used to avoid installing stakes in the middle of the road bed. This offset stake was mistaken for the proper Yard "construction limits" stake causing a more acute angle and resulting in the off-ROW activities. Approximately seven big sage brush (*Artemisia tridentata*) within an approximately 300-square-foot area were impacted.

The LEI conducted an investigation of the impacted area outside of the work limits on September 24, 2013. Approximately 200 square feet of native big sage brush scrub was mowed outside of the Yard limits but within the Section 1 ROW, and approximately 100 square feet of big sage brush scrub was mowed outside of the Yard limits and the Section 1 ROW limits. The root systems remained intact, and little soil disturbance occurred. The impacted area is located more than 100 feet away from any known cultural Environmentally Sensitive Area. No rare plant species were impacted, and no drainages under the jurisdiction of the U.S. Army Corps of Engineers, California Department of Fish and Wildlife, or Regional Water Quality Control Board were disturbed.

Photograph 1: View facing west of the area of disturbance outside of the approved limits for the Yard but within the Section 3 ROW.

had been staked prior to vegetation removal; however the limits of work was not correctly interpreted by the construction crews and biological monitor. An approximately 300 square foot area was impacted beyond the approved work limits. In response to Non Compliance Report No. 003, SDG&E will be implementing the following corrective measures to minimize the potential from a similar incident occurring in the future (1) Stakes will be flagged with different colors for delineating work limits vs offset stakes, (2) Construction personnel will walk the limits prior to clearing to identify the authorized work limits, (3) Rope will be strung between work limits staking to clearly delineate the approved work limits.

A follow-up meeting will be held between SDG&E and its Contractors within one week (by October 1, 2013) to review Quality Control/Quality Assurance procedures intended to ensure that staking is confirmed and easily decipherable by construction personnel in the field prior to clearing or grading activities. SDG&E's Contractors will also evaluate the existing procedures for adequacy, assess if any procedures were not properly implemented, and develop new procedures, as necessary, within one week (by October 1, 2013) to minimize the potential for a similar incident to occur in the future.

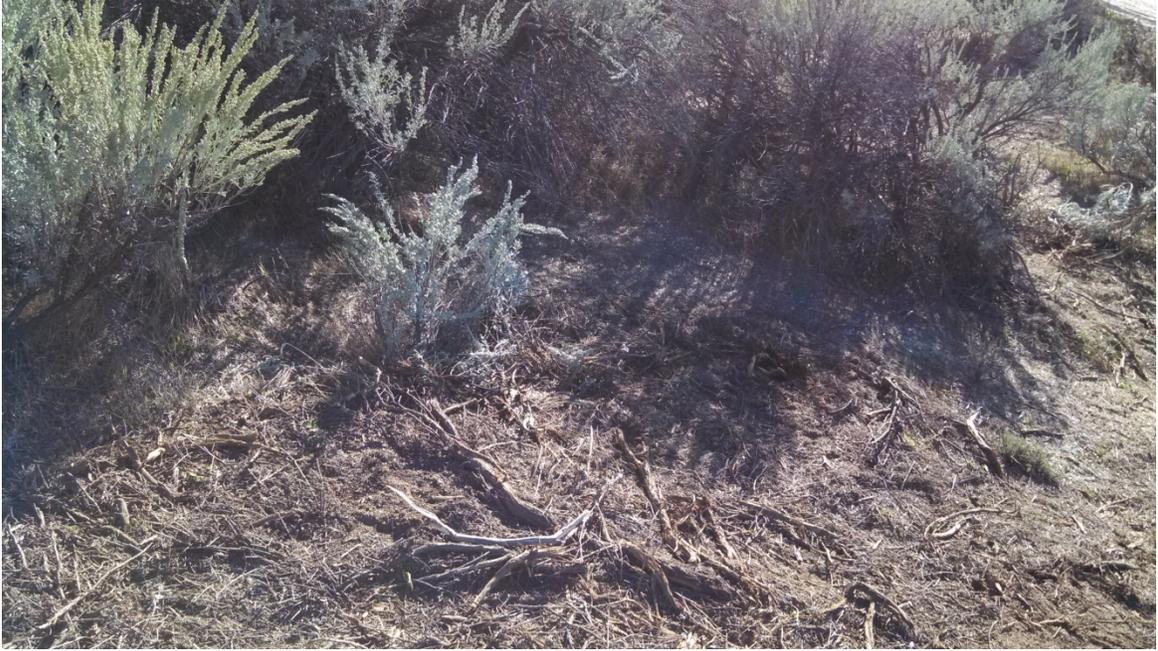
Photograph 2: View facing southwest of the area of disturbance outside of the approved limits for the Yard and the Section 3 ROW.
