# **APPENDIX B**

## **SOIL MAP UNITS**

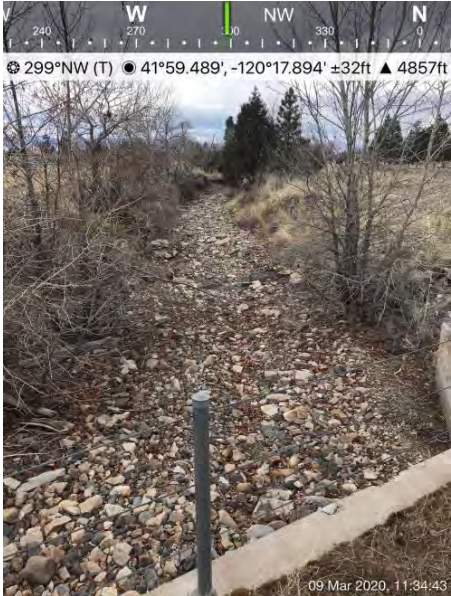
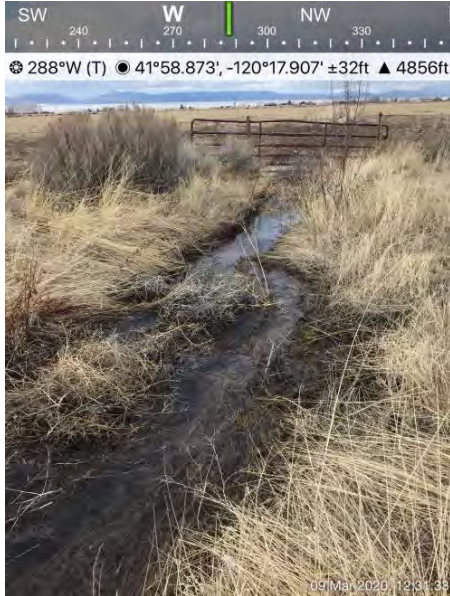
<p>Photo 1. Intermittent stream (D50-1bx, 50-1) with a break in bank slope and change in vegetation cover indicating the ordinary high water mark (OHWM).</p>	<p>Photo 2. Intermittent stream (D51-bx, 51-1) with OHWM same as top of bank (TOB).</p>

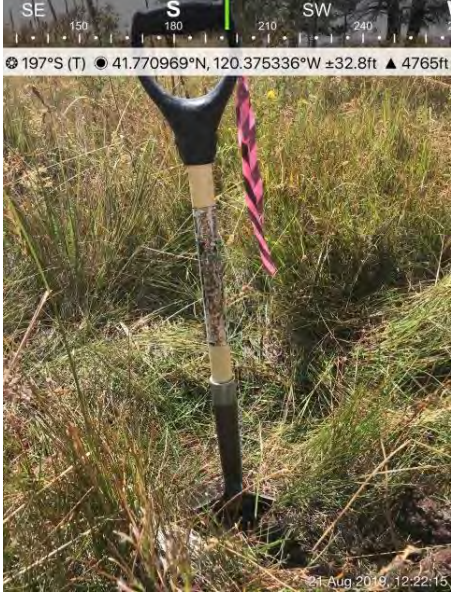
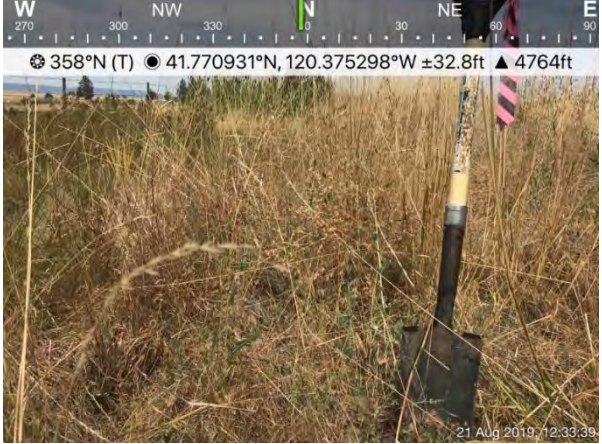
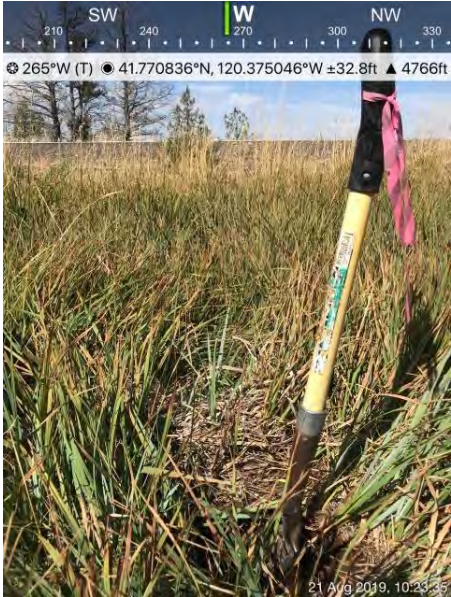
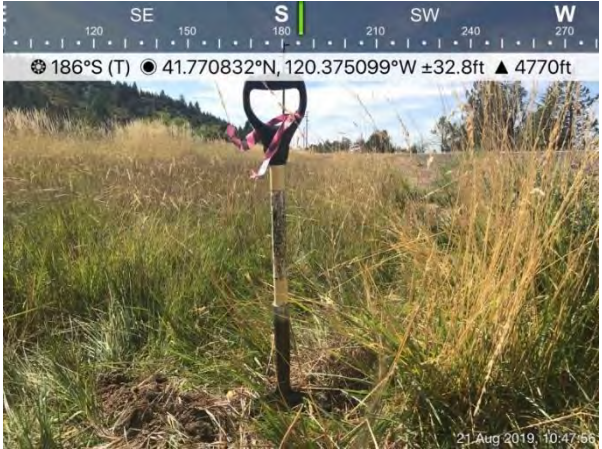
<p>Photo 1. Fresh emergent wetland (W64-2, 68-2) dominated by <i>Carex</i> sp.</p>	<p>Photo 2. Upland (U64-2, 69-2) adjacent to fresh emergent wetland and dominated by perennial grasses.</p>
<p>Photo 3. Fresh emergent wetland (W62-2, 66-2) appearing to be fed by nearby agricultural fields.</p>	<p>Photo 4. Upland (U62-2, 67-2) adjacent to fresh emergent wetland and dominated by perennial grasses.</p>

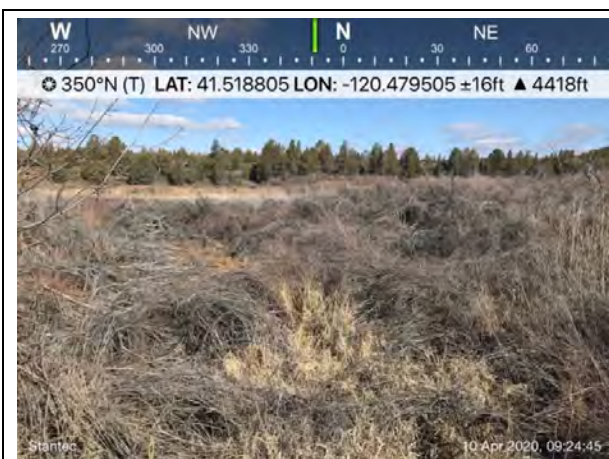
Photo 5. Riparian wetland (W06-3x) dominated by *Salix* sp. and *Carex* sp.

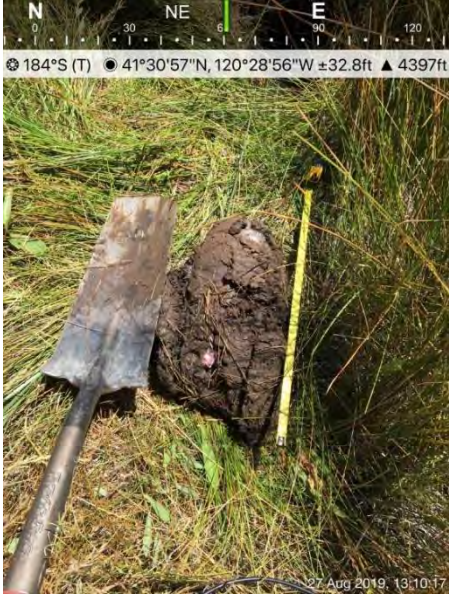
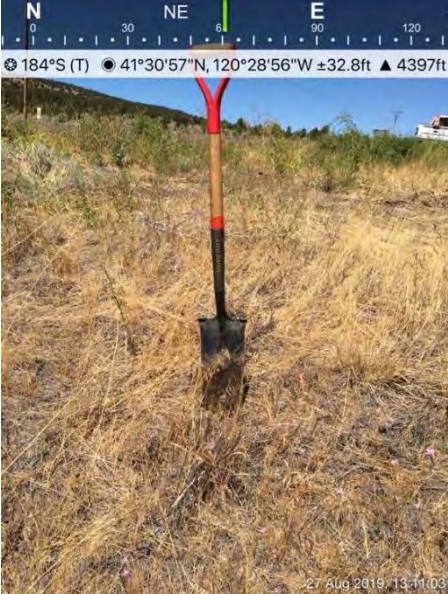
<p>Photo 1. Riparian wetland (W500-5, 550-5) dominated by <i>Carex</i> sp.</p>	<p>Photo 2. Upland (U500-5, 501-5) adjacent to riparian wetland.</p>

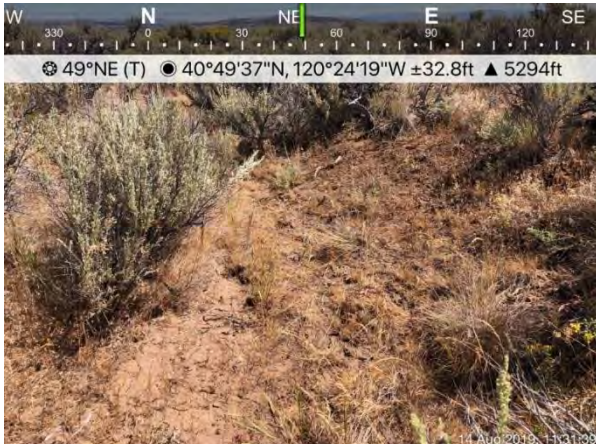
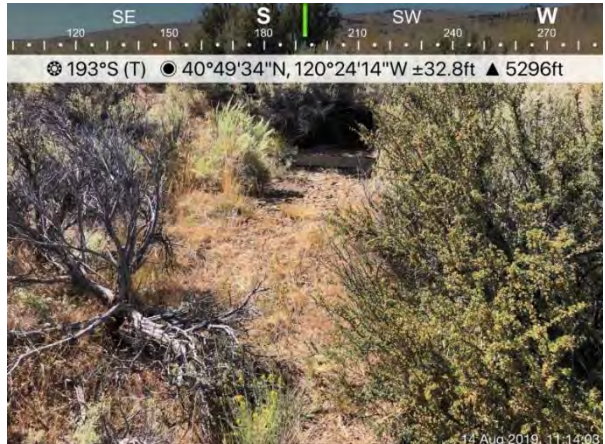
<p>Photo 1. Non-vegetated ditch (D101-6, 101-6) showing break in bank slope and change in vegetation cover with some upland vegetation occurring below the OHWM.</p>	<p>Photo 2. Ephemeral stream (D100-6, 100-6) showing break in bank slope and change in sediment indicating the OHWM.</p>

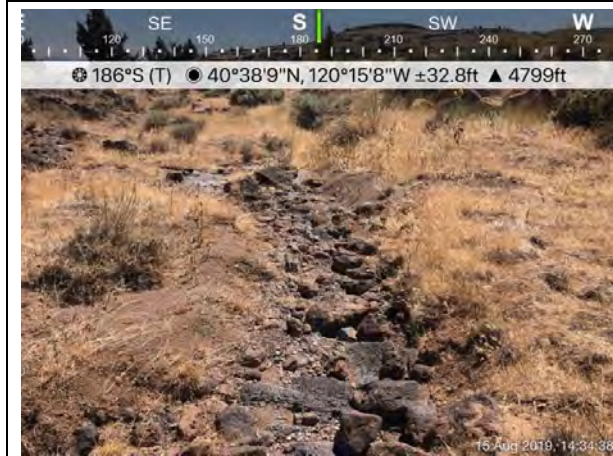
Photo 1. Non-vegetated ditch (D11-7, 21-7) adjacent to Hwy 395 in perennial grassland.

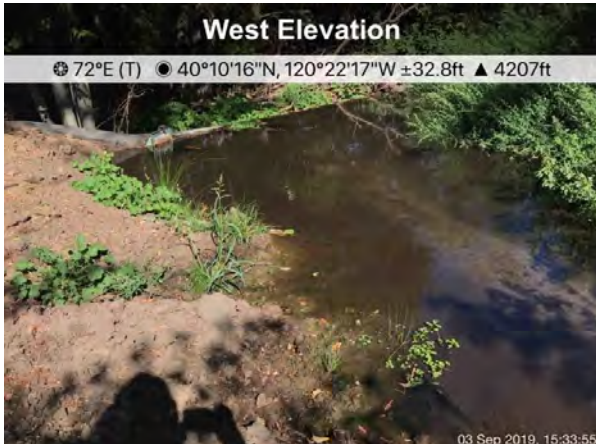
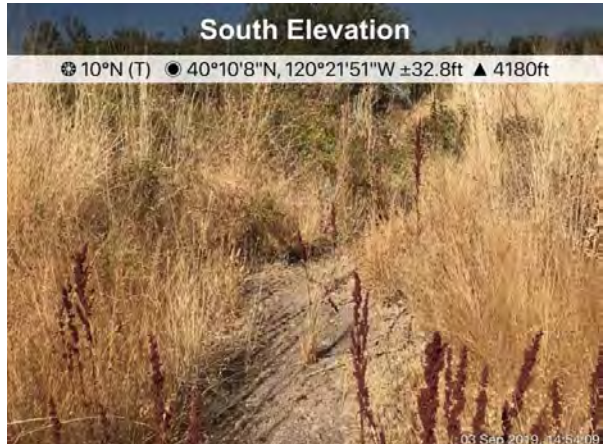
<p>Photo 1. Perennial stream (D08-10, 14-10) with TOB the same as OHWM.</p>	<p>Photo 2. Intermittent stream (D07-10, 13-10) with TOB the same as OHWM.</p>

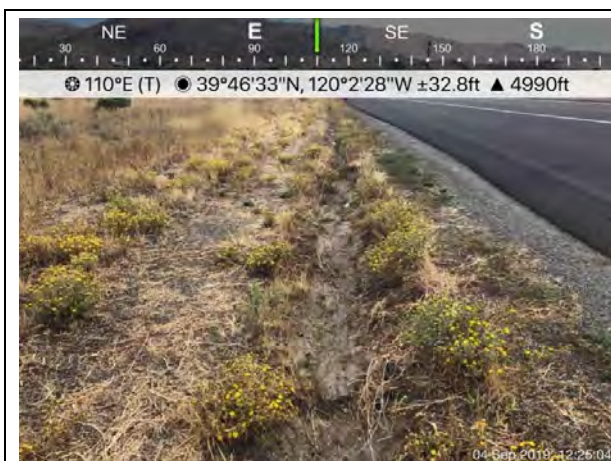
Photo 5. Non-vegetated ditch (D03-12, 03-12) in perennial grassland.
