memorandum

subject MPWSP – Carmel Valley Pump Station Project Weekly Report (3/29/2021 – 4/02/2021)

CalAm Weekly Report

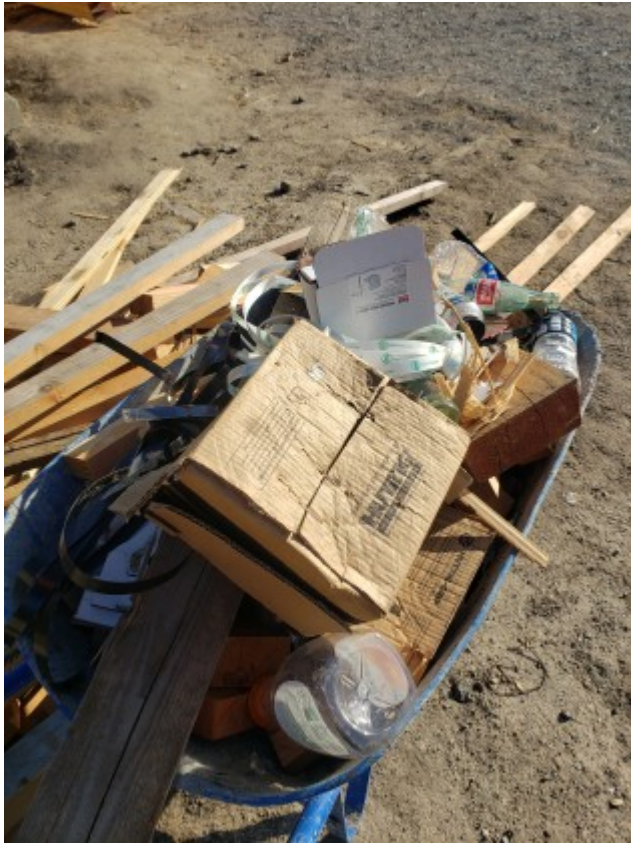
4.6-1c. 18. Trash and food items were contained in closed containers and removed from the construction site daily to reduce the attractiveness to opportunistic predators such as common ravens, coyotes, and feral dogs?	No	Food trash observed by Biological Monitors outside of proper receptacle. DD&A to inform construction manager.

04/01/2021 - Food waste not placed in proper receptacle.

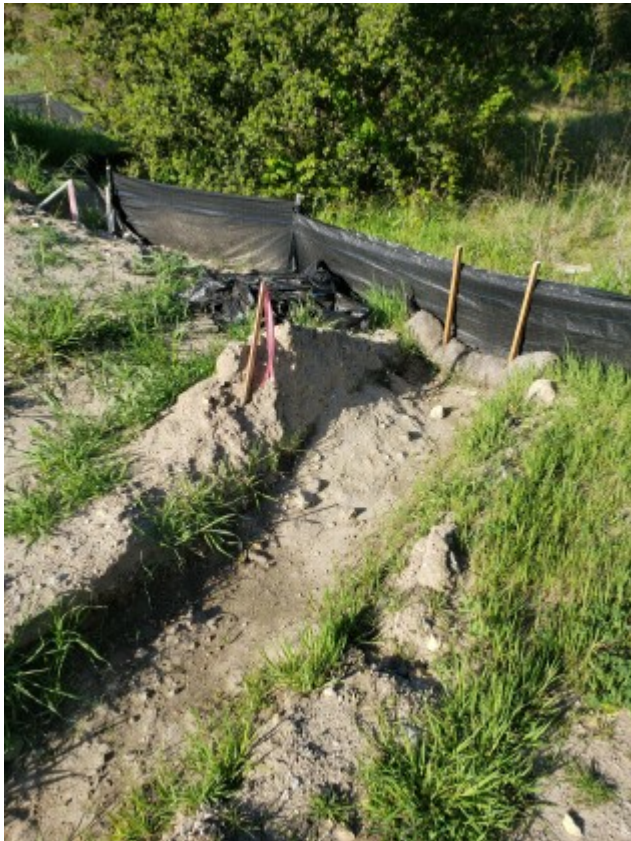
04/01/2021 - Drainage feature installed on northern boundary of project site.

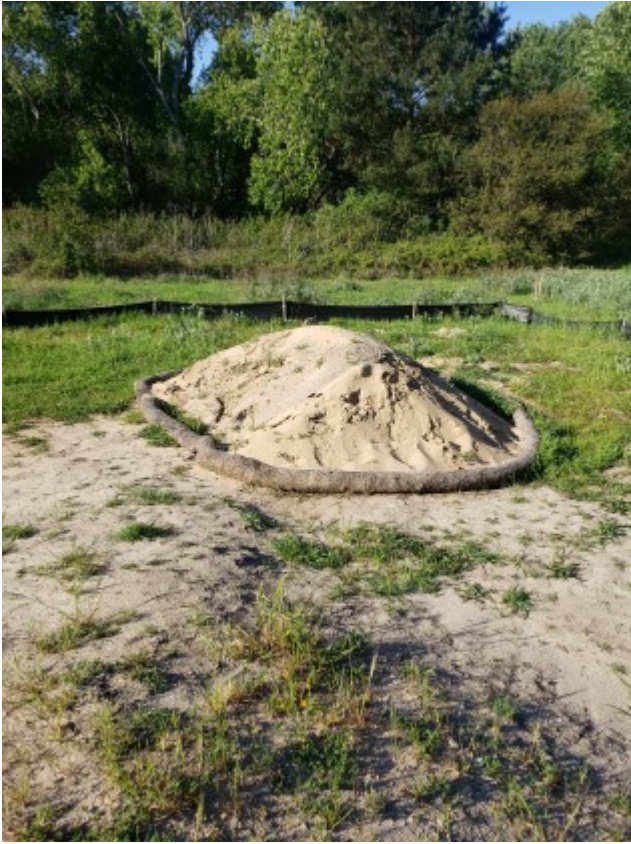
04/01/2021 - BMP insalled on soil stockpile.

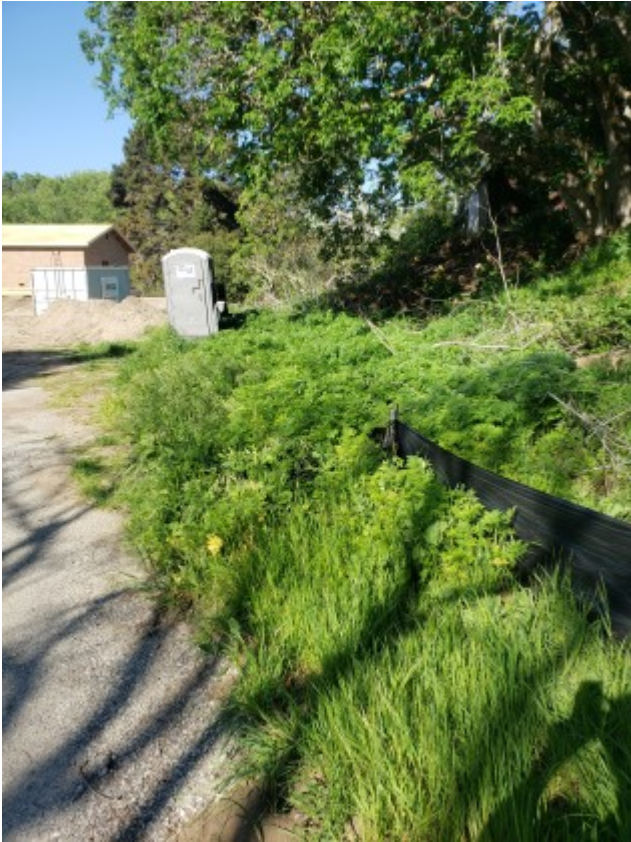
4.6-1c. 6. Fueling of construction equipment within existing paved areas and at least 50 feet from drainages and native habitats?	Yes	
4.6-1c. 7. Introduction of exotic plant species avoided through physical or chemical removal and prevention?	Yes	DD&A Biological Monitors to have discussion with contractor and construction manager regarding exotic plant species development along the exclusion fence line. Solution pending.

04/01/2021 - Overgrown vegetation; confirming fencing integrity difficult.

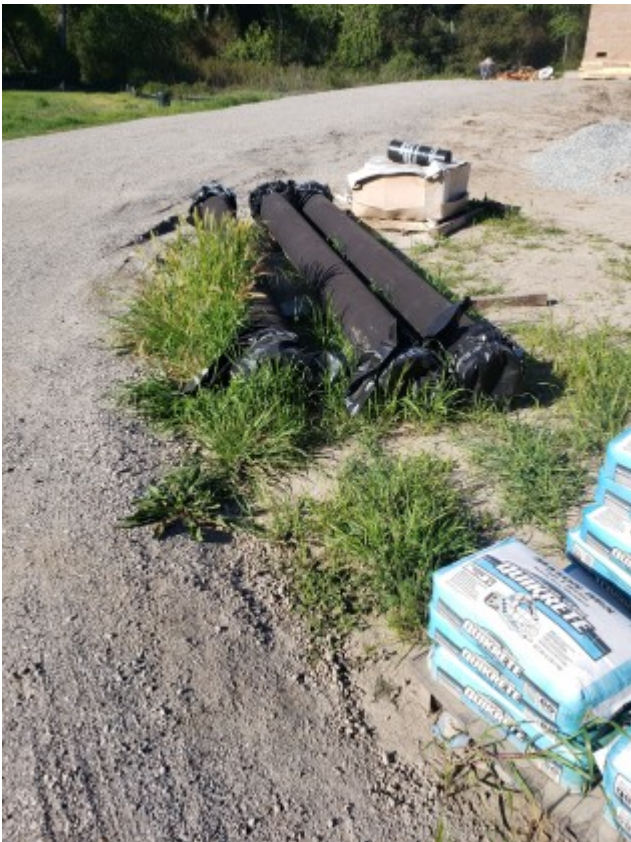
4.6-1c. 13. All construction pipes, culverts, or similar structures that are stored at a construction site for one or more overnight periods and with a diameter of 4 inches or more were inspected for special-status wildlife before the pipe was subsequently buried, capped, or otherwise used or moved in any way?	Yes	See photo.

04/01/2021 - Piping on ground surface with covered ends to prevent wildlife entrapment.

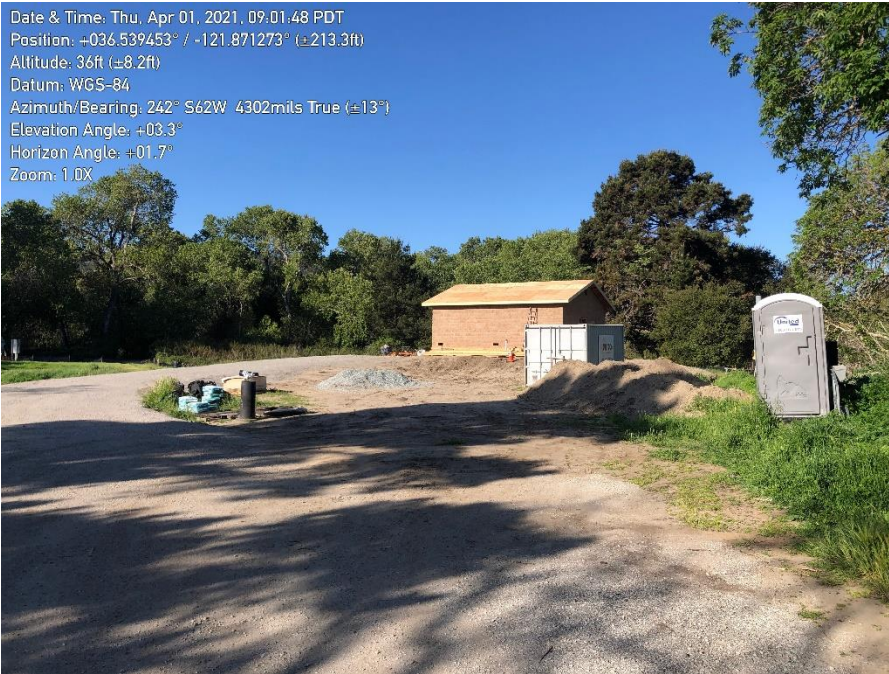
Photo 1. Pump station and overall site conditions.

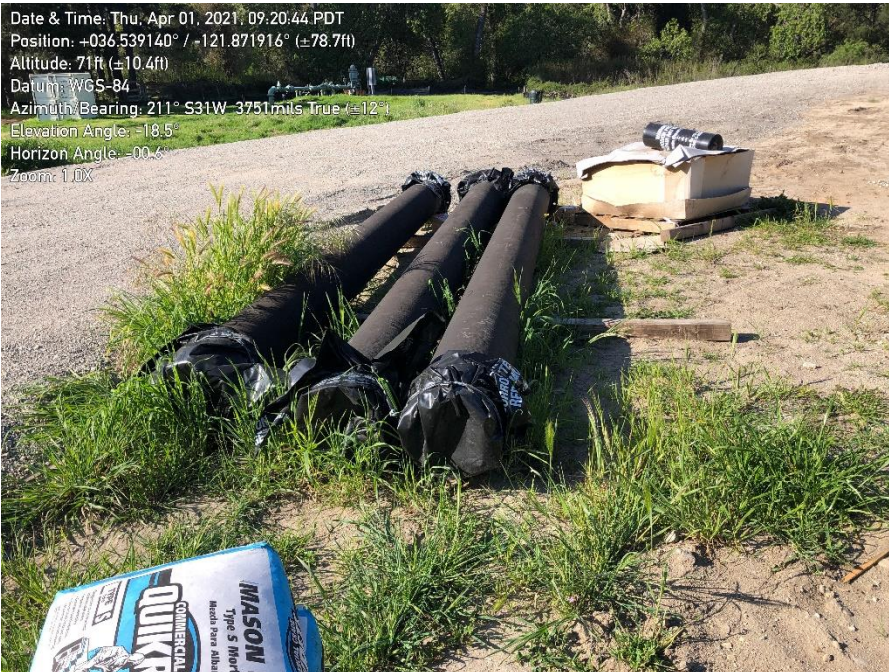
Photo 2. Pipes capped.

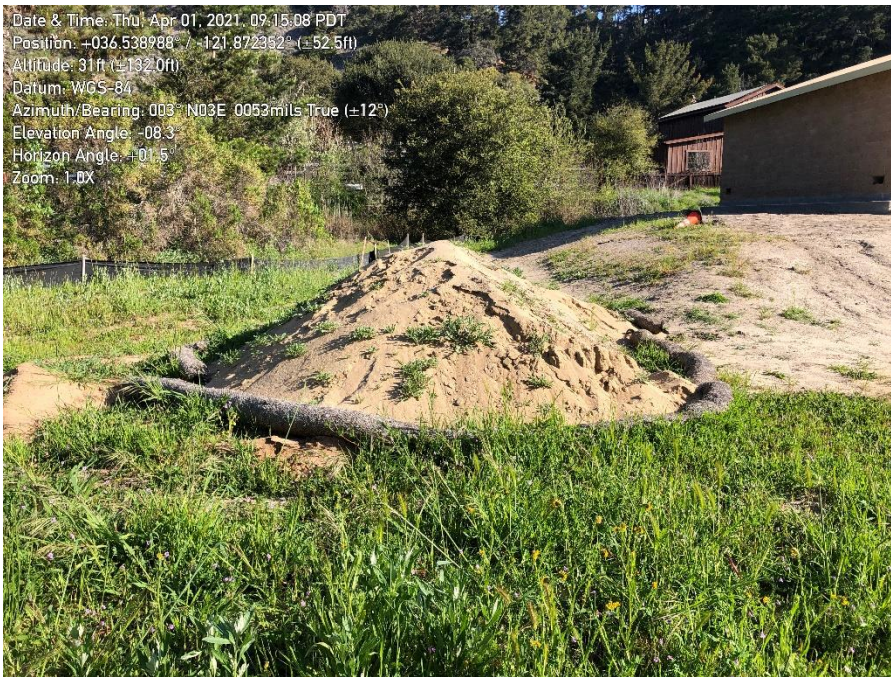
Photo 3. BMPs in place.

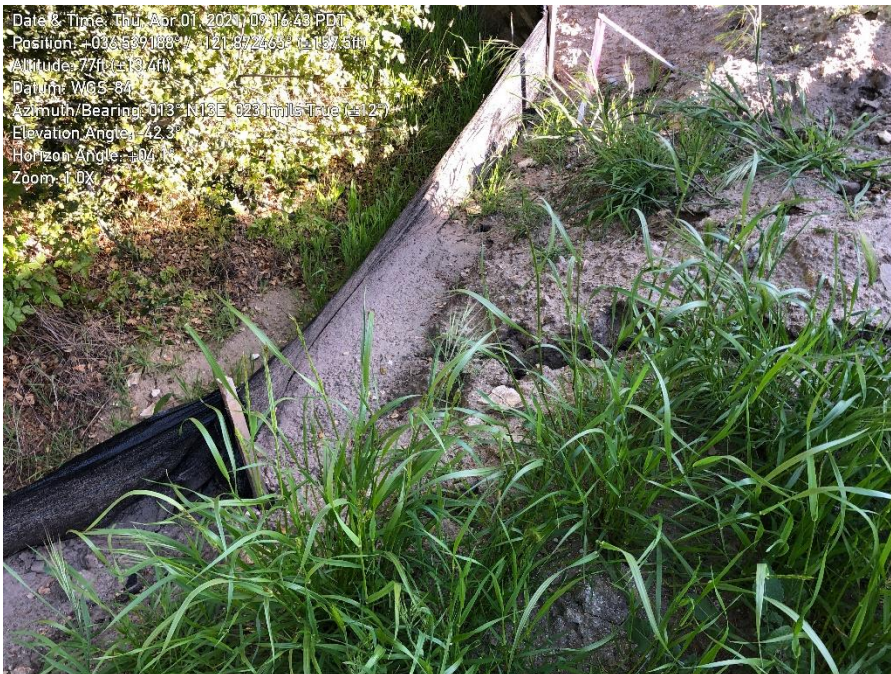
ESA noted that a small amount of sediment from the building pad was still backed up against a section of silt fence near the northwest corner of the site. This was originally noted during the 3/11/2021 site inspection. The silt fence was not compromised and was in adequate condition to prevent special-status amphibian species from entering the site. However, ESA recommended that any sediment observed building up against the silt fence be removed to prevent the silt fence from slumping.

Photo 4. Sediment backed up along silt fence near pad.

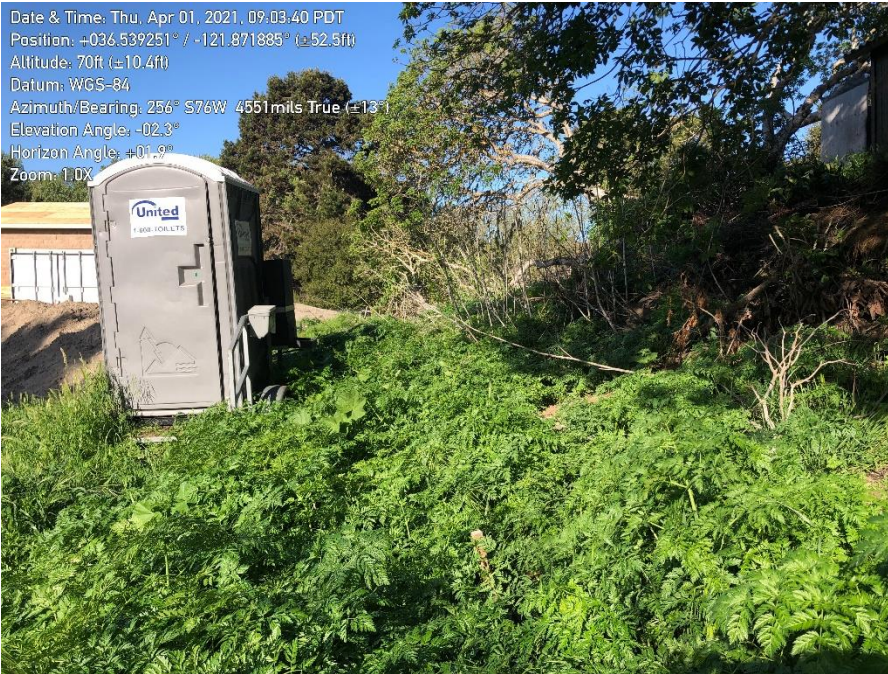
ESA also noted that invasive hemlock (*Conium maculatum*) continues to grow along both sides of the silt fence at the north border of the site. A Habitat Monitoring Plan was prepared for the CVPS site as required in **Mitigation Measure 4.6-1n** and specifies invasive species removal and management actions.

Photo 5. Hemlock growing up around silt fence along north border of site on both sides of exclusionary silt fence.

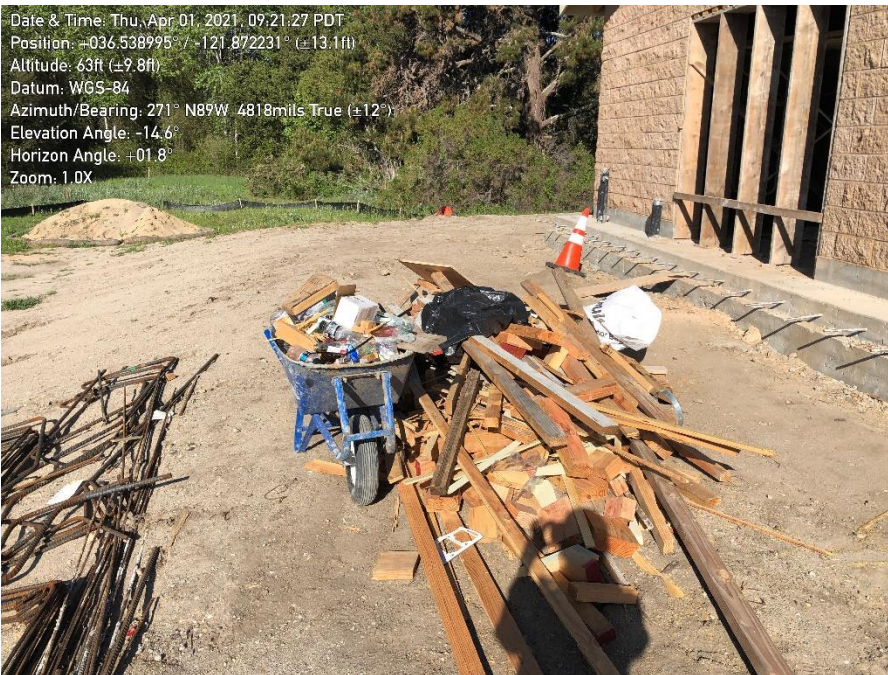
- Trash, including food scraps, was observed in a wheelbarrow rather than being properly disposed of in a covered trash receptacle as required by **Mitigation Measure 4.6-1c**.

Photo 6. Trash improperly disposed of in wheelbarrow.
