memorandum

subject MPWSP – Carmel Valley Pump Station Project Weekly Report (5/03/2021 – 5/07/2021)

subject MPWSP – Carmel Valley Pump Station Project Incident Report

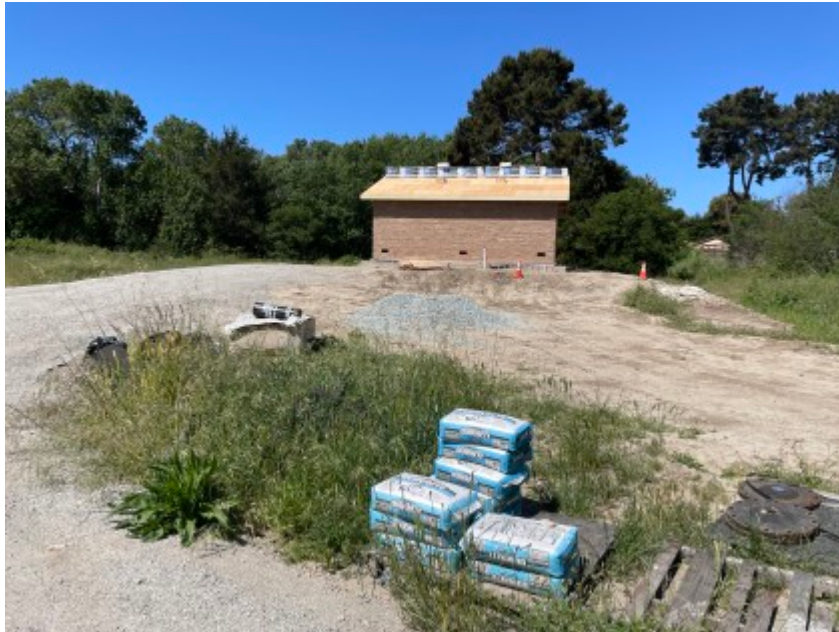
05/03/2021 - Site conditions

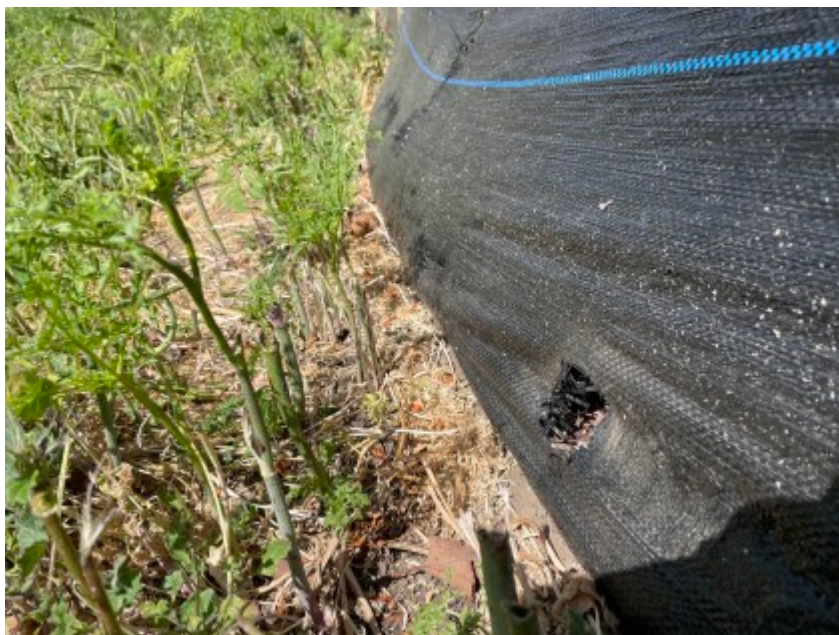
- DD&A performed ongoing monitoring in accordance with Mitigation Measure 4.6-1a.
- Photographed project site conditions.
- Inspected exclusion fence to determine sections in need of repair.

05/03/2021 - Holes in exclusion silt fence

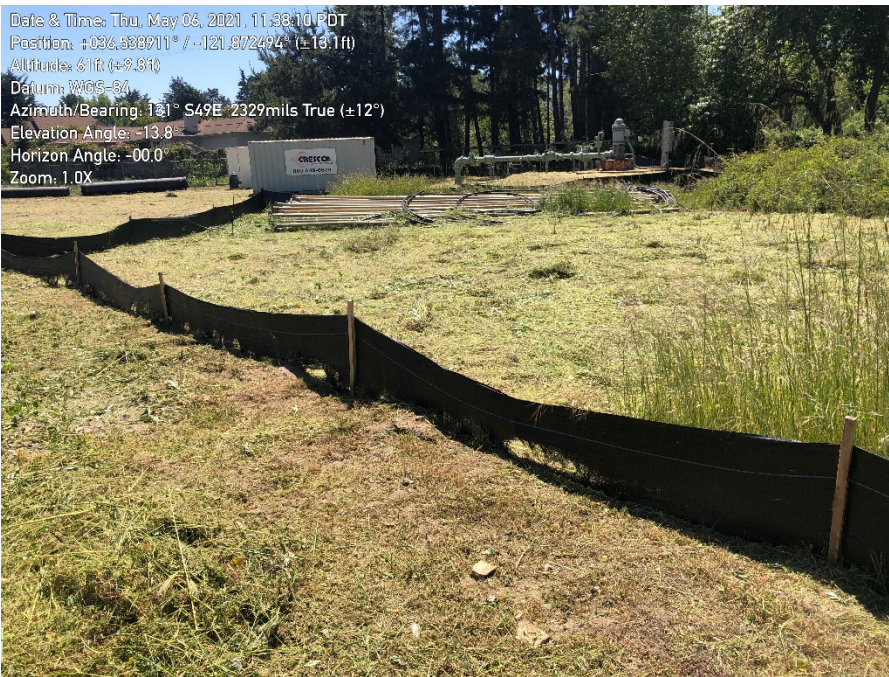
- A three-person crew was observed on site mowing vegetation both inside and outside of approved work area, which is delineated by exclusion fencing. Per **Mitigation Measure 4.6-1c (1, 11)**, any construction related disturbance outside of approved work areas shall be prohibited without explicit approval of the Lead biologist, and a qualified biologist shall survey within the exclusion area to ensure that no special-status species are present prior to vegetation removal activities. CalAm monitors were not informed prior to initiation of this work and no surveys were performed.

- Exclusion fencing was damaged during weed removal activities. In addition, a portion of silt fence near the northeast border of the site was down due to ground squirrel activity. Other sections of silt fence, originally documented as damaged during the April 9, 2021 site inspection due to earlier weed management activities have yet to yet to be repaired. Per **Mitigation Measure 4.6-1c**, any needed repairs to the fence shall be performed on the day of their discovery.

Photo 1. Mechanical weeding activities inside and outside of exclusion fence. Exclusion fence has been damaged by weed removal activities.

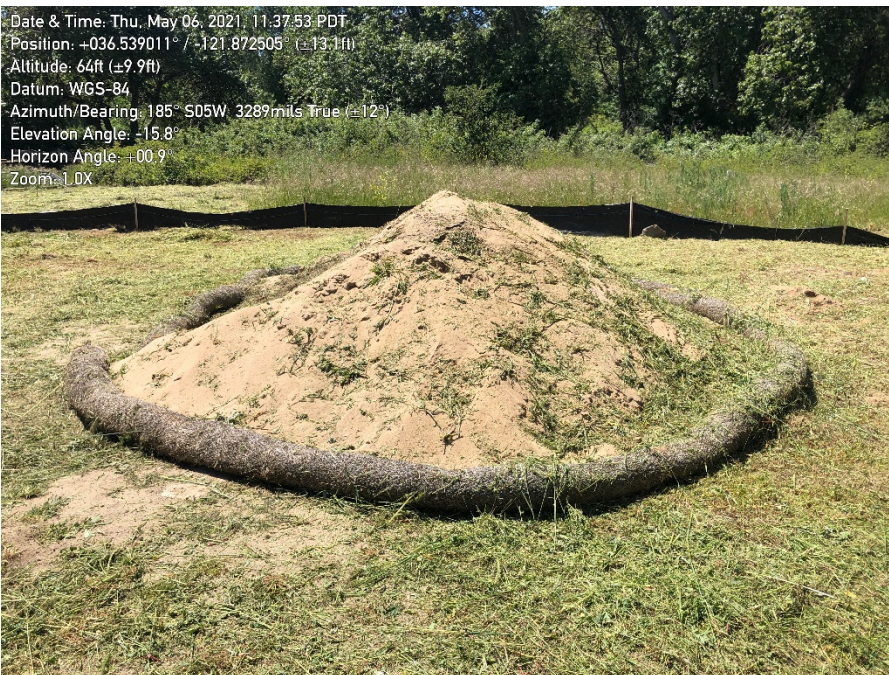
- ESA noted that straw wattle encased in monofilament netting is installed on the site. Per **Mitigation Measure 4.6-1p**, “Only certified, weed-free, plastic-free imported erosion control materials (or rice straw in upland areas) shall be used for the project.” To prevent additional establishment and spread of invasive species on site, ESA also recommended that inactive stock piles be covered.

Photo 2. Spoils pile uncovered during weed removal activities. Monofilament straw wattle used.

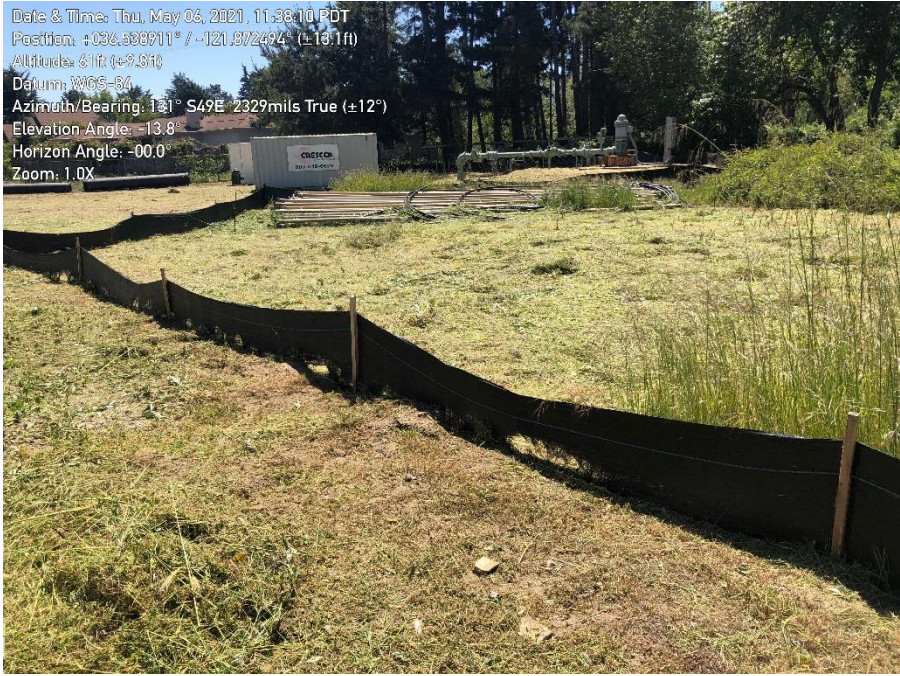
- A three-person crew was observed on site mowing vegetation both inside and outside of approved work area, which is delineated by exclusion fencing (silt fence; see Photo 1). Per **Mitigation Measure 4.6-1c (1, 11)**, any construction related disturbance outside of approved work areas shall be prohibited without explicit approval of the Lead biologist, and a qualified biologist shall survey within the exclusion area to ensure that no special-status species are present prior to vegetation removal activities. DD&A was not informed prior to initiation of this work and no surveys were performed.

- Exclusion fencing was damaged during May 6, 2021 weed removal activities (see Photo 1). In addition, a portion of silt fence near the northeast border of the site was down due to ground squirrel activity. Other sections of silt fence, originally documented as damaged during the April 9, 2021 site inspection due to earlier weed management activities have yet to yet to be repaired. Per **Mitigation Measure 4.6-1c**, any needed repairs to the fence shall be performed on the day of their discovery.

Photo 1. Mechanical weeding activities inside and outside of exclusion fence. Exclusion fence has been damaged by weed removal activities.

- Work shall remain within approved work boundary.
- A qualified biologist shall survey for special status species prior to any proposed vegetation removal or ground disturbing activities.
- Exclusion fence shall be maintained and any repairs shall be performed on the day of their discovery.
- Replacement of monofilament wattle with amphibian-friendly wattles or other BMPs be used on the site.
- Non-active stockpiles shall be covered with plastic or a comparable material to prevent establishment of invasive species.
- An environmental inspector shall inspect equipment during weed management activities to prevent spread of invasive weeds (see **Mitigation Measure 4.6-1p (4)**).

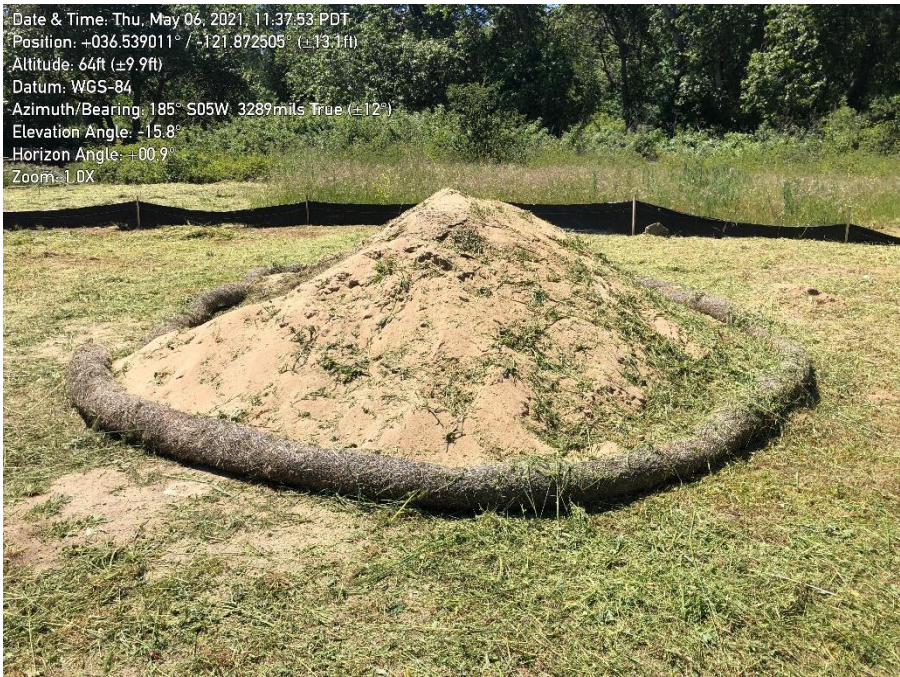
- Monofilament straw wattle is installed around a non-active stockpile on the site (see Photo 2). Per **Mitigation Measure 4.6-1p (2, 6)**, only plastic-free erosion control materials should be used on site, and non-active stockpile should be covered to prevent establishment of invasive species.

Photo 2. Spoils pile on site.
