# memorandum

subject MPWSP – Carmel Valley Pump Station Project Weekly Report (5/10/2021 – 5/14/2021)

## **CalAm Weekly Report**

### Daily Monitoring Log

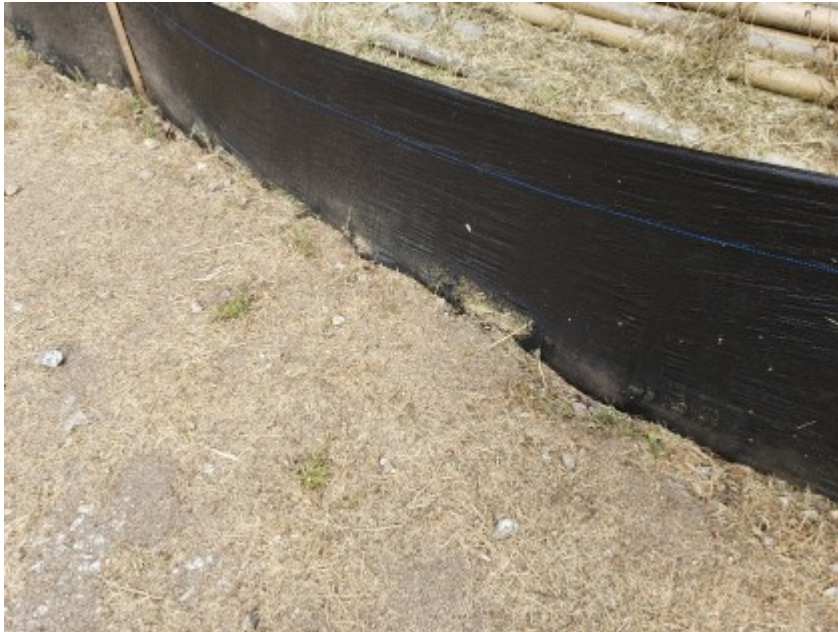
05/13/2021 - Exclusion fence to be repaired.

- DD&A compliance monitor inspected the status of exclusionary fencing and proper trash disposal in accordance with Mitigation Measure 4.6-1c.
- DD&A performed ongoing monitoring in accordance with Mitigation Measure 4.6-1a.
- Photographed project site conditions.
- Inspected exclusion fence to determine sections in need of repair. DD&A biological monitors gave direction to Project Contractor with regard to fence repair and wattle removal.

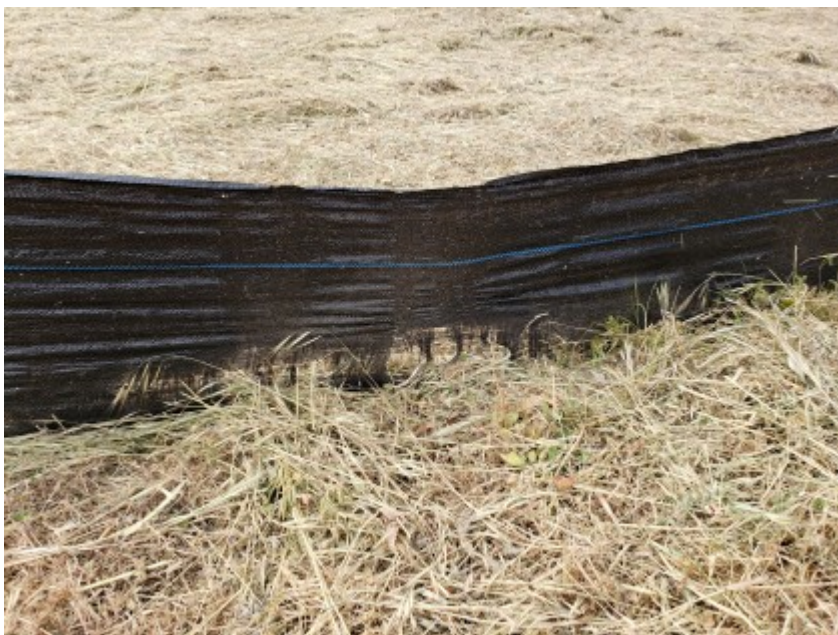
05/13/2021 - Exclusion fencing to be repaired.

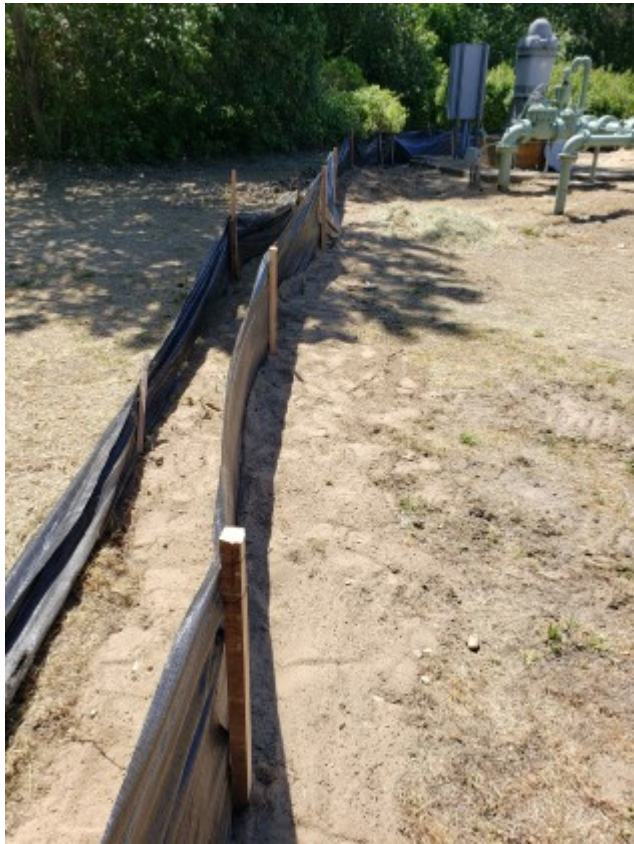
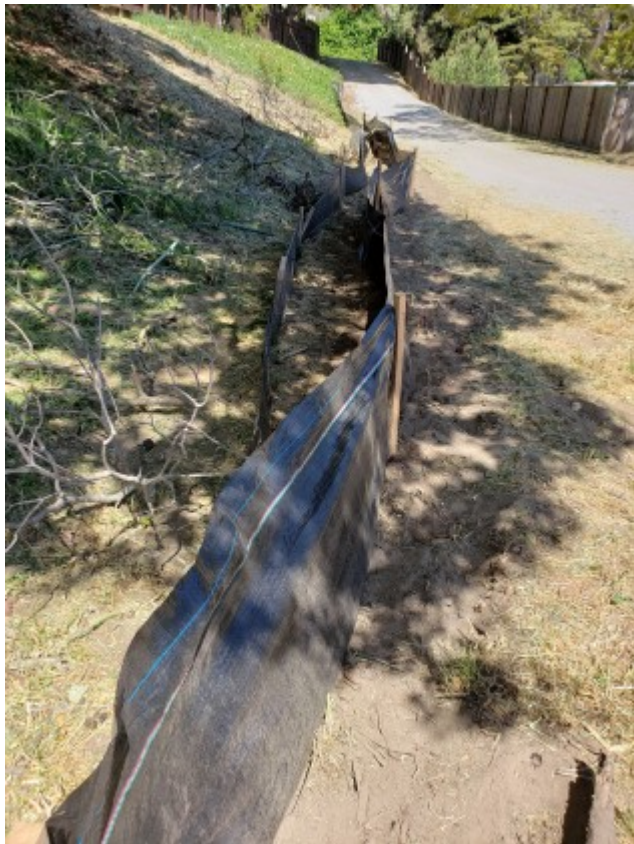
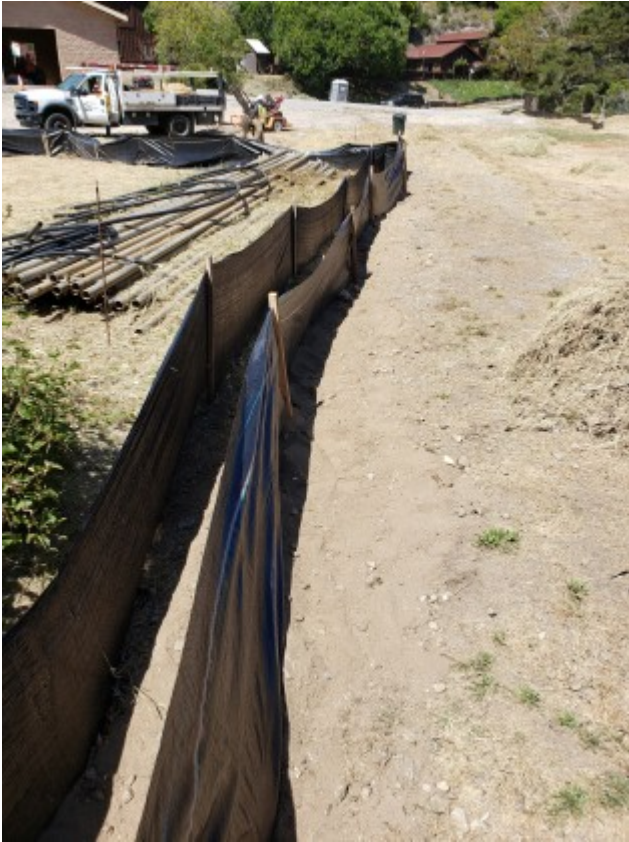
05/13/2021 - Repaired exclusion fencing.

4.6-1c. 6. Fueling of construction equipment within existing paved areas and at least 50 feet from drainages and native habitats?	Yes	
4.6-1c. 7. Introduction of exotic plant species avoided through physical or chemical removal and prevention?	Yes	Project Contractor installed new exclusion fencing materials to replace the fencing that had been damaged during vegetation removal.

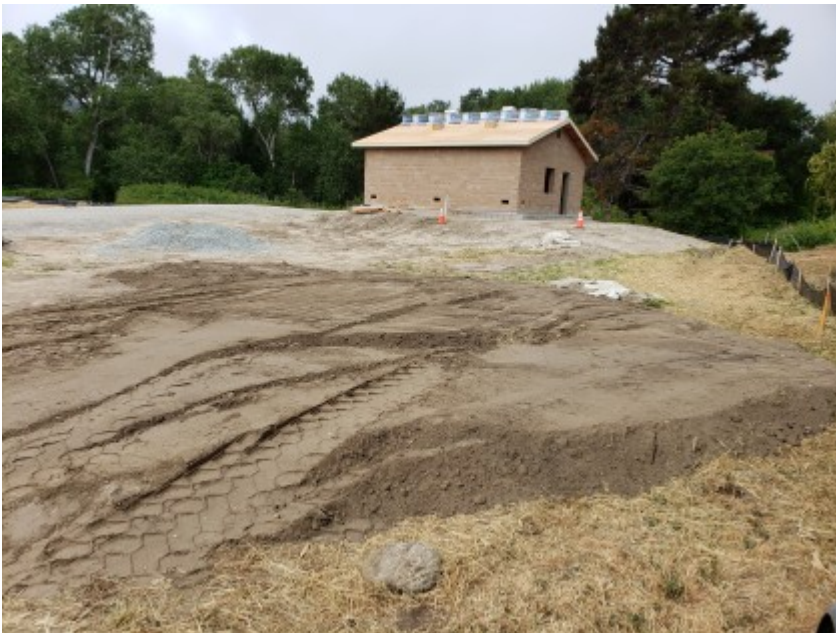
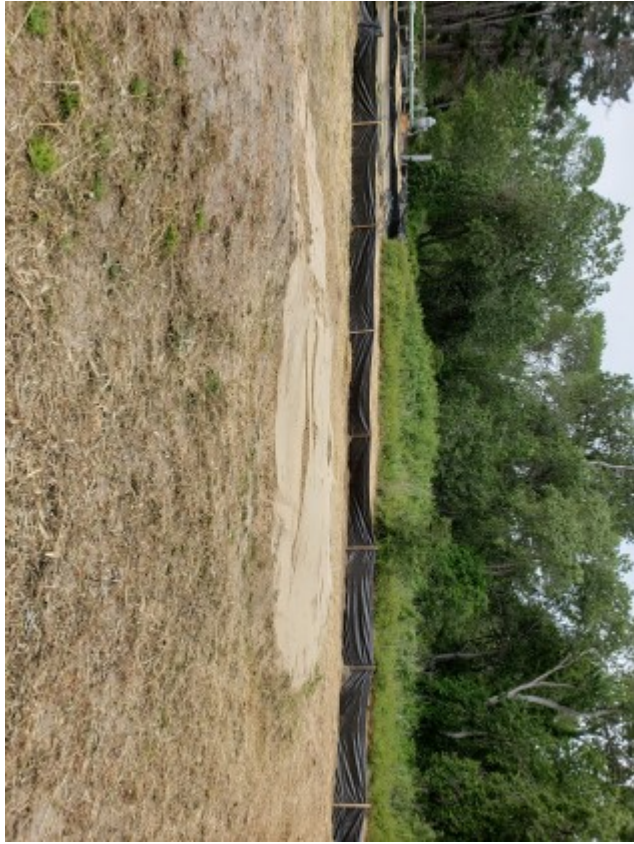
05/13/2021 - Dispersed spoils pile.

4.6-1p. 8. Only certified, weed-free, plastic-free imported erosion control materials (or rice straw in upland areas) were used for the project?	Yes	All plastic monofilament wattles have been removed by the Project Contractor. Spoils piles have been dispersed throughout the project site.

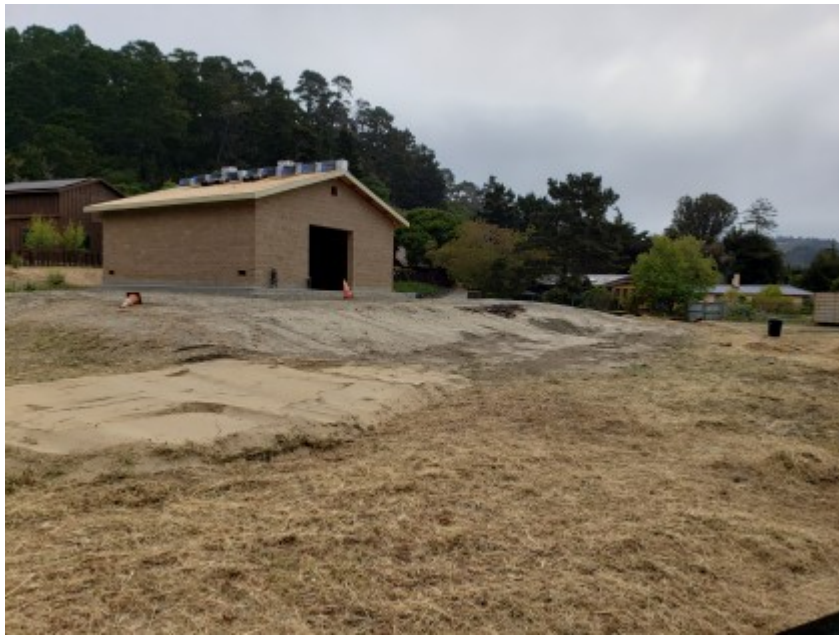
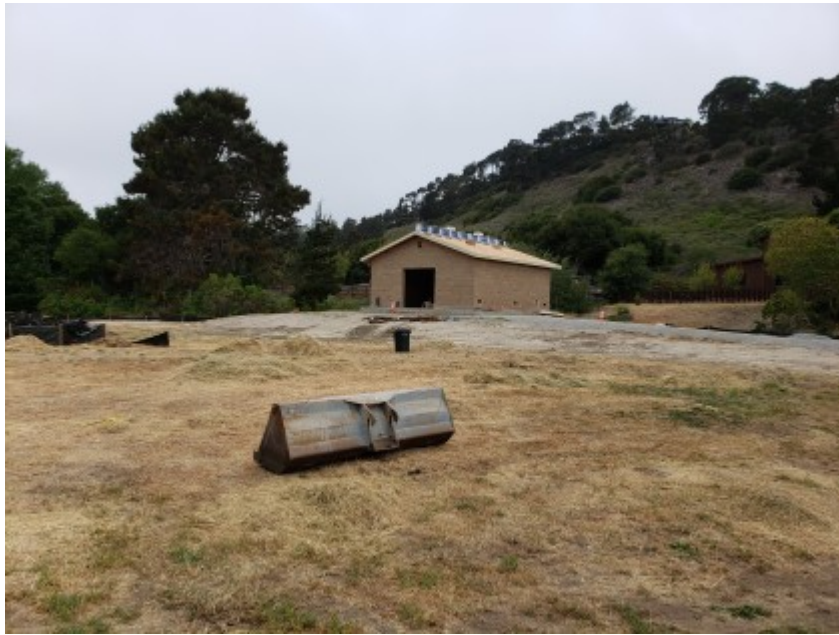
05/13/2021 - Site conditions.

05/13/2021 - Site conditions

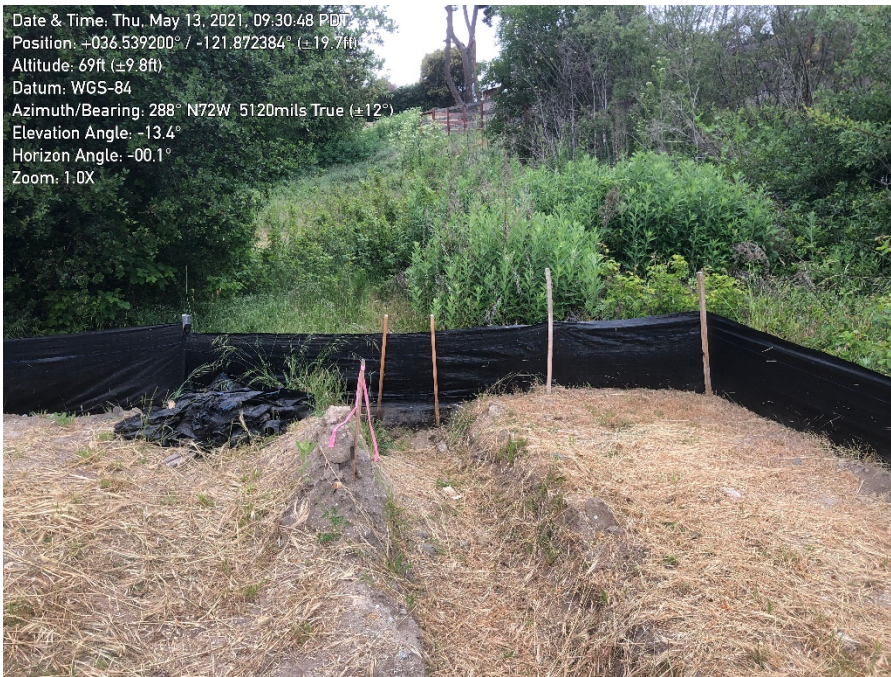
- On 4/09/2021, ESA noted that straw wattle encased in monofilament netting is installed on the site, primarily around stock piles. Per **Mitigation Measure 4.6-1p**, “Only certified, weed-free, plastic-free imported erosion control materials (or rice straw in upland areas) shall be used for the project.” ESA observed that all monofilament wattles had been removed and stockpiles had been dispersed during the 5/14/2021 site visit.

Photo 1. All monofilament straw wattle has been removed from site.

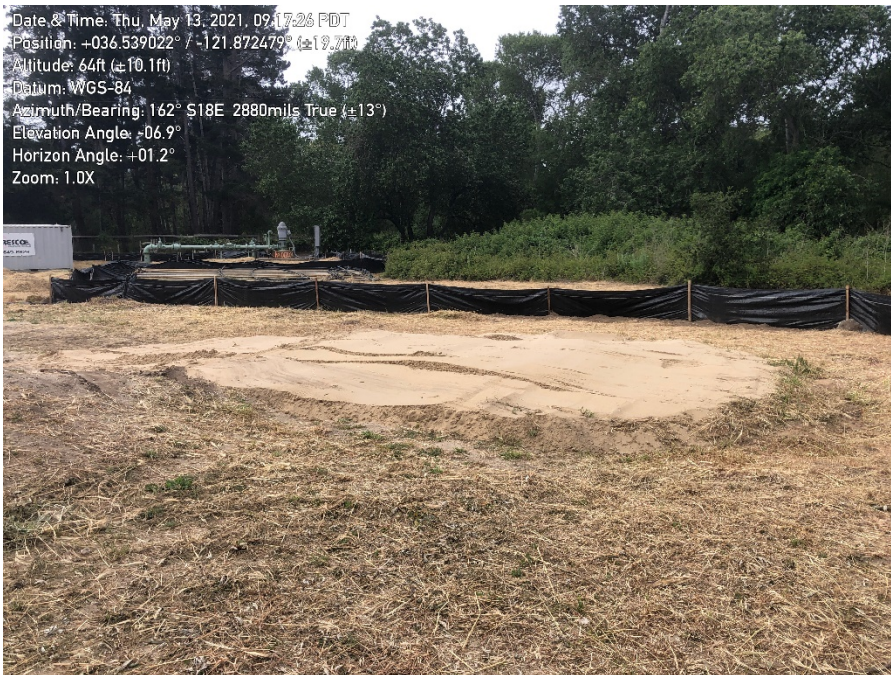
Photo 2. Former location of spoils pile.

- CalAm monitor onsite to conduct weekly site inspection.
- Stock piled soil piles have been graded.
- Pipes in work area were capped as required by Mitigation Measure 4.6-1o.
- No leaking equipment or hazardous materials storage issues observed.
- No evidence of sensitive species.
- ESA observed that the following compliance issues have been resolved:
  - All wattle with plastic monofilament installed within the project site has been removed.
  - New silt fence has been installed where previous vegetation management activities damaged silt fence.

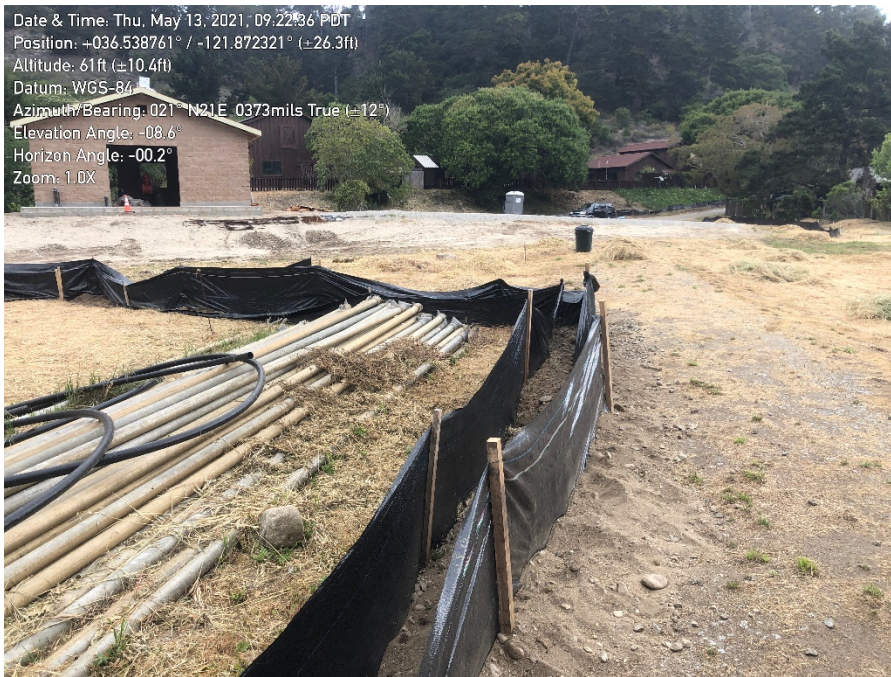
- On 5/06/2021, ESA noted that exclusion fencing had been damaged during weed removal activities. In addition, a portion of silt fence near the northeast border of the site was down due to ground squirrel activity. Other sections of silt fence, originally documented as damaged during the April 9, 2021 site inspection due to earlier weed management activities had yet to yet to be repaired. Per **Mitigation Measure 4.6-1c**, any needed repairs to the fence shall be performed on the day of their discovery. An Incident Report was prepared by ESA and was included in the weekly report for 5/03/2021 – 5/07/2021. During the 5/13/2021 site visit, ESA observed that new silt fence had been installed in damaged areas in a manner sufficient to prevent special-status species from entering the site.

Photo 3. New silt fence installed adjacent to damaged silt fence.
