subject MPWSP – Carmel Valley Pump Station Project Weekly Report (12/13/2021 – 12/17/2021)

### CalAm Weekly Report

## Monterey Peninsula Water Supply Project (MPWSP)

### Daily Monitoring Log

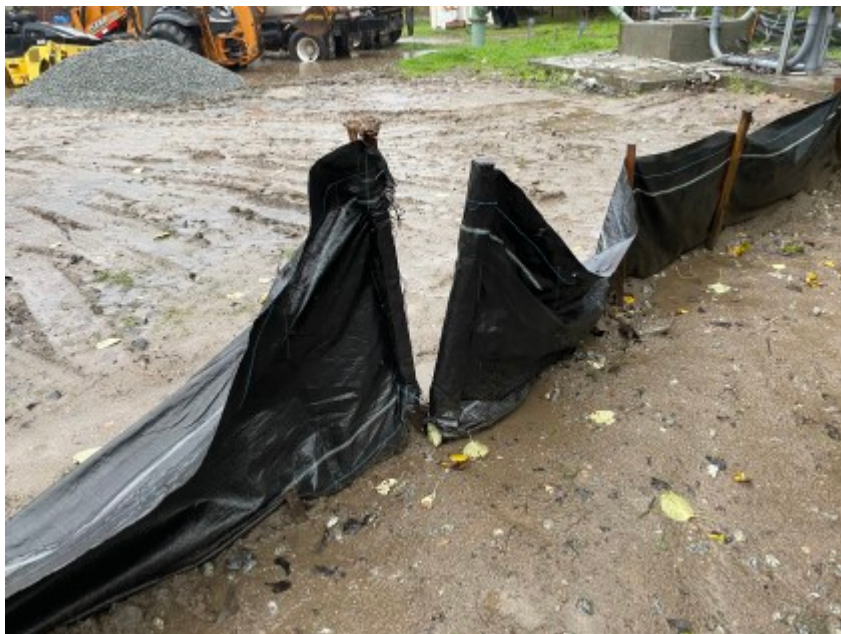
12/14/2021 - Downed silt fencing that needs to be repaired. Repaired by DD&A on 12/16/2021.

- DD&A compliance monitor inspected the status of exclusionary fencing and proper trash disposal in accordance with Mitigation Measure 4.6-1c.
- Photographed project site conditions.
- DD&A compliance monitor documented section of the exclusion fencing that required repair.

- DD&A compliance monitor inspected the status of exclusionary fencing and proper trash disposal in accordance with Mitigation Measure 4.6-1c. Repaired section of fencing that was documented on 12/14/2021
- Photographed project site conditions.
- Conducted weekly site inspection with CPUC representative.

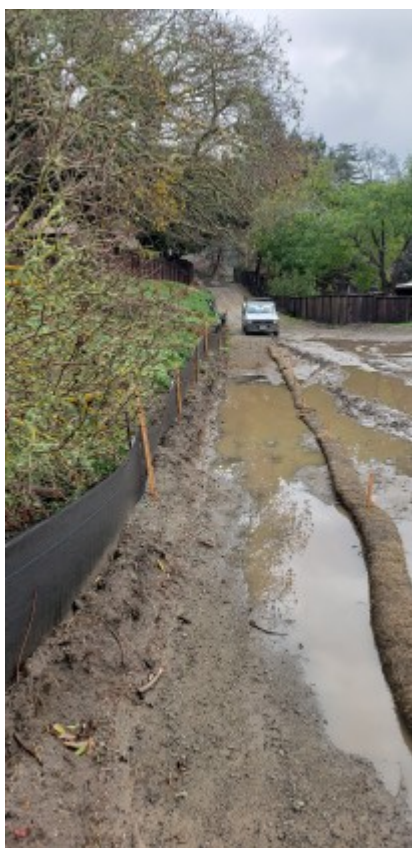
12/16/2021 - Monofilament wattles need to be replaced.

On 12/16/2021, ESA and the CalAm monitor observed that monofilament-encased straw wattle had been installed on site. This wattle should be replaced with amphibian-friendly straw wattle or other amphibian-friendly erosion control materials (**Mitigation Measure 4.6-1p**). CalAm monitors reported that the issue was discussed with MPE.

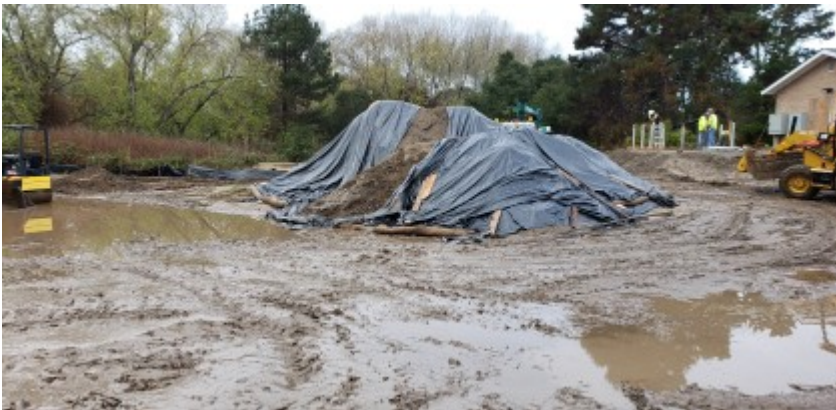
12/16/2021 - DD&amp;A recommended contractor repair spoils pile erosion control materials.

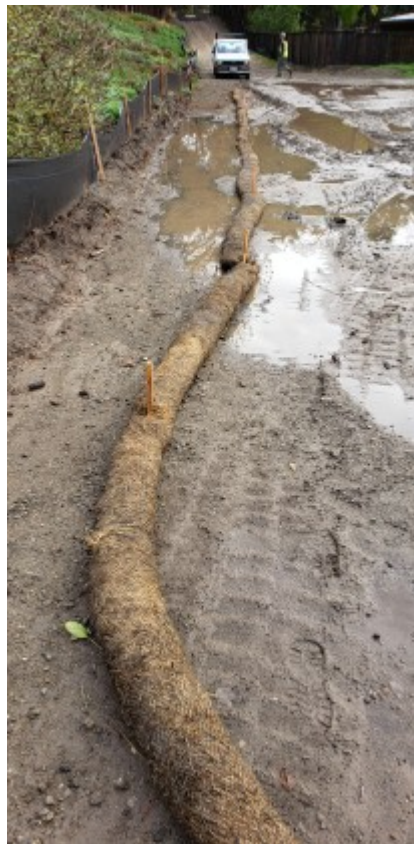
12/16/2021 - Monofilament wattles need to be replaced.

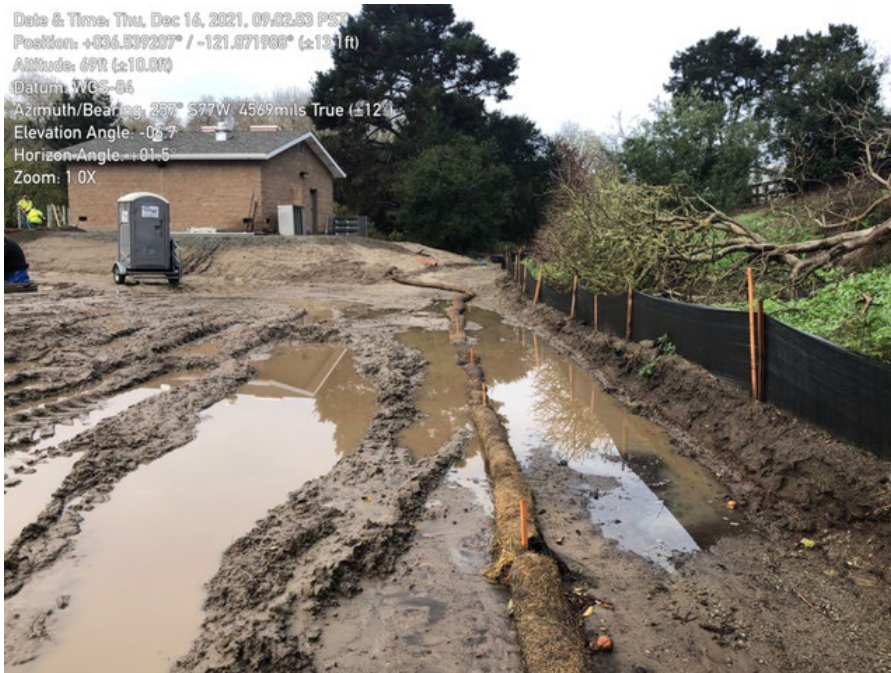
- DD&A compliance monitor on site for spot check.
- Silt exclusion fence in acceptable condition.
- Spoils stock pile is covered with Visqueen and protected with amphibian-friendly straw wattle.
- Amphibian-friendly BMPs remain installed along access road at pipeline connection point.
- No hazardous materials storage issues observed.
- No food waste issues observed.
- No special-status species observed on site.
- Water from recent rain events is ponded in the southwest portion of the site. If ponding persists water should be pumped to prevent the pond acting as a wildlife attractant.
- The following minor compliance issue was observed:
  - Monofilament lined straw wattle has been installed on site. Discussed with DD&A compliance monitor.

Photo 1. Monofilament straw wattle installed on site.

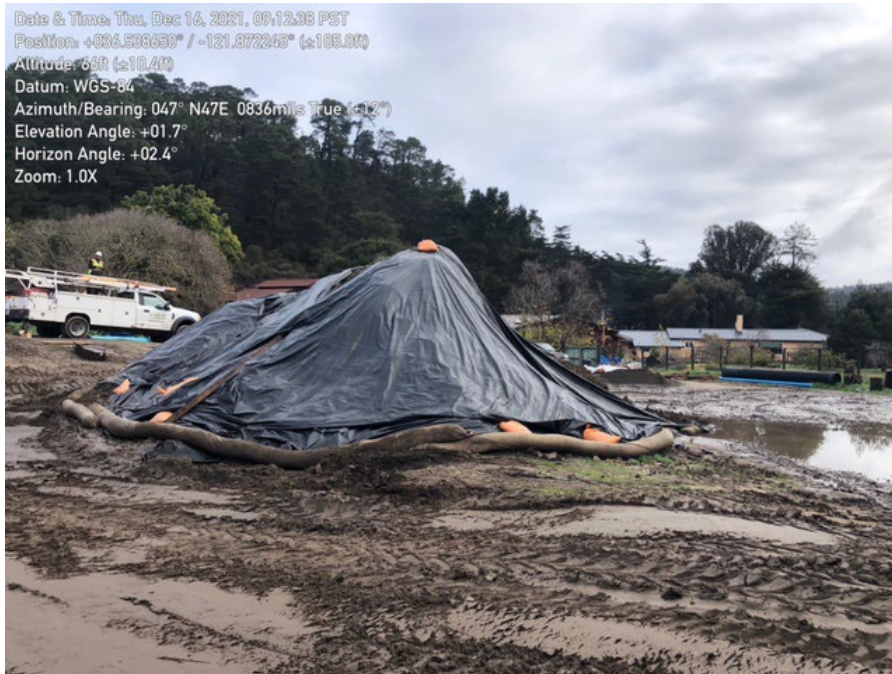
Photo 3. Spoils stockpile.

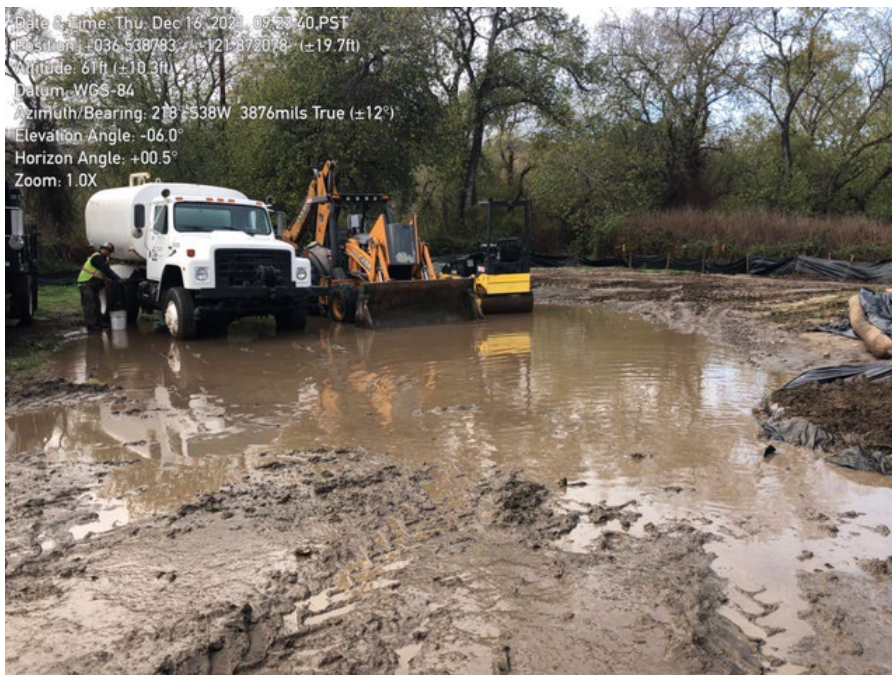
Construction activities this week were minimal due to the rain. The spoils stock pile remains covered with Visqueen material and surrounded by amphibian-friendly straw wattle (**Mitigation Measure 4.6-1**). No spills or hazardous materials were observed (**Mitigation Measure 4.6-1c. 17**). Trash was properly disposed of in a closed receptacle (**Mitigation Measure 4.6-1c.**). No special-status species were observed. CalAm monitors documented a section of silt fence that was in need of repair on 12/14/2021 and repaired the silt fence on 12/16/2021. Water from a recent rain event was observed ponded in a topographically low area on the site. No signs were observed to indicate this feature is attracting wildlife; however, ESA and the CalAm monitor discussed potential actions if ponding persists.

Photo 4. Ponding from recent rain events.
