**Jurisdictional Delineation Report for Tie-  
Line 649 Wood-to-Steel Pole Replacement  
Project**

*Prepared by:*  
**San Diego Gas & Electric (SDG&E)**  
8315 Century Park Court, CP21E  
San Diego, CA 92123  
**Contact: Ms. Tamara Spear**

**April 28, 2015**

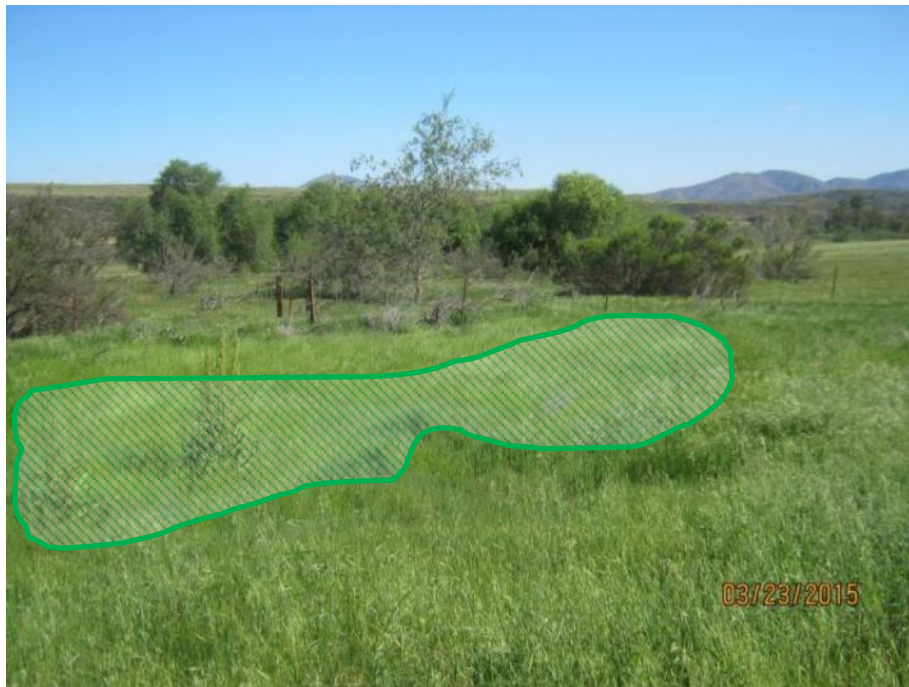
**Photograph 21:** Feature 21 is an un-vegetated ephemeral drainage located in between Location 57 and Location 58. Project activity includes vehicular access through the drainage as it crosses the road. Photograph taken facing north.

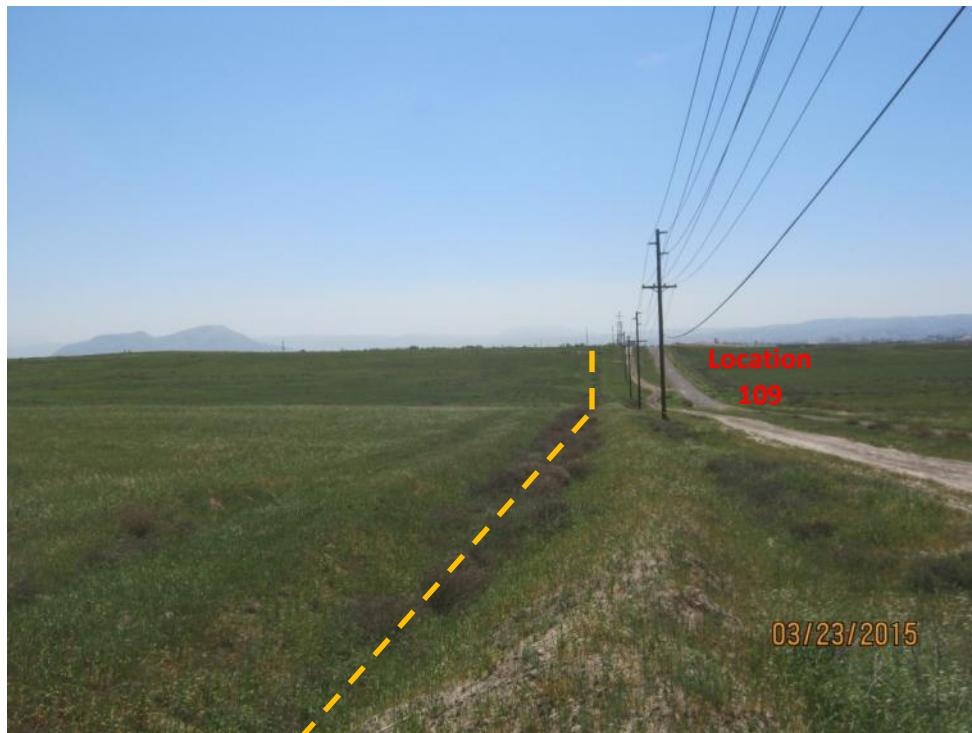
**Photograph 31:** Feature 31 is an ephemeral drainage with CDFW riparian scrub habitat located west of Location 100. Project activity includes vehicular access through the drainage as it crosses the road. Photograph taken facing southwest.

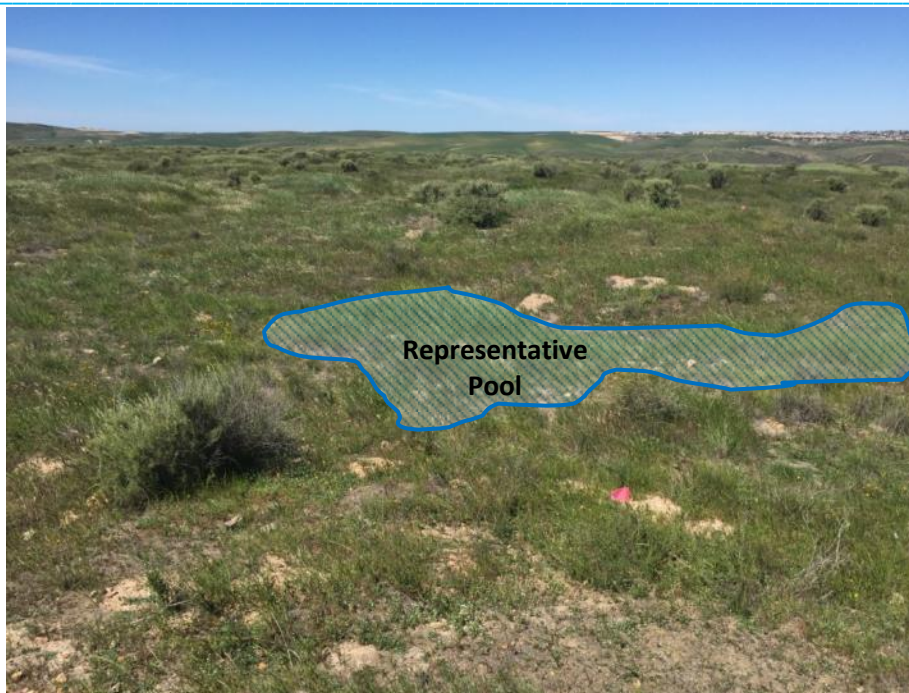
**Photograph 66:** Vernal pool 51 is located on a utility access road approximately 75 feet south of Location 95. Photograph taken facing south.
