# **JURISDICTIONAL DELINEATION REPORT RIVERSIDE TRANSMISSION RELIABILITY PROJECT**

**June 2017**

ICF. 2017. *Jurisdictional Delineation Report, Riverside Transmission Reliability Project*. June. (ICF 00286.17) Corona, CA. Prepared for Southern California Edison, Irwindale, CA.

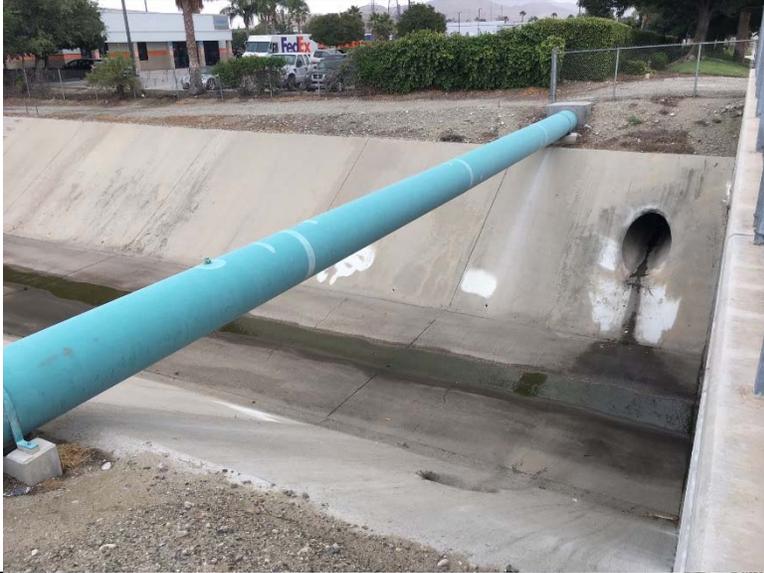
Photo ID: 0001  
Feature ID: 0001  
Photo Date: 5/10/2017  
Direction: East  
Description: Intermittent concrete-lined channel.

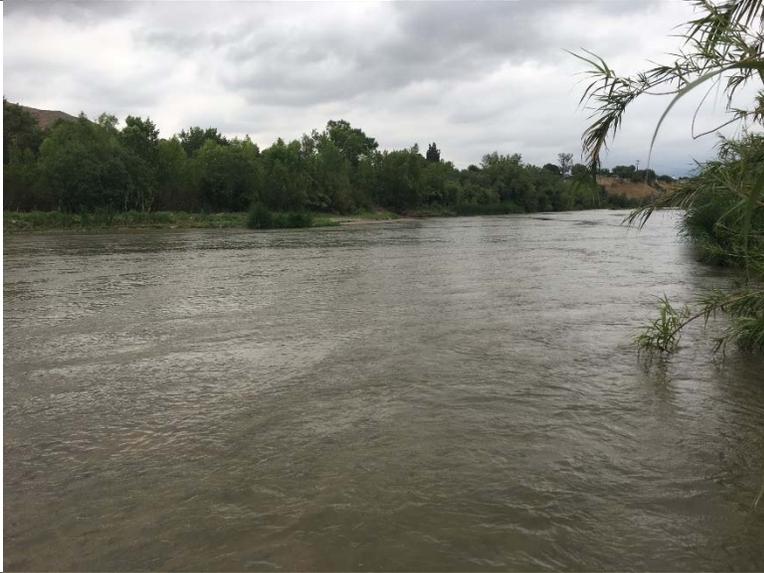
Photo ID: 0002  
Feature ID: 0002  
Photo Date: 5/10/2017  
Direction: South  
Description: View of open water portion of the Santa Ana River. Vegetation in the vicinity comprised of southern willow scrub and freshwater marsh.

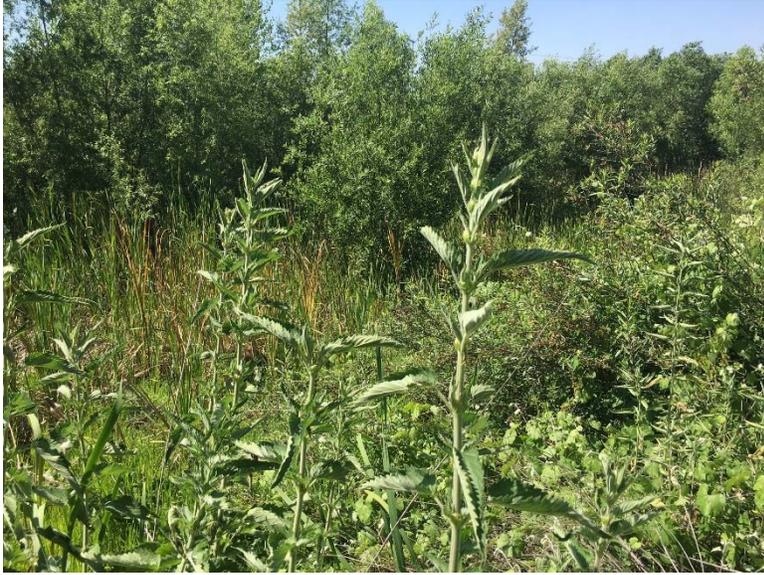
Photo ID: 0003  
Feature ID: 0002  
Photo Date: 5/11/2017  
Direction: North  
Description: Perennial stream surrounded by freshwater marsh, within the OHWM of the Santa Ana River.

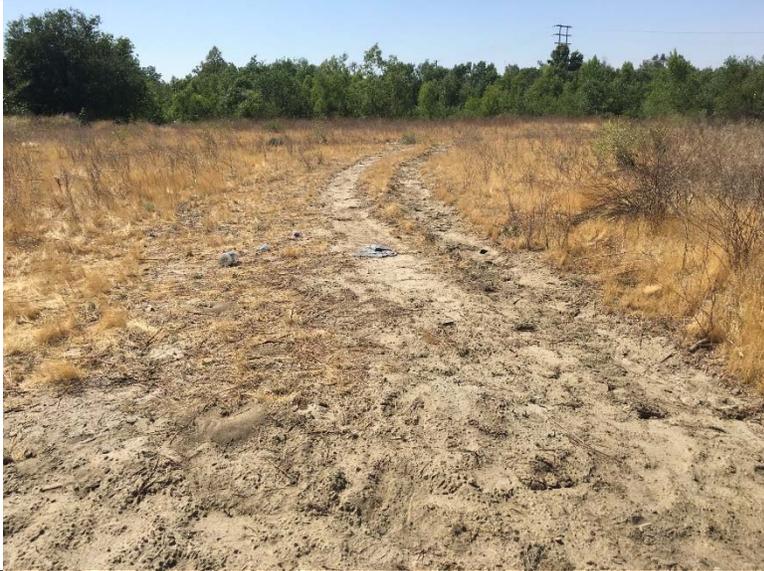
Photo ID: 0004  
Feature ID: 0002  
Photo Date: 5/11/2017  
Direction: East  
Description: View of the floodplain of the Santa Ana River. Soils are primarily sandy and vegetated with nonnative grasses, but also intermixed with southern willow scrub.

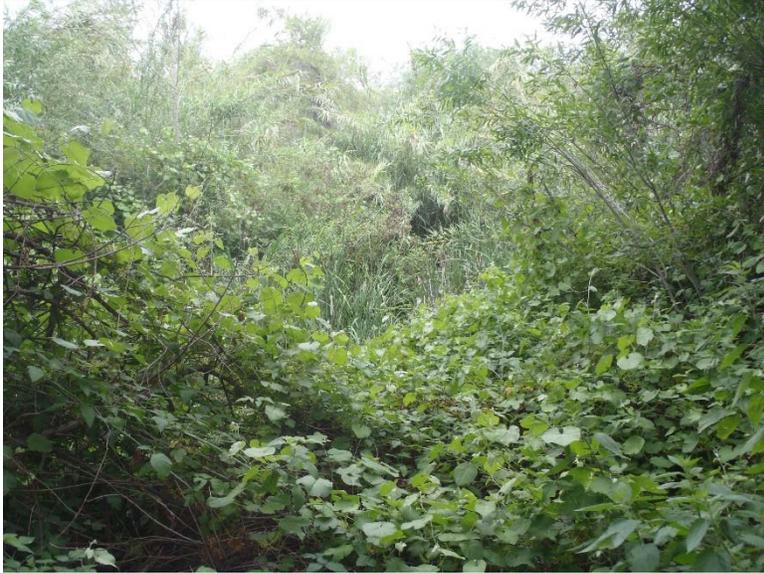
Photo ID: 0005

Description: Wetland area within drainage of the Santa Ana River floodplain. Dominated by hydrophytic vegetation, including southern cattail (*Typha domingensis*, OBL), wild grape (*Vitis girdiana*, FAC), black willow (*Salix goodingii*, FACW), and giant reed (*Arundo donax*, FACW). Drainage inundated during site visit.

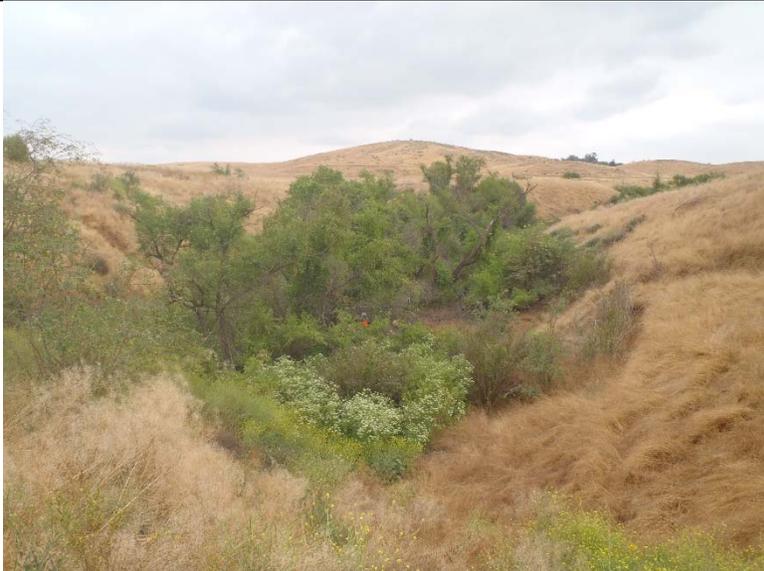
Photo ID: 0006

Description: View of ephemeral drainage and riparian woodland.

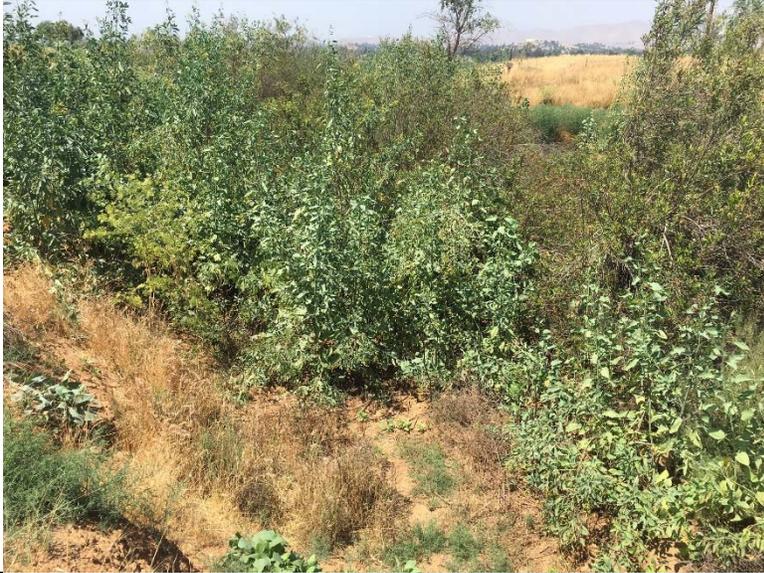
Photo ID: 0007  
Feature ID: 0004  
Photo Date: 5/11/2017  
Direction: North  
Description: Ephemeral stream surrounded by southern willow scrub.

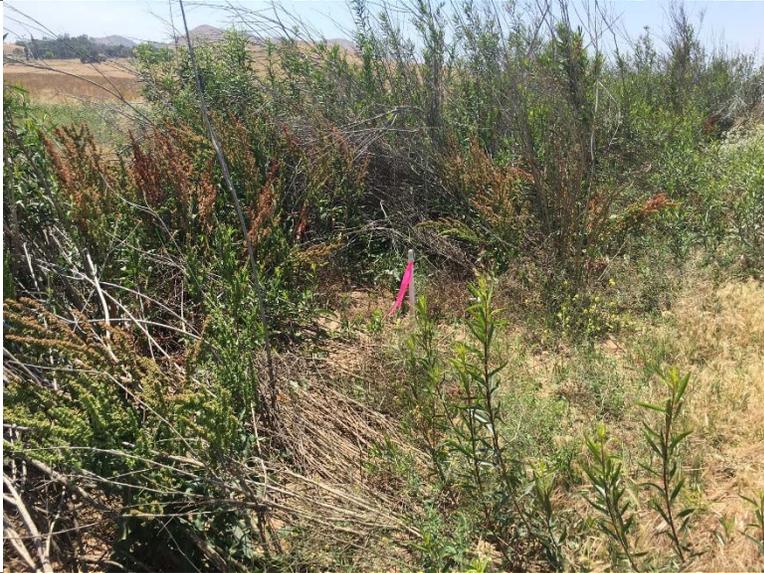
There is one area within the JD study area comprised of an isolated seasonal wet depression (Feature 0005). This depressional area formed from old road ruts and is located near the center of the east-west segment of the JD study area just south of the Santa Ana River Trail. The location had hydrophytic vegetation indicators and wetland hydrology present (Attachment 3; SP-3). Wet and dry, cracked soils occurred, with ponded areas containing mulefat and curly dock. Hydric soils were assumed to be present due to those conditions, but sampling was not conducted to avoid potential impacts to potential habitat for listed fairy shrimp. The wetland was of low quality due to off-road vehicular disturbances on the dirt road directly adjacent to the wetland and due to the feature having formed from disturbed soils. For the purpose of water permitting, this feature is being presumed an isolated wetland.

Photo ID: 0008  
Feature ID: 0005  
Photo Date: 5/11/2017  
Direction: West  
Description: Depressional area that ponds seasonally. Soil cracks observed along with mulefat scrub vegetation.

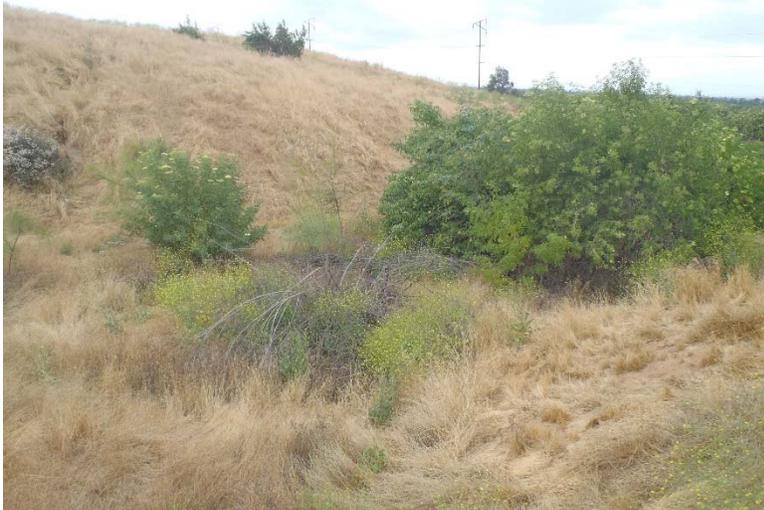
Photo ID: 0009

Description: Ephemeral stream surrounded by nonnative grasses and riparian scrub dominated by Mexican elderberry (*Sambucus nigra*, FAC).

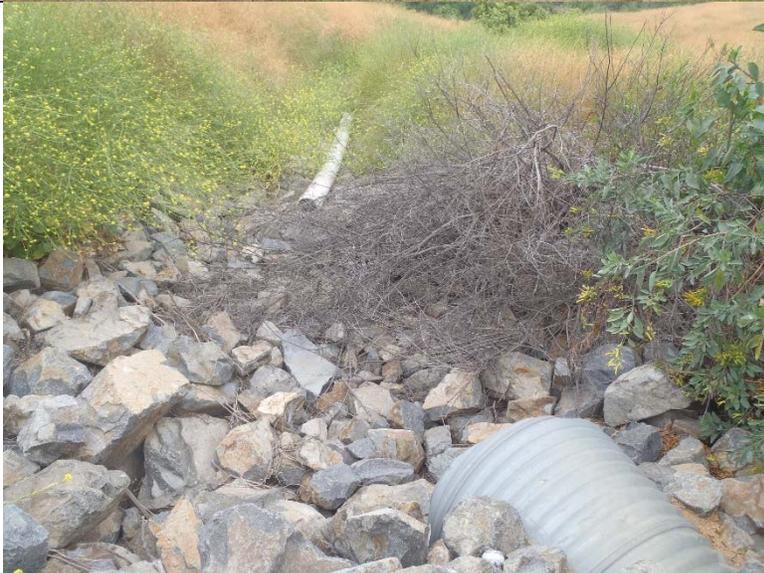
Photo ID: 0010

Description: Ephemeral drainage surrounded by nonnative vegetation, including black mustard (NL), summer mustard (NL), tree tobacco (FAC), and black elderberry (FAC).

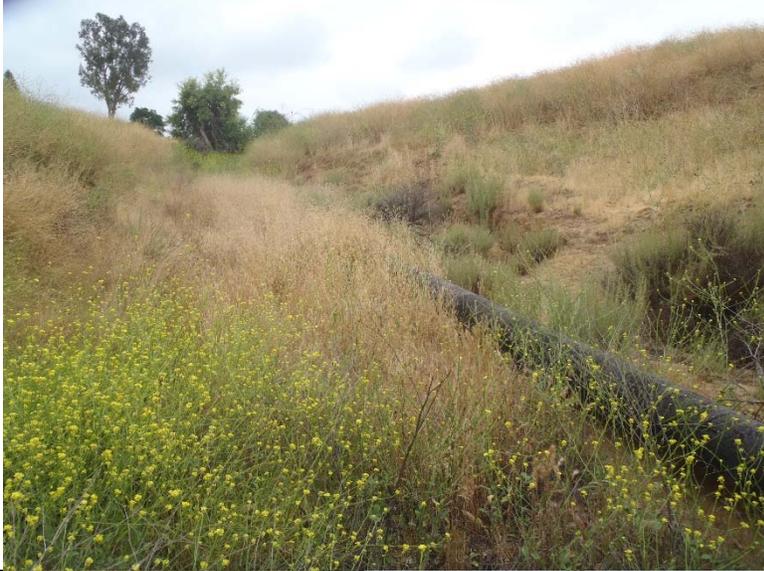
Photo ID: 0011  
Feature ID: Non-jurisdictional  
Photo Date: 5/10/2017  
Direction: North  
Description: Black pipe appears to convey the ephemeral flows from Feature 0009 to the Santa Ana River. No OHWM indicators or TOB was observed.

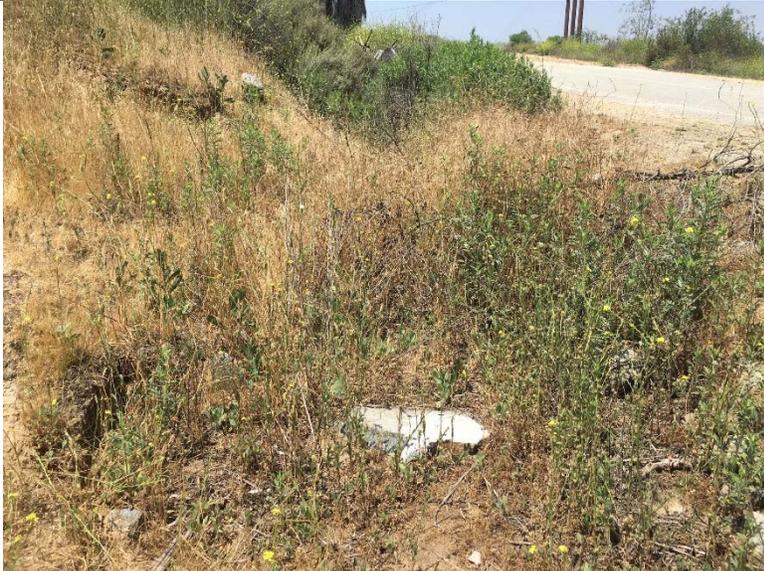
Photo ID: 0012  
Feature ID: 0010  
Photo Date: 5/11/2017  
Direction: West  
Description: Ephemeral armored riprap ditch, anthropogenically disturbed.

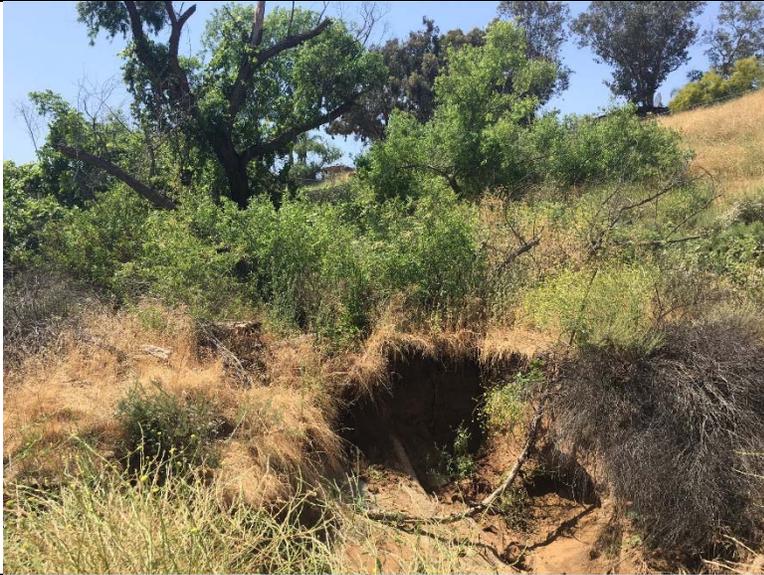
Photo ID: 0013

Description: Ephemeral stream surrounded by southern willow scrub.

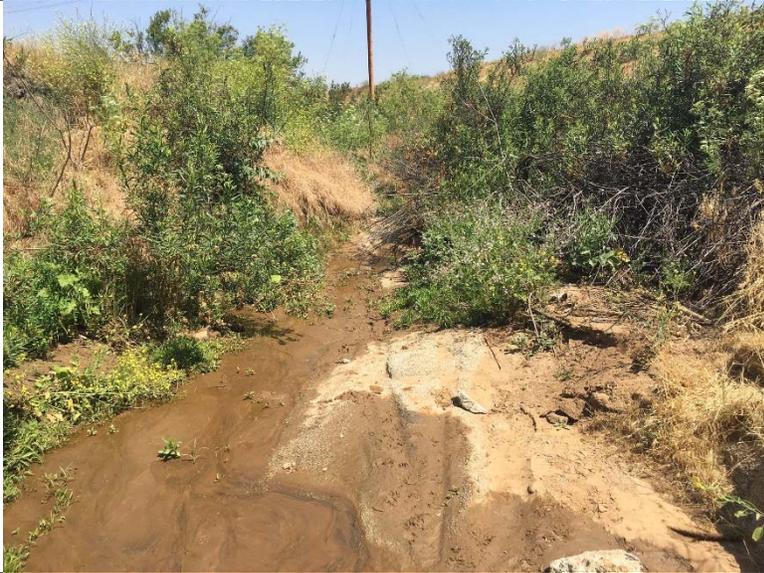
Photo ID: 0014

Description: Looking downstream at ephemeral stream surrounded by mule fat scrub.

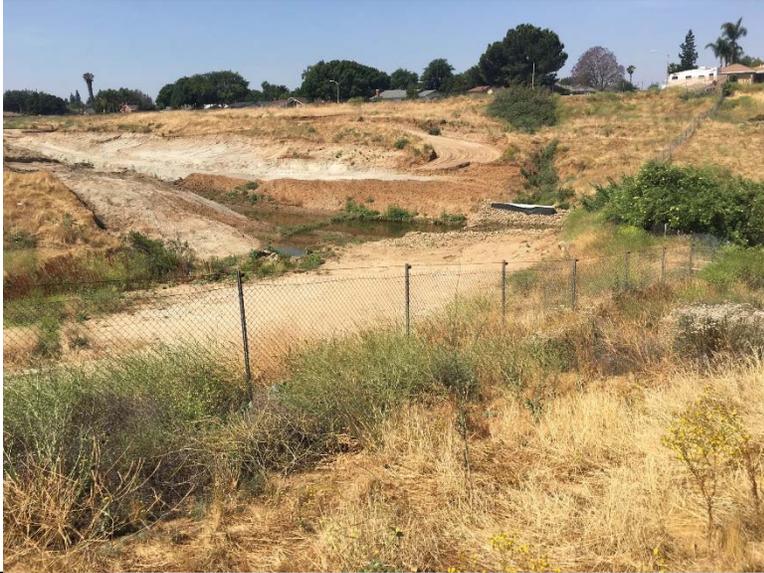
Feature 0013 is an earthen channel that has been modified by construction activities, including a portion converted to basins and the majority of the channel lacks riparian vegetation. Small amounts of mulefat (FACW), castor bean (FACU), and curly dock (*Rumex crispus*, FAC), were noted in the

Photo ID: 0015  
Feature ID: 0012 and 0013  
Photo Date: 5/11/2017  
Direction: Southwest  
Description: Looking at confluence of two ephemeral streams. Streams occur within an active construction area. The stream has been anthropogenically disturbed by construction including, the installation of water quality basins.

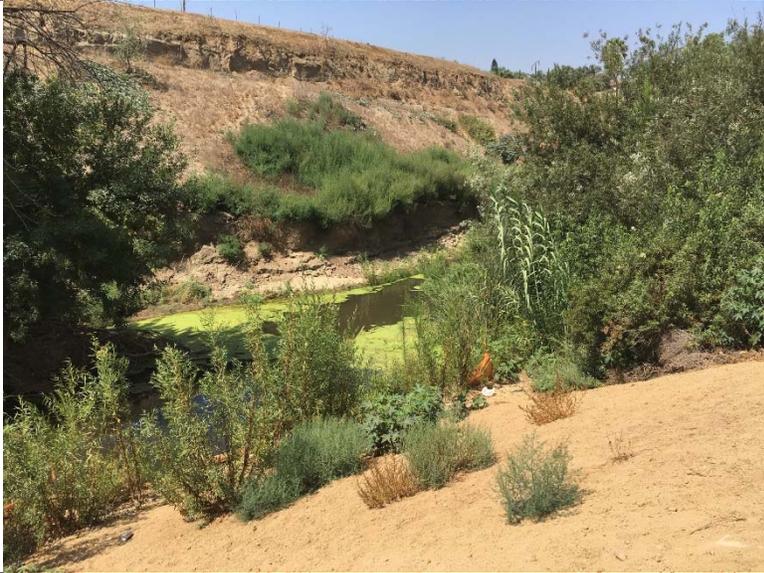
Photo ID: 0016  
Feature ID: Feature 0014  
Photo Date: August 10, 2016  
Direction: West  
Description: View of the perennial channel from TOB.

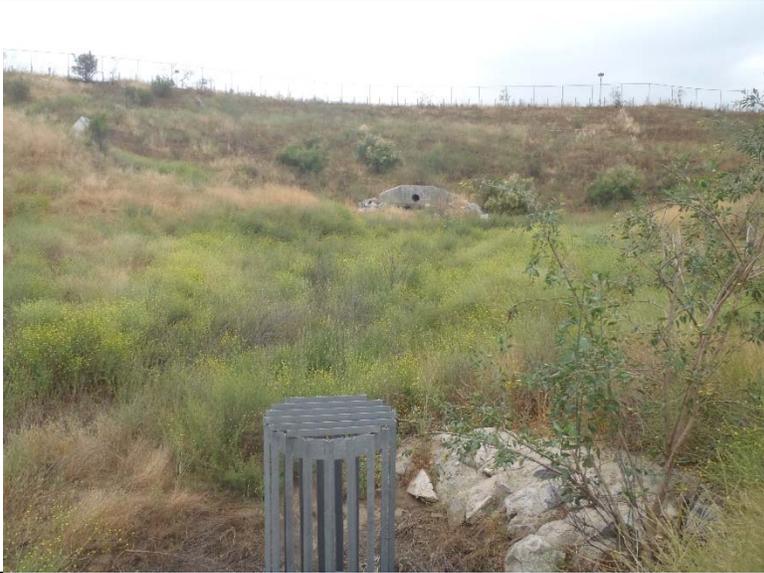
Photo ID: 0017  
Feature ID: 0015  
Photo Date: 5/10/2017  
Direction: South  
Description: Ephemeral stream surrounded by nonnative grassland. Dominated by dense black mustard (*Brassica nigra*).

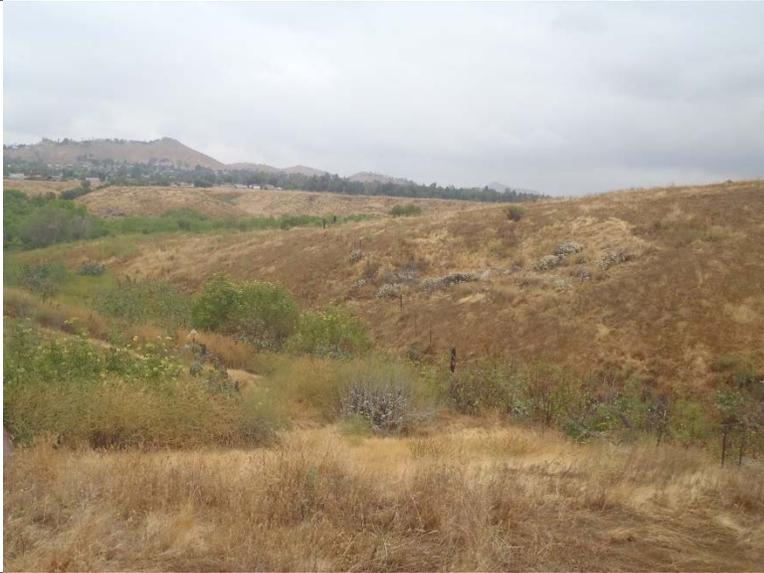
Photo ID: 0018  
Feature ID: 0016  
Photo Date: 5/10/2017  
Direction: North  
Description: Ephemeral stream surrounded by nonnative grassland. Vegetation within the channel comprised of nonnative species, including tree tobacco (*Nicotana glauca*, FAC) and castor bean (*Ricinus communis*, FACU).
