Santa Cruz Long-toed Salamander Assessment and Fencing Strategy
Santa Cruz 115 kV Reinforcement Project

Prepared for:
Pacific Gas and Electric Company

AECOM

July 2013

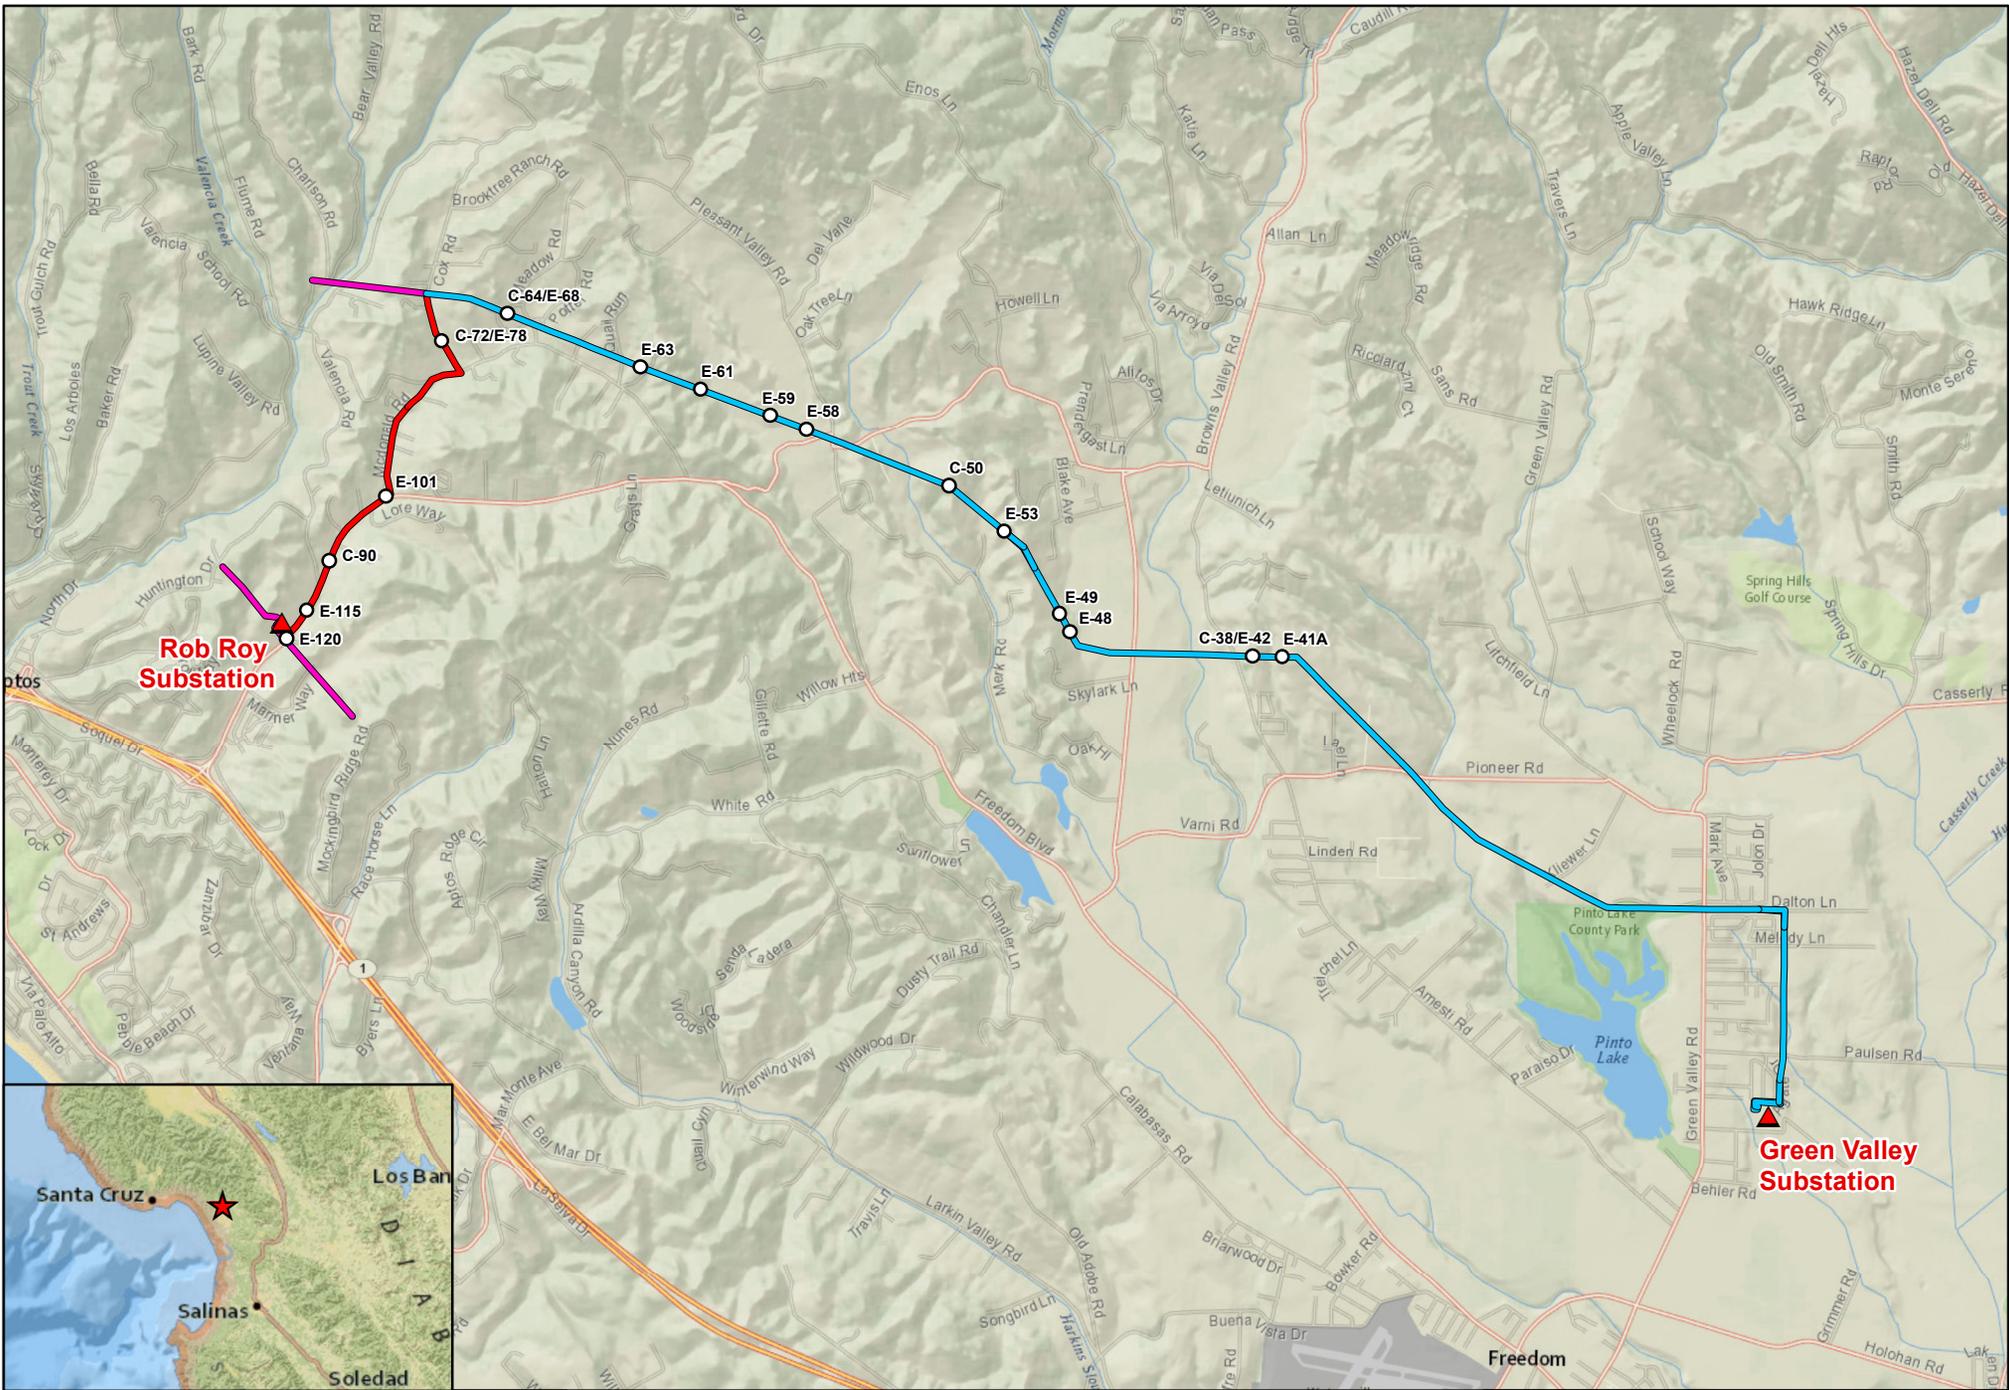
Santa Cruz 115 kV Reinforcement Project
Figure 1: Project Location Map
July 1, 2013

Project Components		▲ Substation
—	Cox-Freedom Segment	○ Select Pole Location
—	Existing 115 kV Power Line	
—	Northern Alignment

The project is located in southern Santa Cruz County, California, as shown in Figure 1. The alignment starts at Green Valley Substation, just north of Watsonville and travels northwest through Corralitos, Pleasant Valley, and Day Valley, before turning south and terminating at Rob Roy Substation, along Freedom Boulevard in Aptos. The project can be divided into two segments:

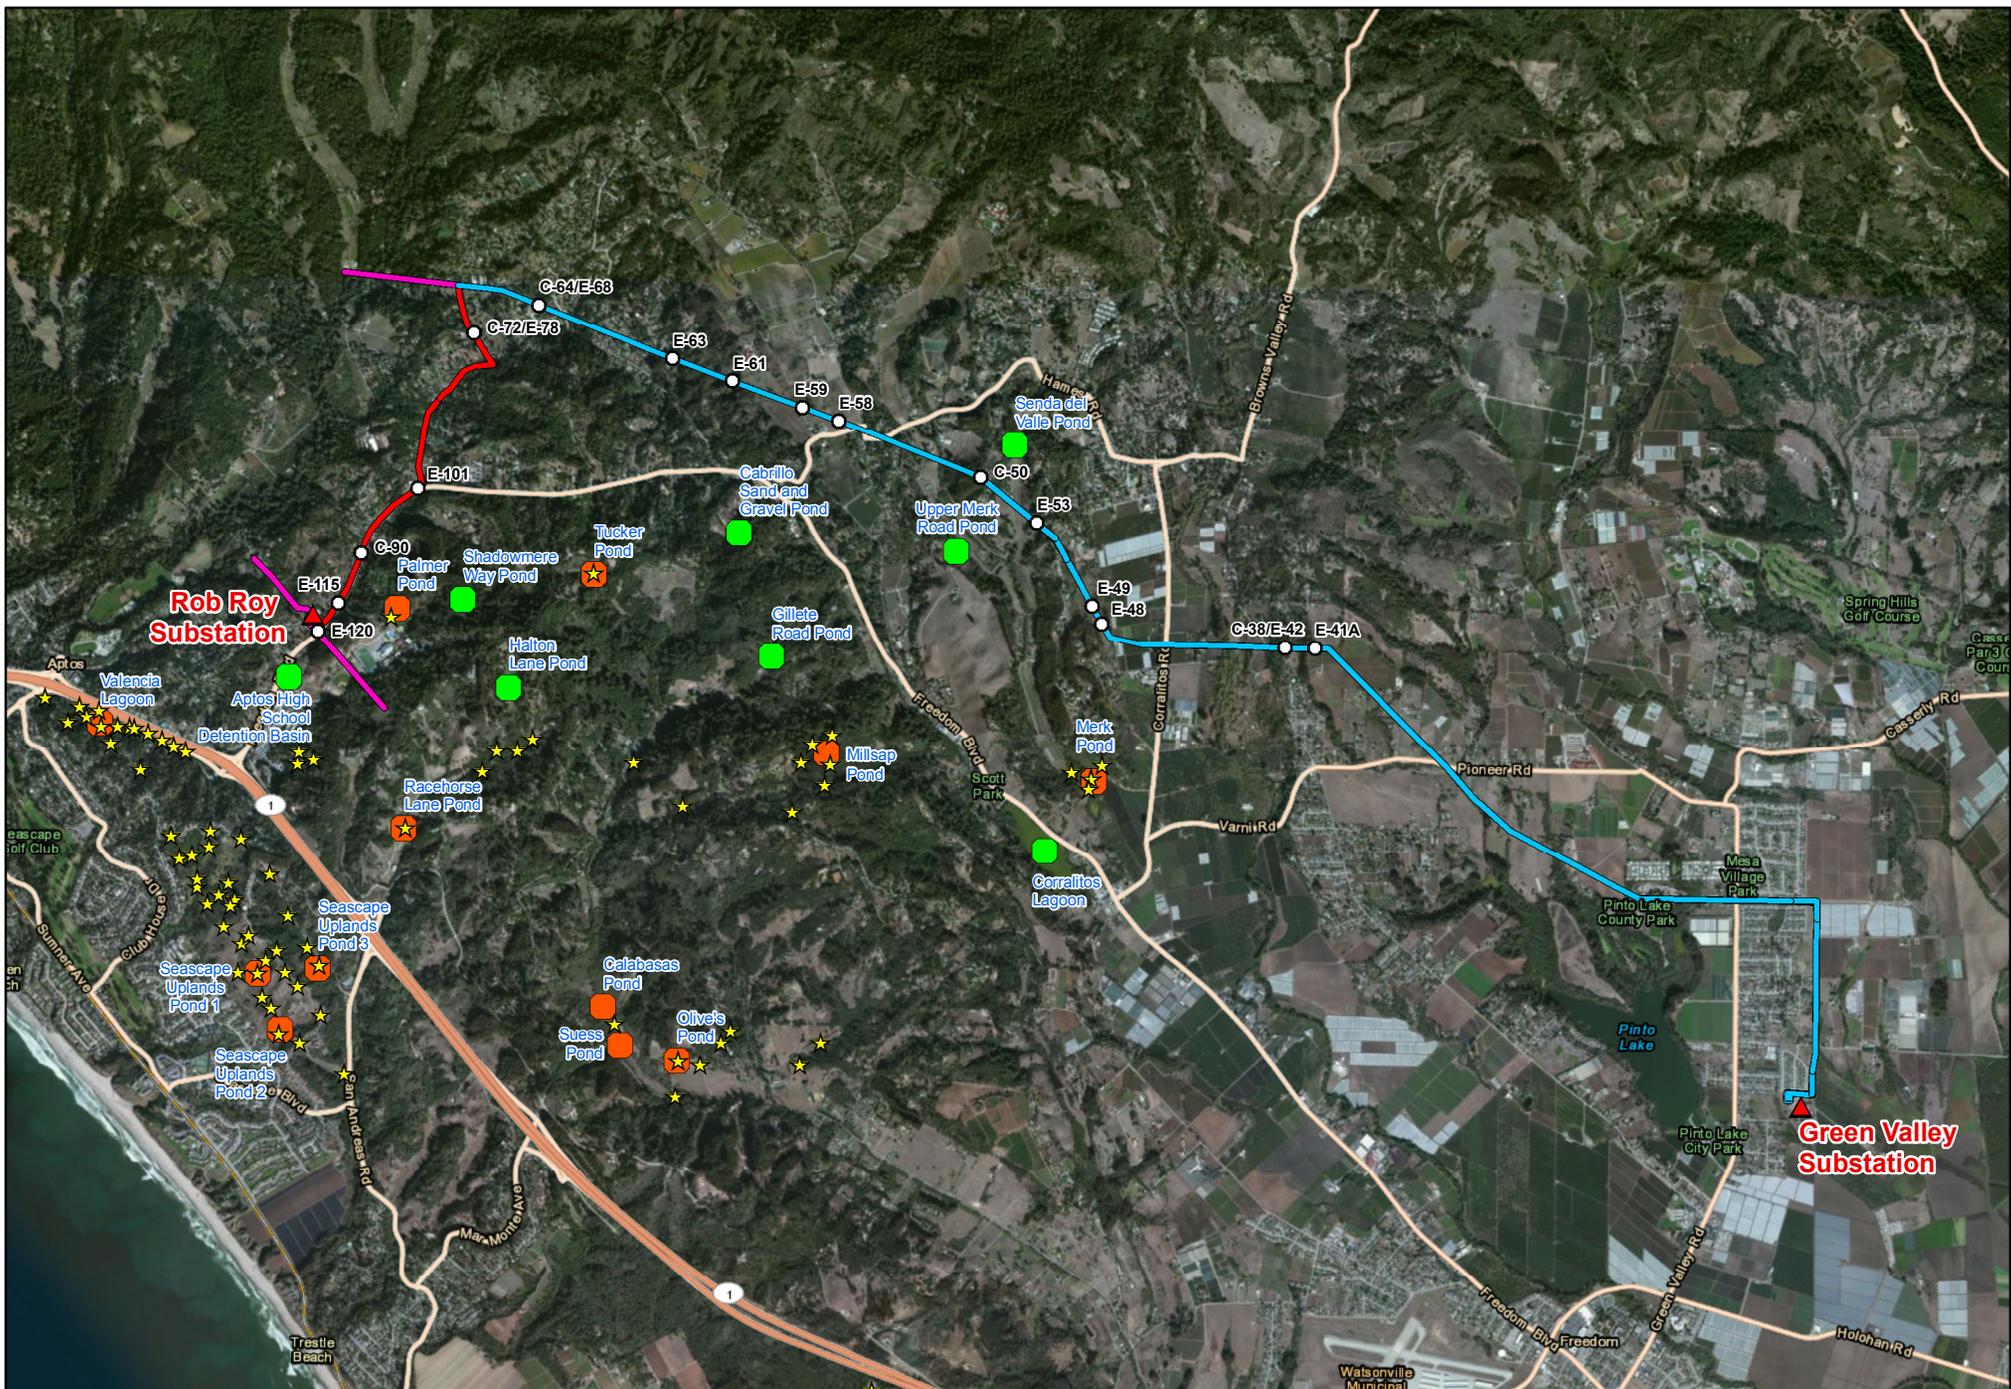
Santa Cruz 115 kV Reinforcement Project
 Figure 2: SCLTS Occurrence and Habitat Map
 July 1, 2013

Known Breeding Site

SCLTS Upland Observations

Suitable Breeding Site

All portions of the Northern Alignment west of Site E-42, as well as the northernmost portions of the Cox-Freedom Segment are located within the northern and eastern edges of the SCLTS Freedom metapopulation (USFWS 1999, 2009 in Biosearch and AECOM 2013). The Freedom metapopulation utilizes a complex of breeding sites that include Tucker Pond (0.8 mile east of the Cox-Freedom Segment), Racehorse Lane Pond (0.4 mile southeast of Rob Roy Substation), Palmer Pond (0.2 mile east of the Cox-Freedom Segment), and Merk Pond (0.5 mile southwest of the Northern Alignment). The locations of these ponds relative to the project alignment are shown in Figure 2.

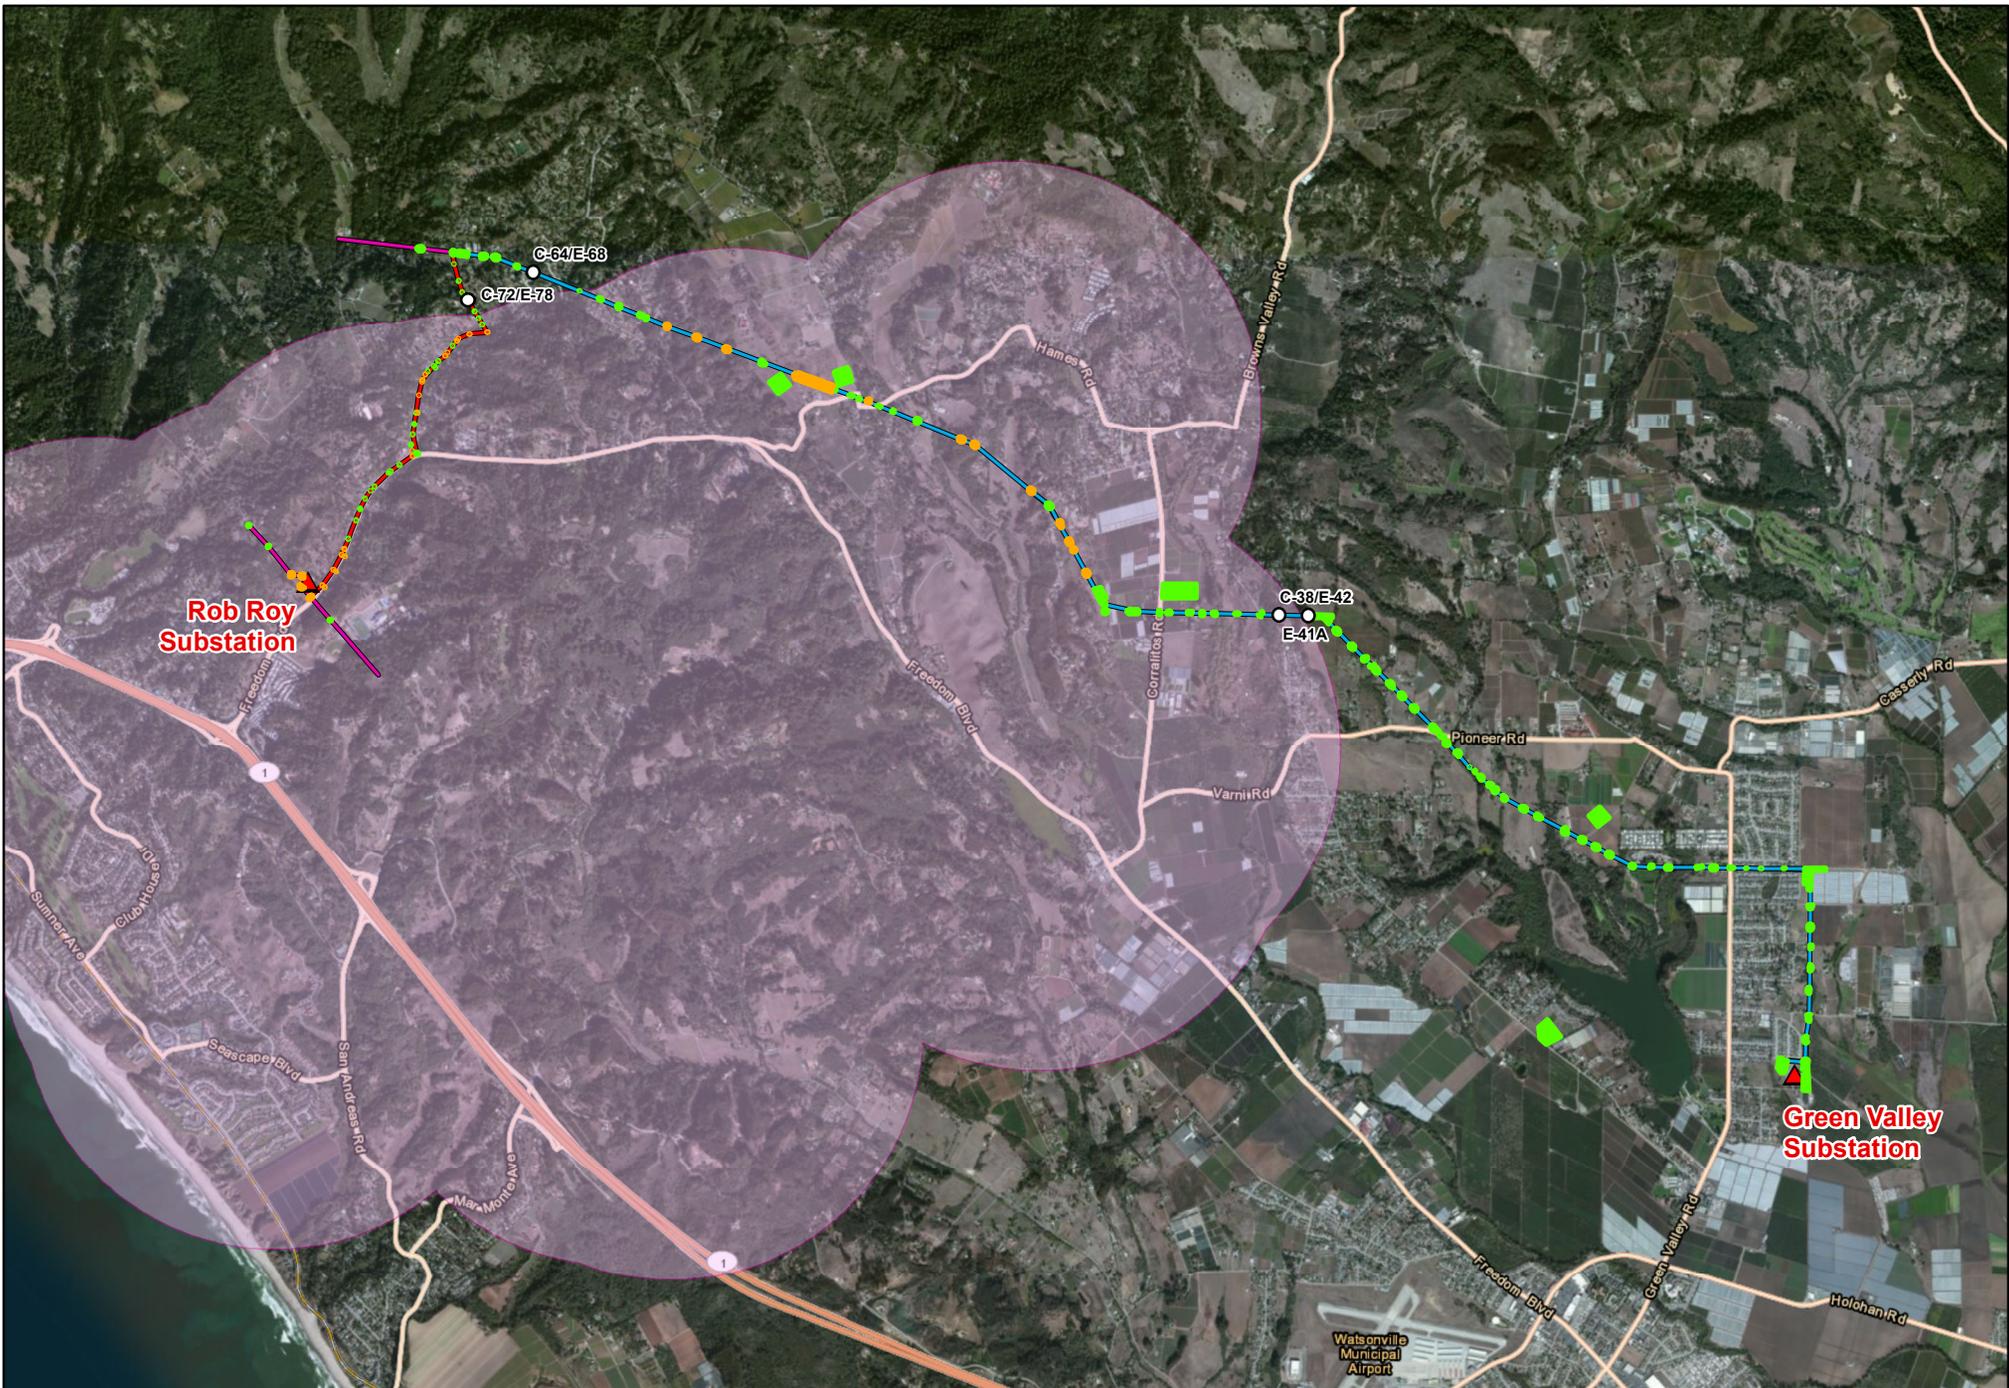
Santa Cruz 115 kV Reinforcement Project
Figure 3: SCLTS Fencing Implementation Map
July 1, 2013

- * Work area boundaries are enlarged for visual purposes of this map

- Potential Area for SCLTS Occurrence**
- 1-mile buffer around known or suitable breeding habitat
- Source: AECOM 2013
Base Image: ESRI 2013

Based on an analysis of the habitat at each project work area within 1 mile of a known or potential pond, up to 37 sites provide potential upland habitat for SCLTS, and thus could support the species during the dry season when construction will be occurring, as shown in Figure 3. As such, fencing enclosures should be installed at these sites to avoid take of SCLTS. At 10 of these 37 sites, which are mostly along the Cox-Freedom Segment, suitable SCLTS upland habitat is present at the fringes of the work area and may be avoidable, pending constructability review. Suitable upland habitat is also present along five overland access routes. Fencing will not be implemented in these locations; however, other measures may be warranted.

Based on Biosearch's data, it was also determined that 73 proposed work areas and access routes are located in dispersal habitats that lack suitable upland habitat characteristics, including grasslands, open coastal scrub, agricultural fields, landscaped yards, or areas denuded of vegetation. SCLTS have the potential to be encountered at these sites during juvenile dispersal or adult breeding migration in the wet season; however, they lack necessary upland habitat characteristics necessary for dry season refuge. As such, SCLTS would not be present during the dry season, and no fencing is necessary at these locations during dry season construction work.

The remaining 16 locations within portions of eastern Corralitos Valley were determined to be outside the range of the SCLTS due to a lack of contiguous habitats between the area and known breeding ponds. While some of these areas lie within 1 mile of Merk Pond, no dispersal corridors exist between Merk Pond and these sites to allow SCLTS to inhabit or disperse through these areas. Because these areas are at the eastern extent of the local population range, and no other source ponds are available to support SCLTS in the area, SCLTS does not occur in these locations and no fencing is warranted to avoid take.
