APPENDIX F: AESTHETIC RESOURCES SUPPORT INFORMATION

Appendix F provides supplemental information for the aesthetic resources impact assessment approach described in Section 4.2.3. The CPUC has not developed its own method for assessing visual character and quality under CEQA. The visual impact assessment follows the CEQA Guidelines and supplements the CEQA Guidelines with guidelines provided in *Visual Impact Assessment for Highway Projects*, which uses a numeric evaluation approach to assess the degree of impact (FHWA 1988). Supplemental information provided in Appendix F includes:

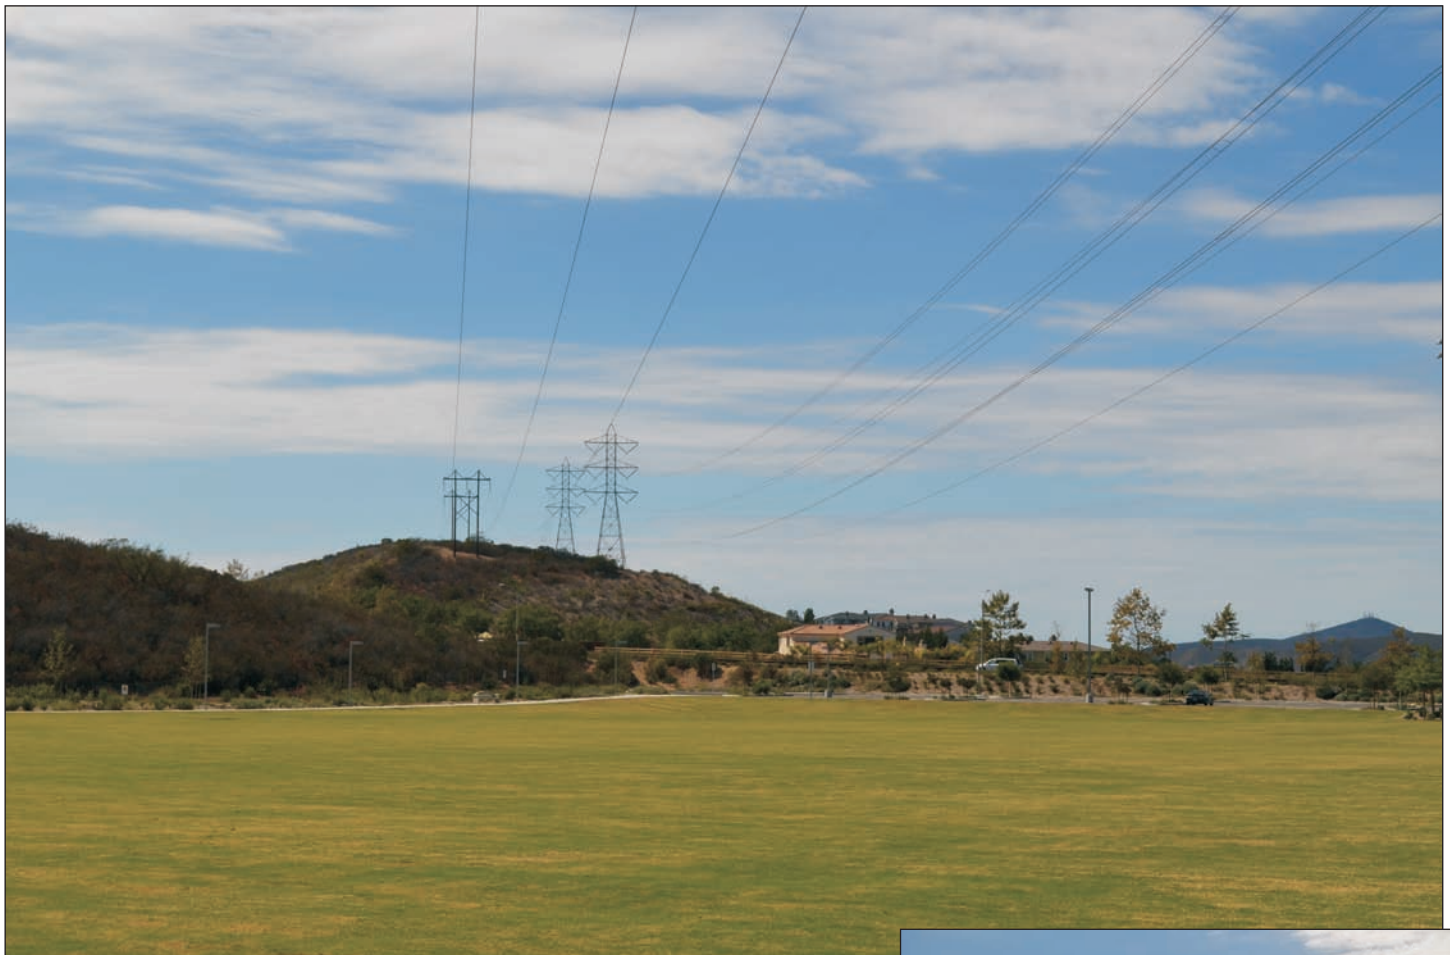
Comments: cKOP 1 is located in the SE corner of the park at a bench behind the perimeter path which could be used as an exercise circuit. 2 lit ballfields, tot lot, shorter lights on perimeter path. Park conceived and planned under TL which passes diagonally over the park. Surrounded on 2 sides by MCAS Miramar. Doppler radar in clear view from the entire park topographically superior and to the southwest. Somewhat enclosed viewshed because of topography. View corridor to Black Mountain to northwest. A few marker balls may be visible on span after the second set of tower structures. Ballfield stadium light standards are not visible in this view but they are a obvious vertical element from other vantage points.

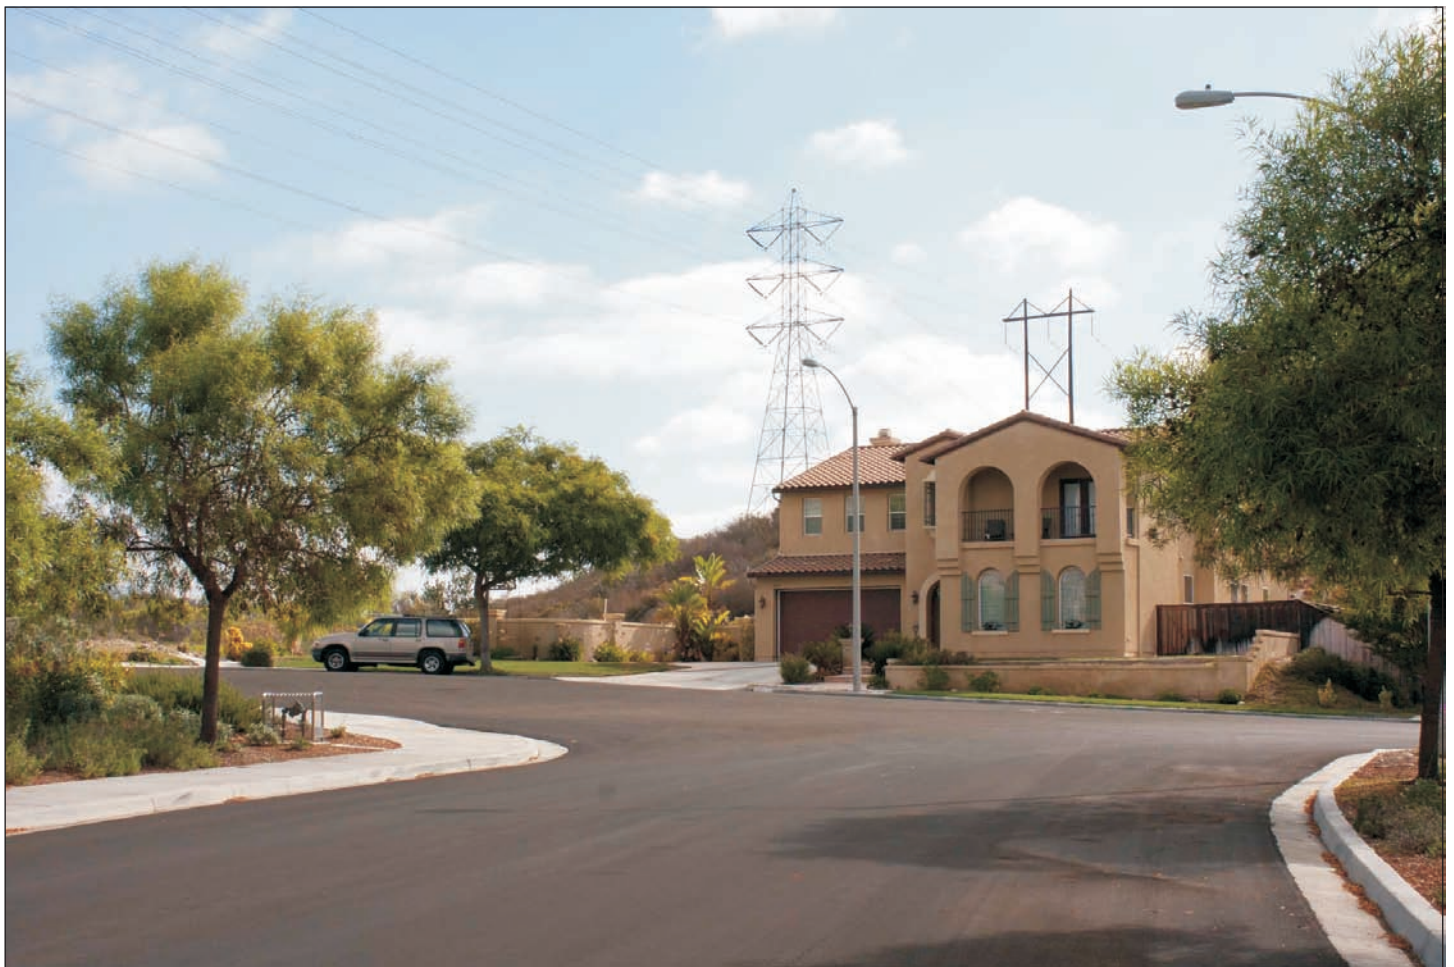
Comments: cKOP 2 is located near the end of a residential street that serves as access to P8 and R8. The view cKOP is from the PEA and will be used as is. The TL ROW predates Rancho Encantata (Stonebridge Estates) by decades. The TL ROW opportunistically uses high ground to traverse the rugged terrain that was graded extensively for the residential subdivision. The TL s topographically superior position relative to the receptors often affords views similar to this one where a single set of tower structures are visible; the rest being screened by topographic obstructions. The existing structures are skylined as would be the proposed incongruent TSP, which would be located left (north) of the existing H-frame structure shown in the baseline visual conditions presented in this view. The number of receptors is considered low because of the residential street designation and residents of this neighborhood would be the most impacted. 32°55'27.87"N 117° 3'5.72"W

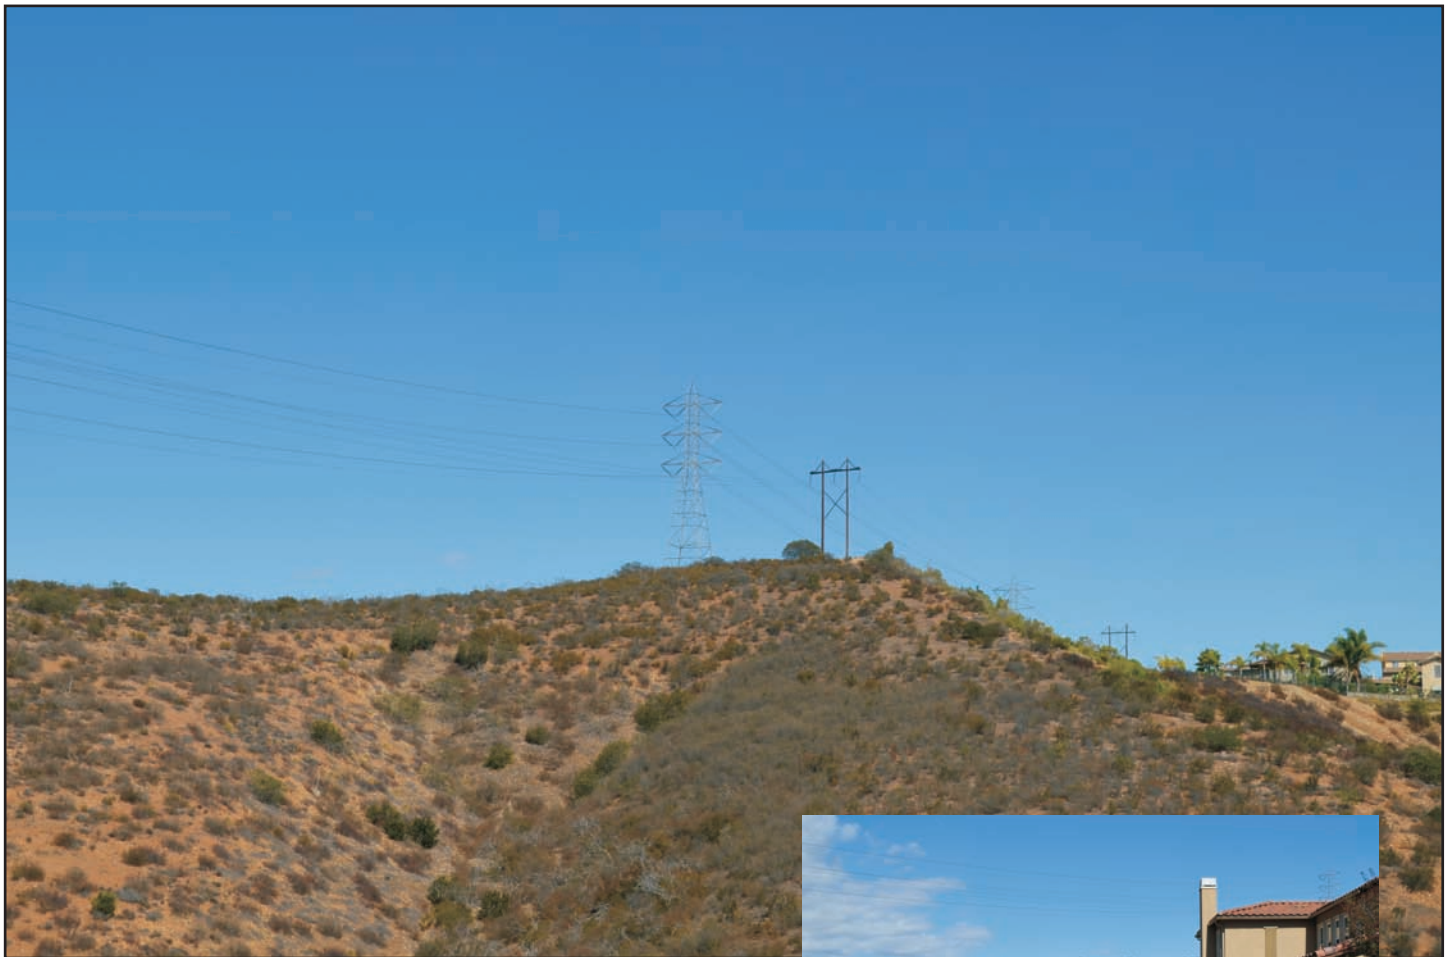
Comments: cKOP 3 is located off a cul de sac on a sewer access road. It characterizes the backyard view of 11547 Rose Garden Ct. very well. It is in the NW corner of Rancho Encantata. Topographically inferior (+/- 250') cKOP, Existing tower structures skylined (P8, R8), long span (=/- 1900') across a tributary canyon to Beeler Canyon and Pomerado Road (left, West). Marker balls and a new tower structure type will be introduced into this decidedly residential viewshed. The view from this backyard is panoramic and will be changed markedly if marker balls are required.

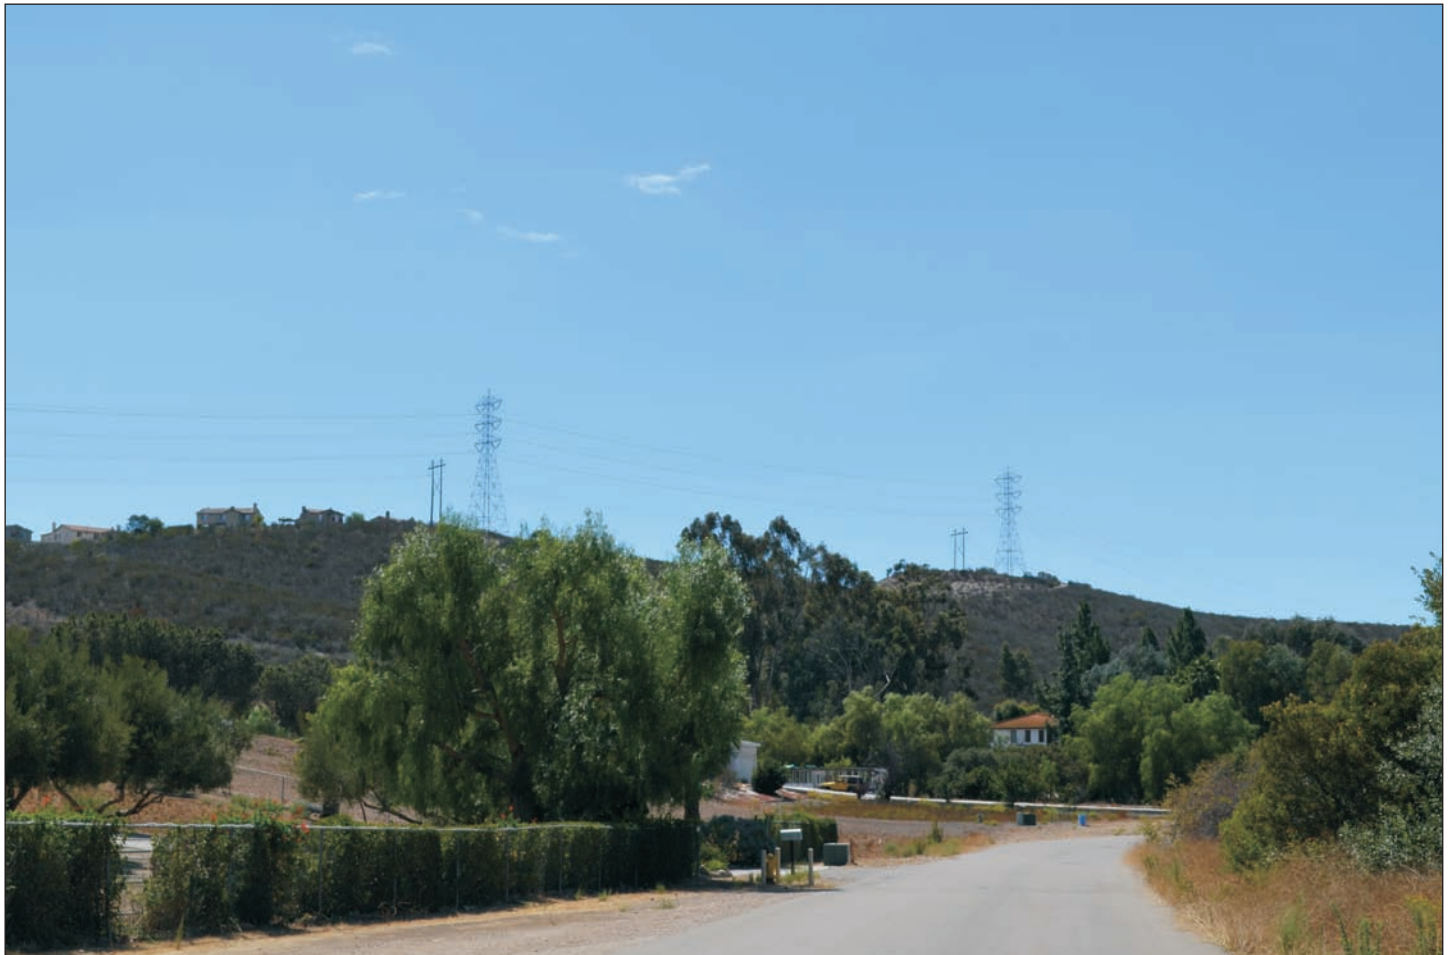
Comments: Topographically inferior (+/- 250') cKOP, existing tower structures skylined, some vegetative screening at individual residences in backyards may screen views, large lots, horse properties, residences built over many years some very new. Quiet secluded neighborhood on a dead end road. Anticipated high viewer sensitivity. East of cKOP 4 is a Vulcan Materials Plant, it is well screened by mature oleanders. Not certain if its still extractive, no worker activity or truck traffic observed.

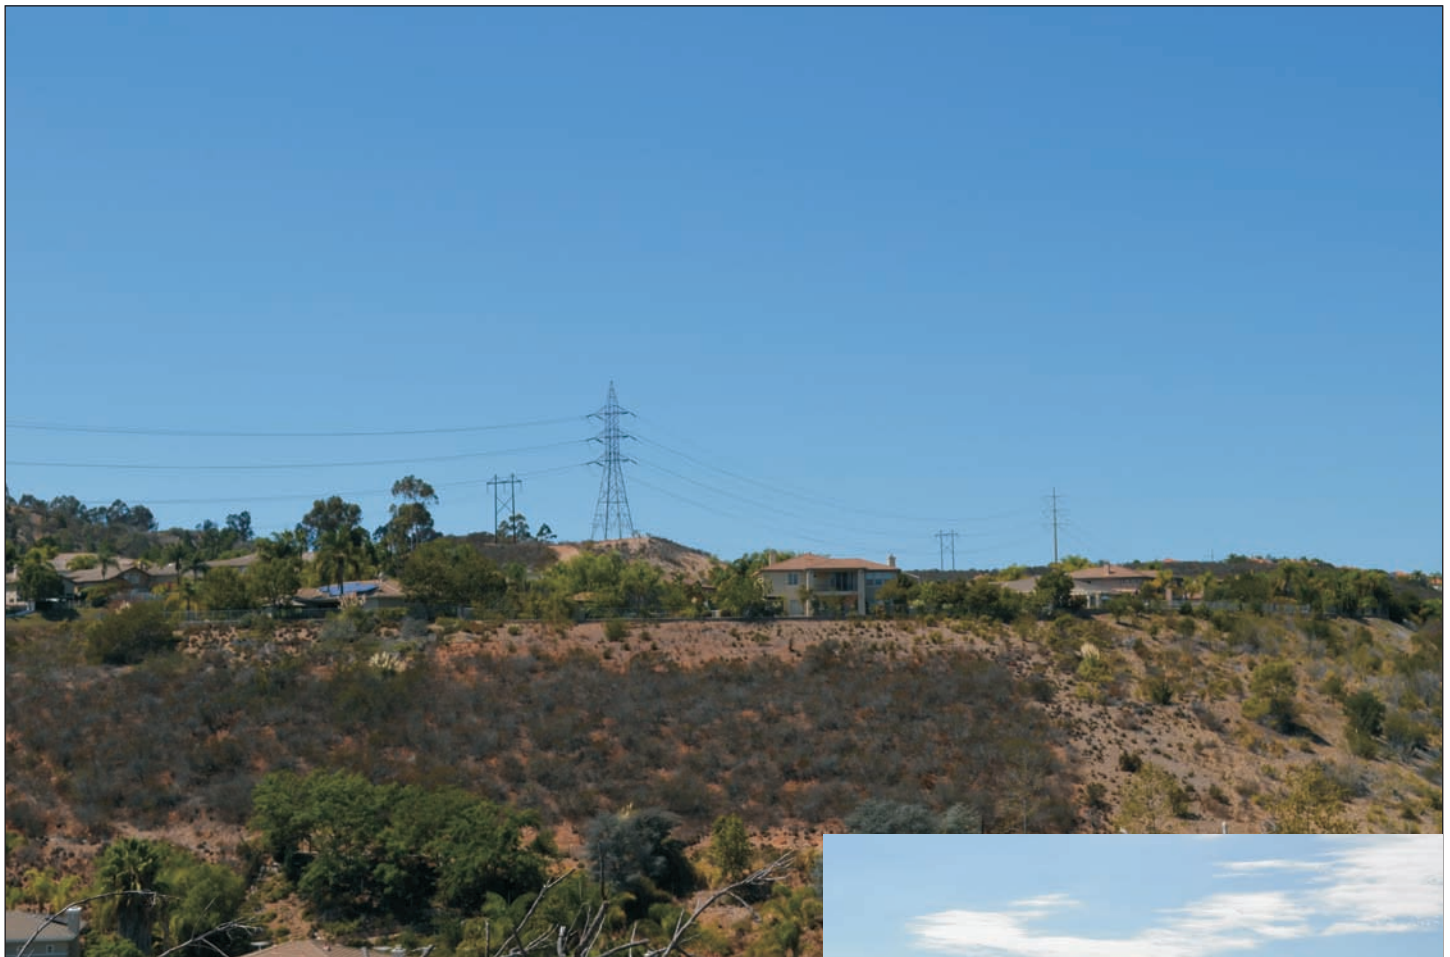
Comments: Representative of residential views along the west side of Eastridge Pl. (+/- 20 residences). Interesting vantage point from the perspective STL and TSP is within a single frame. Topographically superior to adjacent Rolling Hills Estates (cKOP 6) so views are somewhat panoramic and naturally appearing foreground of a canyon/open space.

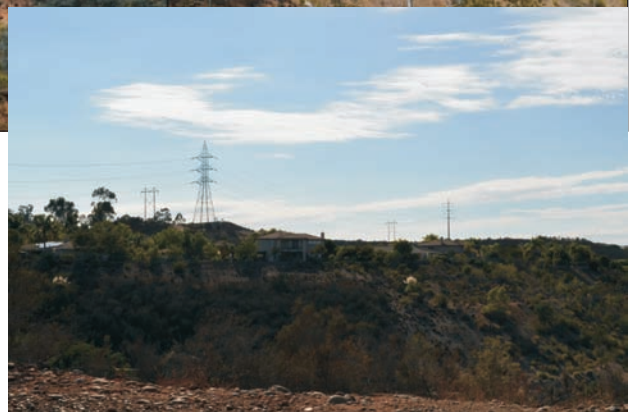
Comments: Luxury custom homes in the SW corner of Poway, not a lot of affected residences but more than several are very close to the line, like this one. Poway's Scrub Oak trail access off Treadwell between homes. TL 23051/6920 are <50' from property line. Two of the homes here use the access for horseshoe pits. Perimeter wall are low and partially wrought iron. No corona observed. Mature dense chaparral dominant over cover. Both primary users groups are considered sensitive receptors.

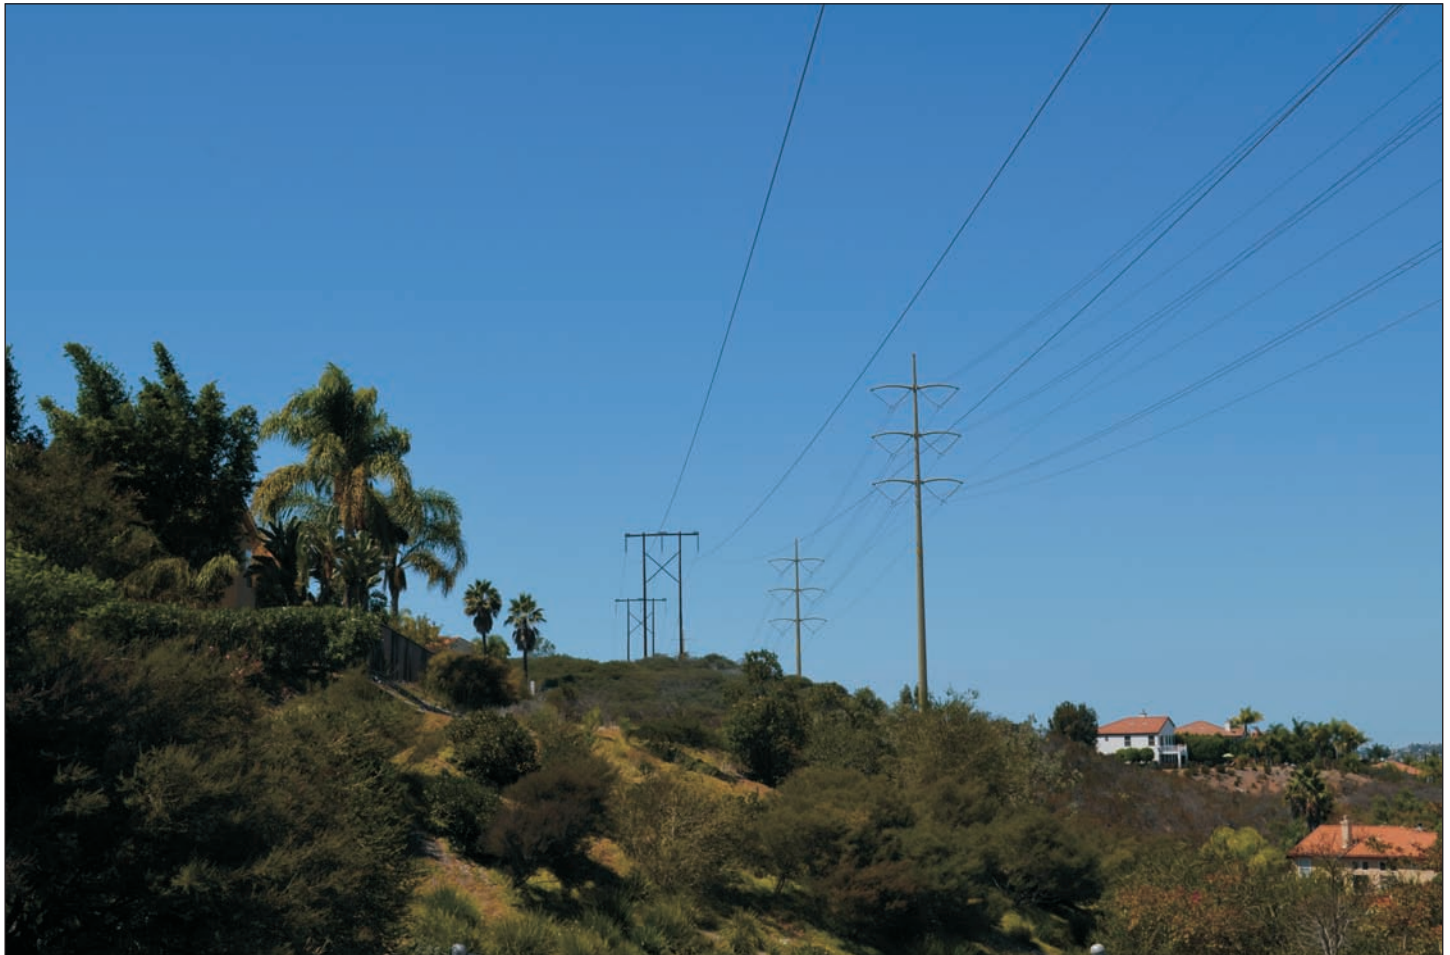
Comments: cKOP 7 is east of and topographically superior to Evergood Street. Views from backyards here are on Cypress Canyon Park Dr. 2 sets of relatively closely spaced spans. Not many homes experience this view. No trail connectivity. There is a turf area north of and below cKOP 7, but no recreational amenities. TSPs are side lit and their green hue is obvious from this distance (665').

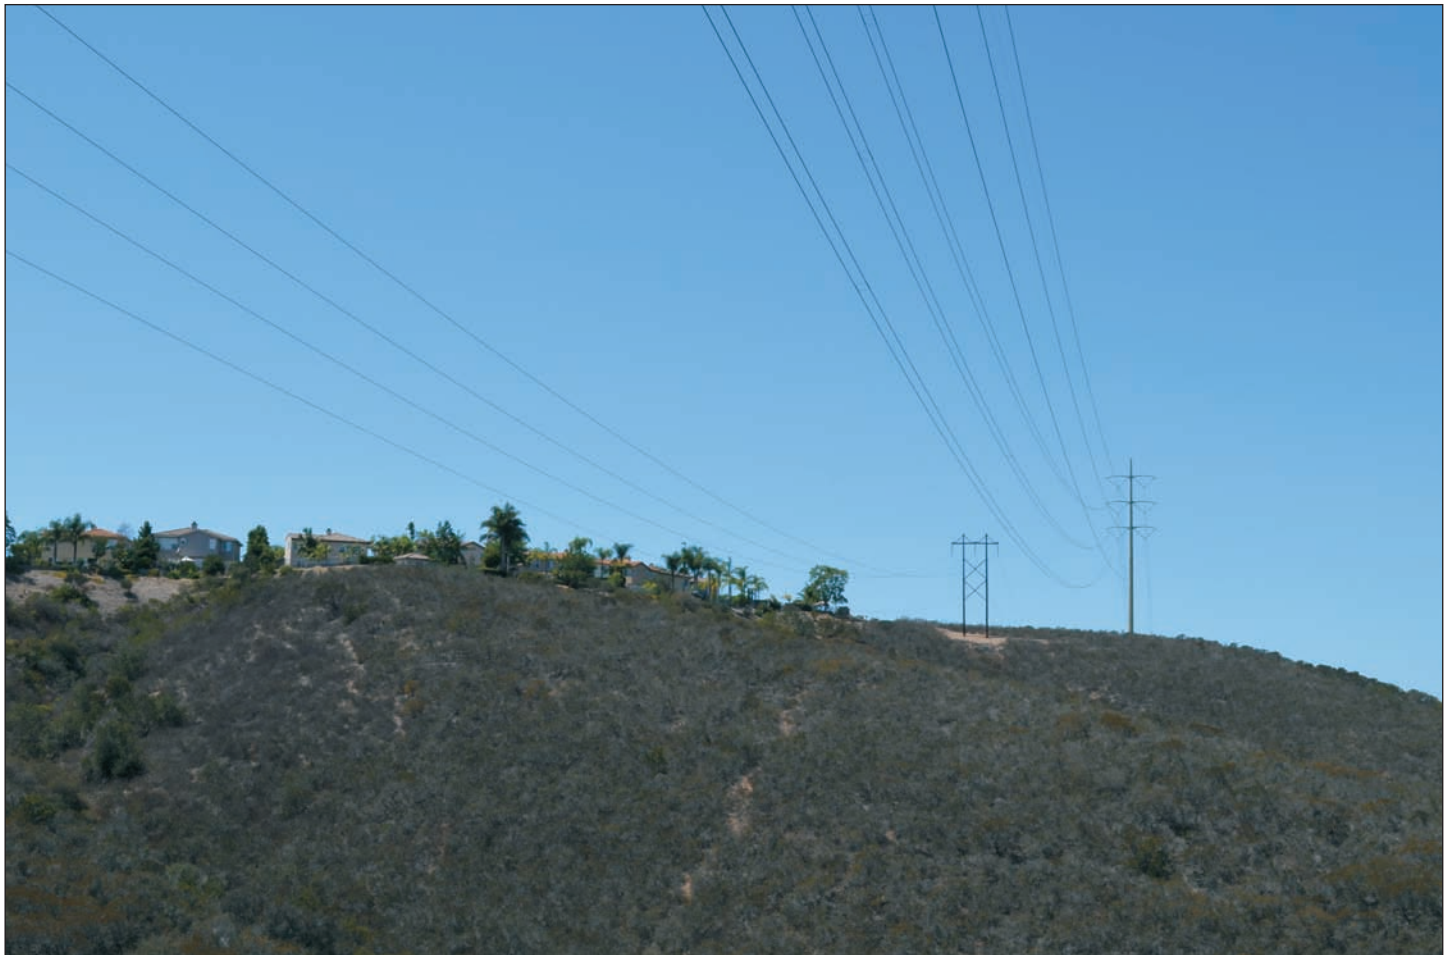
Comments: Representative of residential views along the west side of Angelique Street. A stakeholder at Tuesday evenings scoping meeting voiced assertions his backyard viewshed is already compromised by the conductor catenaries. He was concerned about marker balls and he was directed to my station and the mapbook showed no markerballs across "his" canyon he thought this odd because the next canyon had them and his was larger and deeper. I emailed PM and CEO with my concerns, regarding this. Marker ball shp is in data request 3. Many homes along Angelique and Cypress Canyon will experience similar changes in their backyard views because the 2 long spans across 2 finger canyons will change dramatically.

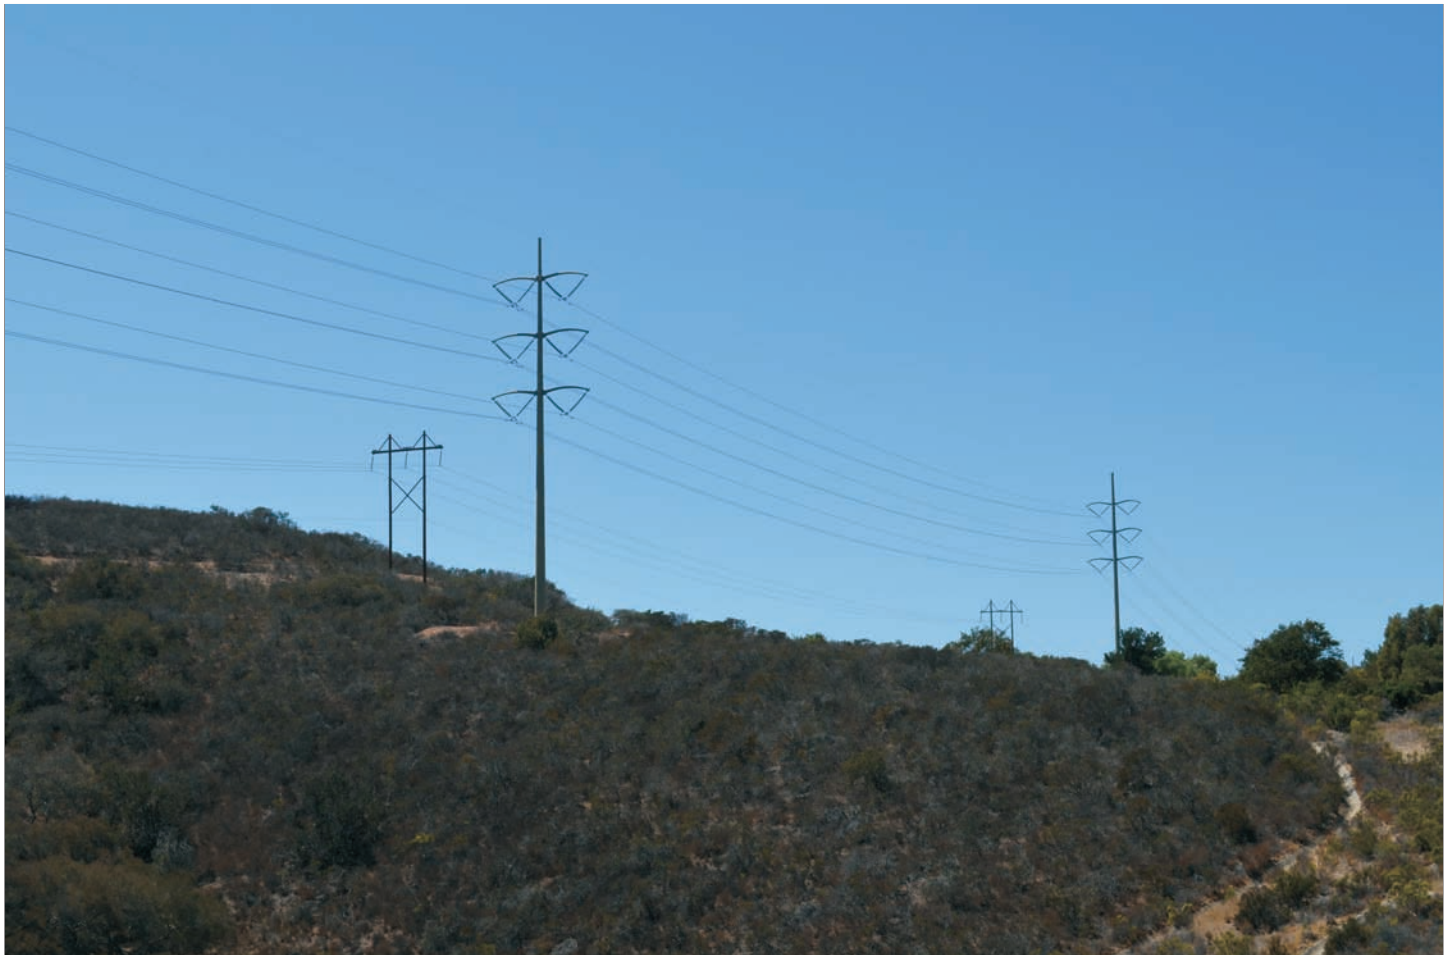
Comments: cKOP 9 is from Fieldstone Summit development it is a small development and 17 residences will be impacted profoundly. This is not the best vantage point but access to better was not possible (steep topo and dense chaparral. Multiple consecutive spans (2) MAY have marker balls along large open space canyons. From this vantage point that will not be evident. TL is topographically superior and conductors and tower structure are skylined. There are no trail access from this development.

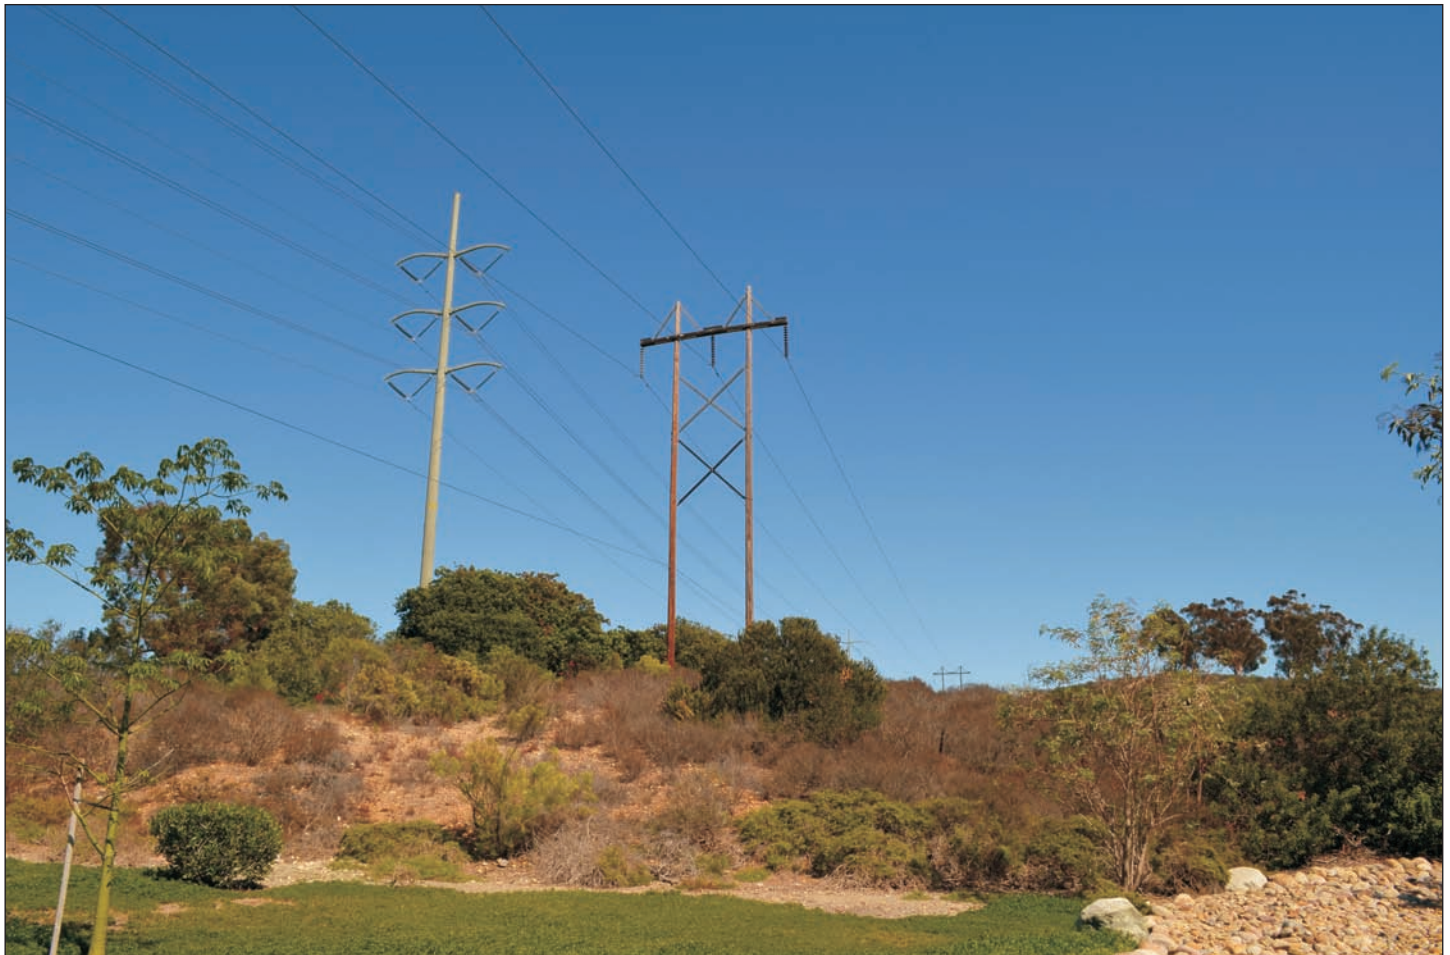
Comments: The community center is a popular local gathering place; the MRN Planning Group meets here. Butterfly Garden is well landscaped with year around flowering plants. The adjacent parking lot, south of and away from the TL is a park and ride and used by parents of adjacent middle school. An area of multifamily residential. Only one pair of tower structure are visible and a limited amount of conductors are visible. This view is from the sidewalk on the north end of Butterfly Park. This is by far the worst case scenario for the community center. TSPs are front lit so there green hue is apparent. Dulled untreated galvanized TSP adjacent to and north (left) of the H-frame will appear incongruent under similar lighting conditions. The large stringing area east (right) of the structures is obscured by intervening vegetation.

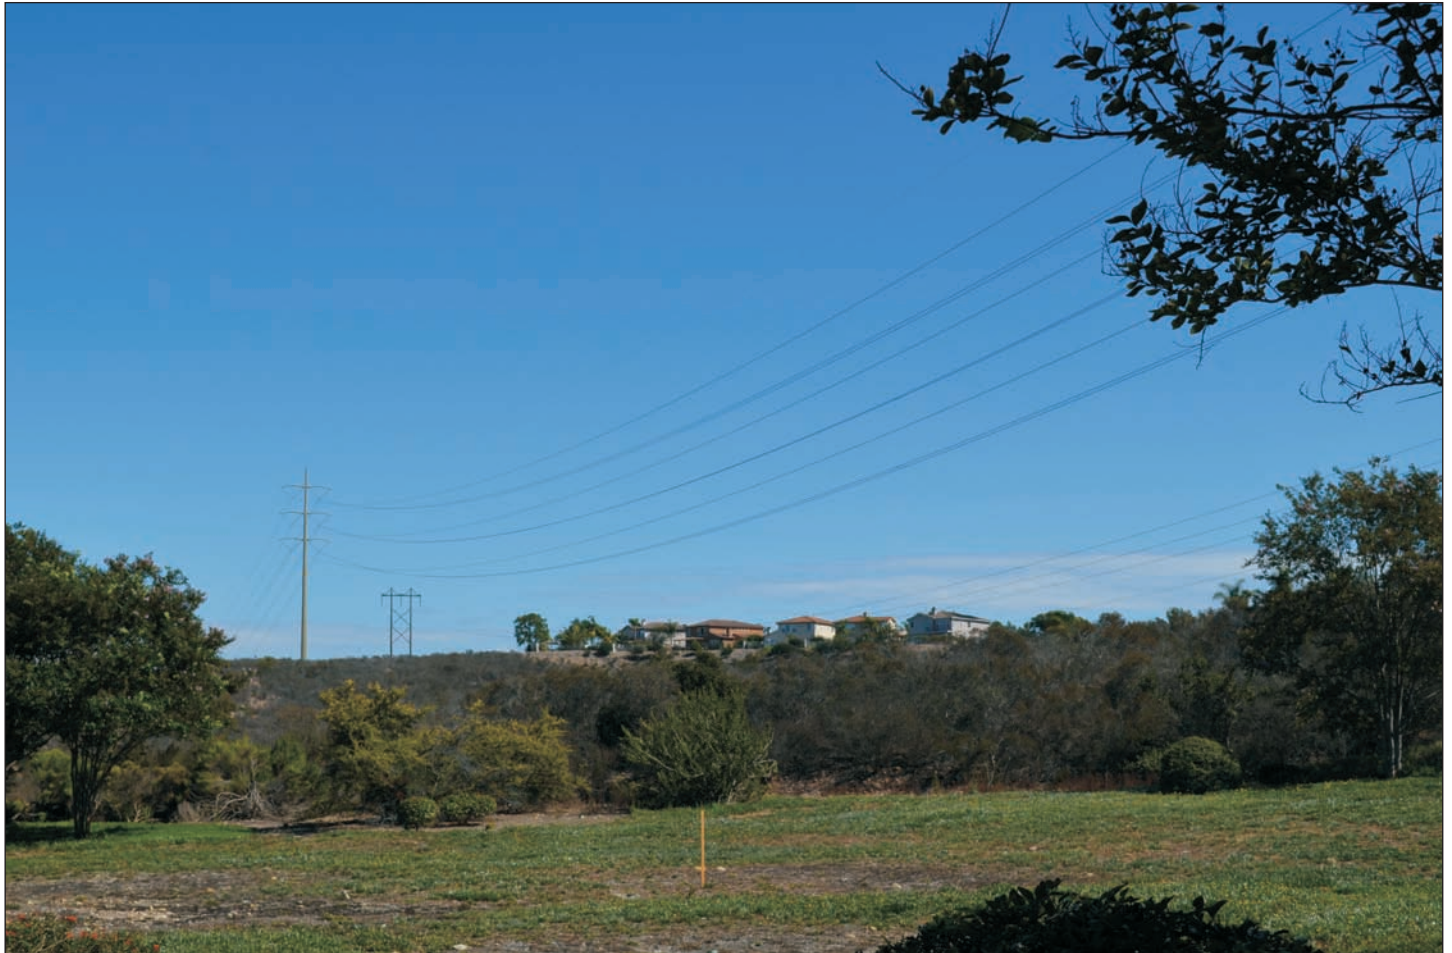
Comments: cKOP II is looking easterly from the eastbound lanes of this busy thoroughfare (ADT 34,973). Only 1 set of tower structures are visible but 2 spans of conductors are visible and marker balls will be on both span across open space canyons, only 2 places in the alignment where this occurs. Heavy and mature ornamental trees, scrubs, and ground cover along the travelway's edges and median obscure views of the ROW from SP Prky. This planting plan definitely softens the ROW's presence, given its nearly parallel alignment for +/- 1.5 miles through a heavily populated portion of the planning area. For motorists the conductors are difficult to see because of their immediate vertical presence. The immediate foreground is a landscaped area that is planted with spring flowering perennials part of Butterfly Park. The homes visible on the horizon are on Aberhill Terrace. Their views will be impacted but cKOPs 8, 9 are similar but not as close.

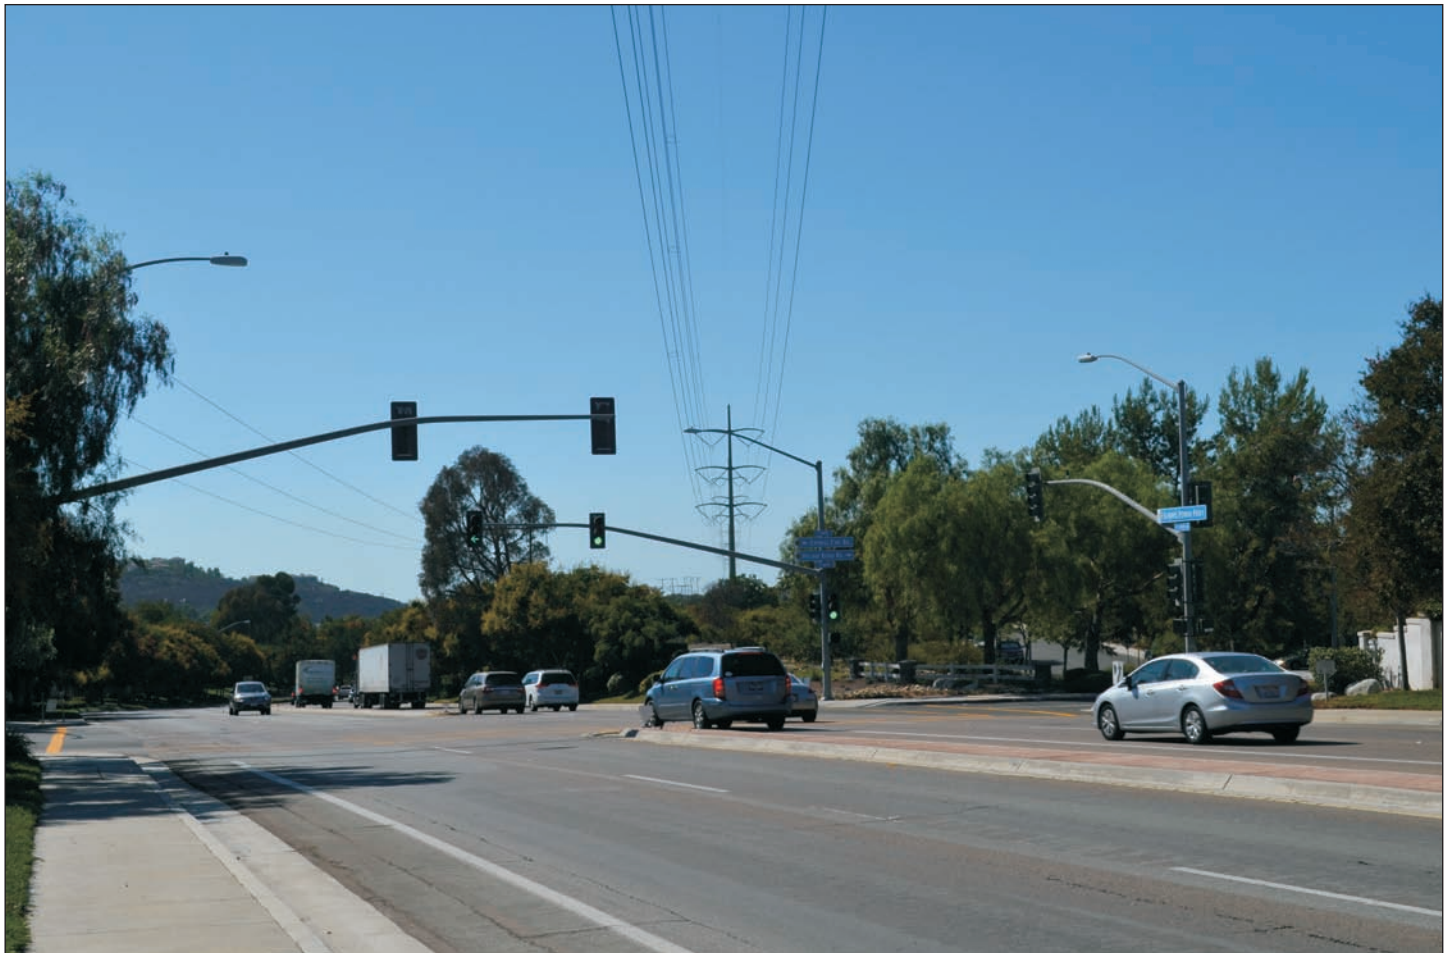
Comments: This vantage point is west of the previous cKOP (11) and looks in the opposite direction 30 yds from the Cypress Canyon Rd's intersection with SP Prkwy. Because of it position is mildly representative of a westbound motorist perspective. In this view TL 23051/6920 tower structure are aligned. A large permanent work area is screened from view by ornamental landscaping and Heritage Trees. This is an area that acts as a traffic calming because the travelway transitions to 2 lanes in each direction. Further east and west there a 3 lanes and higher posted speed limits. The existing TSPs are side lit at this time of day (3:19 pm) so there green hue is not as apparent as when they are front lit. SP Prkwy. has an ADT of 34,973.

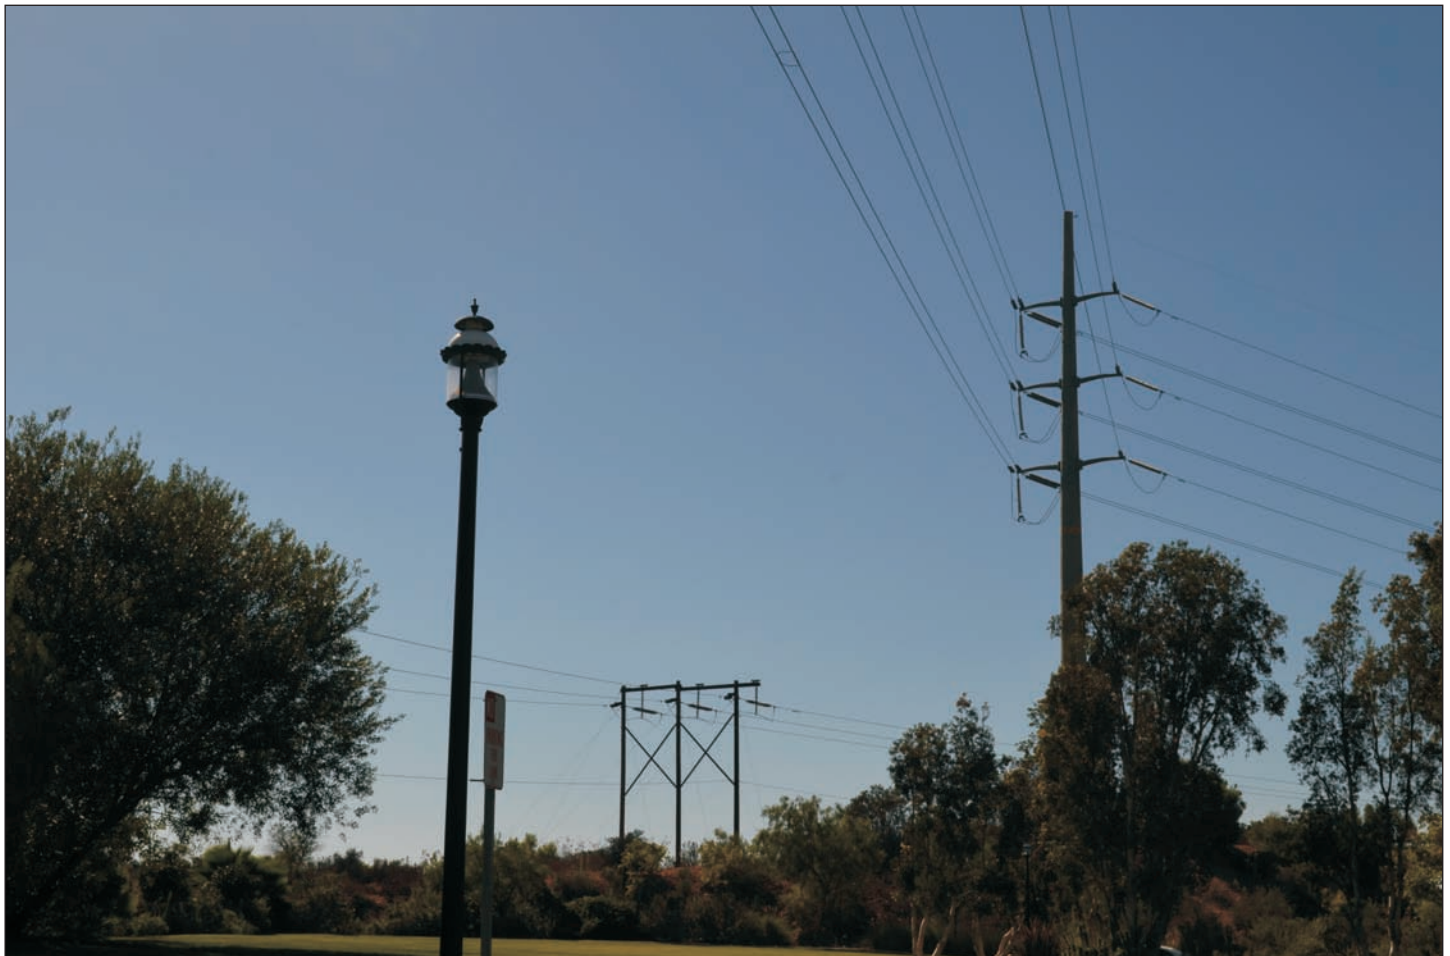
Comments: cKOP 13 is behind a large multi-family development north of SP Prkwy and Scripps Ranch Marketplace. The westerly view is of 2 angle structure where the line transition to a northwesterly direction. As apparent in the views the diameter of the robust angle structures is noticeable. Angle or tension poles are nearly 6' in diameter near the base; tangent towers are +/- 3' in diameter. The TSP is just over 400' from the vantage point which is in one of the few turf area of the development and is no doubt used for dog walking and other recreational activities of the many residents. It also provides access to a trail which is also access to the angle pole. The proposed TSP would be 40' closer to the TSP than the existing H-frame although it will not require the guy wire that exist on the steel H-frame structure. The large permanent work area at the base of the poles would not be visible from this vantage point because of the topographically superior location of the angle pole and intervening vegetation. In the late afternoon sun from this perspective the TSP is backlit so its faded green hue is less decernable.

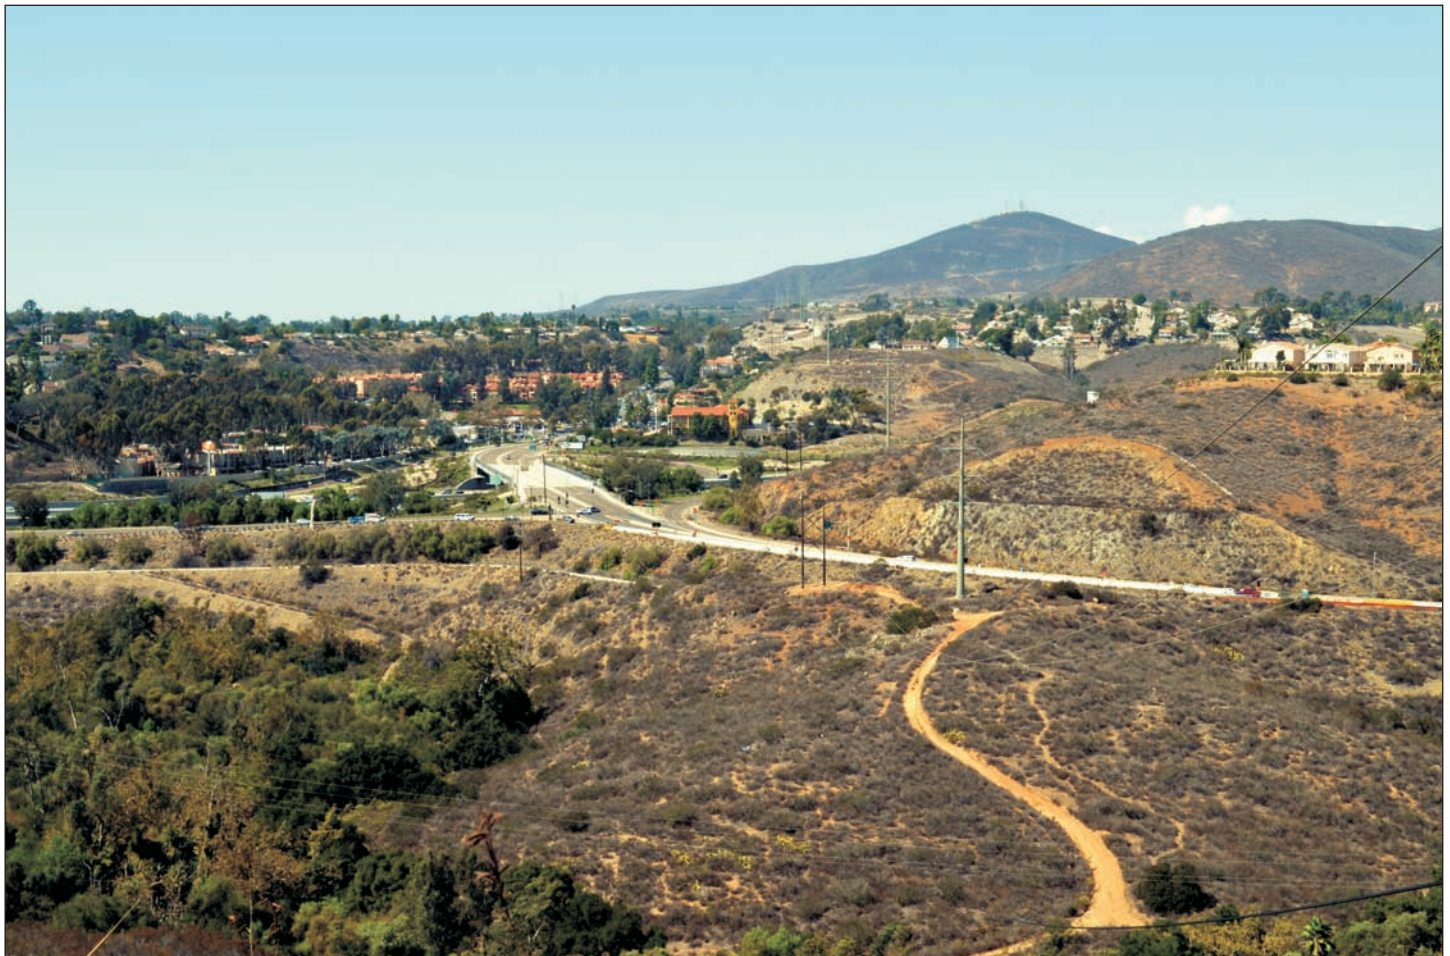
Comments: cKOP 14 is in the parking lot of a large office building complex in an elevated position. It is representative of views from windows facing north in area offices where the ROW spans Penasquitos Canyon. From this elevated perspective much of the ROW is visible all the way to the SLT angle pole outside of Hilltop Park and two or three poles north (>2.5 miles). From this elevated perspective all the TSPs and conductors are back dropped so there presence is difficult to perceive beyond the first few. The first TSP just south of Poway Rd. is an in-line dead end tower structure (6' dia.). A large (12 acres) stringing site South of the structure has been removed by project refinements; however it was replaced with a smaller staging area down the slope. Vegetation removal will create obvious contrast. The permanent vegetative clearing at the base of the new TSP would also be visible. Existing marker balls spanning I-15 on the guard wire are back dropped but visible 0.45 miles distant. The Poway Road TSP is partially front lit and its color is somewhat obvious even at a distance (>1300'). Marker balls will be required on the OHGW across Peñaquitos Canyon (foreground). Preliminary engineering also indicates that a retaining wall will be required for the first pole visible (P24, E24) which is just south of Poway Rd as well as for the next new TSP (P25).
