APPENDIX F: AESTHETIC RESOURCES SUPPORT INFORMATION

Appendix F provides supplemental information for the aesthetic resources impact assessment approach described in Section 4.2.3. The CPUC has not developed its own method for assessing visual character and quality under CEQA. The visual impact assessment follows the CEQA Guidelines and supplements the CEQA Guidelines with guidelines provided in *Visual Impact Assessment for Highway Projects*, which uses a numeric evaluation approach to assess the degree of impact (FHWA 1988). Supplemental information provided in Appendix F includes:

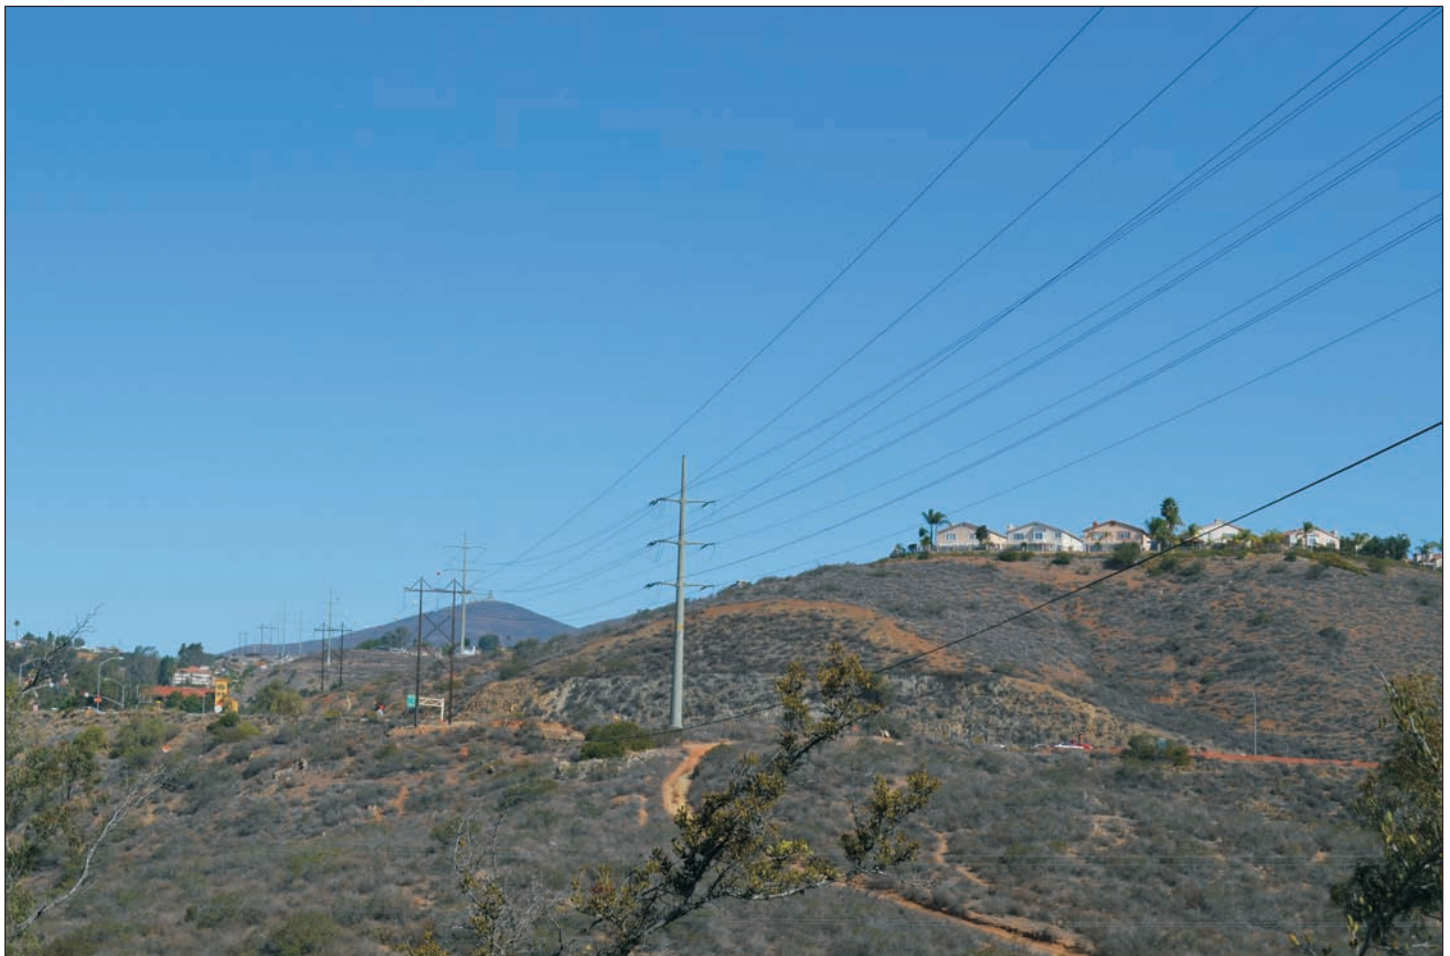
Comments: cKOP 15 is located on a popular trail through the eastern extent of Los Peñasquitos Canyon Preserve (LPCP). Cherry stems from the main trail also connect to the Summit Business Park to the south. The trail at this point is +/- 50' above the canyon floor and Peñasquitos Creek (perennial). The Trans County Trail is extremely popular with the mountain bike community but is also used by hikers and equestrians. It is an important link between population centers to the east (Sabre Spring and Poway) to the main part of LPCP to the east; it runs under I-15. The first TSP in the view is the tension pole south of Poway Rd. discussed in the previous cKOP (14). Unlike cKOP 14 it is an inferior perspective so almost half of the TSP and the majority of the conductors are skylined as are the existing marker balls spanning I-15. This image was taken at 10:15 a.m. and the majority of the TSPs are front lit and their green hue is obvious. Like cKOP 14 the Permanent work area and staging area at the base of the new TSP will be visible. Marker balls will be required across the canyon (foreground). This span is contrary to other spans in that if you look below the catenary of the conductors a large diameter cable is suspended off the H-Frames. It goes underground at Poway Rd. The IOU has said they intend relocate the cables on the new TSP. However it is the responsibility of the cable's owner to do the relocation, so they may temporarily top the H-frame's left pole to provide a support structure until the cable is relocated. In addition to the visual intrusion mentioned a 2 sided retaining wall is proposed for P24 which will be clearly visible from this vantage point.

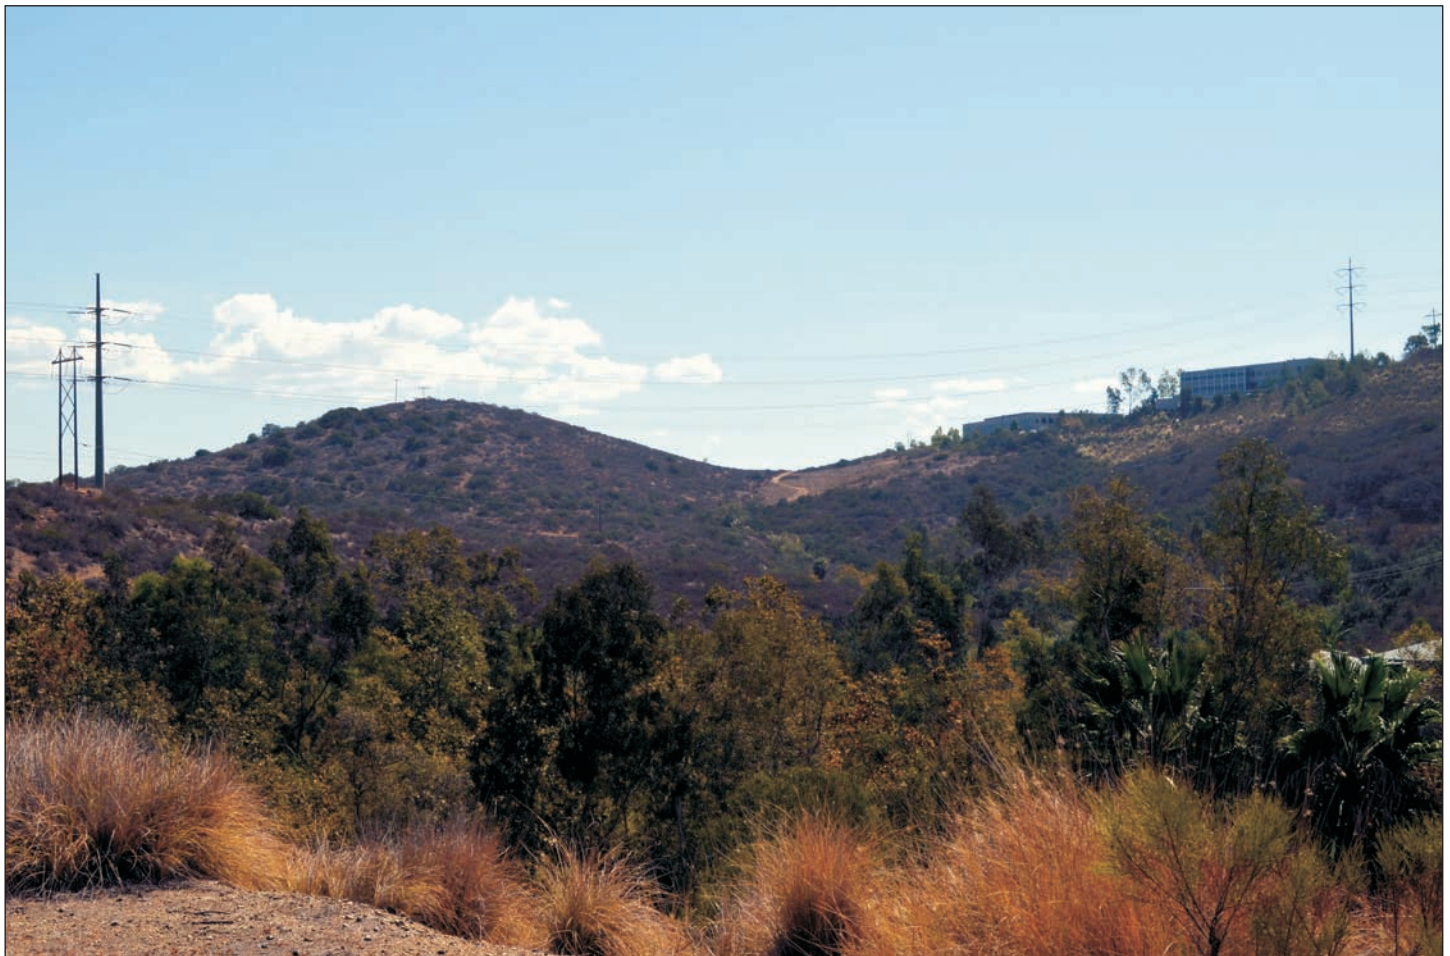
Comments: cKOP 16 is located on Class I bike trail which begins at Poway Road and ends in Scripps Ranch (+/- 2 mi.). This is the former route of US 395 the predecessor to I-15. It crosses PQ canyon on beautiful arched bridge that must be historic. Cara Way is a memorialization to an SDSU student who was murdered by a CHP officer after a traffic stop. In the canyon below the bridge Cara Knott's father created a memorial oak grove in her honor. It remains popular and well maintained despite his passing. The span shown below has been the discussion of cKOPs 14 & 15. New tower structure and marker balls will be introduced into this viewshed. The left (north) tower structure is an in-line dead end structure and the new (P24) TSP will also be dead end. There is also a retaining wall proposed that will no doubt be visible from this vantage point. The marker balls on the OHGW will be skylined and at times front lit conditions that make them most noticable.

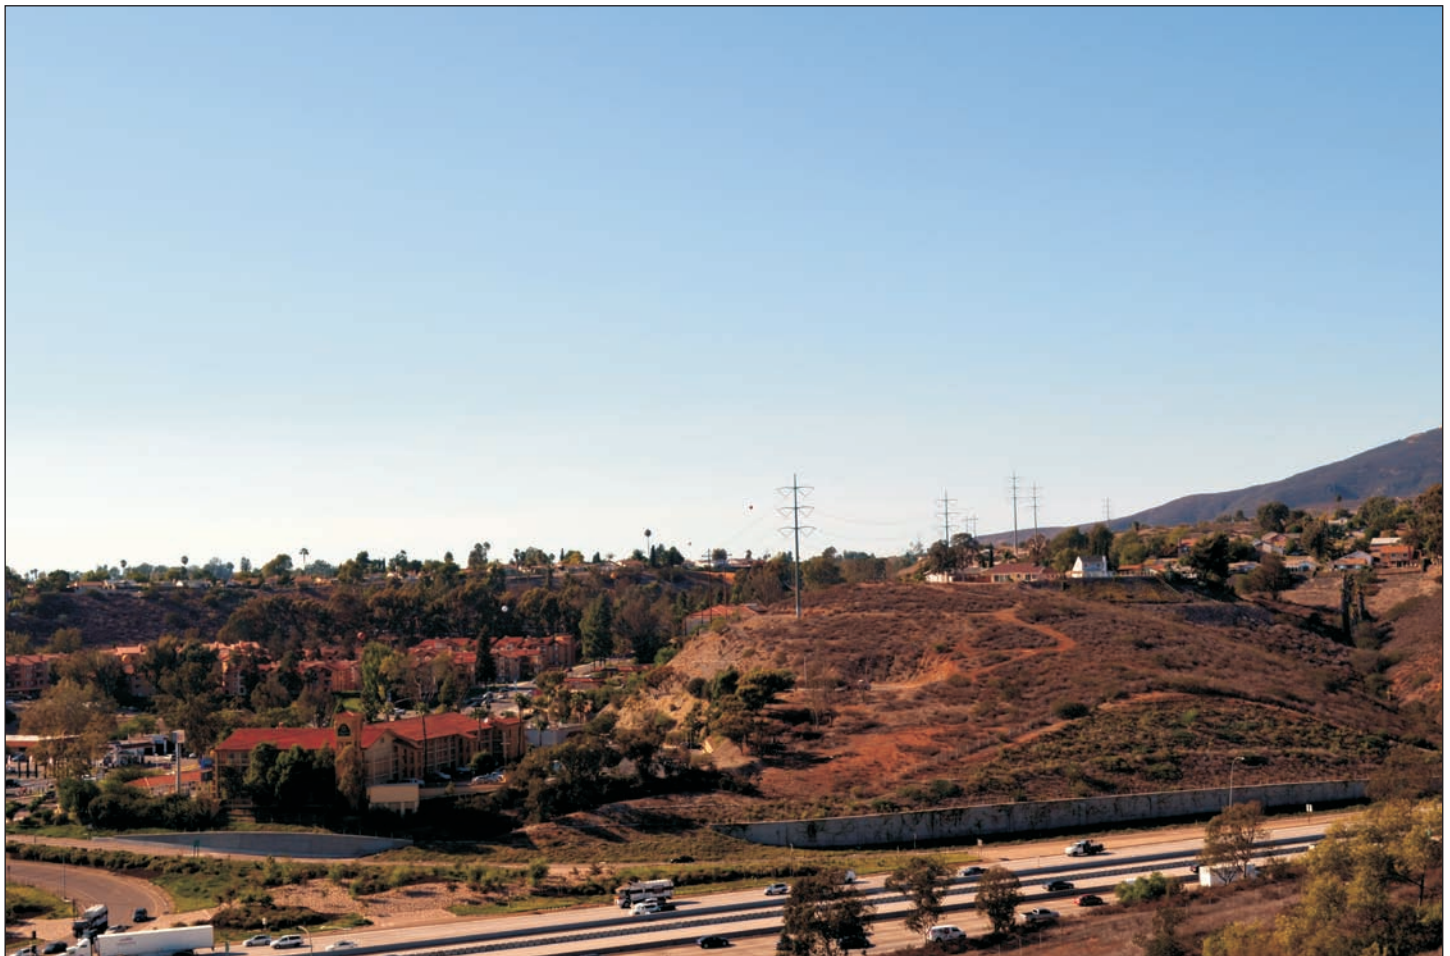
Comments: cKOP 17 is located on a cul de sac in a residential neighborhood above where the ROW crosses I-15; it is east of the freeway and north of the ROW. Homes on the perimeter of this development have sweeping views because of its hilltop location. This cKOP shows the ROW where it crosses I-15 looking into Rancho Peñasquitos. The view was captured in the late afternoon (4:30 pm) the TSPs are backlit and appear dark. Notice that the H-frames are difficult to detect, the new taller TSPs will be much more apparent because they will be partially skylined. Marker balls are visible across the I-15. The GIS data we have from the IOU shows additional marker balls, which seems redundant.

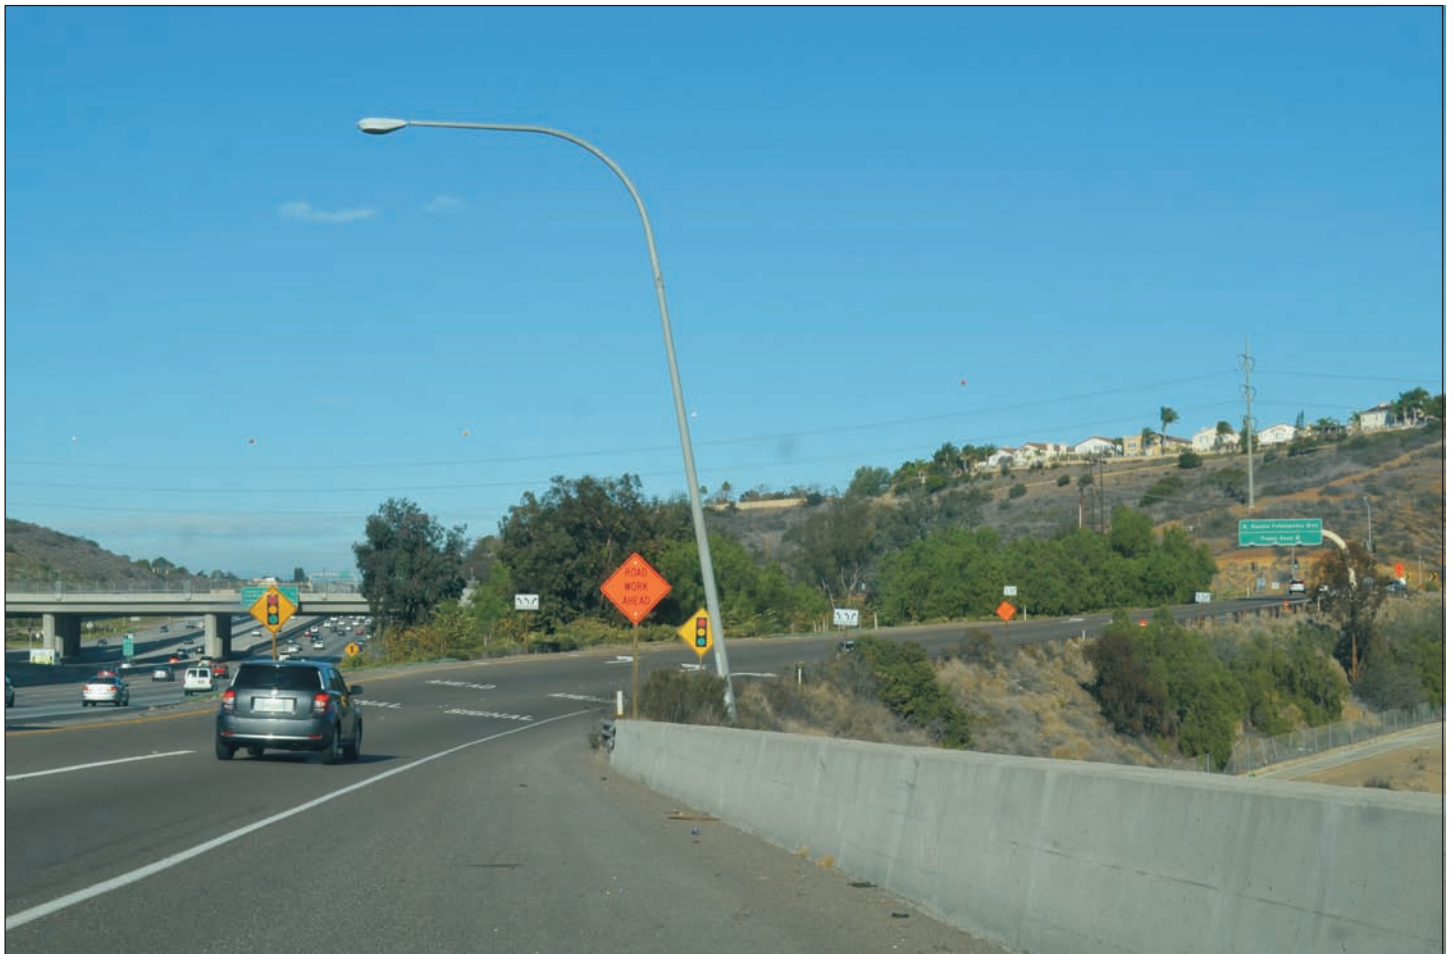
Comments: cKOP 18 is located along the I-15 corridor. Southbound on I-15 the tower structures are not in your typical field of vision as a driver and the conductors and marker balls are back dropped against the landscape so they are not really an intrusion. Northbound is similar but the viewshed is not as enclosed by topography; there are places where the conductor catenaries and existing marker balls are skylined. P25 on the north side of Poway Road and east of I-15 is typically partially back dropped. P25 however, does propose a large retaining wall and work area. The interchange was recently improved but the vast majority of the mature landscaping was retained; the landscaping provides vegetative screening. The ADT on this portion of the I-15 corridor is very high (221,395) but views of the corridor and structures is relatively brief; in the neighborhood of 60 seconds in each direction at posted speed limits. During morning and evening commute hours this section of I-15 is often slowed by heavy traffic, because of lane reductions to the north to accommodate HOV lanes.

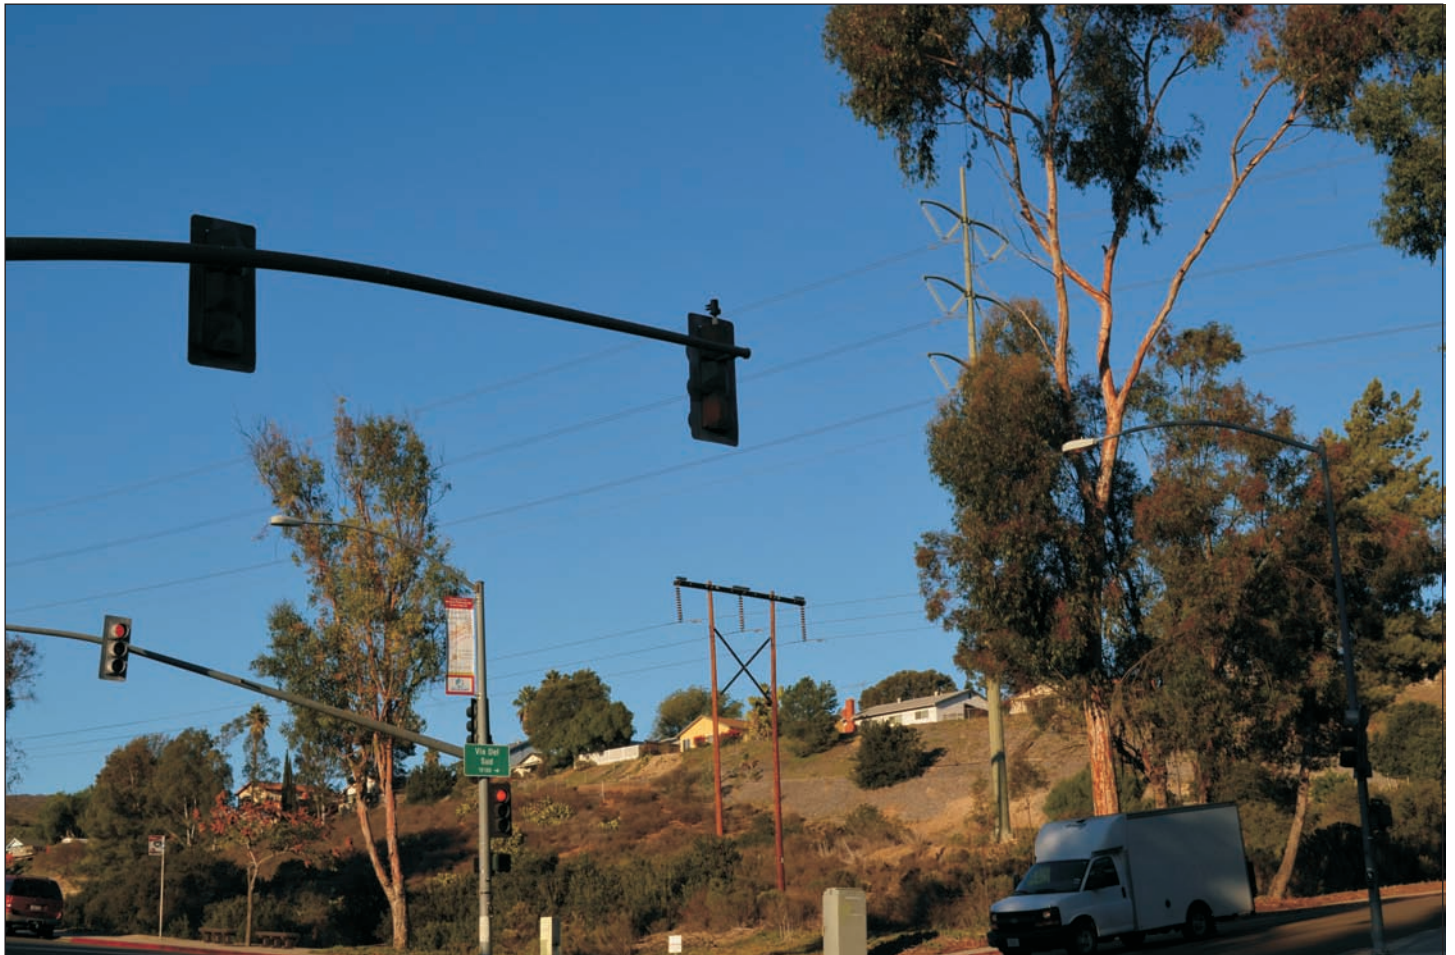
Comments: South side sidewalk on Rancho Peñasquitos Blvd. at MTS bus stop. Adjacent land uses include Multi-family residential, assisted living facility and commercial. The north side of PQ Blvd is lined with mature eucalyptus trees; there is also a median with trees and scrubs which serves as vegetative screening of the ROW. This portion of the ROW is constrained by topography and relatively tall buildings, I had to search to find this view where the height of the TSPs fit within the view frame.

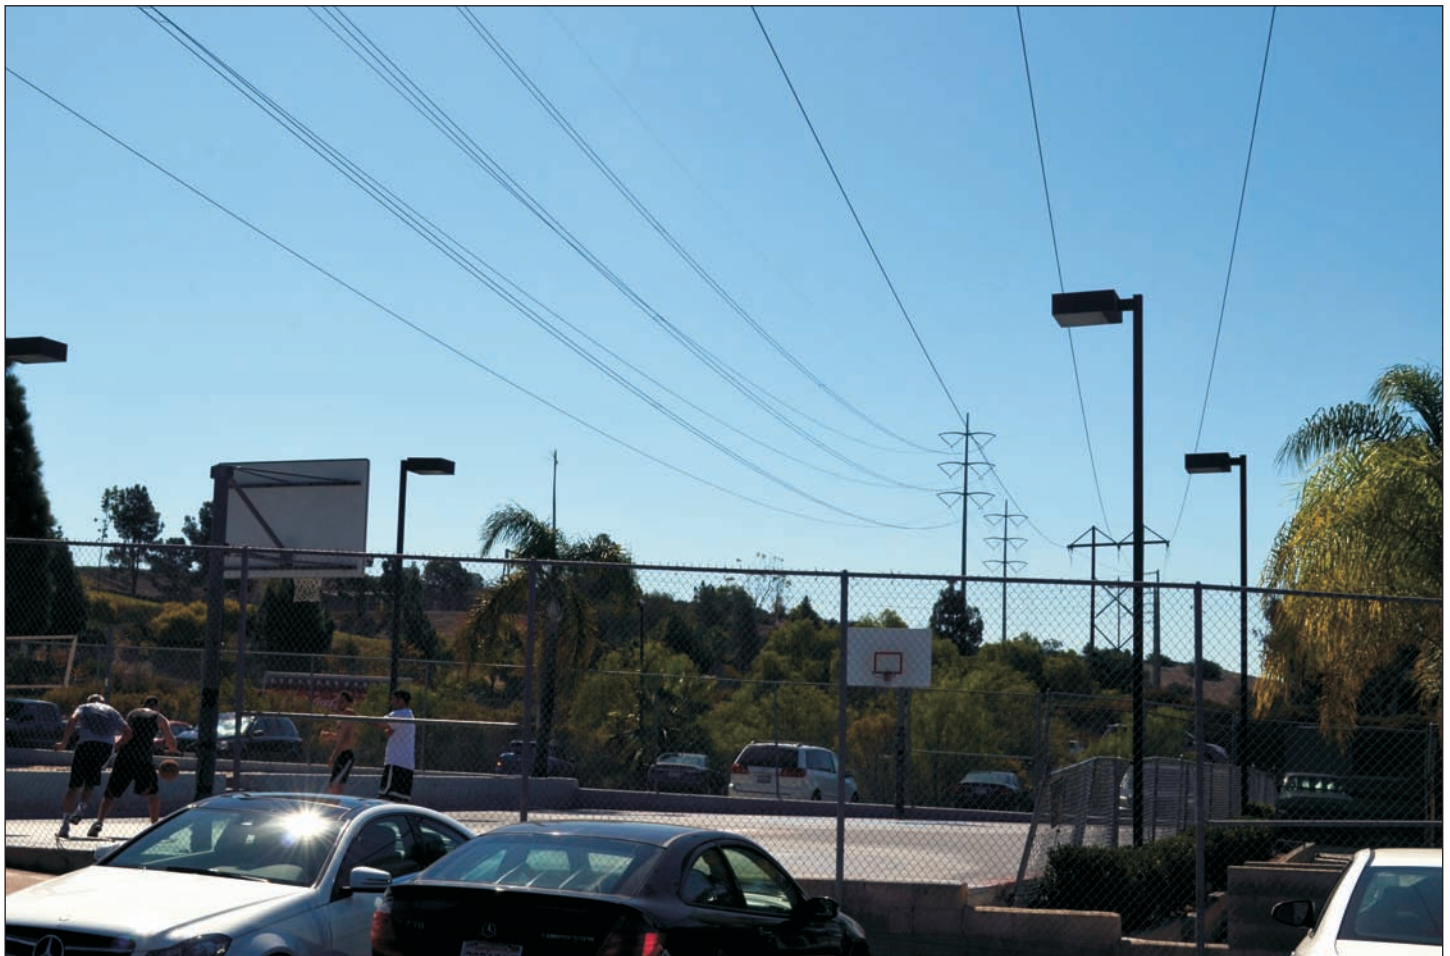
Comments: cKOP 20 is in a shopping center north of the ROW's first SR-56 crossing. Adjacent to the shopping center is a skate park. Directly under the ROW is a basketball and sand volleyball court. The main part of the shopping center is west of the ROW. There is a park and ride lot between the shopping center and the skate park. The Center was undergoing a significant face lift when the site was visited. The pole behind the cKOP in the parking lots is a large diameter in-line dead end pole. A skate park is 100yd north a park and ride is in between. Left of the basketball court in the foreground is a sand volleyball court.

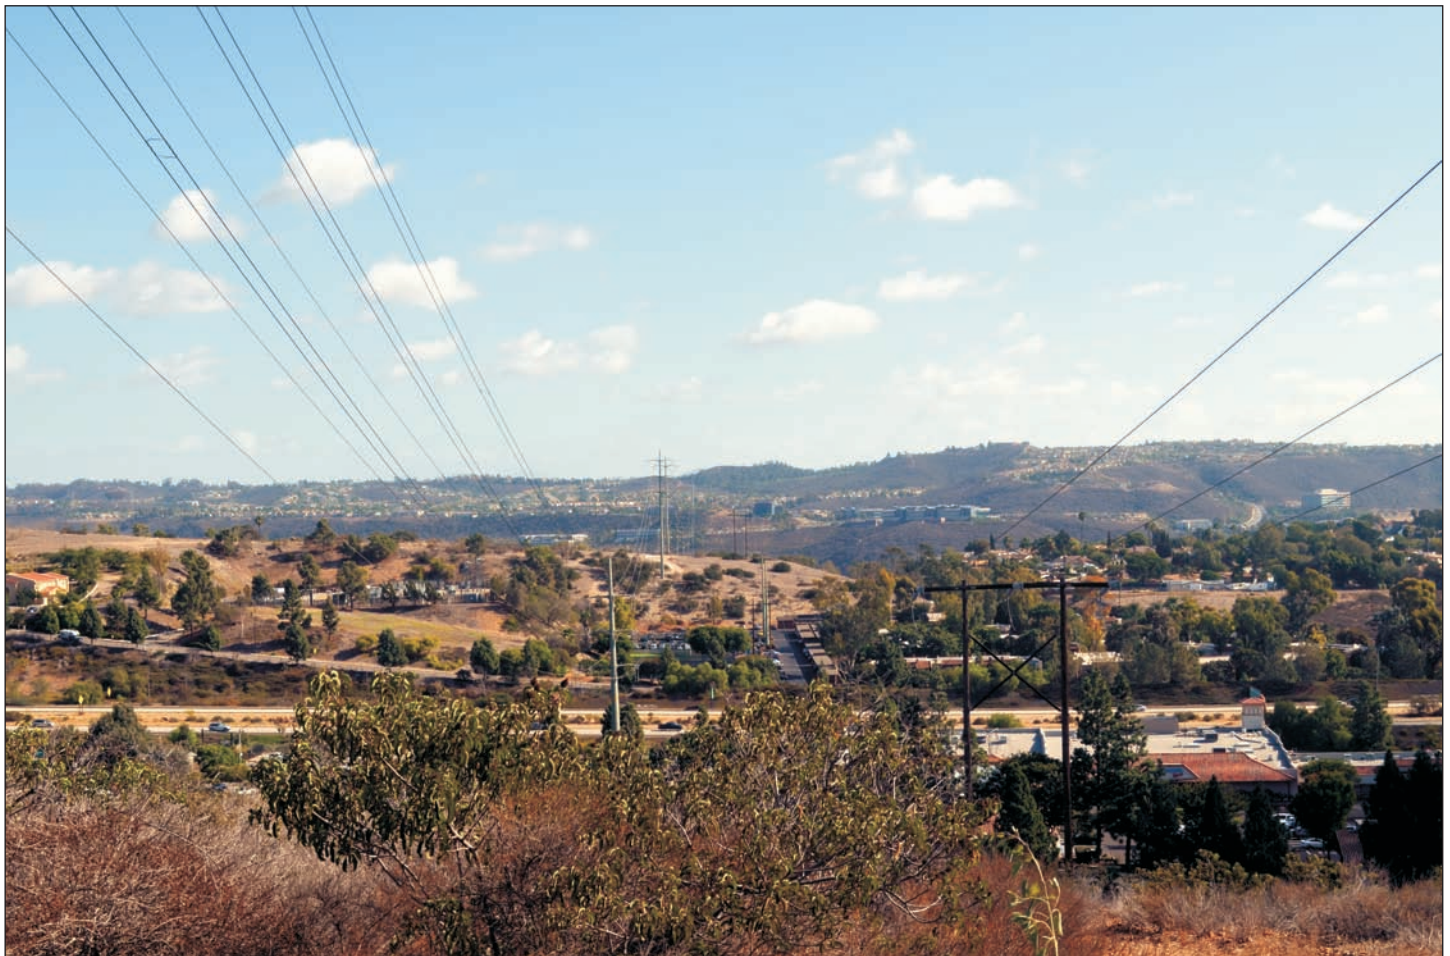
Comments: cKOP 21 represents a group of home that occupy topographically superior ground. Their views to the north, east, and west are panoramic but decidedly urban. This cKOP was added because of scoping comments. 2 commenters replied multiple times during the process. They also had a lengthy petition. The view shows the TSPs, H-frames, and conductor catenaries are mainly back dropped so their presence recedes quickly. Chacarita SS is visible north (left of the ROW).

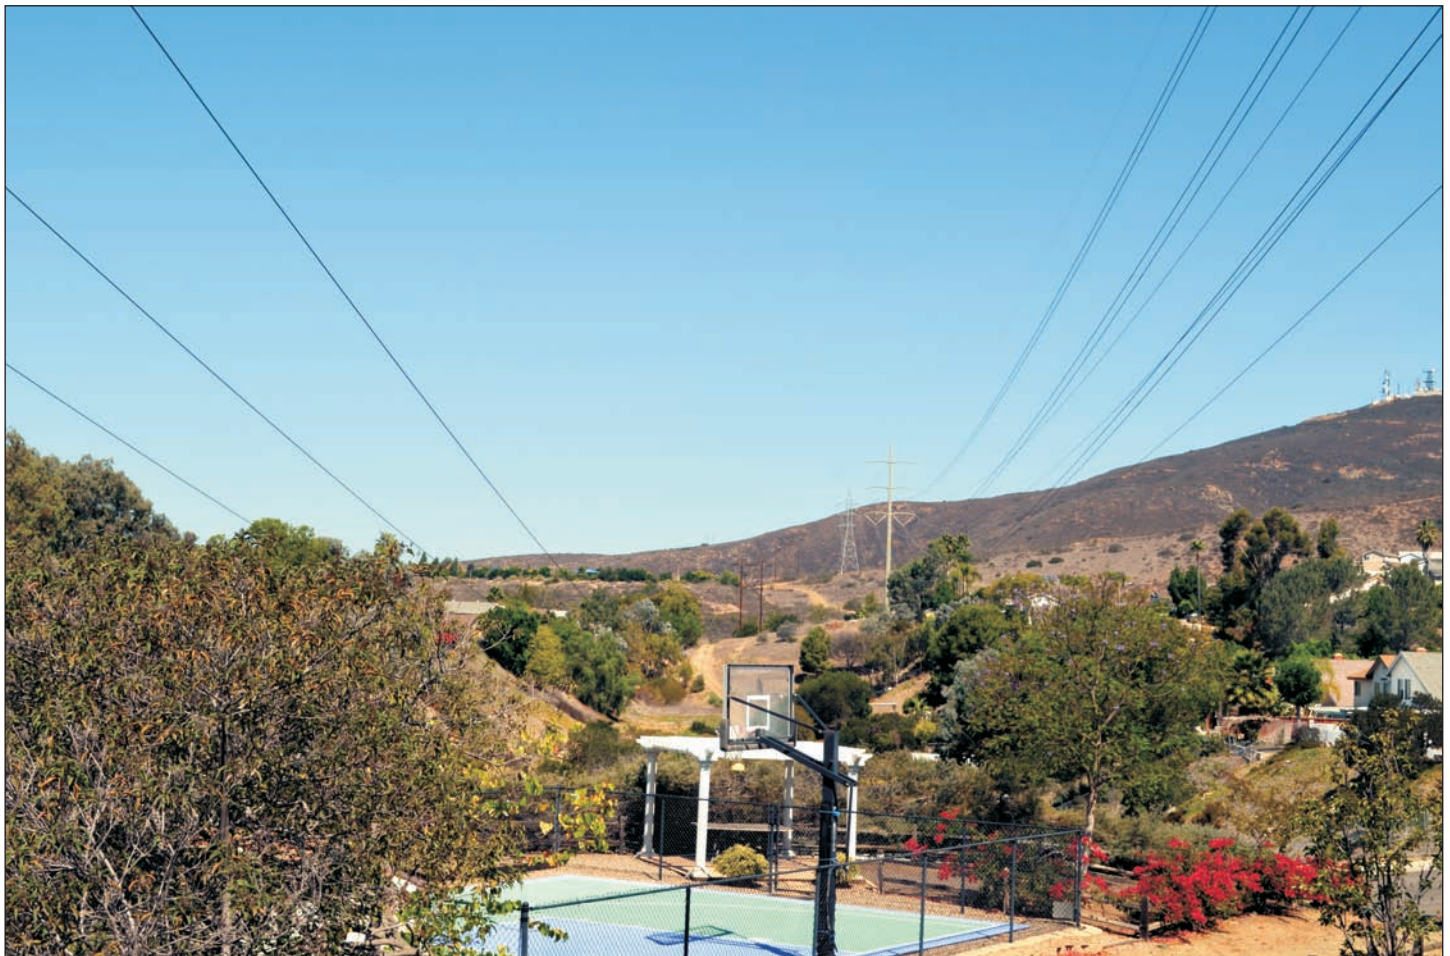
Comments: cKOP 22 represents views from the access road, it could be used as recreational asset but it is relatively short and has no destination; essentially a one way trail. The neighbor has built a basketball court and a shade ramada under the TIL s. This is kind of a private vantage point. The view is somewhat important because of the transition from TSP to SLT in the near middleground. It may help to demonstrate the incongruity of this approach. Overlook Park is south (left) of the ROW. The proposed TSPs will also be partially skylined were the H-frames are back dropped. Notice how the existing color-treated TSP recedes when it is skylined vs. backdropped against the dark vegetation of BMOSP. Also notice how the more distant SLT recedes when backdropped compared to the TSP.

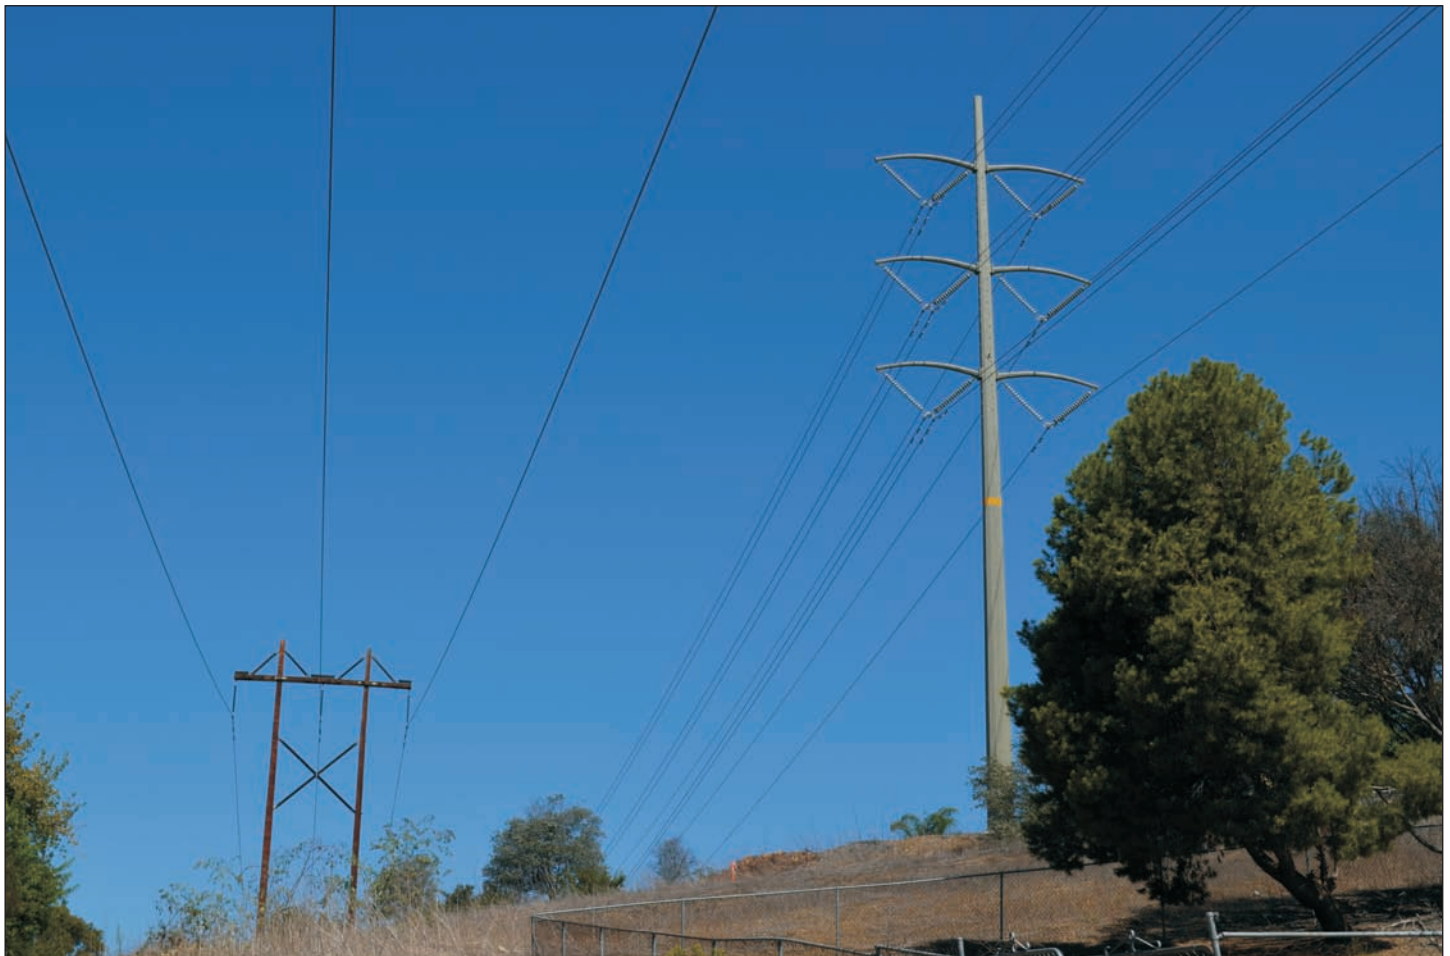
Comments: cKOP 23 represents views from 2 residential streets, Paseo Cardiel and Bassmore Dr. +/- 50 homes are on the street. An access trail to BMOSP is across Sundevil Way (in the direction this view is looking, so the ROW may be used by some residents as hiking or Mountain Bike access. The ROW drops steeply down from the pictured structures. In this cKOP the camera is pointed considerably up, not a normal view for a resident or recreationist. cKOPs 23, 24, & 25 were in response to a scoping letter from a resident attorney who live on Bassmore Dr.. His fence backs up to very near the TSP pictured. It was difficult to capture his backyard view because of a chainlink fence surrounding the perimeter of his property.

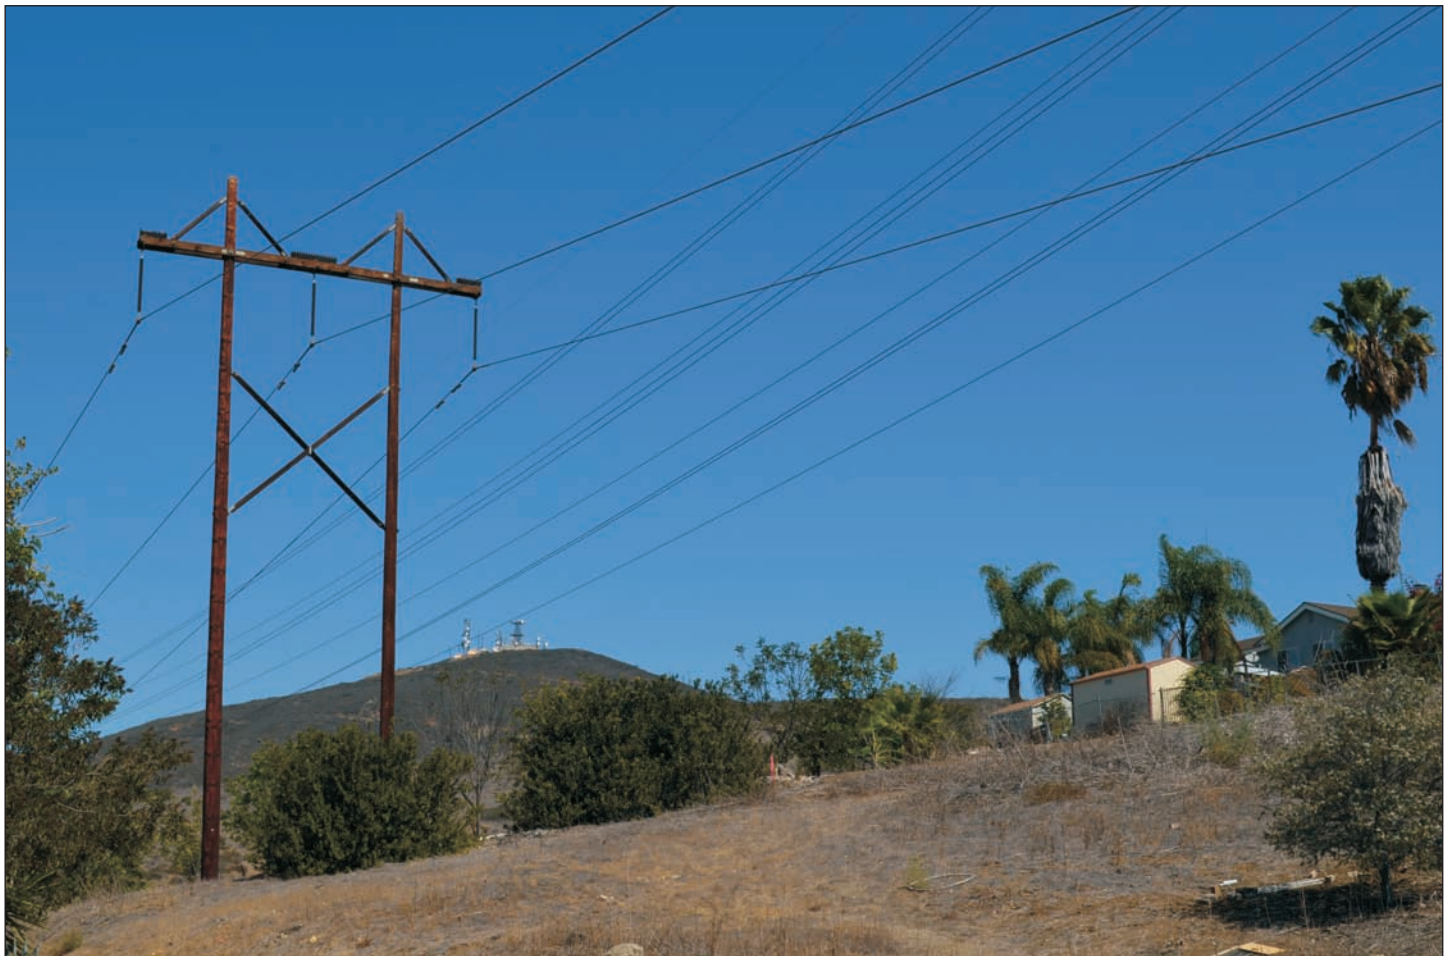
Comments: cKOP 24 demonstrates how difficult it was to characterize the views in this enclosed viewshed. This view is from the opposite side of the ROW than the scoping commenter's residence. It is so close the TSP doesn't fit in the Horizontal field of view. The survey marker right of the H-Frame shows where the new TSP is proposed. The SW corner of the chain link fence around the cementer's residence is visible near the yellow out-building.

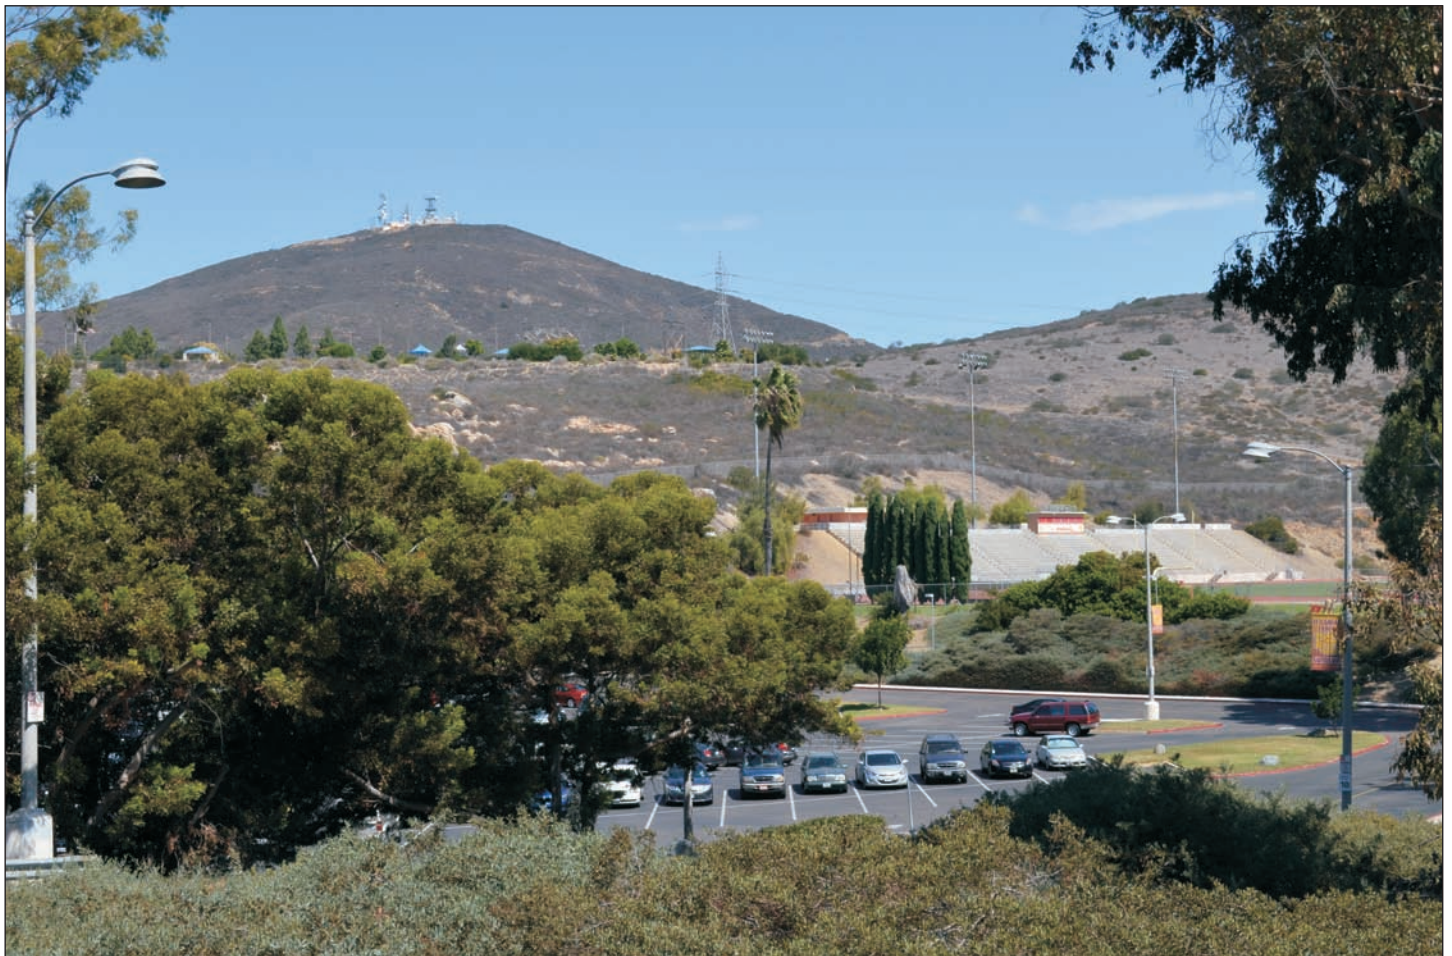
Comments: cKOP 26 is in response to a scoping commenter who thought the students at the HS needed a vantage point. A large parking lot and Sundevil Stadium and some open space lie between the cKOP and the ROW. The blue roofs of the shade ramadas at Hilltop Park are visible in the distant foreground. Black Mountain and its Comm Site forms the horizon. The new TSP will be partially skylined and the H-frame is difficult to distinguish in these lighting conditions.

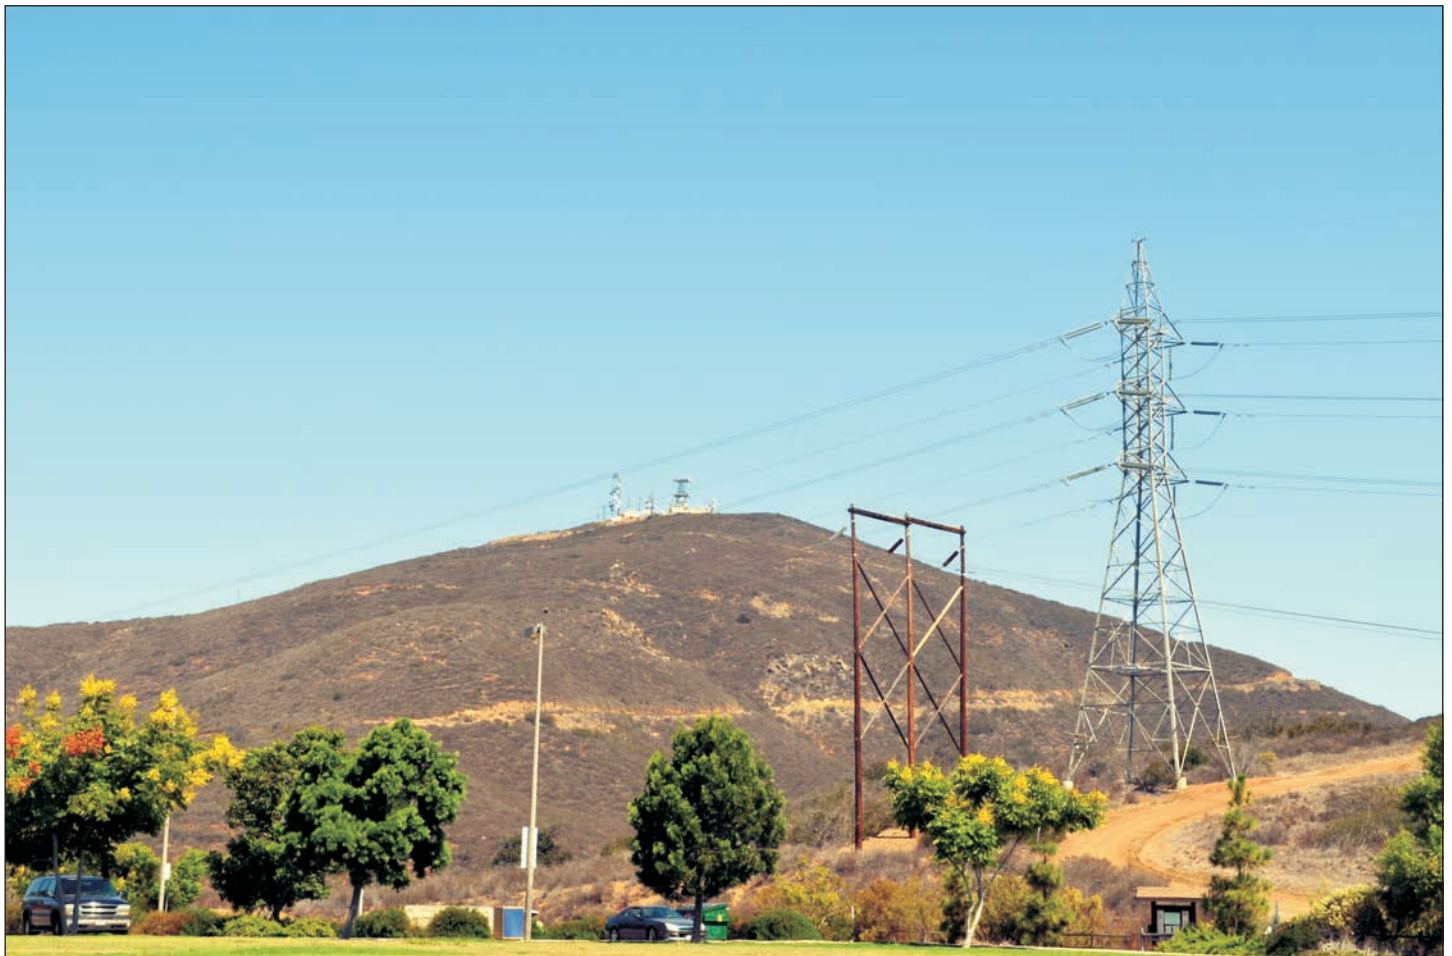
Comments: cKOP 27 is from a popular community park with sweeping views, on a clear day blue water ocean views of Catalina and San Clemente Islands could be afforded in the opposite direction as the project. A kiosk with a map and information on the trails to Black Mountain Open Space Park is visible in the immediate foreground. The angle (tension) structures are immediately beyond with the trail curving in front of it. The diagonal line behind the TL is the main access road to the summit. The massive microwave and satellite communications infrastructure are skylined along its horizon. The new TSP will no doubt require a large diameter in-line dead end tower structure. This SLT is rather short, less than 90'. The new TSP will tower above it if the IOU builds a 125' TSP as purported. There is also a large (1.62 acres) stringing site on both sides of the tower structures which will clear significant amounts of vegetative over cover and create additional contrasts.

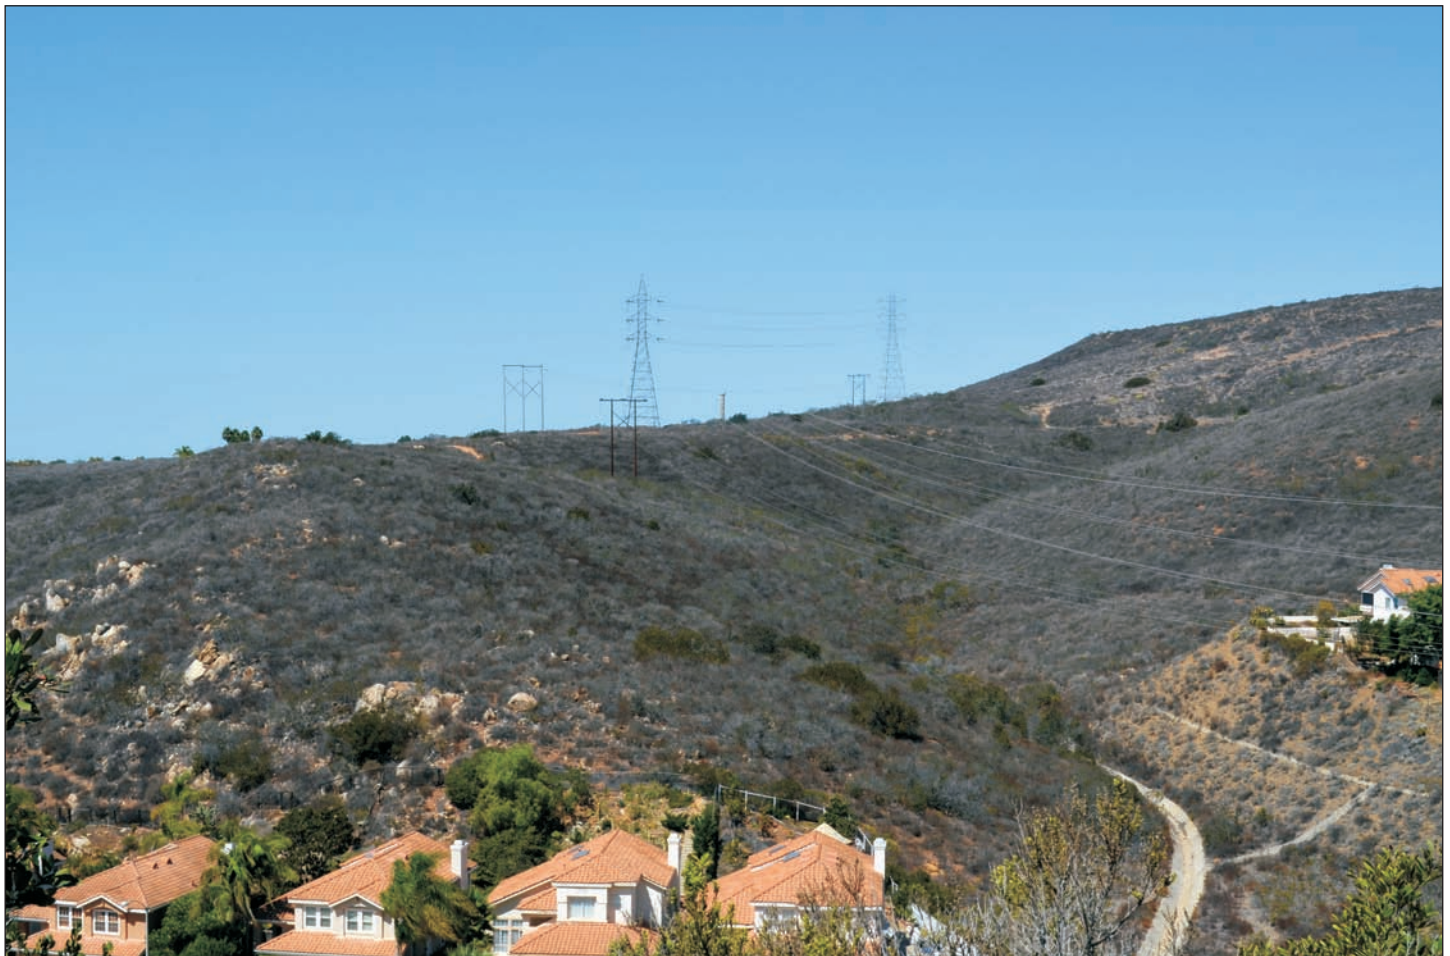
Comments: cKOP 28 is from a popular community park with sweeping views, on a clear day blue water ocean views could be afforded in the opposite direction as the project. This view is the next set of structures from the previous cKOP; it is an extremely long span (>2500') anchored by two large diameter tension structures. Currently there are 3 H-frame visible. there will be 2 new incongruent TSPs next to the SLTs. The new tower structure will be a large diameter pole that will be nearly completely skylined as will the next pair of tower structures, which are tangent poles. A large stringing site (SS II) is proposed for both sides of the work area. This will require vegetation removal and the light colored ground will contrast strongly with the dark chaparral. The cylindrical structure to the right of the first SLT is a stand pipe for the aqueduct that shares the ROW.

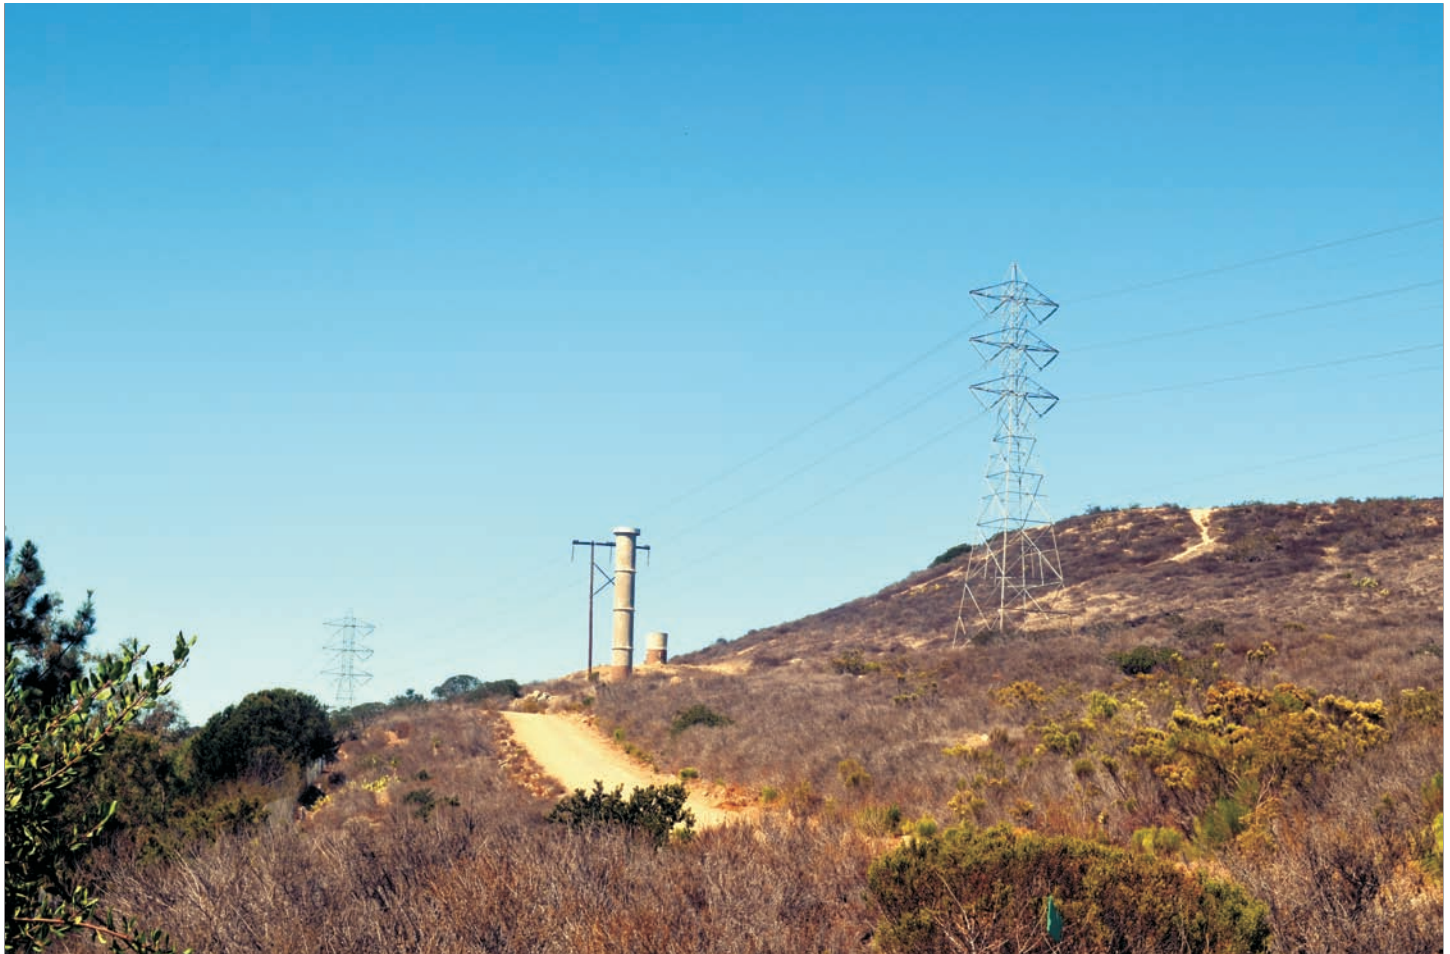
Comments: cKOP 29 approximates the back yard view of a handful of residences along this residential street. This is an area of steep topography, so much so the street is single loaded farther north. The vent structure and stand pipe are water aqueduct infrastructure. Only one H-frame is visible 2 of the new TSPs will be visible.
