APPENDIX F: AESTHETIC RESOURCES SUPPORT INFORMATION

Appendix F provides supplemental information for the aesthetic resources impact assessment approach described in Section 4.2.3. The CPUC has not developed its own method for assessing visual character and quality under CEQA. The visual impact assessment follows the CEQA Guidelines and supplements the CEQA Guidelines with guidelines provided in *Visual Impact Assessment for Highway Projects*, which uses a numeric evaluation approach to assess the degree of impact (FHWA 1988). Supplemental information provided in Appendix F includes:

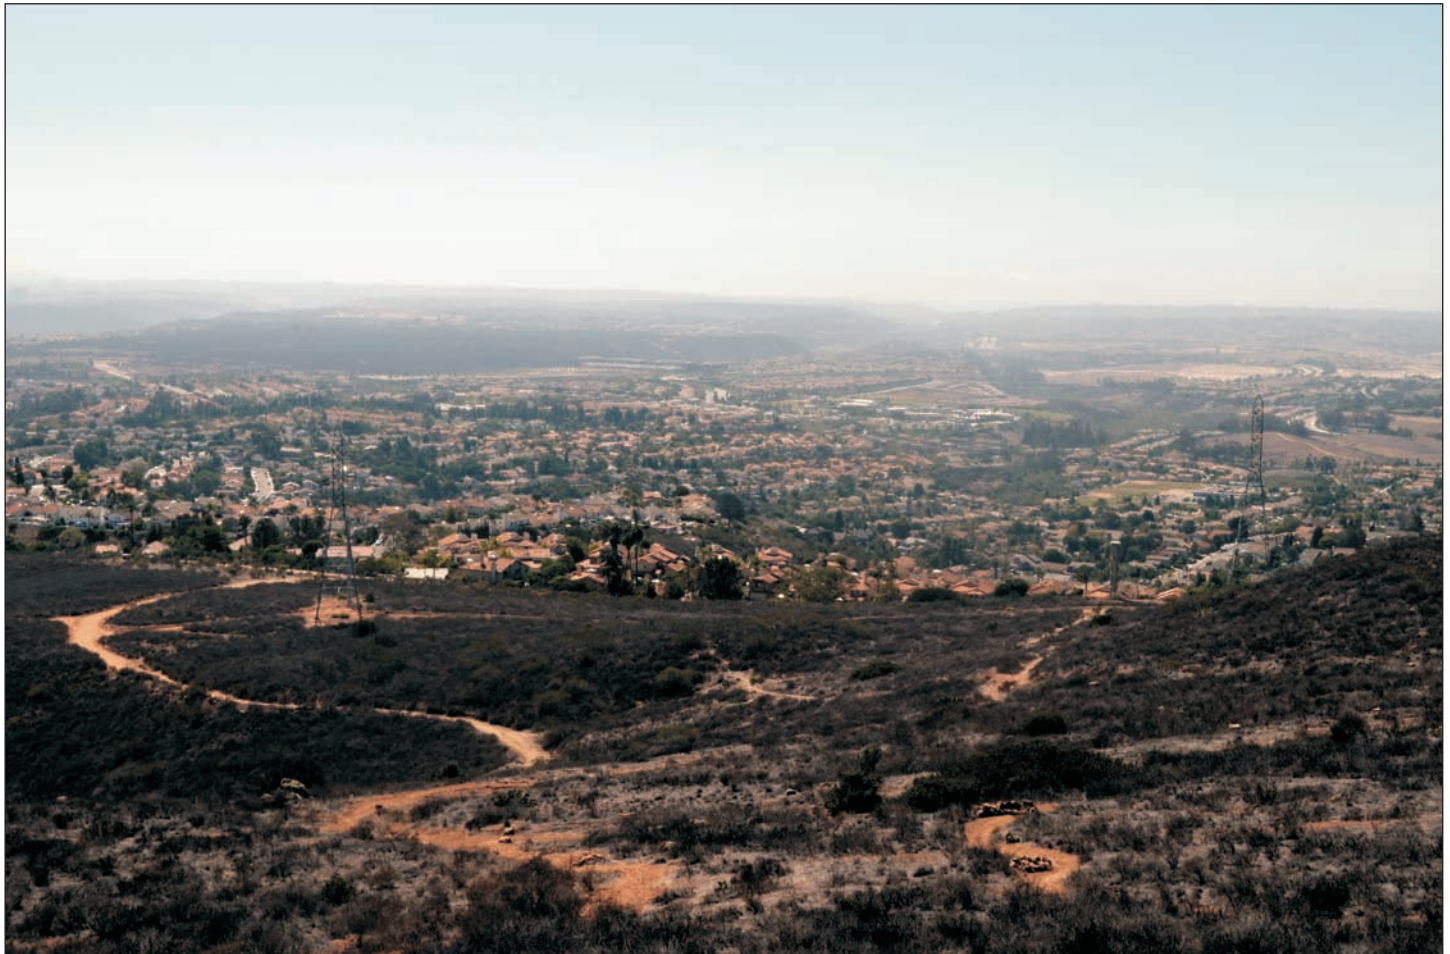
Comments: cKOP 30 is from a labyrinth of single track trails that provide a shorter but steeper route to the summit of Black Mountain. I'd intended this one to be from the main summit access trail (double track) but as that trail trended easterly the ROW was quickly obscured by topography. I did meet a couple hikers descending the summit using this steep trail. This photograph demonstrates how the open lattice structure recedes when appropriately lit and back dropped. The photograph was taken late in the afternoon and the camera was aimed in the direction of the sun, which explains the dramatic amount of contrast in the photo. A photo at a different time of day would be preferable. The 2 pairs of tower structures visible are tangent structures however, the proposed TSPs will be more noticeable. From this elevated cKOP the permanent vegetative clearing for the new TSP will also be evident at the south (left) structure. Current data shows that north (right) of the second towers will require marker balls.

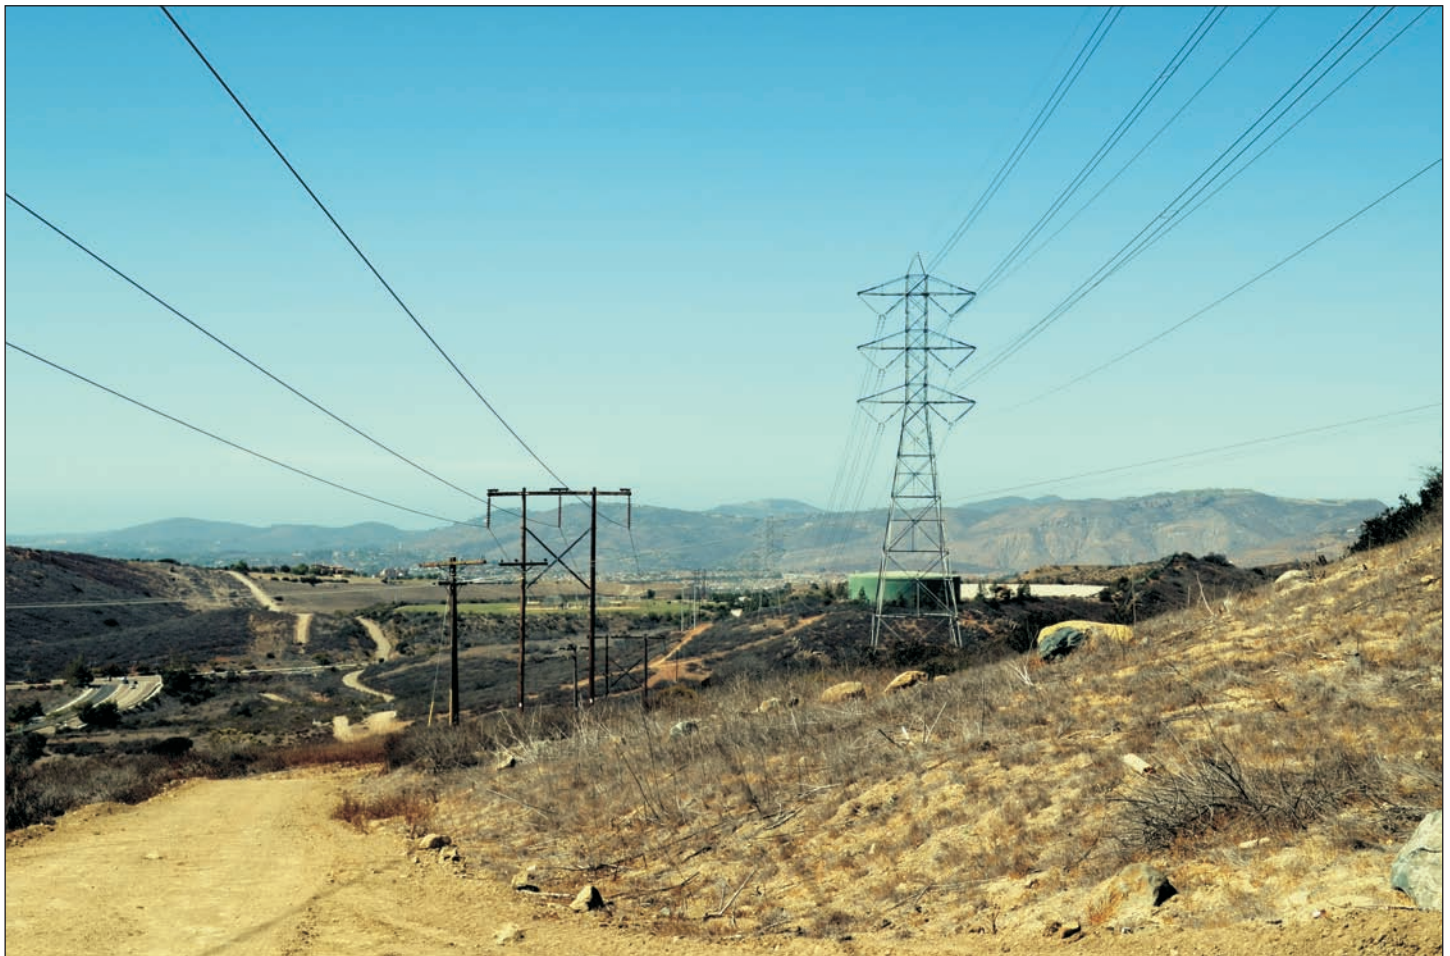
Comments: cKOP 31 is from a trail that parallels the TL ROW several single tracks afford access to higher portions of the open space. These trails offer shorter but more challenging routes to the summit. This view again demonstrates how the SLTs recede with distance, when back dropped. Black Mountain Ranch Park is in the near middleground. To the right of the park, the charred vegetation from the fast moving Bernardo Fire from the spring of 2014. The trail to the left (south) of the park is part of the popular Lusardi Creek Loop Trail that traverses open space managed by the San Dieguito River Park. The intersection of Black Mountain and Carmel Valley Roads is nearly visible in the lower left part of the view frame. Marker balls are proposed on the overhead span and terminate at the first visible poles. The land scar from the vegetative clearing for the new tower will be visible.

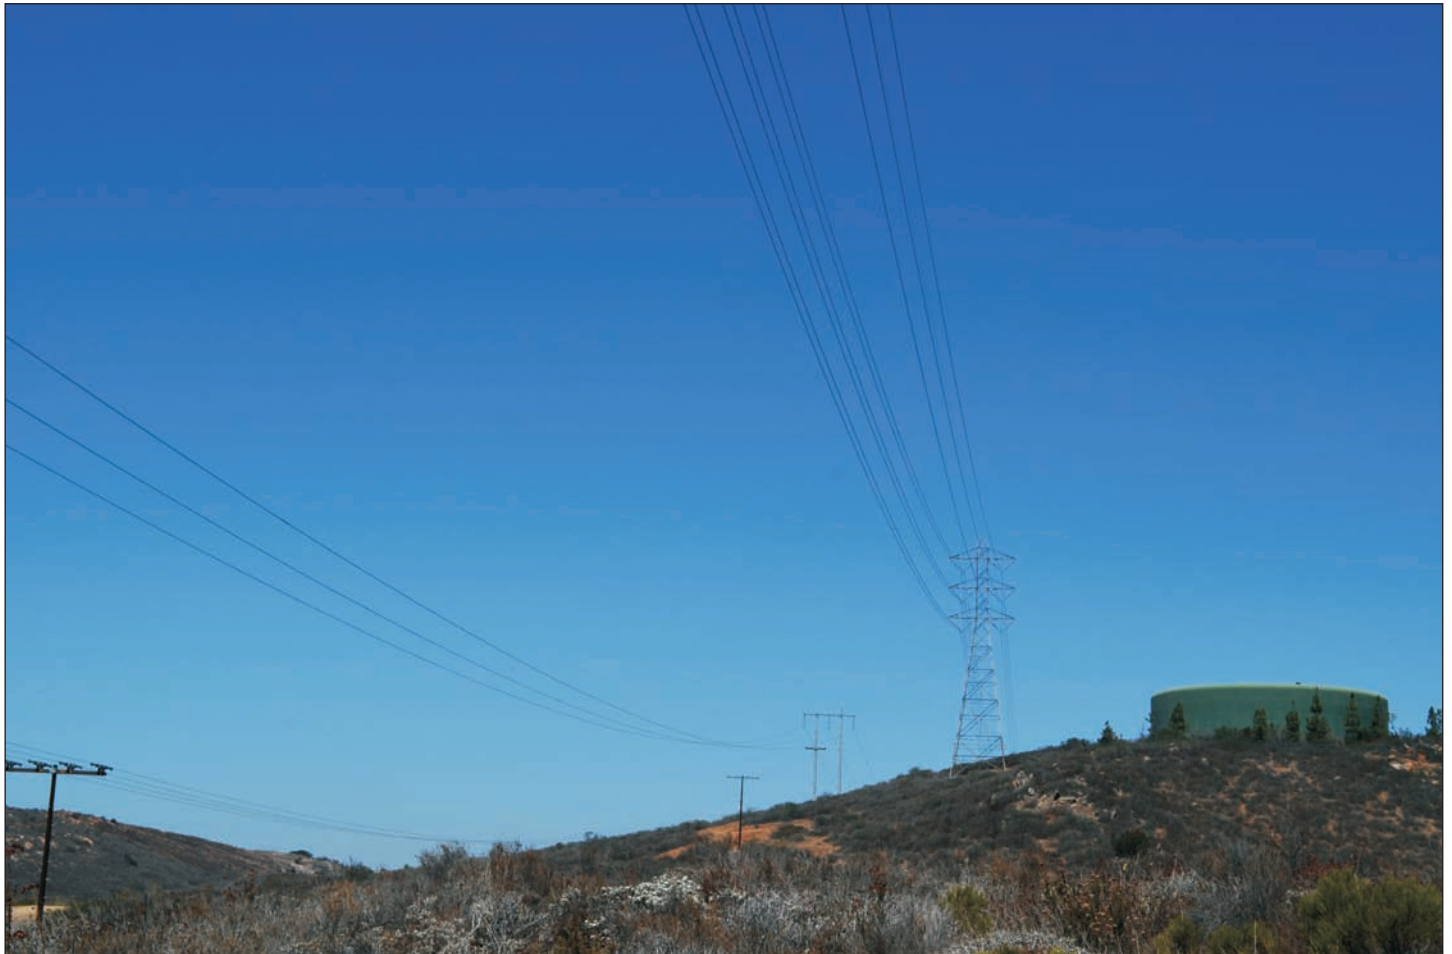
Comments: cKOP 32 is from the entrance to a small isolated residential development (+/-26 homes) in a finger canyon surrounded by BMOSP. The topography rises steeply around these homes. The pair of structures are skylined and adjacent to a large color treated water reservoir (SDCWA Second San Diego Aqueduct). The overhead span will likely require marker balls. The reservoir exhibits visual mitigation to reduce its contrast. The color treatment, albeit not perfect helps to reduce its dominance and the vegetative screening softens its mass. The bundled conductors of TL 23051 are very evident from this perspective.

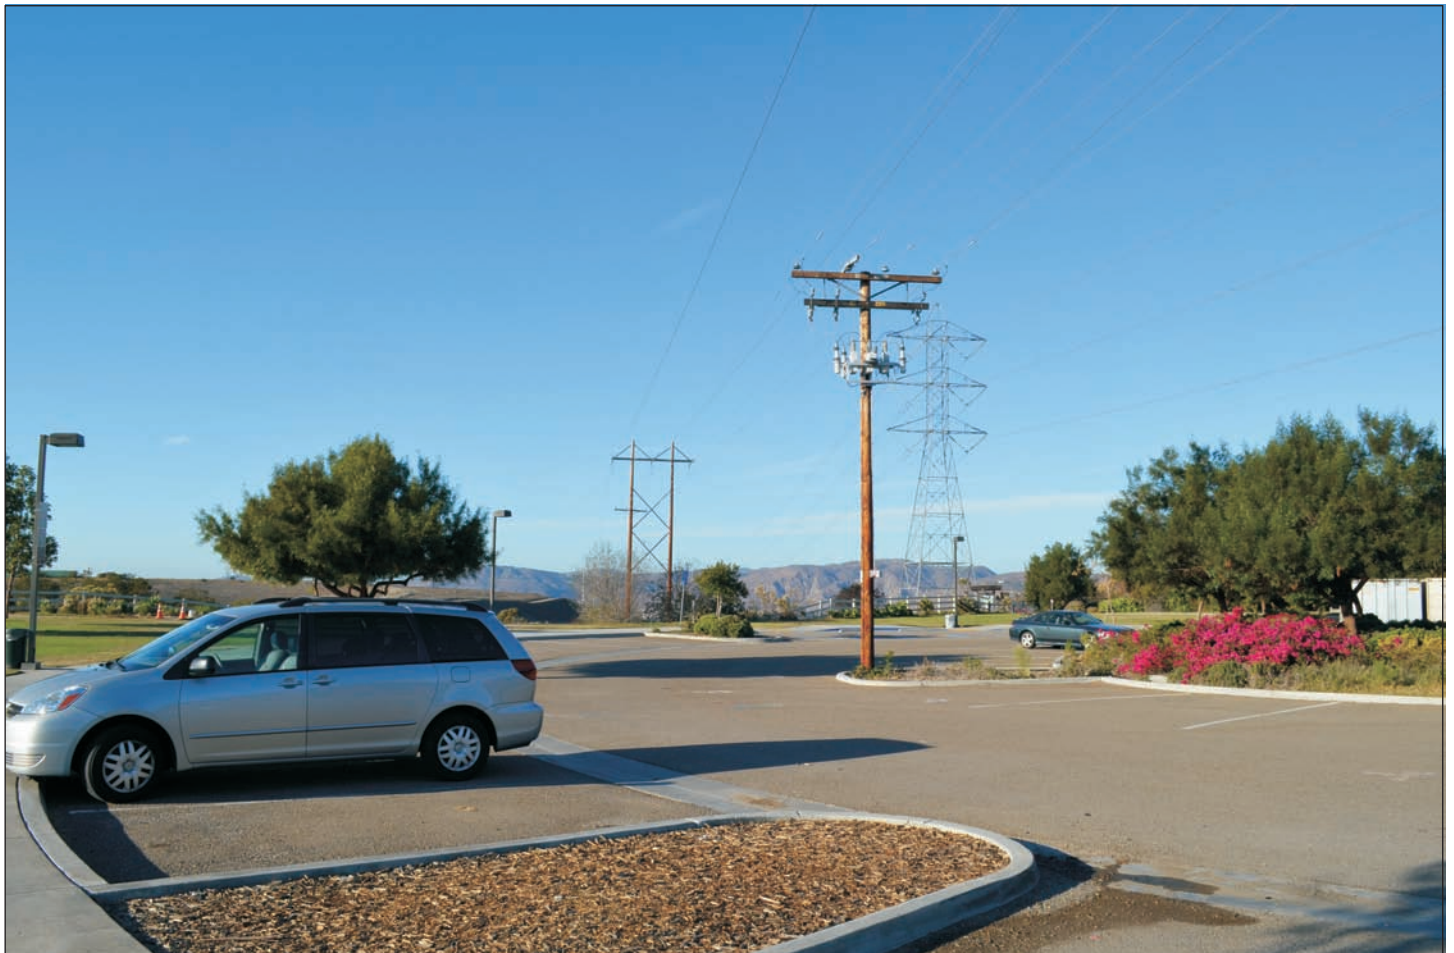
Comments: cKOP 33 is from Black Mountain Ranch Park and active recreation area that also serves as a trail head to the popular Lusardi Loop Trail which is part of San Dieguito River Park a JPA administered facility; the trail is a multi-use trail that follows La Jolla Canyon. The open space lands beyond the transmission structures shown was extensively charred in the Bernardo Fire (May 2014). A kiosk and trail head are visible on the right (north) side of the existing TSP. The H-frame structure at this location is proposed to be replaced with a TSP cable pole; a large diameter in-line dead end structure that reroute the conductors from an overhead to underground position. Cable pole because of their mass and function could be construed as the most visually obtrusive of the tower structures proposed. The horizon of this viewshed is framed by the uplands of the Harmony Grove area. The existing pair of tower structures are in Black Mountain Open Space Park (City of San Diego) and are only partially visible due to a +/-15' elevation difference between the towers base and the existing park. Data recently provided shows the proposed cable pole to be located in the turf area of the park near the white fence in the distant foreground.

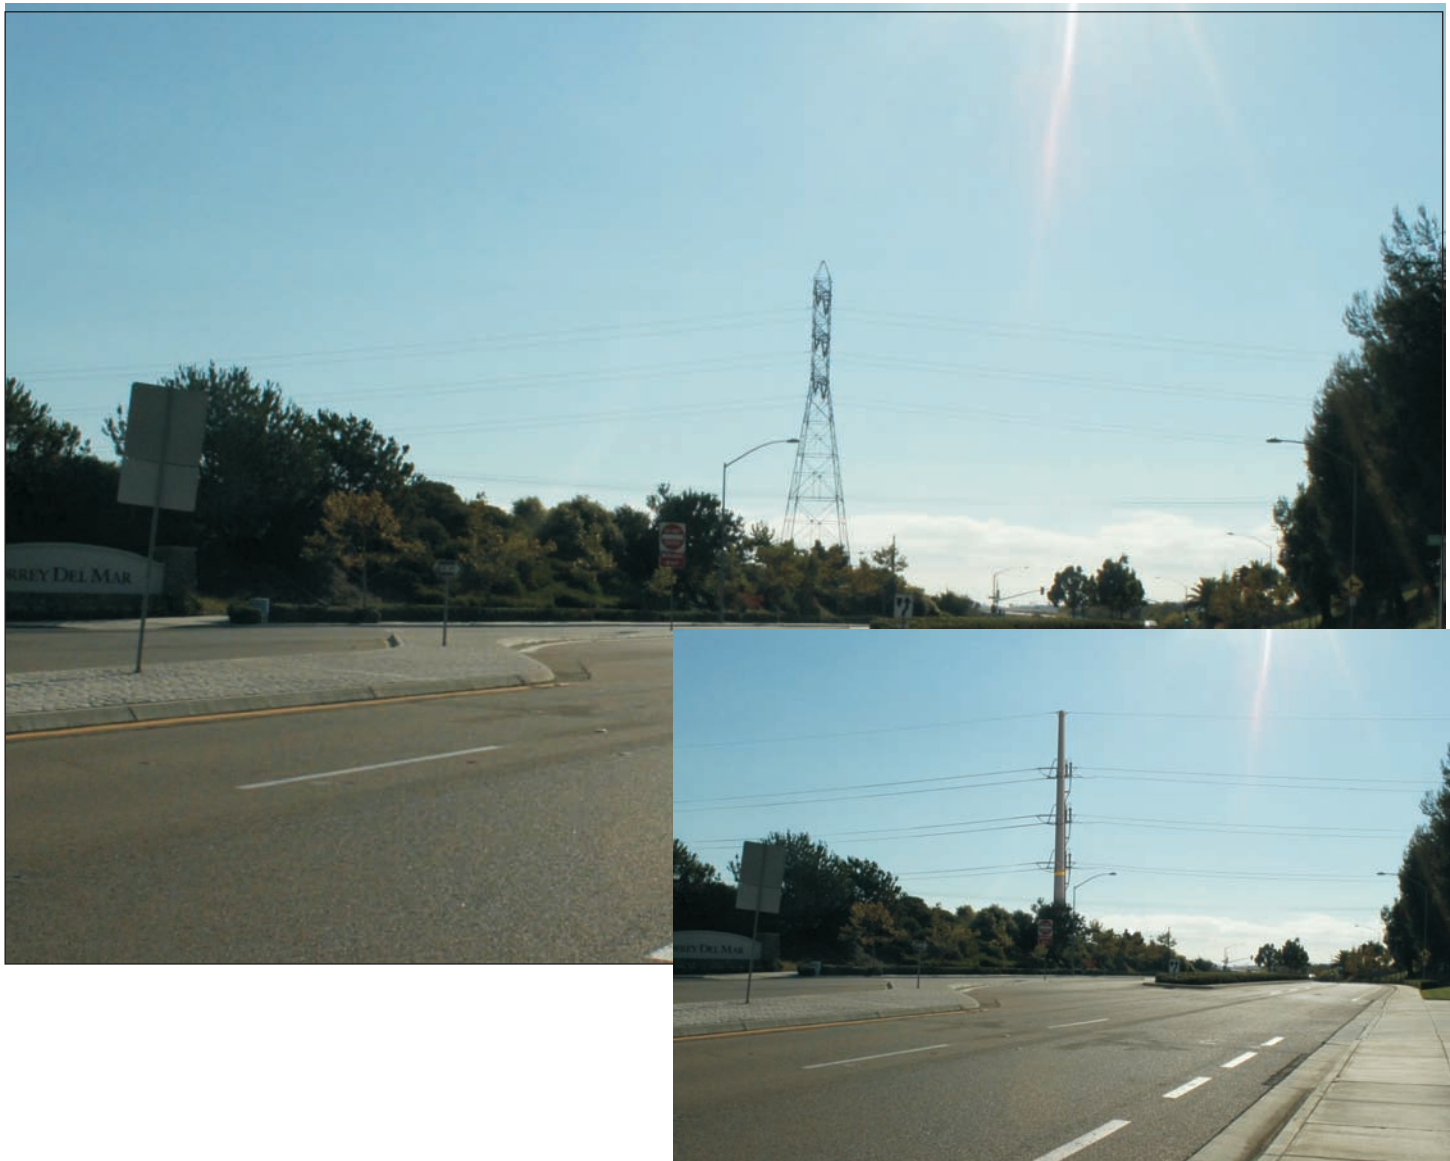
Comments: Upon further review and field observations, I would like to suggest we change the location of cKOP 34 (see field notes). The vantage point currently chosen tends to minimize the visual impact by aligning the cable pole and the STL and partially screening the base. There is also a relatively large stringing site (SS 15) and permanent work area at the base that is not evident in this perspective. The location of the cable pole (P42) is topographically superior to Carmel Valley Road so I doubt that I will find a vantage point from where the impacts of the vegetation clearing for the cable pole's work area will be visible. However, adjacent residential development is underway, and those future receptors may be impacted.

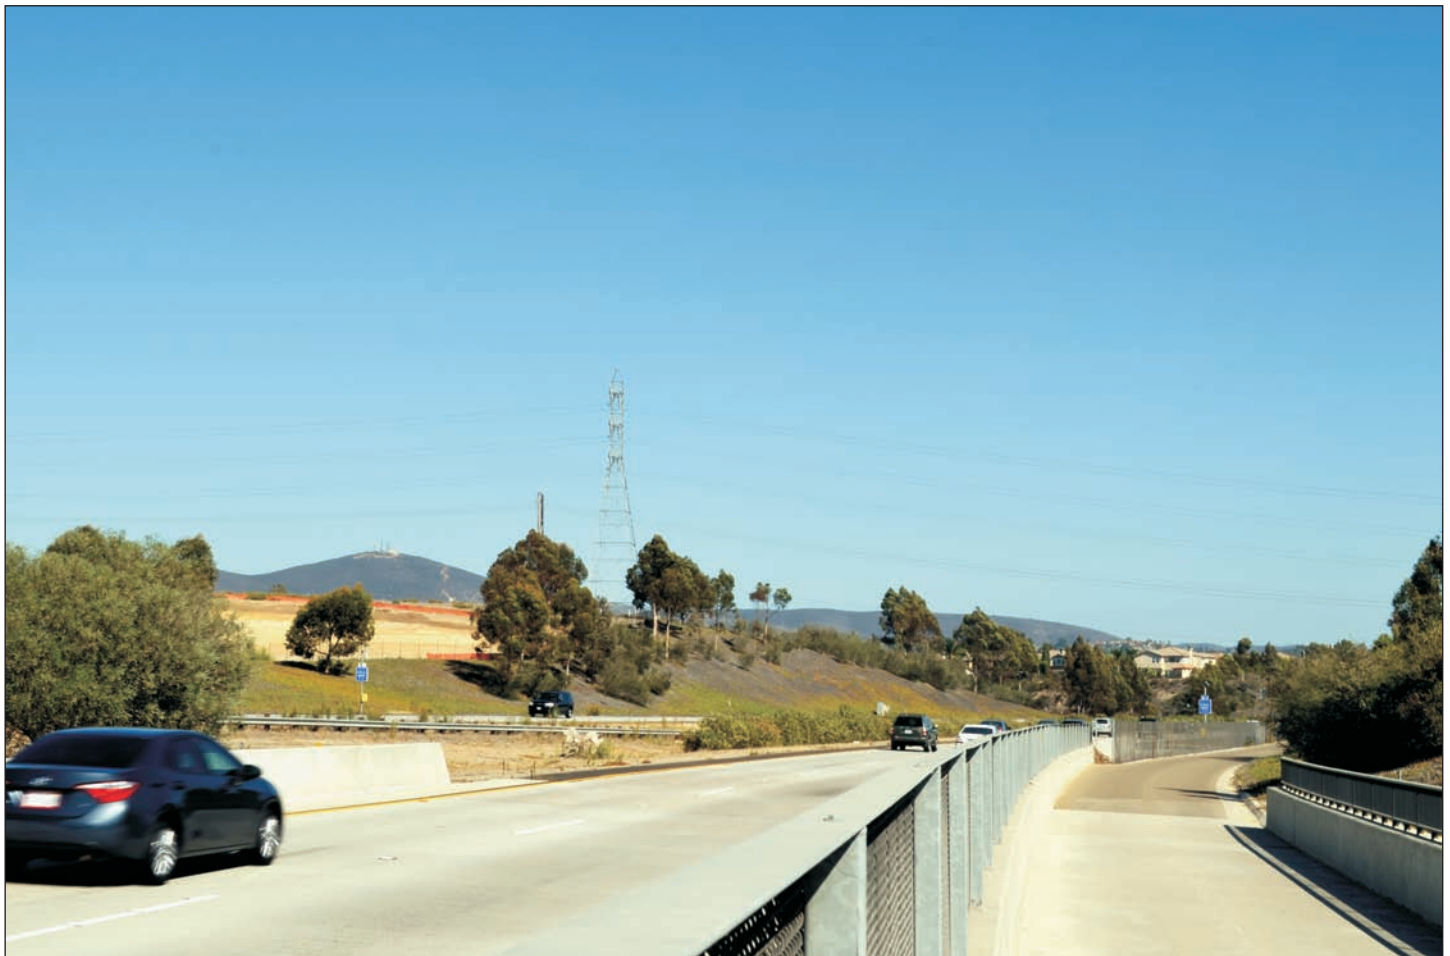
Comments: cKOP 35 is the eastbound lane of SR-56 near the crest of its arch. The motorist view of the line is short due to the rate of speed and the roadways sinuous alignment. This route is heavily traveled and during rush hours the duration of the view could change significantly. The ground disturbing activities visible on the north (left) side of the freeway is a large area of new home construction which continues to the other side of the freeway to the right of the view cone of the cKOP. This is the first cKOP that looks at Segment C. Segment C is the least visually impactful Segment because no new tower structures are proposed. The bundled conductors on the SLT will contain 12 phases (conductors) where now there are 6.

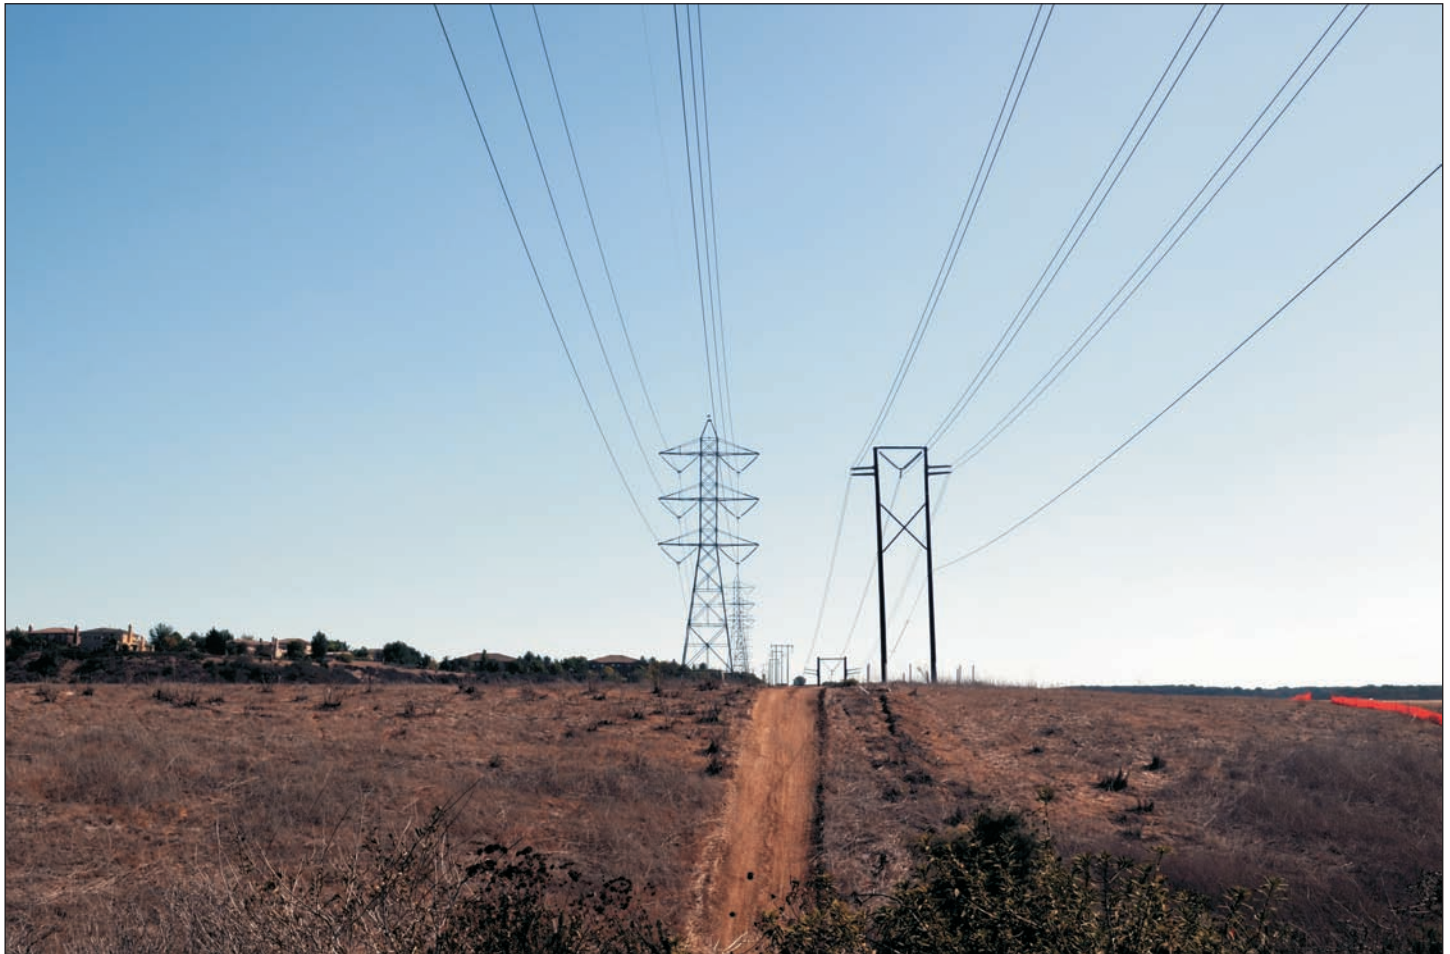
Comments: cKOP 36 is the Class I bikeway that runs from Del Mar to Carmel Mtn. Ranch along the south side of SR-56. The blacktop bikeway is enclosed on both sides by a 5' black vinyl chain link fence. The din of the passing vehicles makes it less than a bucolic experience. The bikers observed seem to be avid cyclists commuting or seeking a long relatively unencumbered exercise route. The cKOP is located under the ROW where the bundling of conductors will be most visually profound.

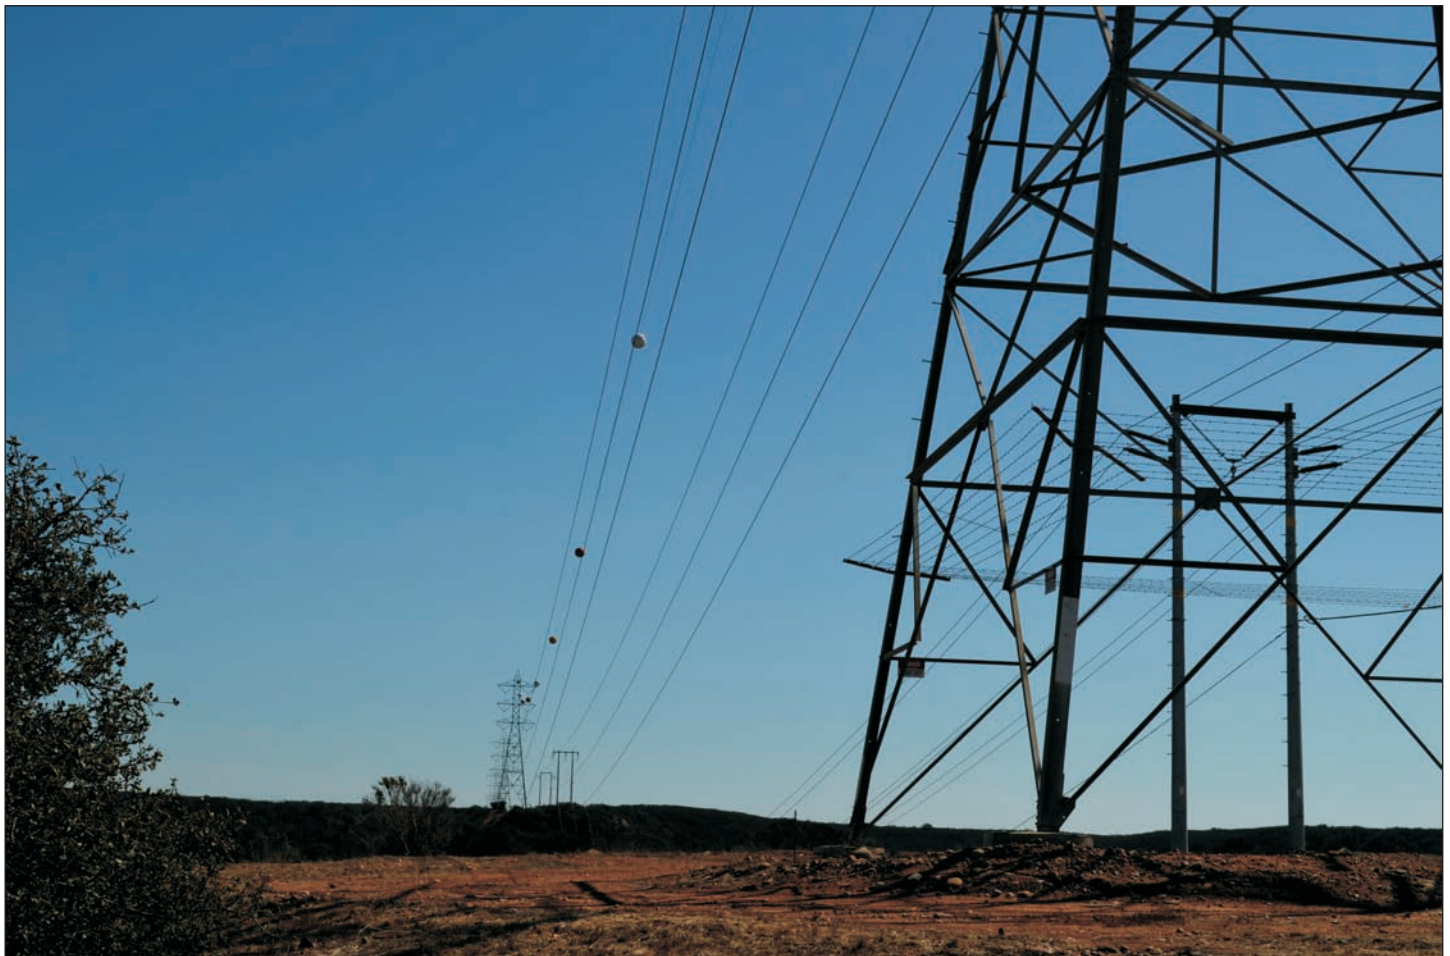
Comments: cKOP 37 is representative of what south facing residents of the Torrey Santa Fe (Santa Fe Canyon Pl. and Via Canyon Dr.) development would experience. These home have dramatic open space views of Del Mar Mesa Preserve's Deer Canyon. Conductor bundling's visual intrusion depends on the viewers perspective. If their perspective is normal (that is if the observer were at a similar elevation as the conductor catenary it would appear as if it were a single conductor. If the observers perspective is superior or inferior the multiple lines (separated by 18") would be more noticeable. This perspective is inferior and nearly underneath the lines which could be construed as a worst case scenario. The presence of the marker balls on the shield wire of the SLTs are very noticeable.

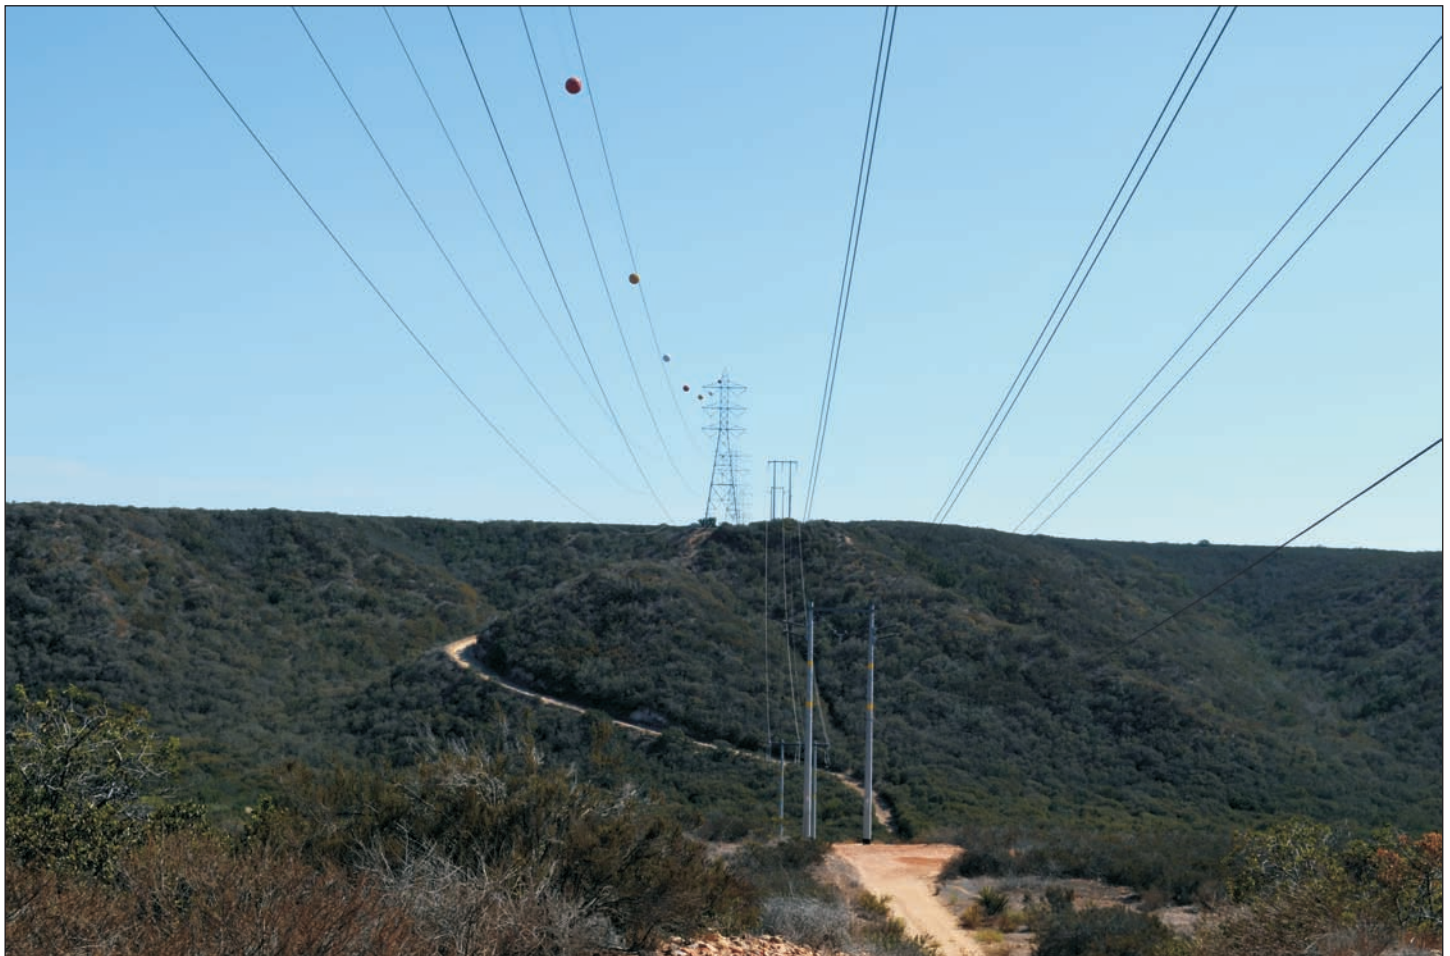
Comments: cKOP 38 is from the TL Trail as it enters Del Mar Mesa Preserve (DMMP). DMMP has restricted access to many of the mountain bike communities favorite trails because of the area's biological relevance. This trail remains open and is the primary N-S access to the handful of other trails on the mesa that remain open and to Los Peñasquitos Canyon Preserve (LPCP). In the foreground is perpendicular crossing of Deer Canyon some 300' feet down to the canyons floor. The hill up the south side of the canyon is called Cardiac Hill. Notice the dense Maritime Scrubs coarse texture and mottled grey-green color. This view would be completely naturally appearing if not for the presence of the TL. The stark contrast of the bare soil is extremely noticeable.

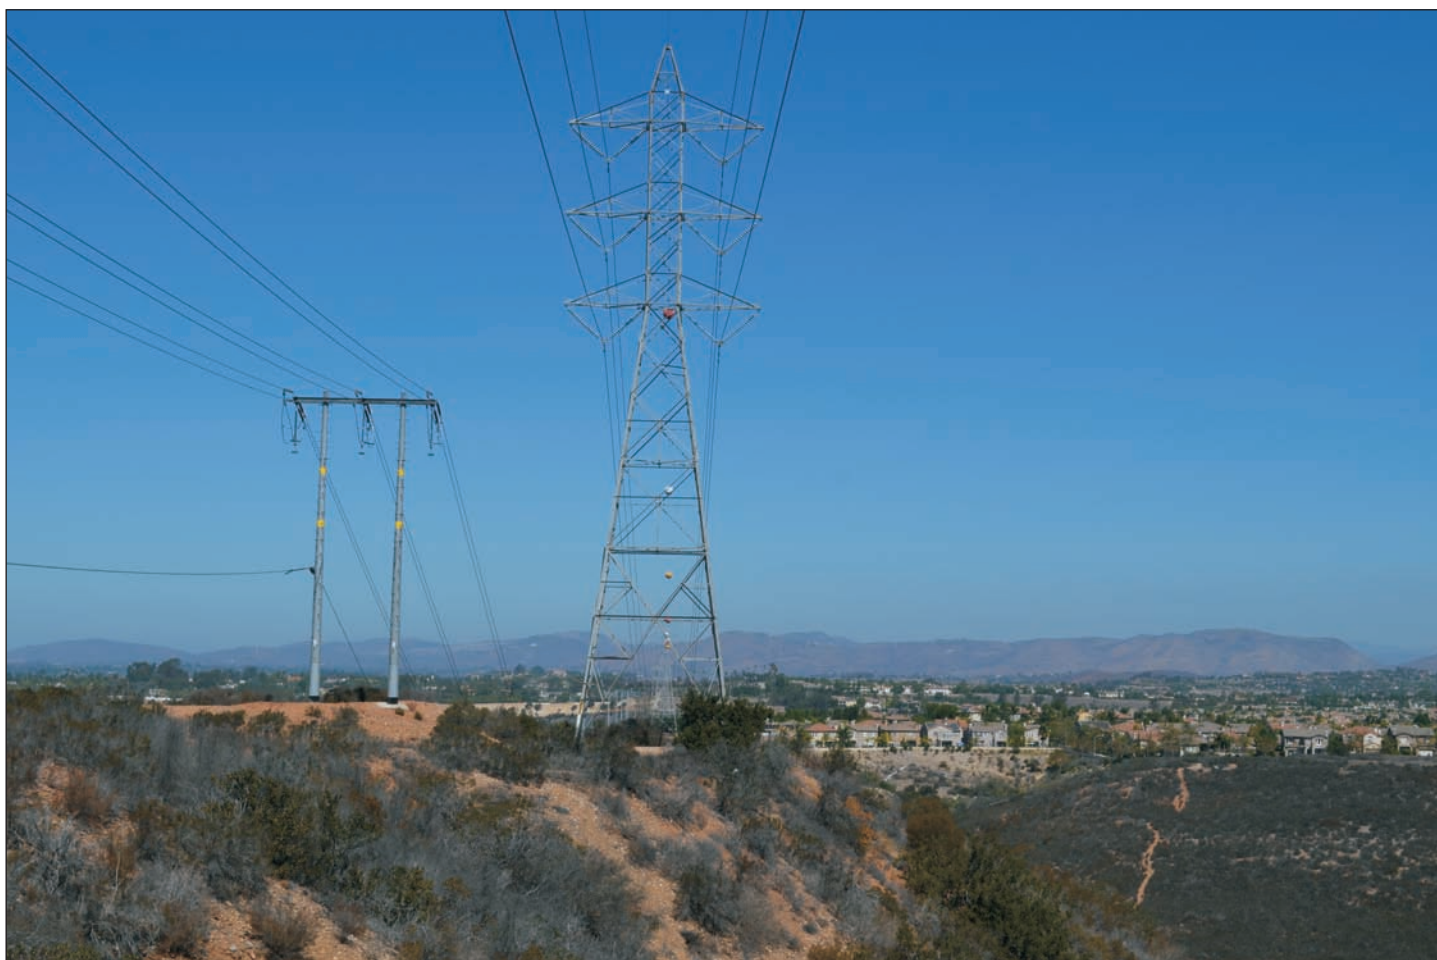
Comments: cKOP 39 is from the opposite side of Deer Canyon as cKOP 38 and is oriented south as opposed to north. Again directly beneath the conductors catenary. Torrey Santa Fe are the house in the distant foreground. Marker ball presence is diminished because of their location behind the SLTs. The low mountains west of Escondido form the horizon.

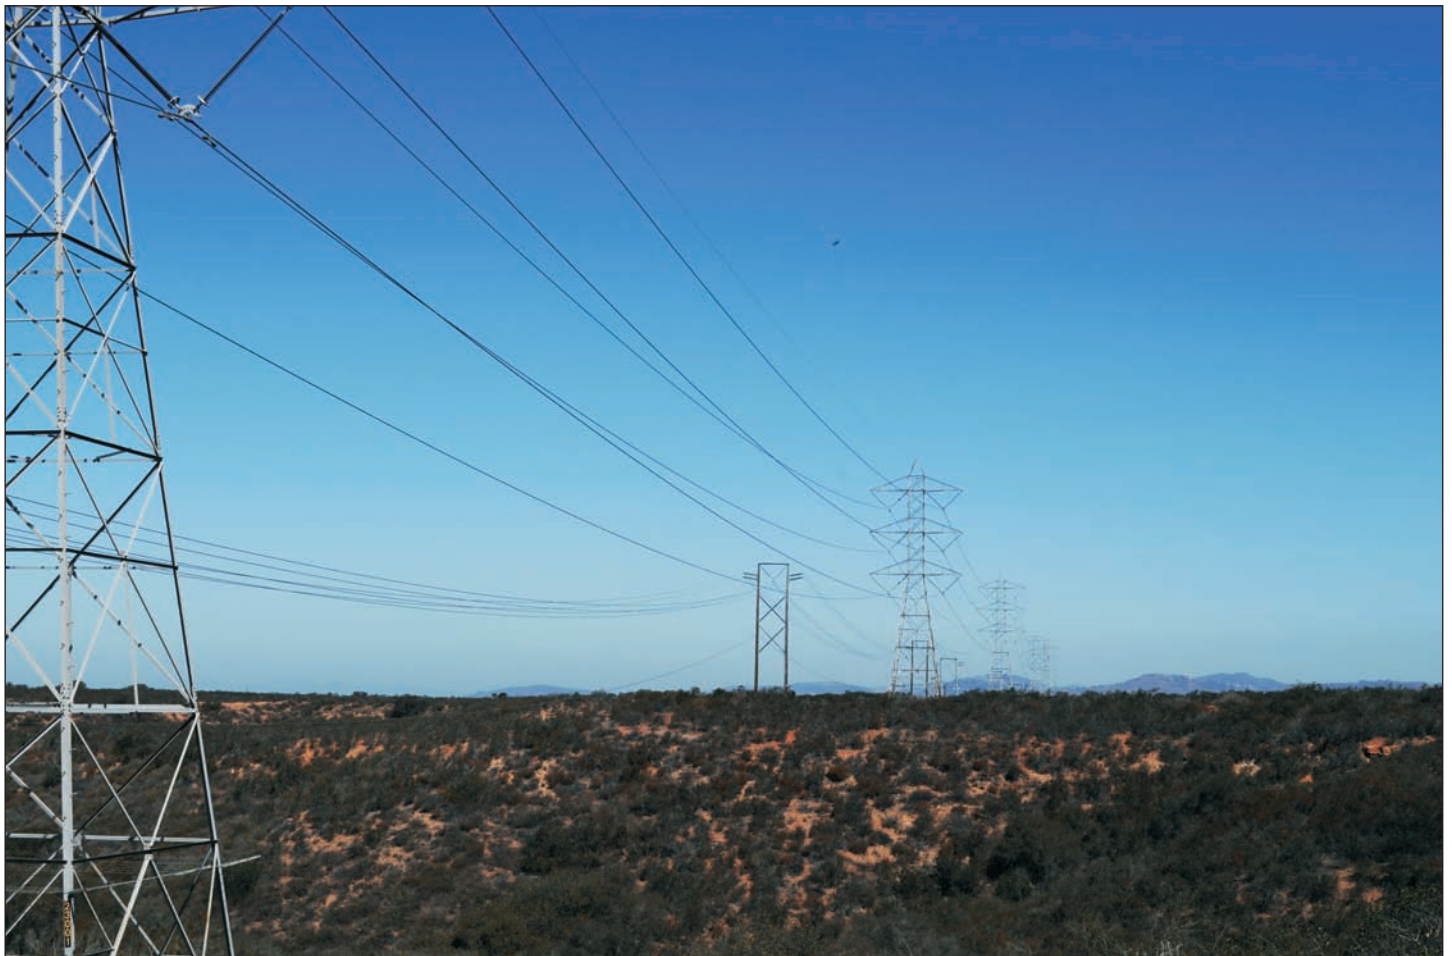
Comments: cKOP 40 is at the intersection of 3 trails. There is an informational kiosk. This is the mesa top there are few finger canyon or other forms of relief. This northerly view along the ROW would be completely naturally appearing if not for the TL presence. The abundant Maritime Coastal Sage Scrub gives the ground plane a coarse texture. The topographically inferior position to the conductor catenaries will allow the additional phases of the bundling to be seen at least in the foreground. Notice the co-location of what is assumed to be a fiber optic cable on the west (left) side of the H-frame. Its catenary is considerable below that of the conductors adding to visual intrusion.

40	DMMP Trails at Peñasquitos Junction	C	5	2.5	2	6	2.5	4.5	5	27.5
41	DMMP Trail and the Preserve Residential	C	4	2	1	6	5	5	3.5	26.5
Segment D – Peñasquitos Junction to Peñasquitos Substation (3.34 miles). The long term visual change would consist of removal of H-frame support structures and replacement with TSPs. Conductor diameter would increase slightly to accommodate increased voltage; however, conductor size increase would not be appreciatively discernable to the casual observer.										
42	DMMP Trail	D	2	2	6	6	5	4.5	4	29.5
43	Peñasquitos Junction	D	5	2	5	6	2	2	4	26
44	View Point on Upper Cobbles Trail	D	3.5	1	4.5	6	3	5	3	26
45A	Duck Pond Trail North	D	3	2	5.5	6	2	5	5	28.5
45B	Duck Pond Trail South	D	2	2.5	4.5	6	2.5	5	5	27.5
46	LPCP Trail	D	1.5	3	6	6	3	5	5	29.5

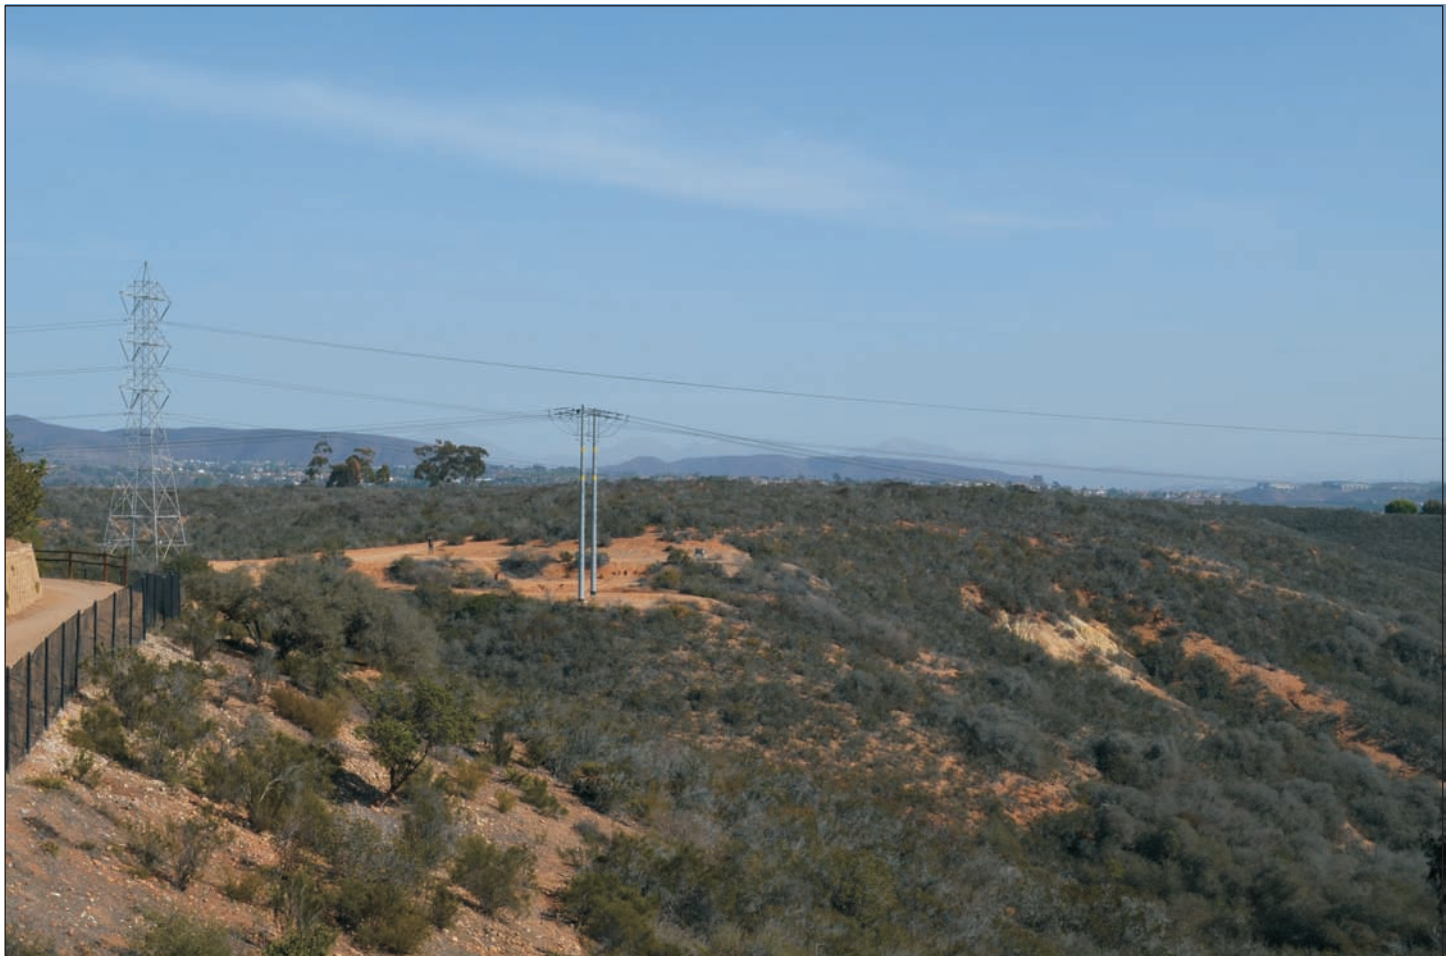
Comments: cKOP 4I is from a multi-use trail that circumnavigates the Preserve Del Mar and exclusive gated community nearly surrounded by Del Mar Mesa Preserve. ~1/2 of the 24 lots have residences. The homes are palatial some are over 20,000 sq. ft. on 1/4 acre lots. Depending on the home's orientation Segments C &/or D are visible. This view was chosen to get some separation from the ROW. Other homes are closer. This view is representative of a existing residential view which overlooks Segment C. The pads of the homes are +/- 10' superior to the view shown from the recreational trail. This elevated perspective provides their views of the conductor catenaries are a nearly normal perspective. Under these conditions the bundling that is proposed on the SLTs will be nearly imperceptible.

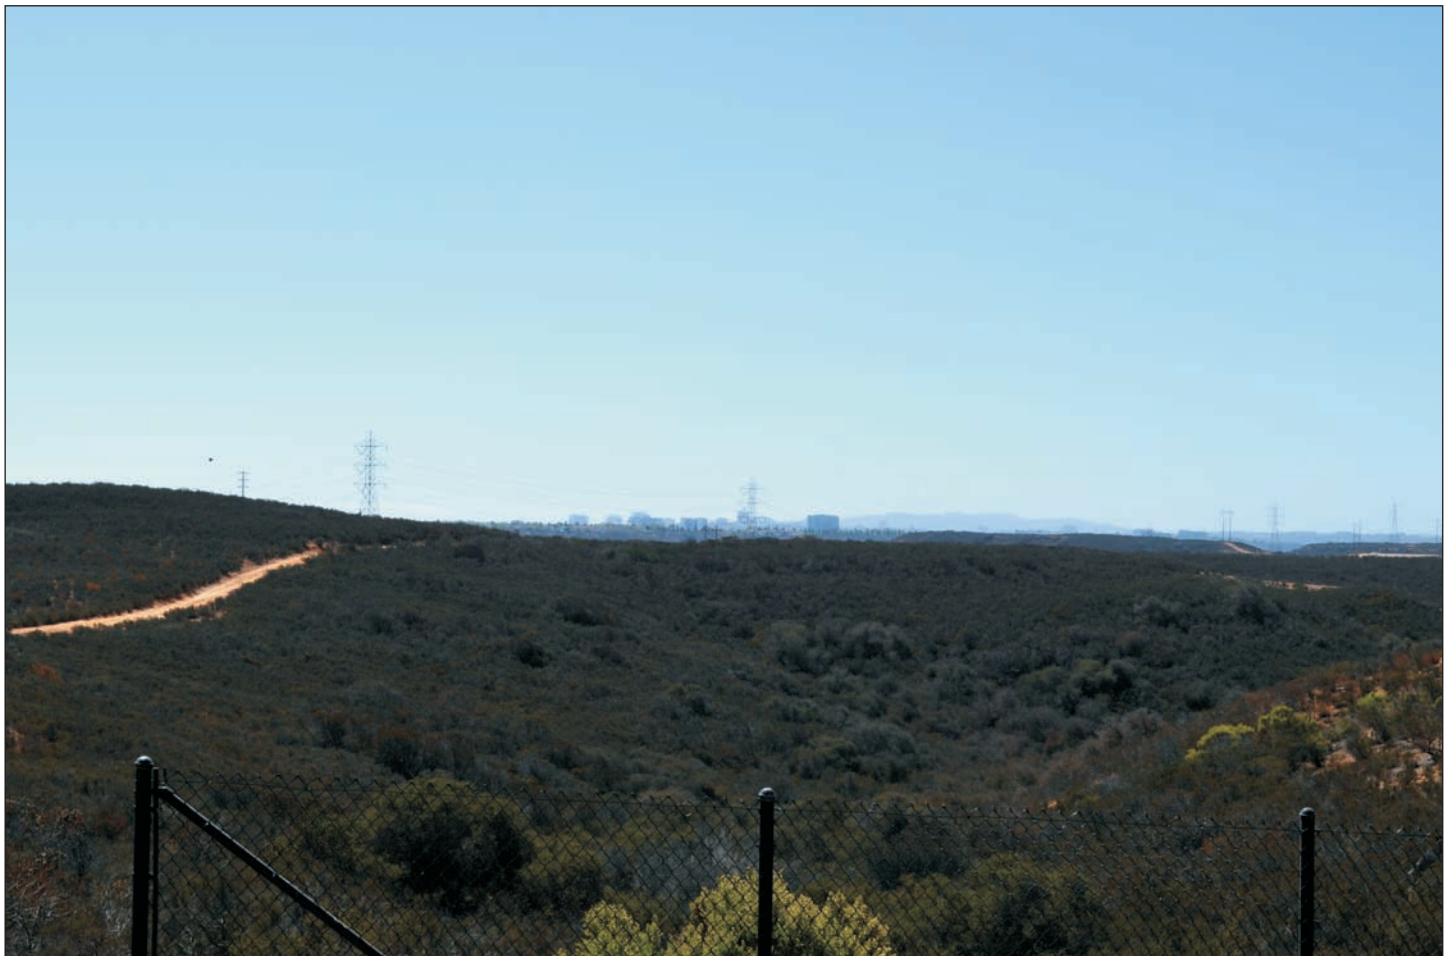
The Upper Cobbles Trail cuts across a portion of the frame diagonally and is representative of the type of impact pole clearing would have in this landscape. This is a middleground (>0.5 mi.) View of Segment D. The new TSPs would be taller and more visible than the H-frames they will replace. 5 SLTs are visible in this view frame. A single marker ball is visible left of the left most SLT.

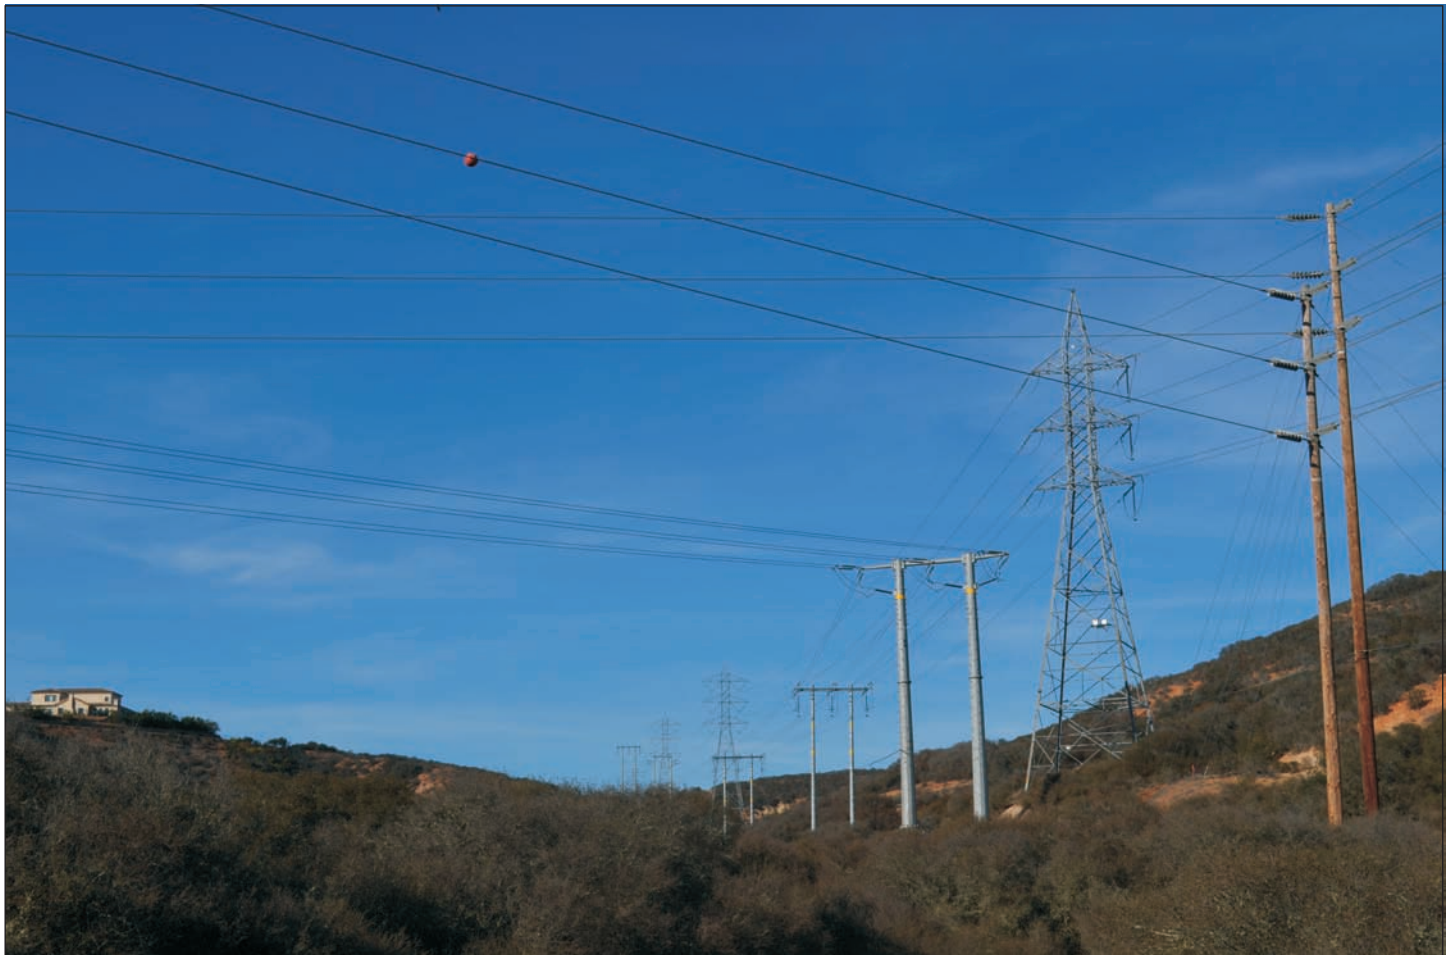
Comments: cKOP 43 is located in LPCP on the Transmission Lines Trail south of PQ Junction looking North at the angle structures proposed. This trail is one of few unrestricted accesses between LPCP and DMMP. The residence visible in the left (west) portion of the view frame is located in the Preserve development. As a result of "project refinements" the SLT will be replaced by a large diameter in-line dead end structure TSP and the steel H-frame next to it will be removed. The 2 wood pole in the left of the frame will be removed and replaced with the first of the TSPs proposed for Segment D. Marker balls will also be required but they already exist. A larger stringing site and permanent work areas will require removal of the dense MSS which will expose the buff colored soil which will create strong contrasts. From this topographically inferior perspective the bundling of conductors proposed in Segment D it be noticeable. This cKOP was moved from a residential cKOP to accommodate changes proposed by project refinements
