APPENDIX F: AESTHETIC RESOURCES SUPPORT INFORMATION

Appendix F provides supplemental information for the aesthetic resources impact assessment approach described in Section 4.2.3. The CPUC has not developed its own method for assessing visual character and quality under CEQA. The visual impact assessment follows the CEQA Guidelines and supplements the CEQA Guidelines with guidelines provided in *Visual Impact Assessment for Highway Projects*, which uses a numeric evaluation approach to assess the degree of impact (FHWA 1988). Supplemental information provided in Appendix F includes:

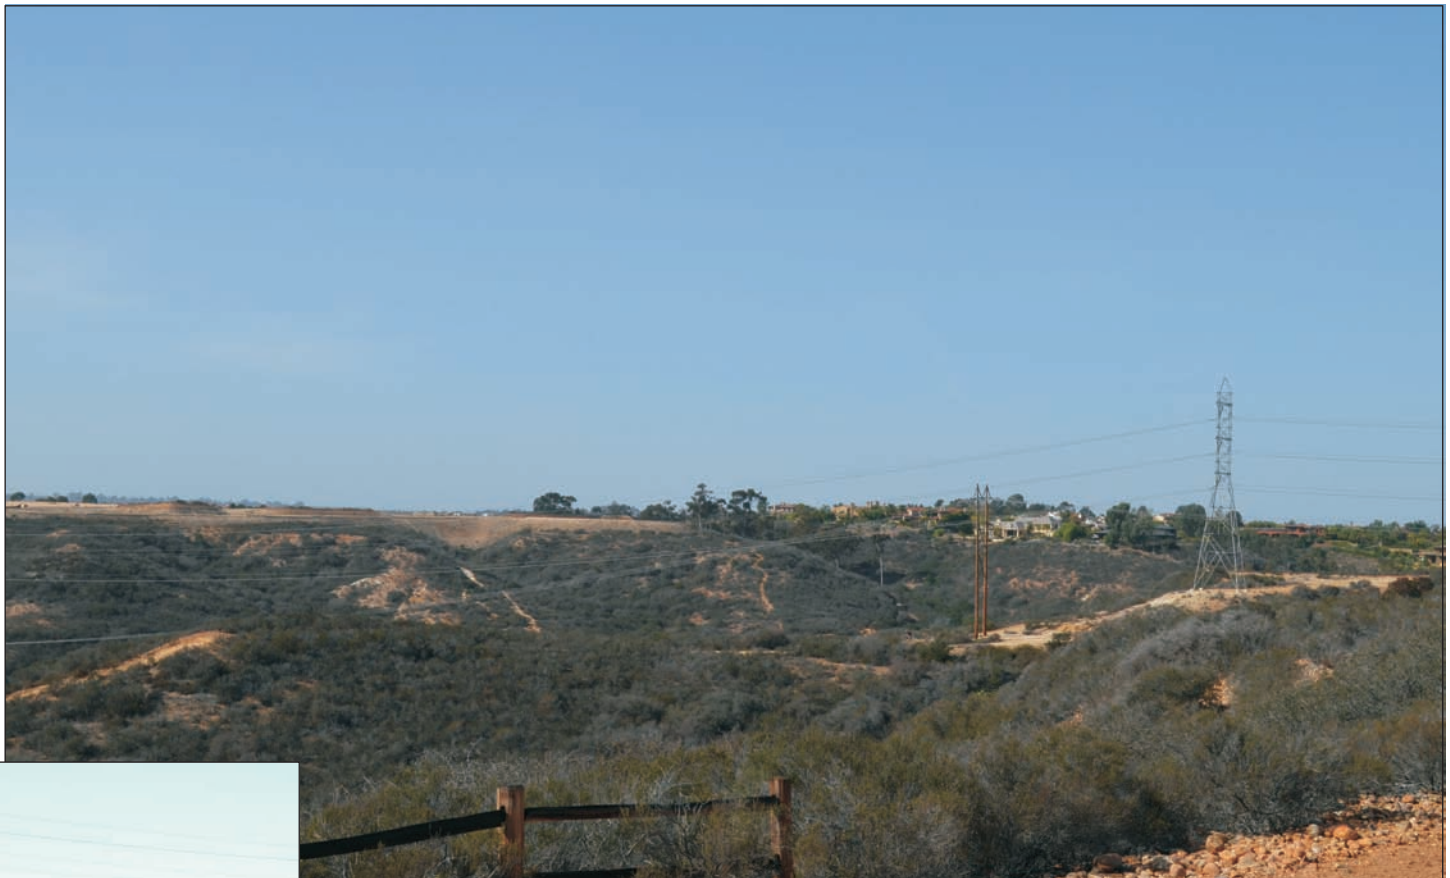
Comments: cKOP 44 is located at the end of a cherry stem off Upper Cobbles Trail. there is a trail sign where upper Cobbles turns westerly and proceeds off the mesa into Duck Pond Canyon. The sign directs recreationists to Duck Pond (right) or View Point (left). The View Point Trail goes under the TL (Segment D) and proceeds another 0.2 miles to a finger mesa on the north rim of Los Peñasquitos Canyon. Views of the canyon here are almost breathtaking; 180° views up and down the canyon. If one scans right from the down canyon viewshed the ROW comes into view as it traverses the canyon's north rim. There is a bench at the view point were recreationists are invited to pause. Viewshed infringement will be of new marker balls proposed between E15 & E16, the new taller TSPs, and the wall and relatively large work areal proposed for P47. *This cKOP's perspective was changed to view the marker balls that were part of SDG&E's project refinements (November 2014).*

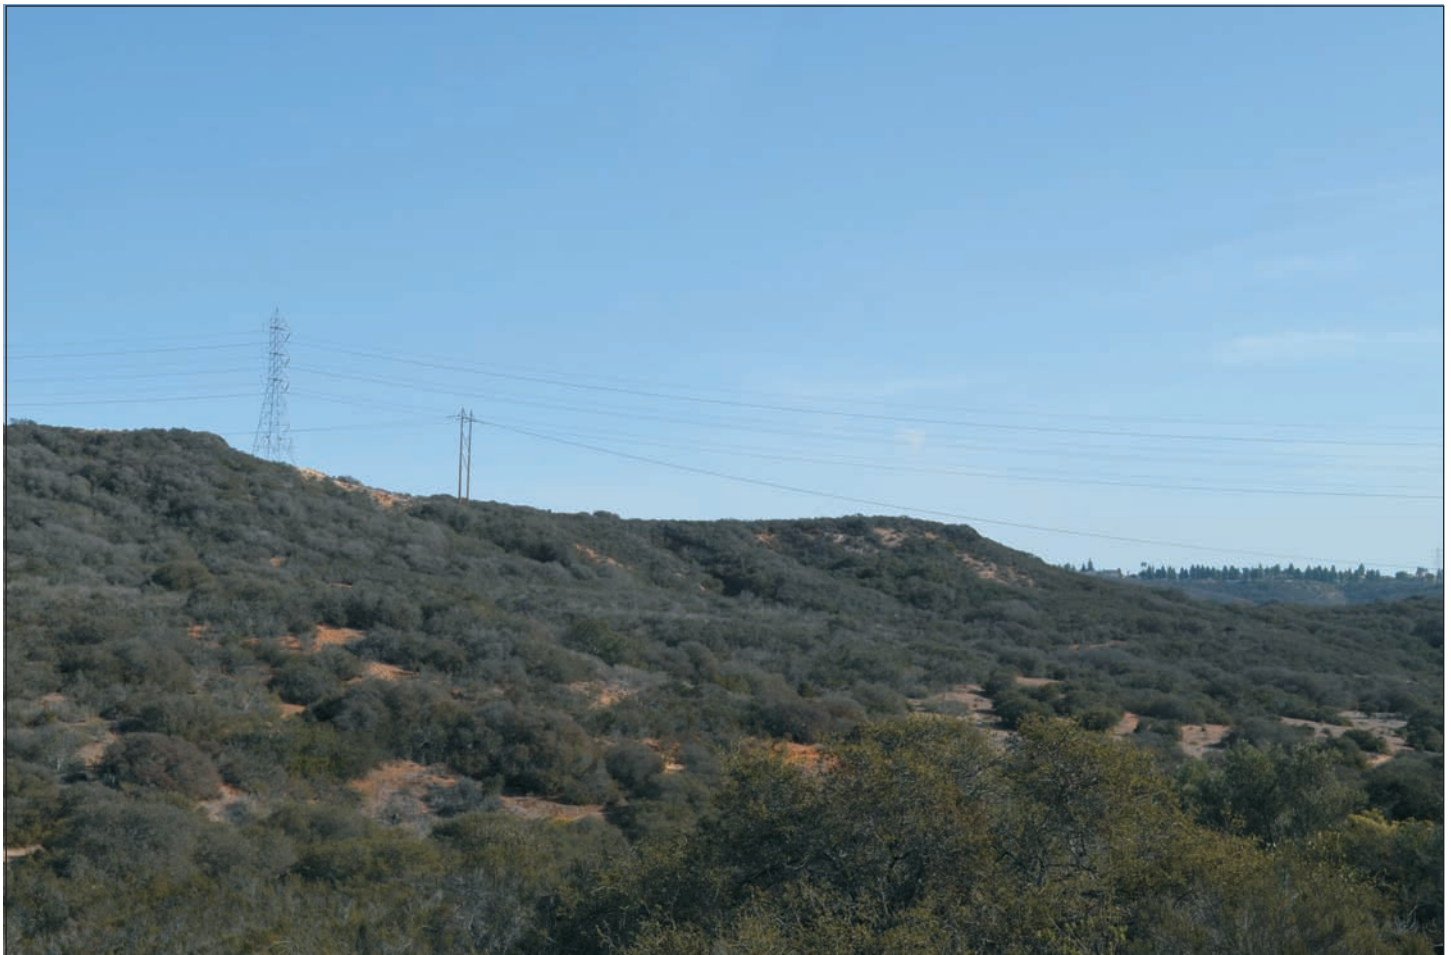
Comments: cKOP 45A is located on upper Duck Pond Trail. At this point the main trail turns westerly and up steeply a tributary canyon to a trail head off Carmel Mountain Road near developing Alta Del Mar and Duck Pond Ranch. Where views of the ROW from the trail are intermittently obscured by topography and vegetation. This cKOP was added to approximate the valuable views from the exclusive residences at Duck Pond Ranch. The cKOP is topographically inferior and in closer proximity than the residential views. This vantage point was chosen because access to a more appropriate location is not in conformance with LPCP's management directives. This view is panoramic as evidenced by only a portion of the TL spanning the canyon is visible. This easterly perspective was chosen because cKOP 45 B captures the westerly portion of the span between P47 and P 48. This view looks at P 47. The new TSP will be left of and up slope of the existing H-frame. A westerly facing wall proposed will likely not be visible from this location. Grading impacts will most likely also be obscured. The marker balls on this span on the new OHGW on the STLs will be skylined and plainly visible from this distance (850'/0.16 mi.). The marker balls from this perspective will be predominantly back lit which reduces their visibility incrementally. If not for the TL this view could be characterized as naturally appearing visually appealing.

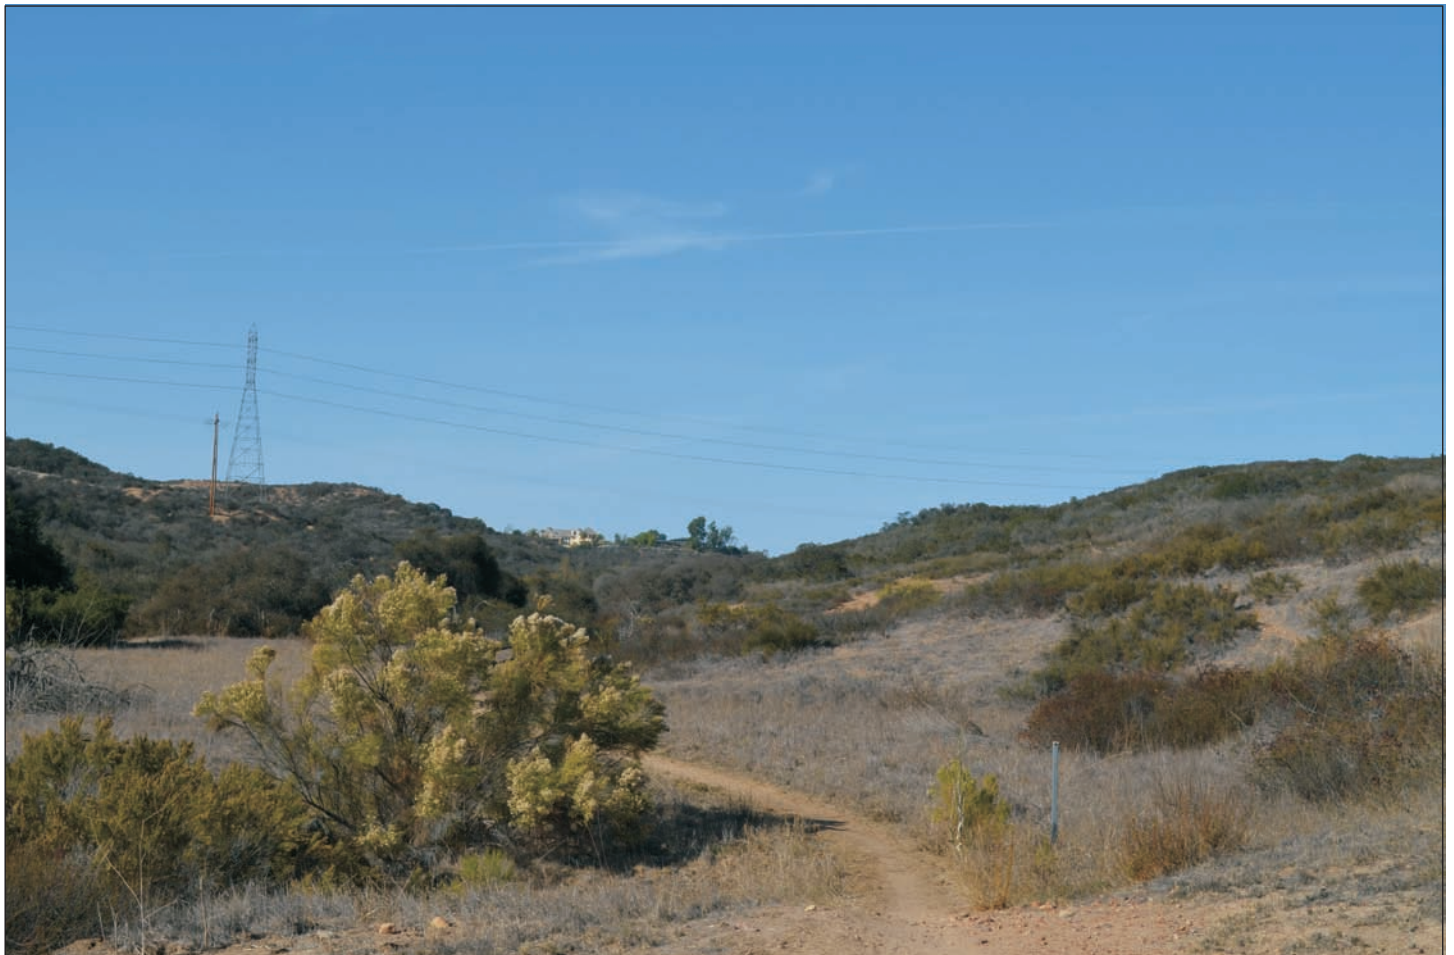
Comments: cKOP 45 is at a trail side kiosk near the mouth of Duck Pond Canyon, a major tributary canyon to Los Peñasquitos Canyon, where Equestrian and Hiking/Biking trails bifurcate. The equestrian trail is east of and occupies higher ground than the hiking/biking trail which follows the canyon bottom which has many scrub oak trees that obscure visibility. The trail goes deep into Duck Pond Canyon before veering west and climbing out to the exclusive residential on southern Del Mar Mesa. The palatial homes of the gated community of Duck Pond Ranch can be seen on the horizon (cKOP 45A). Duck Pond is a destination in LPCP but after 3 years of drought there is no pond or ducks. Project features visible from this vantage point include P48 and the large 3 sided retaining wall proposed. Additionally, project refinements have changed P48 from a tangent to a dead end structure and added marker balls to this relatively long (1400') span. This cKOP is 0.3 miles (1600') from the ROW so it is considered a near middleground view. Marker balls that will be skylined and front lit most times of the day, their most conspicuous state. cKOP 45 was moved from a kiosk near the waterfall to this location as a result of Project Refinements by SDG&E (Nov. 2014), it being rejected as duplicative, and renamed 45B.

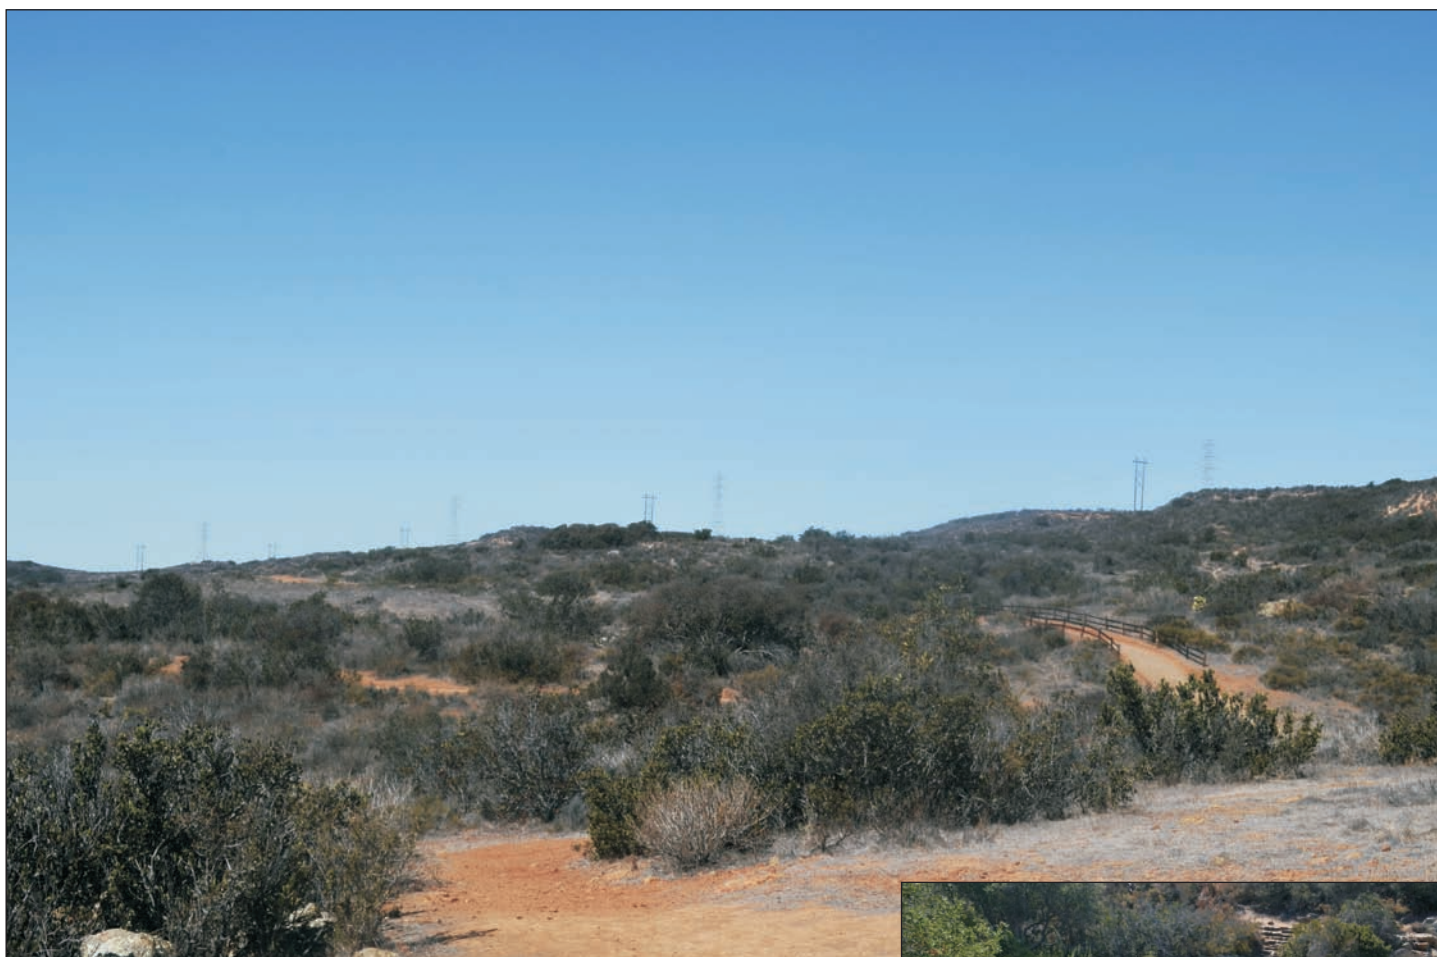
Comments: cKOP 46 is at the waterfall on Penasquitos Creek. Besides the Adobe the waterfall is the most popular destination in the preserve. After 3 years of drought the waterfall is more of a series of nick points, but the water flow is still audible. Vantage points with water, particularly flowing water has a very high visual sensitivity. It psychological effect invites one to pause. More than the 4 pairs of tower structures shown in the view frame are visible from the vantage point. The visible towers are well into the middleground (>0.5 mi.). Marker balls will be visible on spans on the left side of the view cone.

40	DMMP Trails at Peñasquitos Junction	C	5	2.5	2	6	2.5	4.5	5	27.5
41	DMMP Trail and the Preserve Residential	C	4	2	1	6	5	5	3.5	26.5
Segment D – Peñasquitos Junction to Peñasquitos Substation (3.34 miles). The long term visual change would consist of removal of H-frame support structures and replacement with TSPs. Conductor diameter would increase slightly to accommodate increased voltage; however, conductor size increase would not be appreciatively discernable to the casual observer.										
42	DMMP Trail	D	2	2	6	6	5	4.5	4	29.5
43	Peñasquitos Junction	D	5	2	5	6	2	2	4	26
44	View Point on Upper Cobbles Trail	D	3.5	1	4.5	6	3	5	3	26
45A	Duck Pond Trail North	D	3	2	5.5	6	2	5	5	28.5
45B	Duck Pond Trail South	D	2	2.5	4.5	6	2.5	5	5	27.5
46	LPCP Trail	D	1.5	3	6	6	3	5	5	29.5

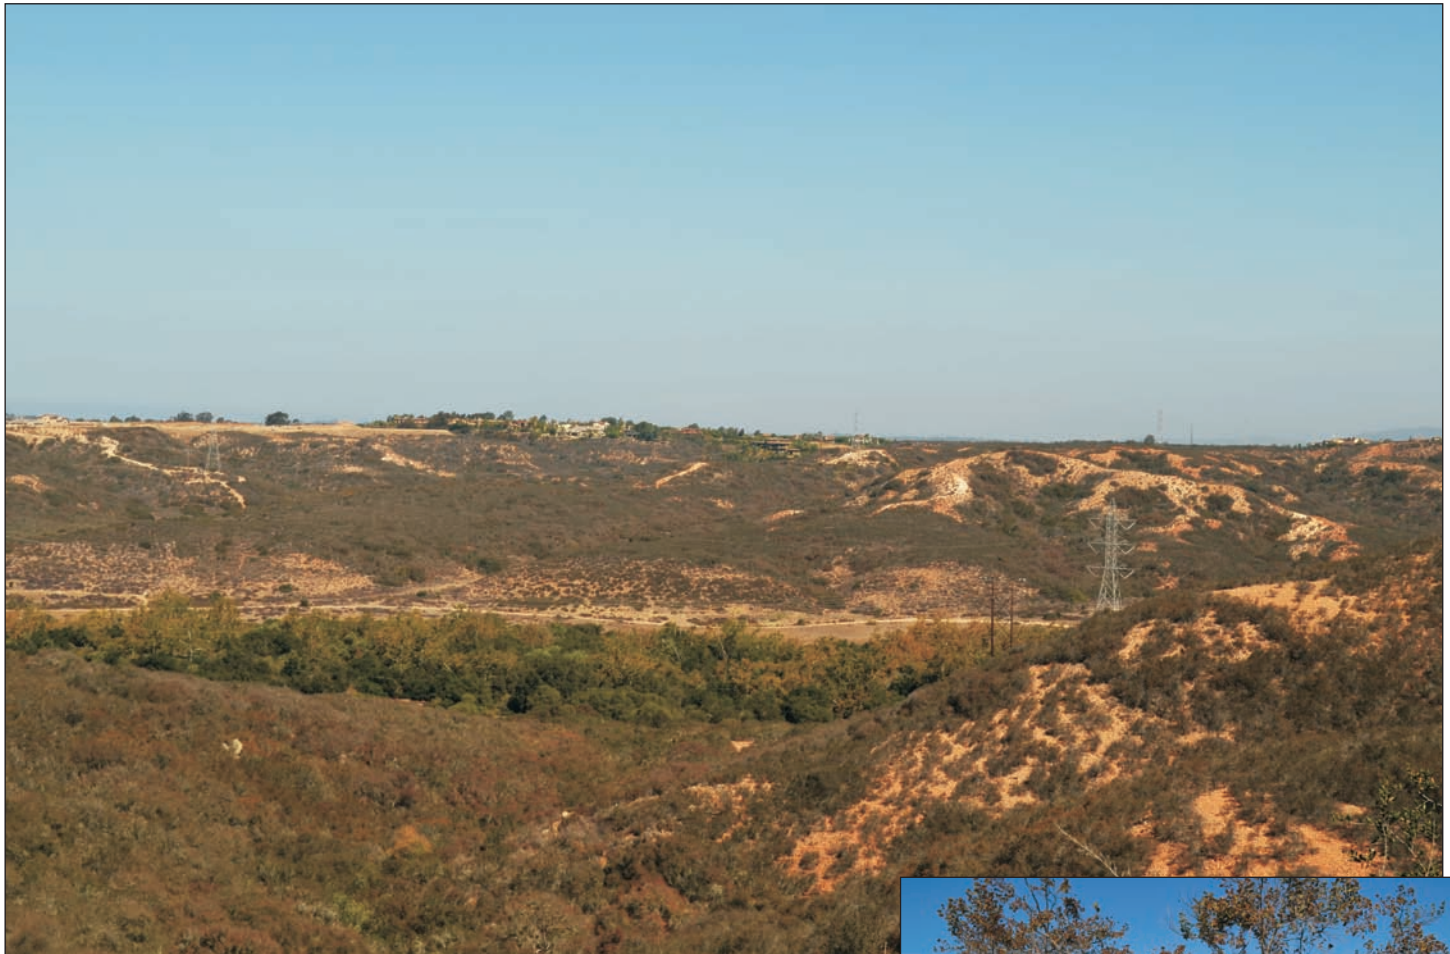
Comments: cKOP 47 is a small "park" on the north side of Calle Christobal. It has a U-shaped access road with 10 parking spaces. The only amenities are a few benches and pleasant landscaping. It is at the head of a large finger canyon and affords panoramic views of the canyon. This view frame was chosen because farther to the west (left) TL 23051 climbs out of the canyon on the side canyon shoulder and the conductors are in the field of vision.

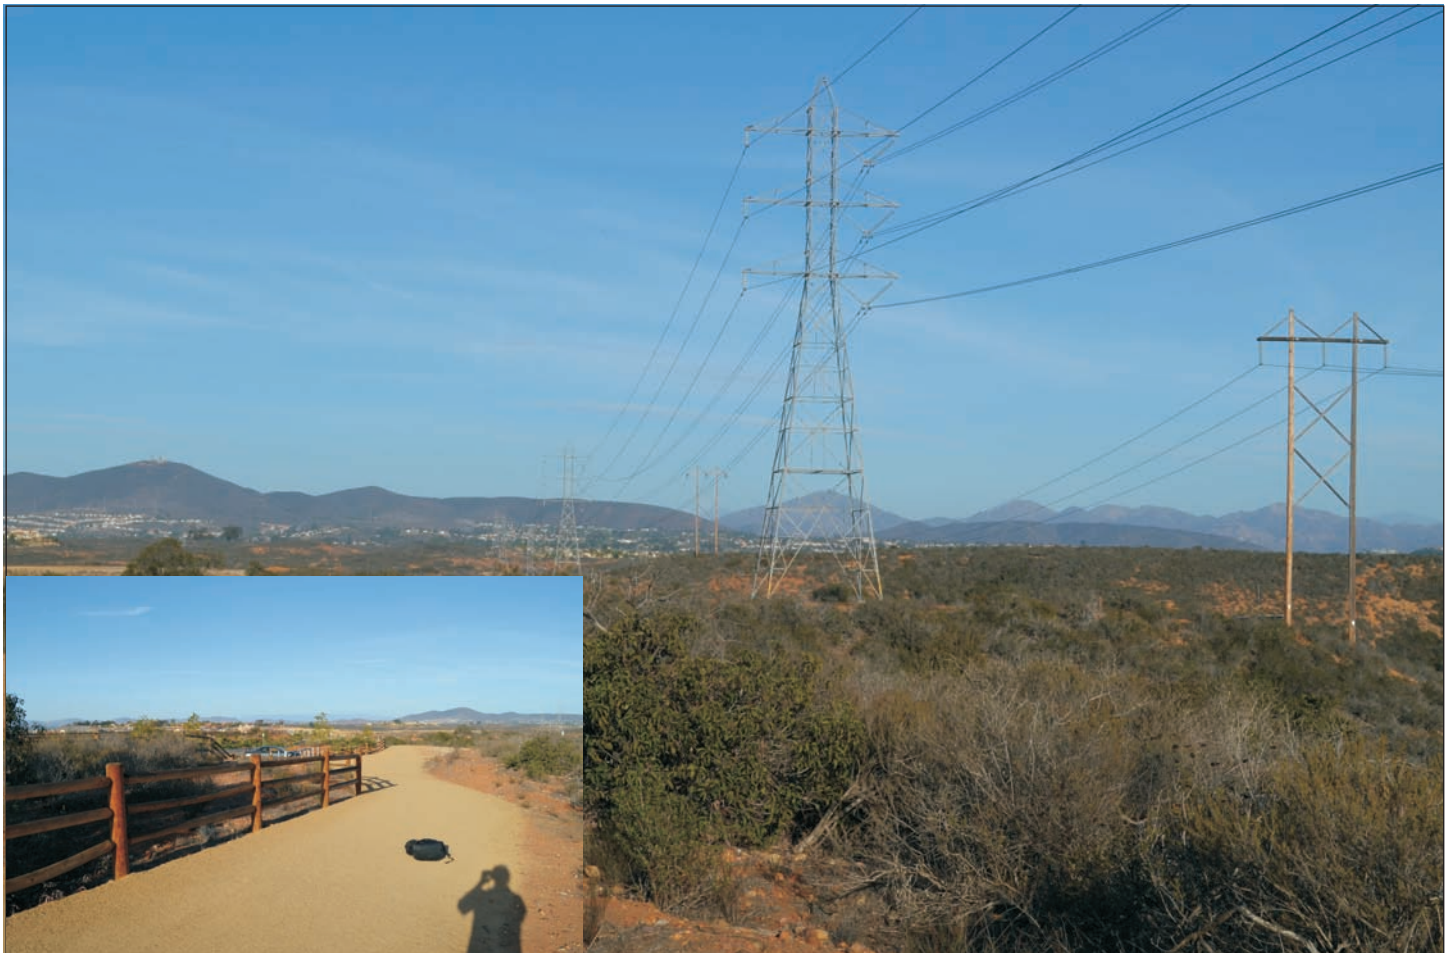
Comments: cKOP 48 is from a new multi-use trail in the under development subdivision of Alta Del Mar. It is on the south side of Carmel Mountain Road west of the SDG&E gated access road. The new trails have a DG bed and are delineated by a equestrian log pole fence. The trail nearly parallels the ROW in this vicinity as it leaves the urbanizing area and heads easterly towards Del Mar Mesa Preserve. Side trails that provide access to LPCP to the south are numerous and often challengingly steep. This easterly view is of Segment D where the wooden H-frames tower structures will be replaced with incongruent TSPs. The pyramidal forms of Black Mtn., Mount Woodson, Iron Mtn. and Cowles Mtn. are silhouetted along the horizon.

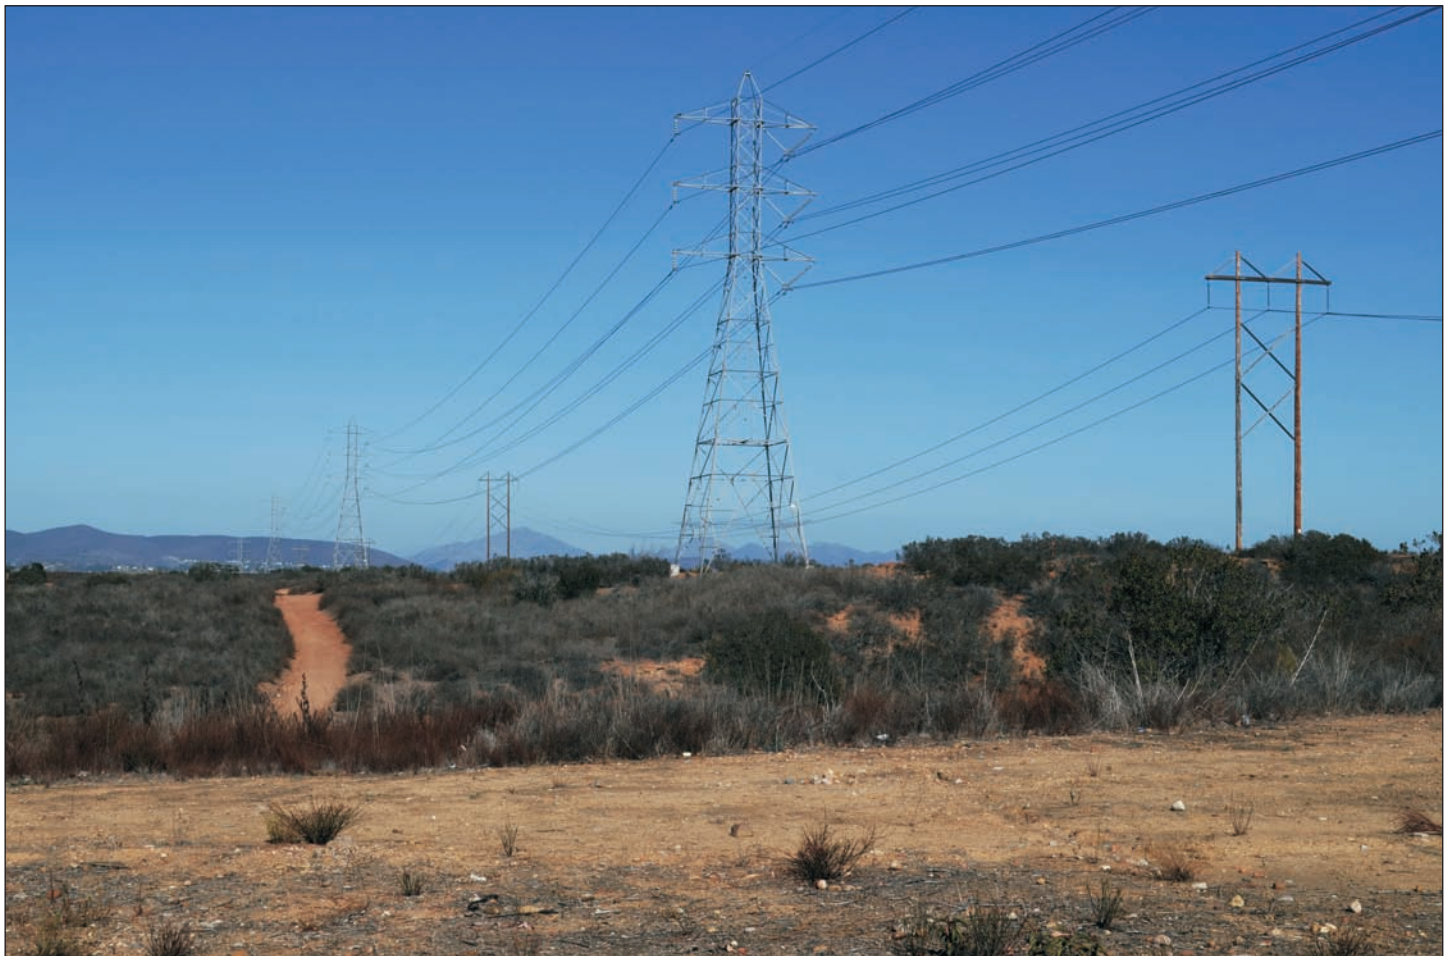
Comments: cKOPs 49, 50, and 51 are from backyard views from this neighborhood that is in close proximity to the ROW. These residents participated vocally in the scoping process with letters and a petition. Their views of the canyon are perhaps the most panoramic of residential views along this Segment. 8 of the homes have cinder block walls in their backyards that also act as retaining walls but these home have unusually deep lots and can certainly see portions of the support structures and the conductors. The rest of score of home have wrought iron or plexiglass yard view fences and many have outdoor entertainment areas. Some are so close to the alignment that the conductors are the real source of visual intrusion.

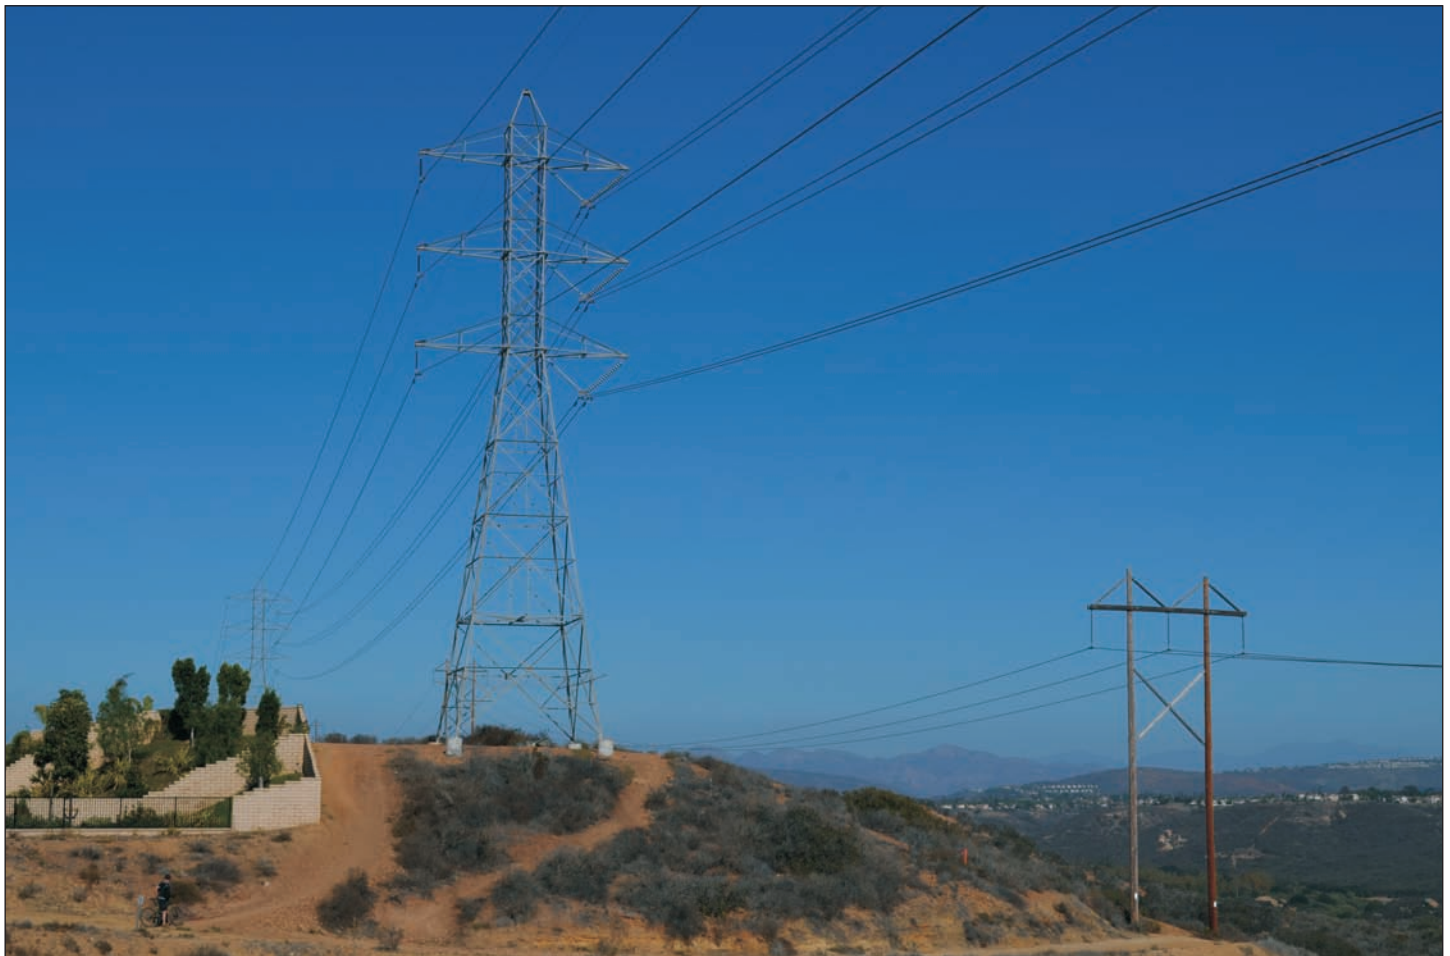
cKOP 50 is looking easterly, their southerly canyon views may be improved by the higher conductors of the new line because the height of the catenaries here is so divergent. The red survey stake is the location of the new TSP, which appears to me to require a retaining wall. The retaining walls on the homes in the left were discussed previously. This easterly view was chosen because a more southerly view would only show conductors. Also this perspective shows the permanent work area that will be cleared of vegetation and probably require landform modification to accommodate the new TSP. Notice the base elevation of the H-frame and the SLT, that +/- 30' so the catenaries occupy a large area of the vertical field of view. The new taller TSPs will reduce this impact by placing the catenaries closer together.

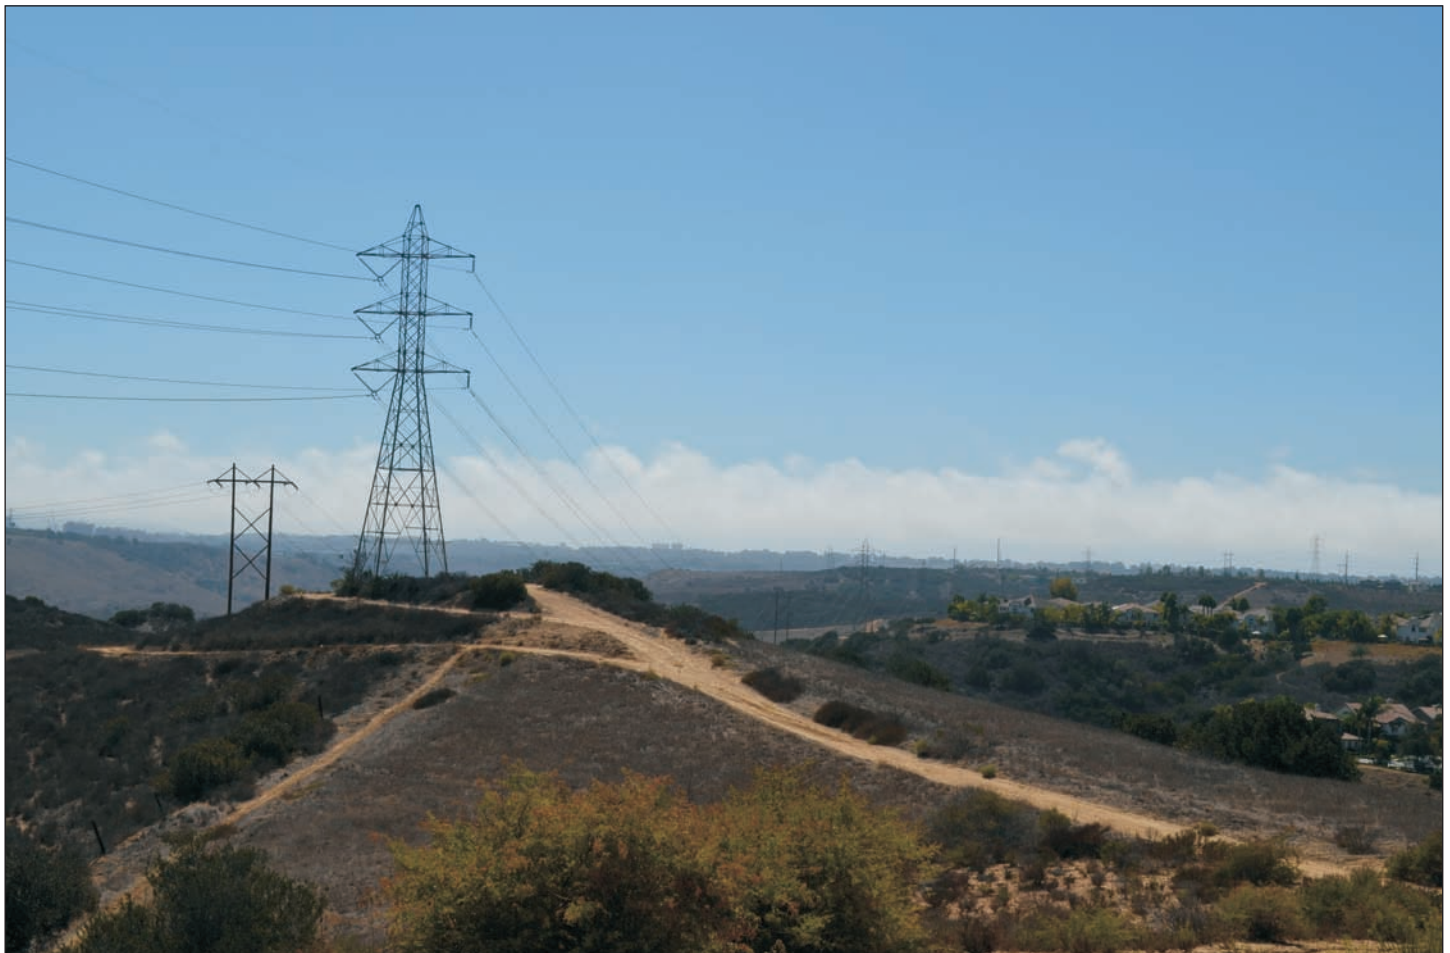
cKOP 51 is from what approximates a view from the backyards at Briarlake Woods Rd. +/- 35 houses on Briarlake Woods Rd. would have similar views but this one is the closest and the other are inaccessibly. The next cKOP would be representative of some of the home that are not as close to the ROW. This view was taken late in the day when the tower structures were backlit and the marine layer was starting to affect visibility. 4 SLTs are visible in this view cone. The middleground is further cluttered by a separate TL supported by TSPs that runs south from Peñaquitos S/S. This perspective was chosen because a view farther left would only show the conductor catenaries. Like cKOP 50 it appears this area will require landform alteration to accommodate the new TSP. Again the proposed taller poles will reduce the vertical field of view of the conductors. A 1 acre stringing site is proposed to the right of the first pair of tower structures and the remaining vegetation and topography will likely screen it from this vantage point. Additionally marker balls may be required on two consecutive spans after the first set of structures. Some of the marker balls will be skylined making their presence much more noticeable.

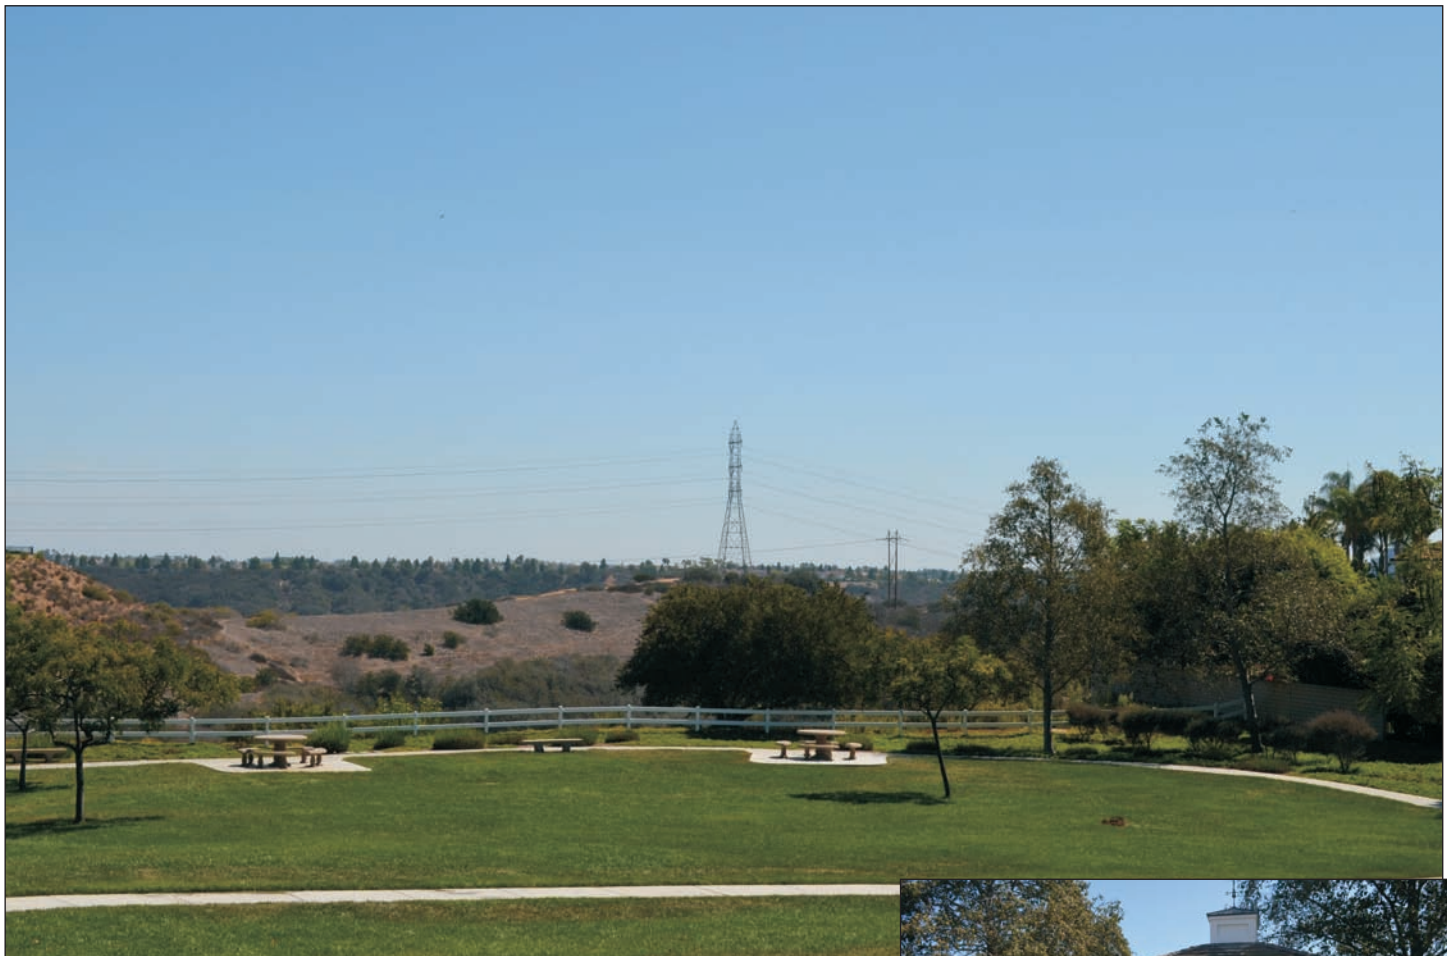
Comments: cKOP 52 is from a formal park at the intersection of Carmel Mtn Rd. and Carmel Country Rd. This would also be more representative of Briarlake Woods homes further to the west than the previous cKOP. Access to the area behind the majority of Briarlake Woods home was problematic. The pair of tower structures in this view are the ones in the foreground of cKOP 52. The new TSP will not be perfectly paired with the SLT but it will be closer than the H-frame currently is. The span to the right of the SLT may require marker balls. The dichotomy of the conductor catenaries is very apparent from this location. However, upon close examination the conductors on the H-frame are primarily backdropped and very difficult to see against the vegetative backdrop of the PQ Canyon's south rim.

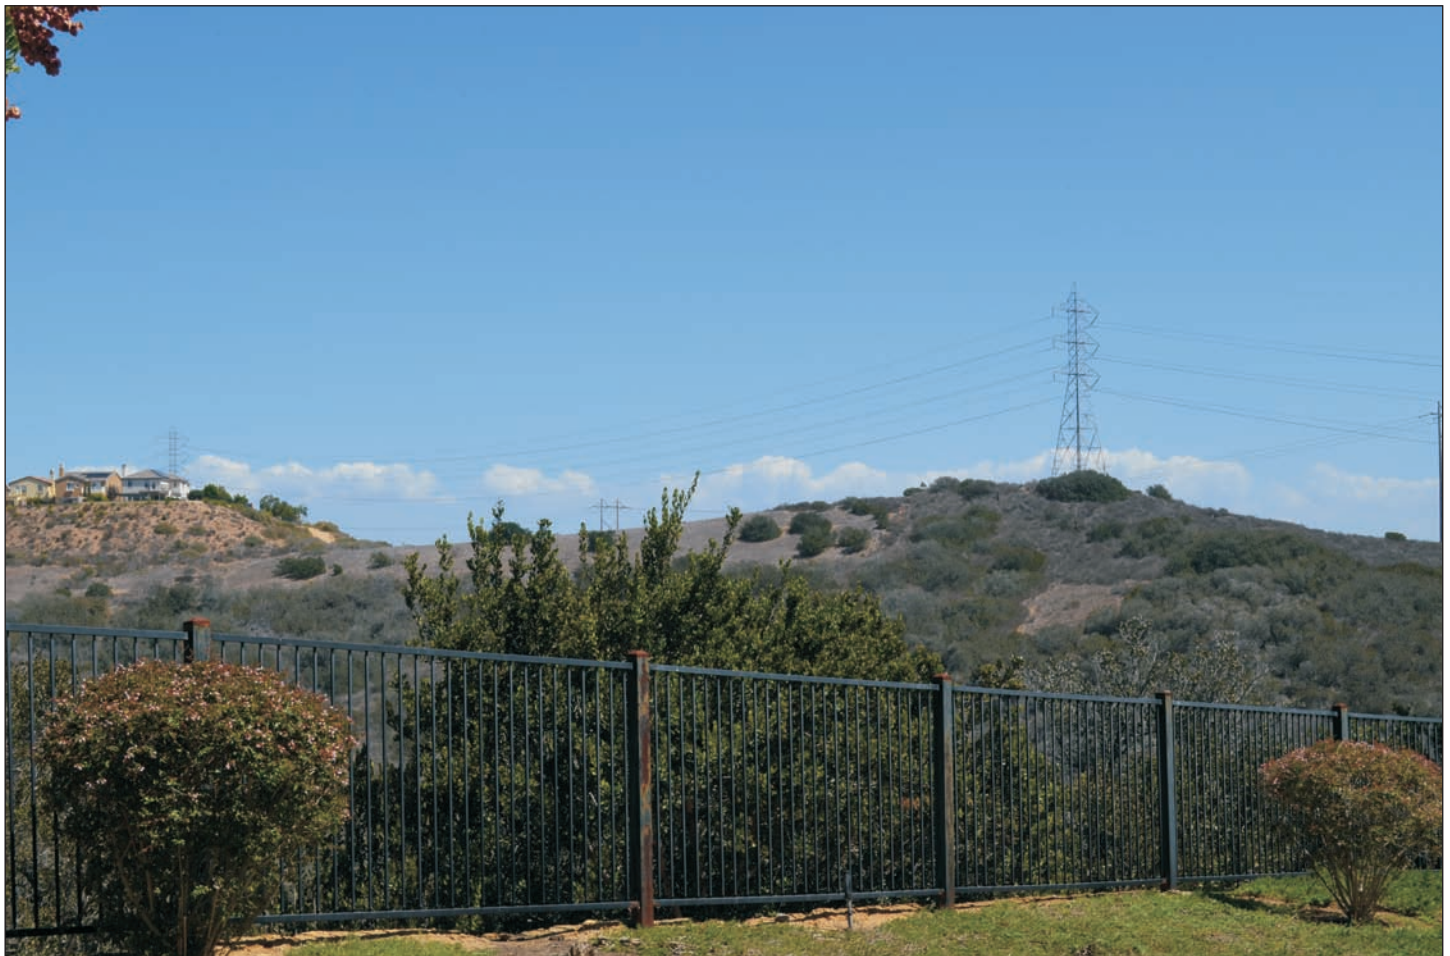
Comments: cKOP 53 is from a small pocket park on the east side of this long cul de sac (Hunters Glen Dr.) on a finger mesa that extends into PQ Canyon. The H-frames structure are inconspicuous. The new taller TSPs will be more evident. These two adjacent canyon are quite large and deep. The STL in the center of this view is the same one that was looked at in the previous 2 cKOPs (E54, P54) The current data we have from the IOU shows marker balls on the span right (west) of the central SLT. The H-frame paired with the STL is obscured by topography. The H-frame right of the SLT is proposed to be removed as the result of project implementation.

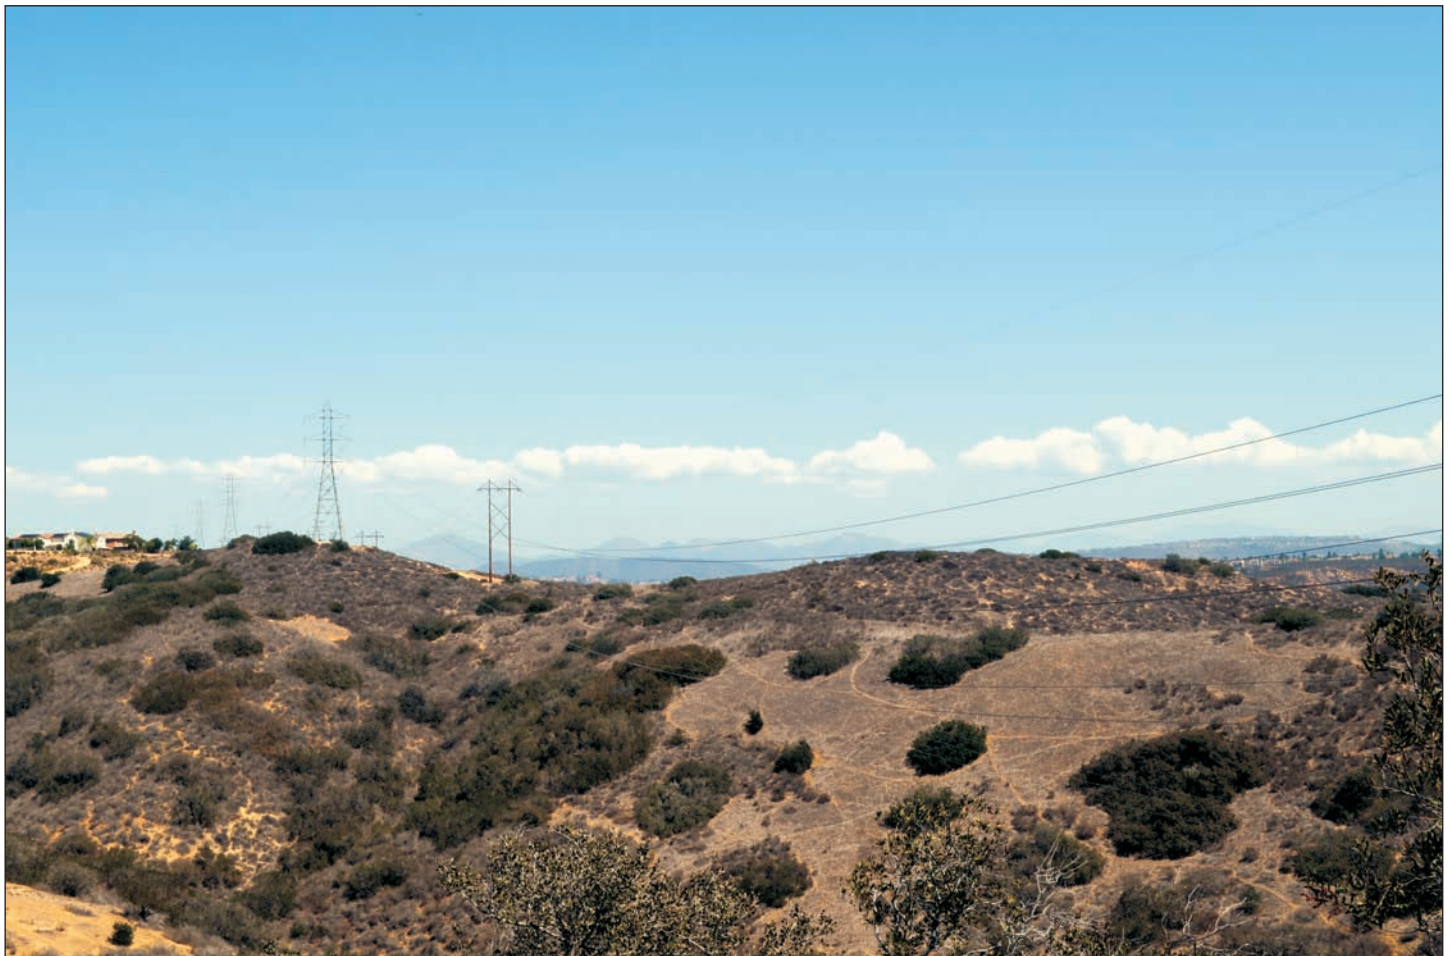
Comments: cKOP 54 is from the next finger mesa to the west of cKOP 53. This one extends deeper into the canyon and is closer to the ROW. The cKOP is a backyard view from a residence next to the IOU's access point, which also affords LPCP access via a steep single track trail. There are perhaps 10 homes in close proximity to the ROW. This view is easterly. This span is designated to require marker balls and they will be very apparent as they come in close proximity to the homes on the end of the cul de sac. If one were to pan right from this view the conductors are the visual intrusion. Yet again the first SLT is E22. In this view however, the 12 acre stringing site will be visible because of the contrast created by vegetation removal (short term impact).

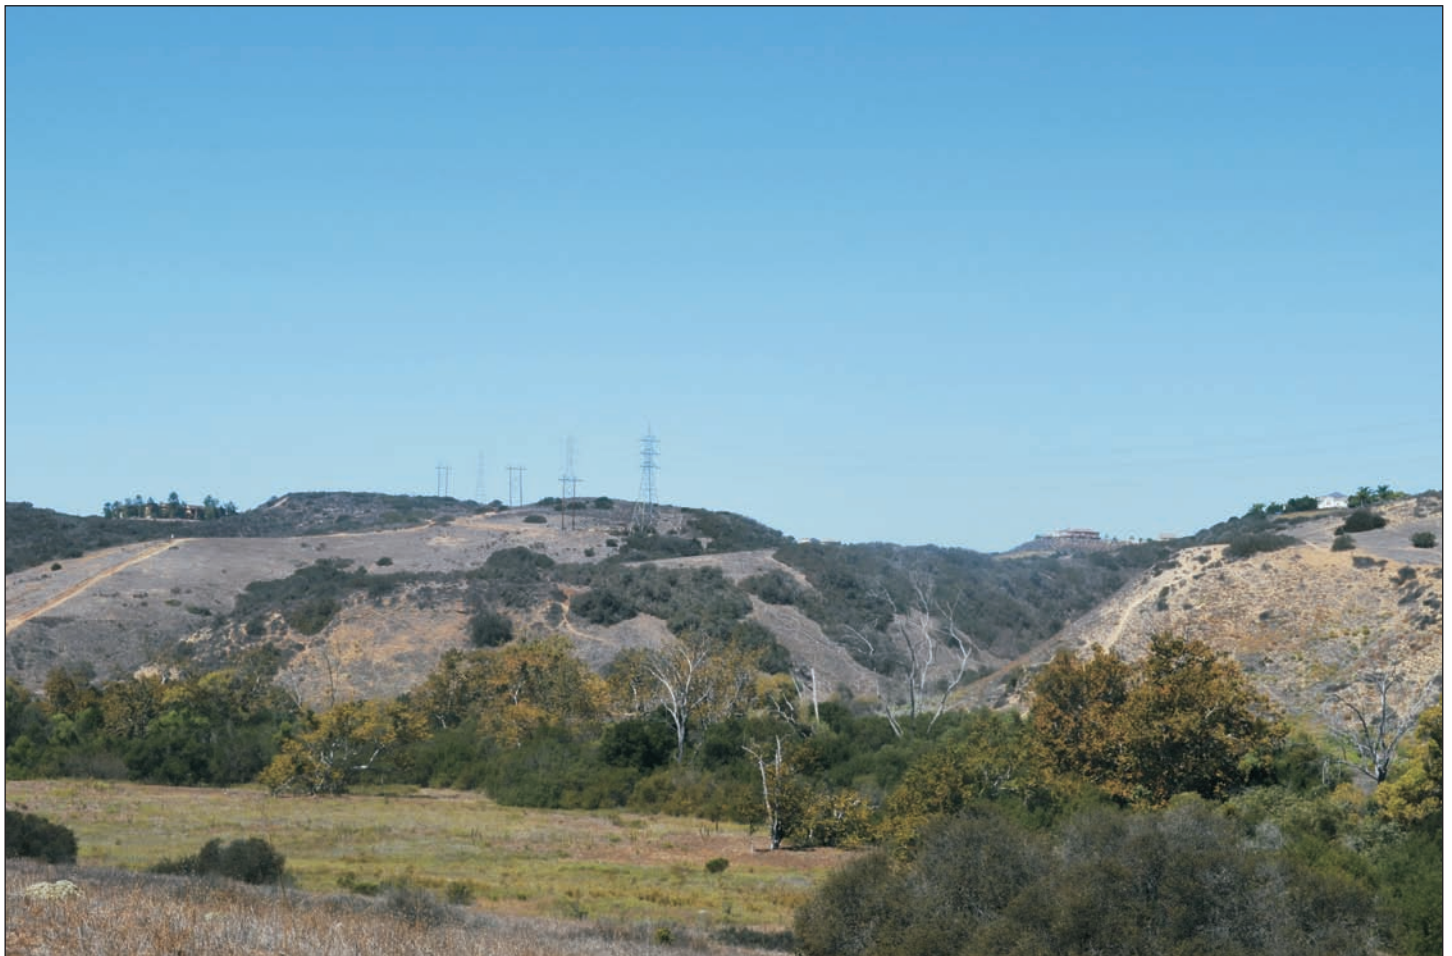
cKOP 55 is from a hill on the LPCP's South Side Trail. The vast majority of the trail that runs along PQ Creek's south side from Sycamore crossing to this vantage point is obscured from the project by the formidable canopy of the creek's riparian corridor. cKOP is an exception where the trail climbs a ridge and gains enough elevation to allow views over the canopy. These multi-use trails are extremely popular with recreationists, the majority of which are mountain bikers. Consecutive spans across deep adjacent canyons will likely require marker balls. This view offers visual variety from the grass covered valley floor rises the multi species multi level riparian canopy to the patchy chaparral covered canyons and mesas of the canyon's north rim. Notice how the SLTs recede with distance.

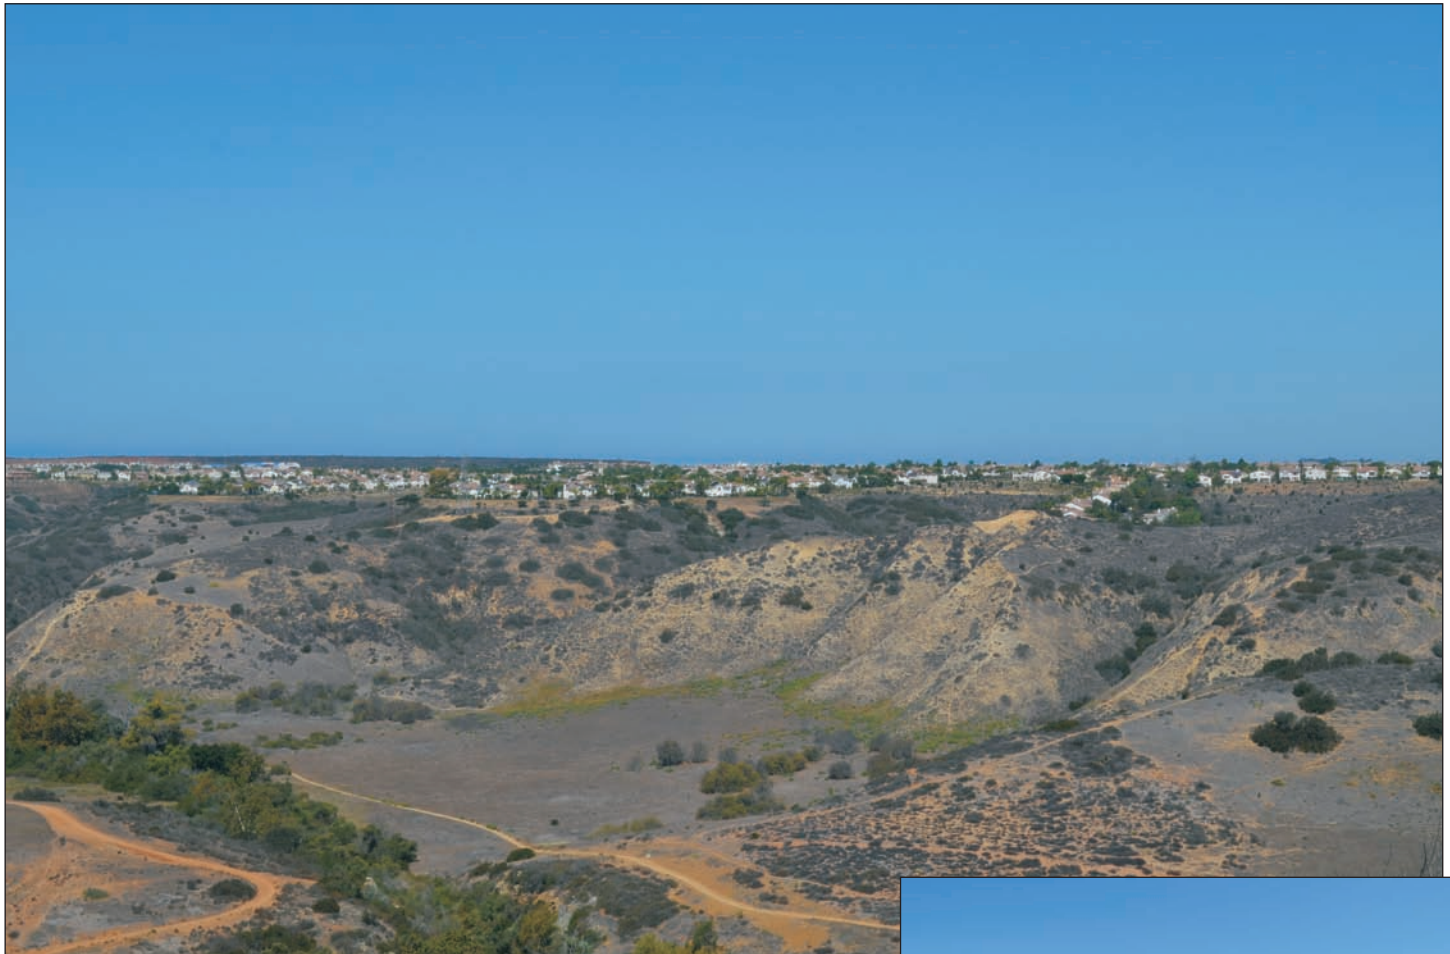
Comments: cKOP 56 much like cKOP 47; it is a pull off the travelway (Calle Christobol) with a few parking space, a bench and landscaping. This on differs from 47 in the fact that there is a 20' knoll and a dead end trail that leads to its acme. The panoramic views of the lower canyon are even broader and perhaps more compelling than cKOP 47. Additionally, it looks northwesterly across the canyon at 2 consecutive span that will likely require marker balls. The elevated prospective if this vantage point causes the tower structures and the conductors to be back dropped and they are very difficult to see.
