APPENDIX F: AESTHETIC RESOURCES SUPPORT INFORMATION

Appendix F provides supplemental information for the aesthetic resources impact assessment approach described in Section 4.2.3. The CPUC has not developed its own method for assessing visual character and quality under CEQA. The visual impact assessment follows the CEQA Guidelines and supplements the CEQA Guidelines with guidelines provided in *Visual Impact Assessment for Highway Projects*, which uses a numeric evaluation approach to assess the degree of impact (FHWA 1988). Supplemental information provided in Appendix F includes:

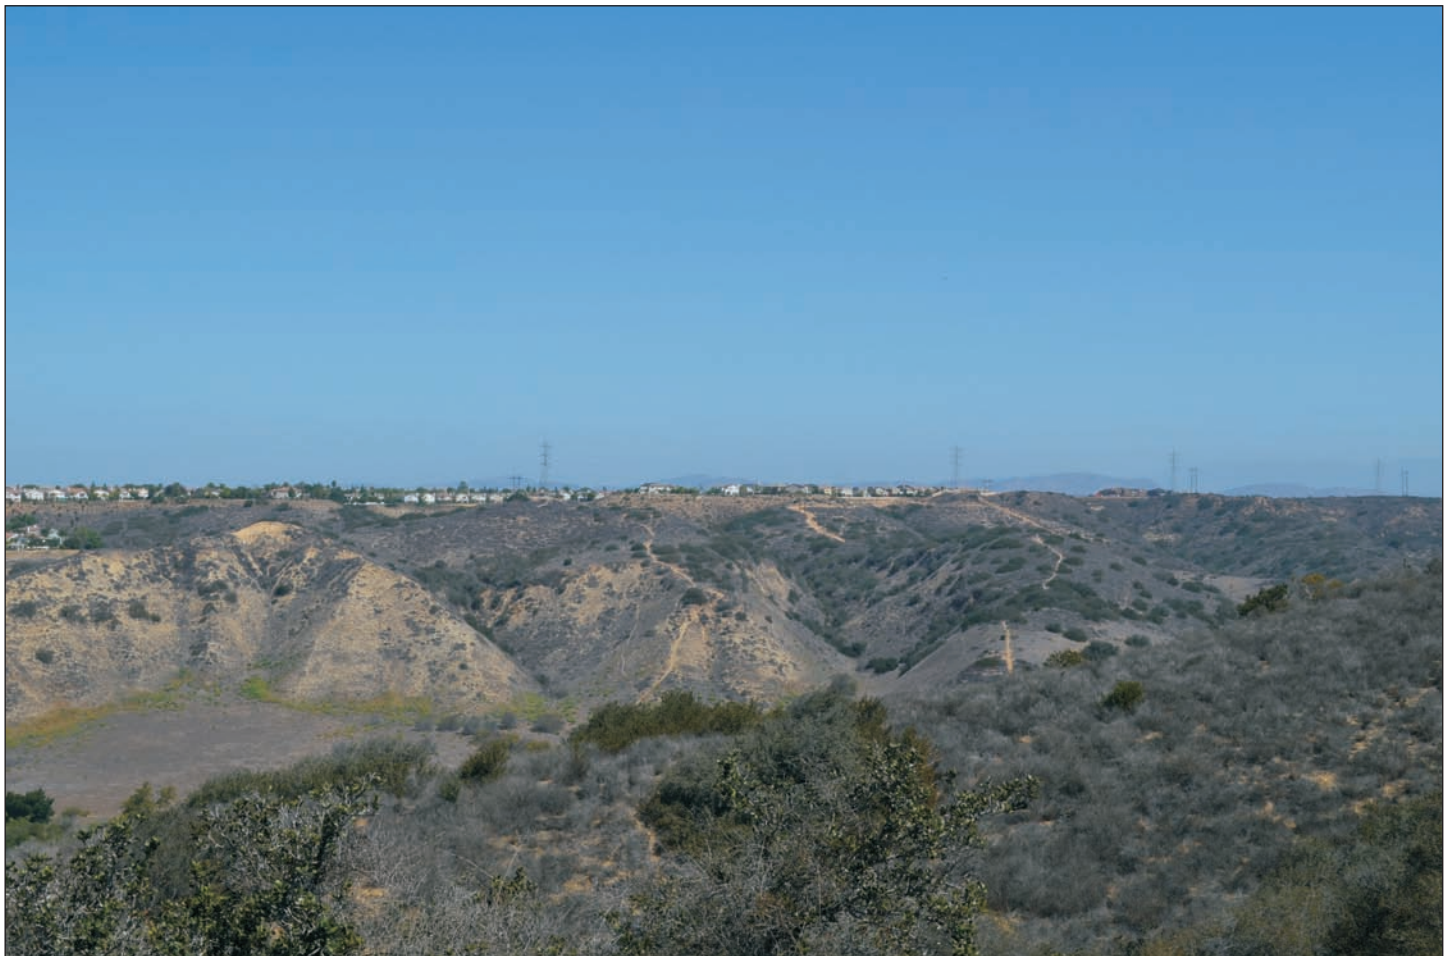
Comments: cKOP 57 is from a single loaded cul de sac on the western edge of Mira Mesa. Like cKOPs 47 and 56 it affords panoramic views of the canyon. The vantage point like cKOP 56, the western portion of the ROW is backdropped and the tower structures and conductors are difficult to see. This view is more easterly where the TL ROW is on higher ground and the tower structures are skylined. The view is just over 0.5 miles (middleground) from the project so the marker balls may not be prominent. At this distance the transparent nature of the lattice structures help them recede the proposed new monopoles will be more visible especially if they are large diameter in-line dead end towers. This view is from the north (unloaded) side of the street. From the homes the panoramic valley floor would not be visible, yet the towers and conductors of the north canyon rim would be visible.

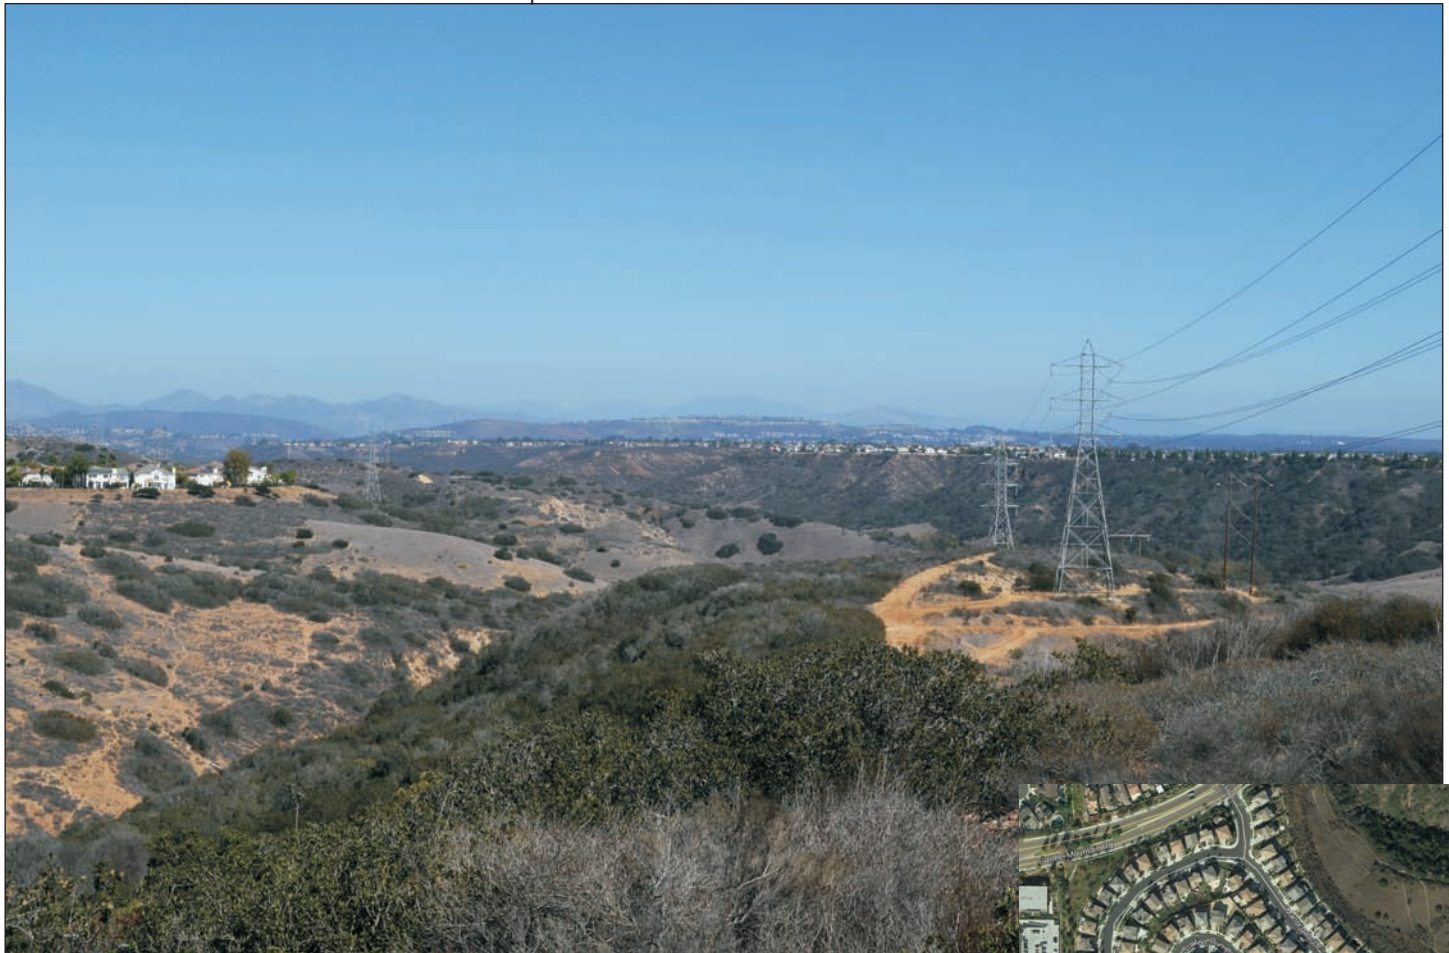
Comments: cKOP 58, 59, & 60 are in response scoping process where residents of this community expressed strong concerns to visual intrusion by a very organized group of individuals in this U-shaped neighborhood that is in close proximity to the ROW. +/- 40 homes will be directly affected. The +/- 40 other homes are internal and their views are much less impacted by the ROW.

This view is from the pocket park on the neighborhood's east side where commentators said they had concerns. If one were to pan to the right (west) you would see a pair of tower structures that are just outside the park. It is also representative of residential views from homes on the east side of Manorgate Dr. Perhaps 15 homes share a similar expansive view. The view is easterly. A large finger canyon to PQ Canyon runs diagonally across the foreground, PQ Canyon and Mire Mesa are in the middleground. The horizon line is the distant Traverse Range. This view is perhaps on of the more dramatic views that are not in one of the Preserve areas. Marker balls will likely be required across the canyons past the second tower pair Which is 1600' distant and they will normally appear back of side lit and they will be backdropped making them less apparent. The closest SLT tower structures are partially skylined as will be the ne TSP. Notice how difficult it is to see the existing H-frames, this will likely no be the case for the new taller more robust TSPs. The houses visible in the left portion of the view are on Hunter's Point (cKOP 54).

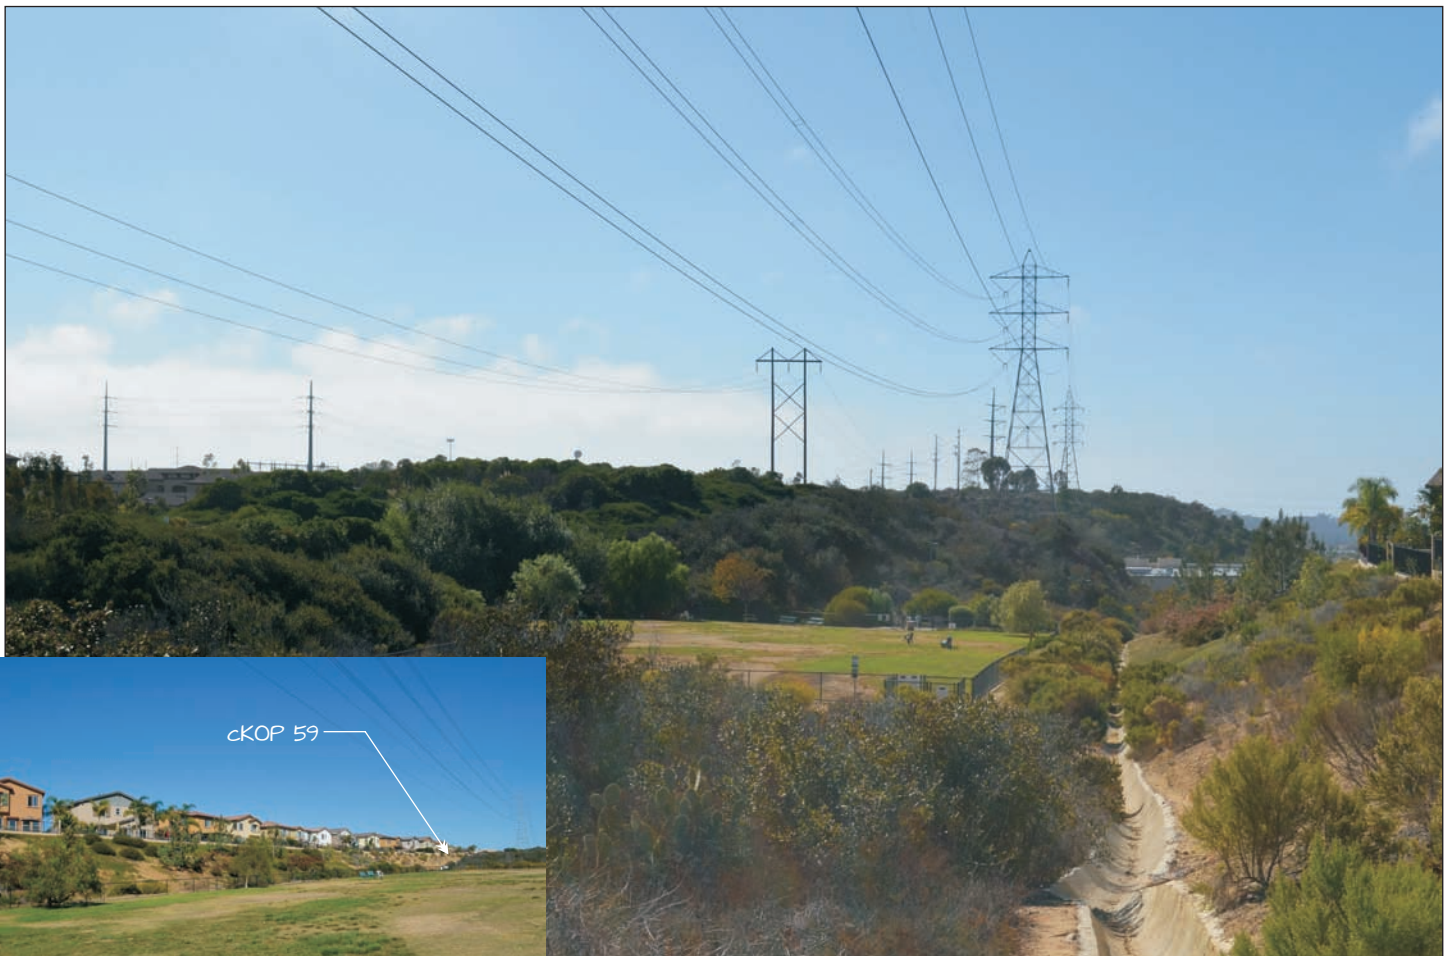
Comments: cKOP 59 is in the same neighborhood as cKOP 58. This view represents residential views that face south would be located on Laurelcrest Dr. It would also be representative of the +/- 12 homes on the north-south portion of Laurelcrest Dr. who's backyards faces west. Access to the slope behind those residences proved problematic. This view is representative of the +/- 20 homes facing south will experience looking westerly toward the Penasquitos Substation. Views directly south are of the conductor catenaries and a single H-frame structure. The catenaries are quite high overhead but no doubt are visible from the upper floor of these two story residences. The more expansive westerly view was chosen as opposed to the more obscured southerly view. The southerly view may be slightly improved by the proposed project because it will remove an intermediate H-frame structure that is direct south of this vantage point. It will also raise the height of the H-frame catenaries so they more closely follow the catenaries on the SLTs. Tower structure pairs are on both side of the development. The majority of these homes have backyard enclosure that are view fences and allow the residents to enjoy their open space views. The Torrey Hills dog park is in the foreground. Farther into the foreground in the lower right portion of the view frame the Torrey Hills shopping center is visible. The myriad of poles and conductor of the Substation are along the horizon. A portion of the infrastructure of the 14 acre Peñasquitos Substation is visible on the horizon in the left (south) portion of the view. The view has additional clutter added by the N-S trending TL on TSPs that are not a part of this project. From this inferior perspective the bundling of conductors on the south side of the SLTs are very evident.

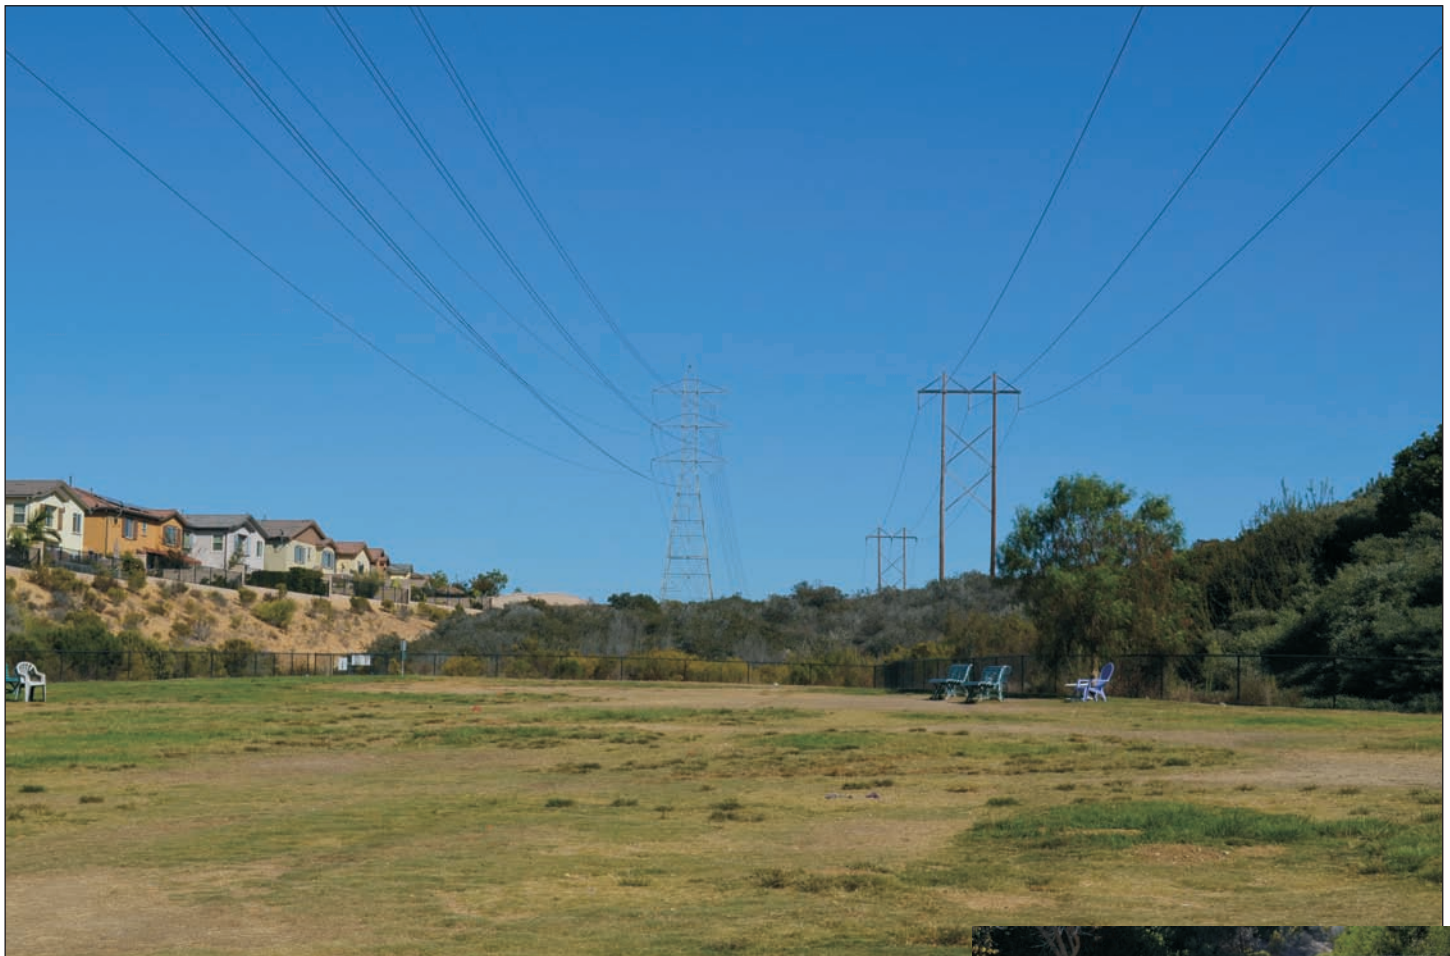
Comments: cKOP 60 is from the west end of the Torrey Hills dog park. The home discussed in the previous 2 cKOPs are visible to the north (left) and demonstrates their views in relationship to the conductors. This view looks east, the 2 h-frames will be replaced by a single TSP. No marker balls are anticipated for this span. Again from this perspective the bundled conductors on the SLTs are obvious. These types of recreationists are typically at leisure and enjoying the company of their pets. They have time to be observant of their surroundings.
