To: Rob Fletcher, San Diego Gas & Electric
From: Ian Maunsell
Date: June 22, 2015
RE: Inclusion of the Camino Del Sur Staging Yard to the Biological Survey Area

This memorandum provides a summary of general biological surveys conducted for the proposed San Diego Gas & Electric Company (SDG&E) Sycamore to Peñasquitos 230 Kilovolt Transmission Line Project (Proposed Project), Application No. 14-04-011 pertaining to the inclusion of one new proposed staging yard. The proposed Camino Del Sur Staging Yard is located near the intersection of Camino Del Sur and Carmel Valley Road within the City of Escondido, and was not previously evaluated within the existing Proposed Project Biological Survey Area (BSA).

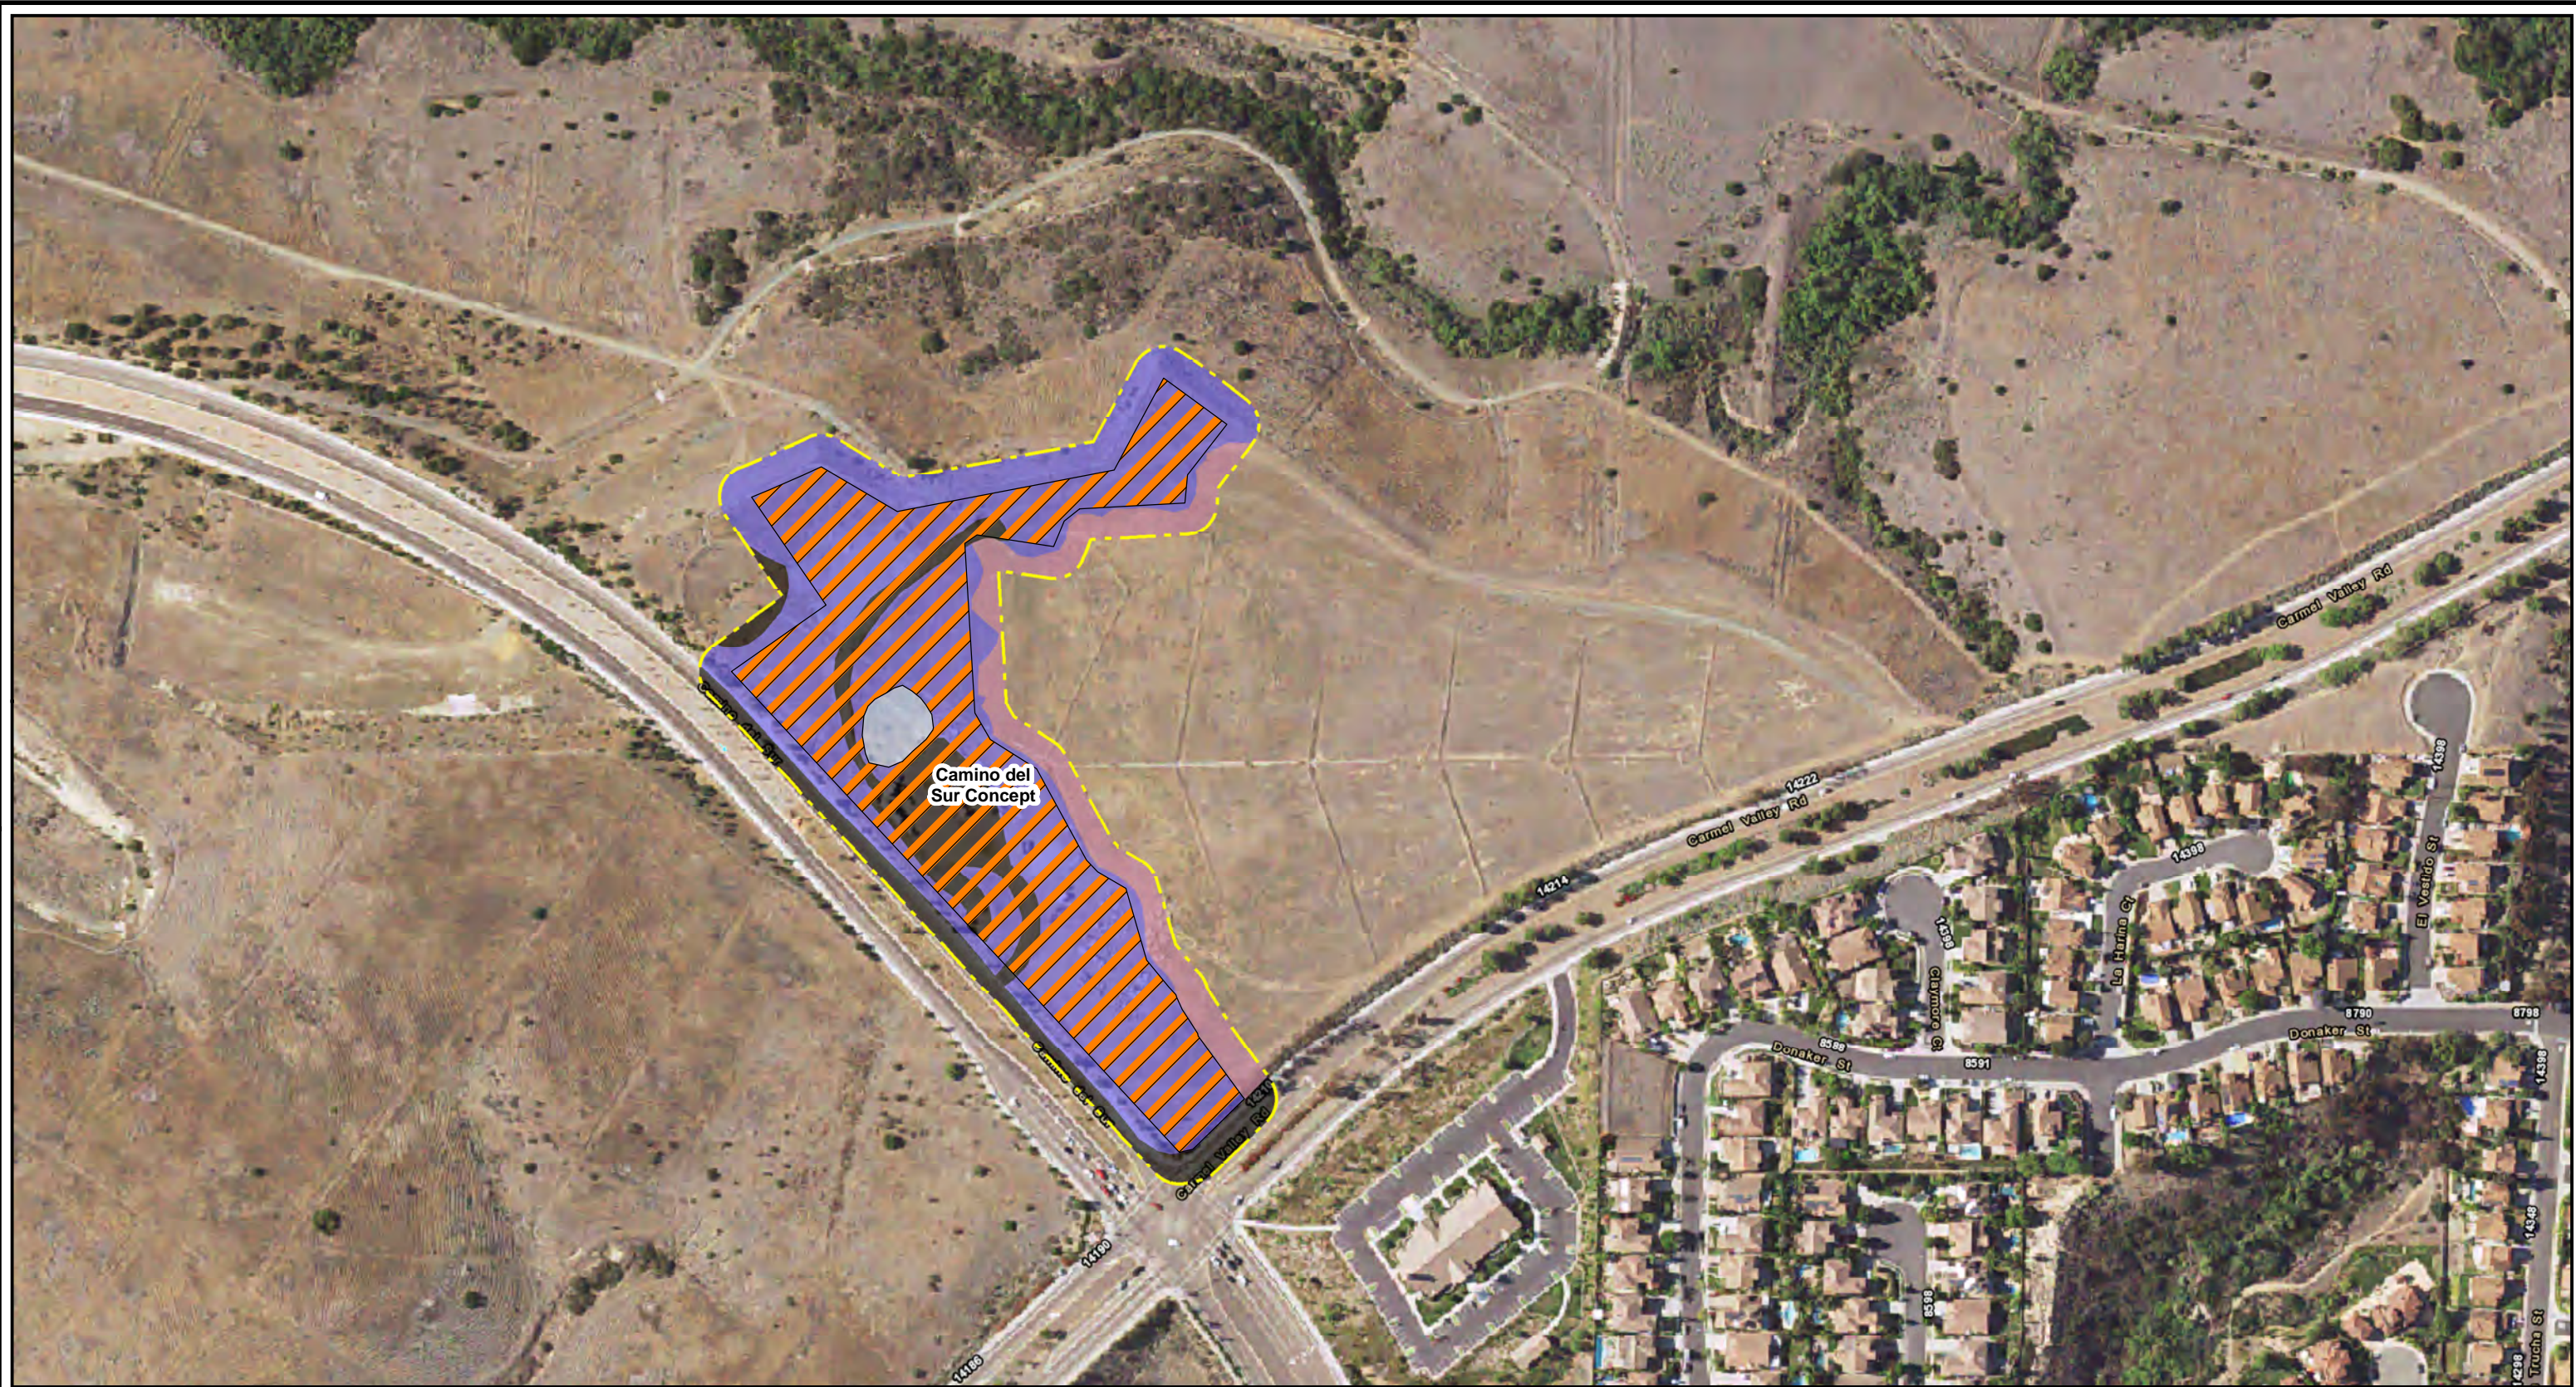
Vegetation Communities Map

Chambers Group biologists mapped vegetation communities and land cover types within the Survey Area on Thursday June 4, 2015 and Thursday June 11, 2015 (refer to the attached Vegetation Communities Map). The following four distinct vegetation communities were observed to occur within the Survey Area: nonnative grassland, disturbed habitat, meadow/seep, and developed lands. Descriptions of these communities are provided below. The total vegetation acreages per vegetation community type within the Survey Area are presented in Table 1 below.
