# PROJECT MEMORANDUM PG&E ATLANTIC-DEL MAR REINFORCEMENT PROJECT

To: Jensen Uchida, CPUC
From: Vida Strong, Aspen Project Manager
Date: May 18, 2006
Subject: Weekly Report #56: May 7, 2006 – May 13, 2006
CPUC Environmental Monitor (EM): Heather Stiles

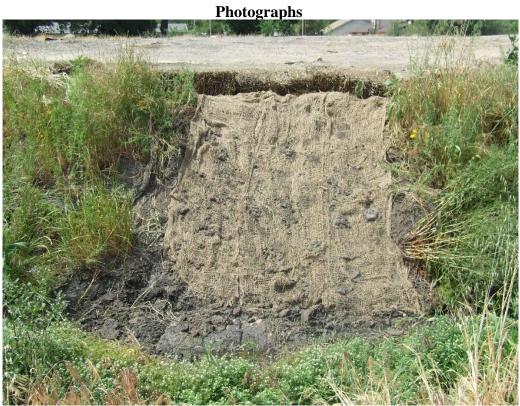
Zayas conducted repair work at seasonal drainage #30. The operator carefully removed soil from the lower section of the bank and placed it into the eroded area. Although there was a small amount of flow within the drainage, the operator was able to complete the work avoiding the flowing water. The repaired section of bank was compacted using the bucket of the backhoe. Seed mix #2 (from the project restoration plan) was hand-broadcast over the bank and the seed was raked into the soil. The entire repair area was then covered with jute netting. Several straw bales were placed along a 4-inch deep trench along the top of the bank above the repair site (the trench was excavated to accommodate the bales). The operator packed soil along the front edge of the bales and additional seed was hand broadcasted along the top of the bank and raked into the soil.

**Figure 1** – Repaired bank of Drainage #30, May 12, 2006.

Wilson and its subcontractors continued to finalize various cable related activities at the vaults and transition structures. The crews also continued conducting cleanup and demobilization. Zayas, the excavation subcontractor, conducted repair work at the seasonal drainage #30 (see Figure 1). An updated list of restoration activities, provided by correspondence between Bert Austin and Kevin Kilpatrick, is provided in the following section of this weekly report.
