PROJECT MEMORANDUM SCE TRANSMISSION PROJECTS, SEGMENTS 1–11

To:	John Boccio, Project Manager, CPUC
From:	Vida Strong, Aspen Project Manager
Date:	April 8, 2010
Subject:	Weekly Reports 114-115 — March 21 to April 3, 2010

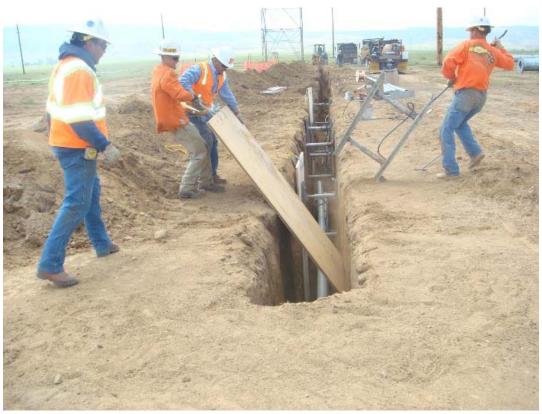
- 1. The relocation of a 66 kV transmission line within the Antelope Substation expansion area continued. A temporary shoofly was constructed in order to maintain service to the line. SCE crews continued with the underground portion of the relocated 66 kV line around the outside of the Antelope Substation expansion area (see Figure 1).

Figure 1: Underground relocation of the 66 kV line outside of the Antelope Substation.

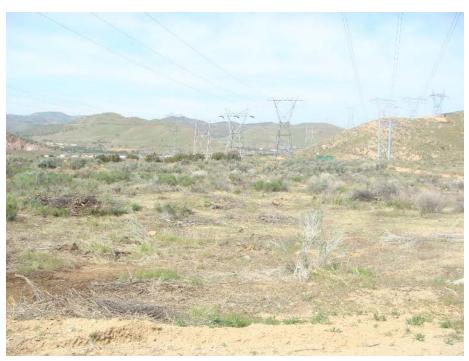
- 1. During vegetation removal at the Vincent Substation expansion area, an active California thrasher nest was found in a Juniper tree. A 300-foot buffer was put into place and no further work was allowed in this area. Vegetation clearing was suspended until April 6th after the birds successfully fledged from the nest (see Figure 2).

Figure 2: Vegetation clearing at the Vincent Substation expansion area. Further vegetation removal is on hold pending CDFG concurrence of a reduced buffer for nesting birds or until birds have fledged.
