**PROJECT MEMORANDUM
SCE TRANSMISSION PROJECTS, SEGMENTS 1 - 11**

To: John Boccio, Project Manager, CPUC
From: Vida Strong, Aspen Project Manager
Date: April 27, 2010
Subject: Weekly Reports 116-118 — April 4 to April 24, 2010

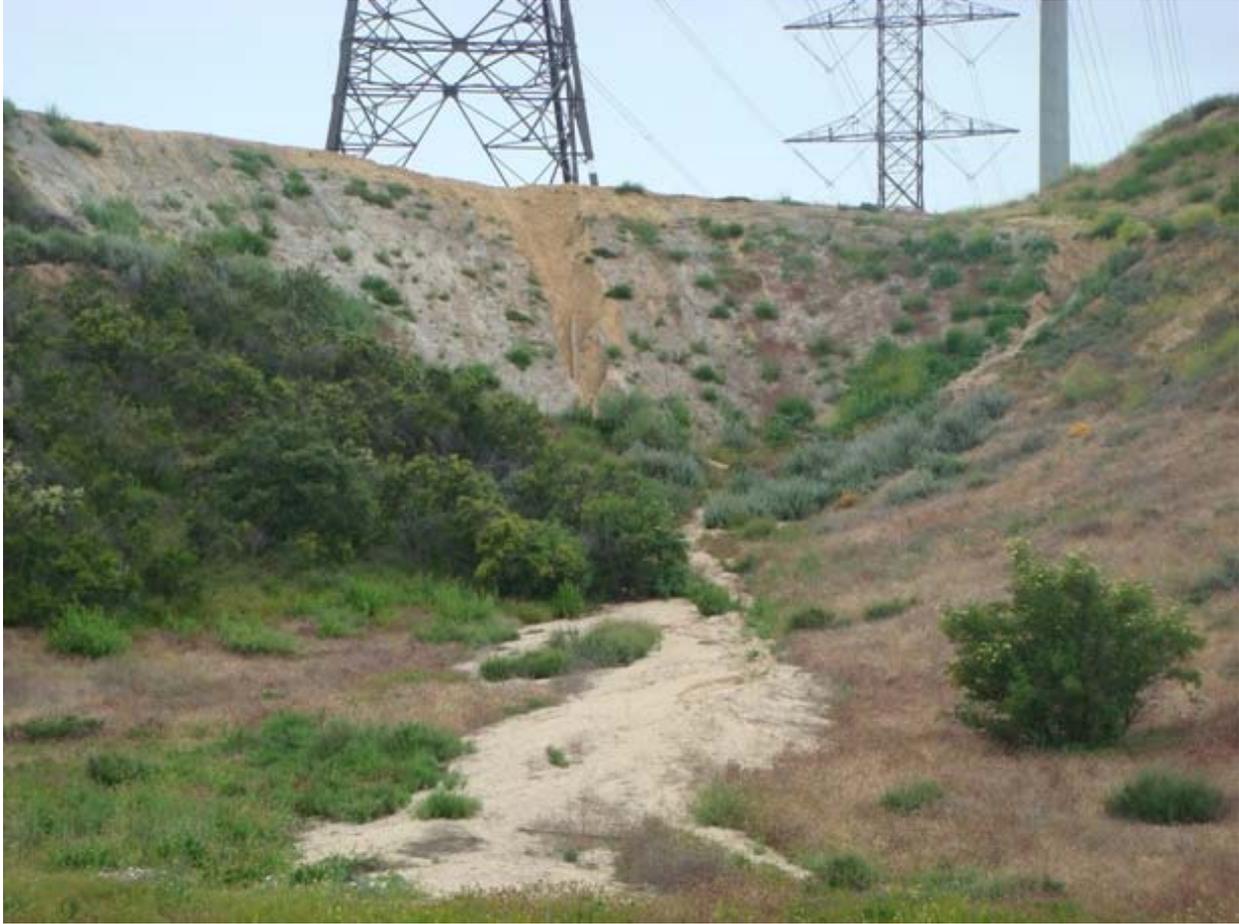
2. Erosion problems have been identified at several locations in Segment 1 including Towers 9 and 99 (see Figure 1). SCE is working with the contractor's hydrologist to implement erosion repairs at these locations. Water bars and drivable dips were installed on the road to Tower 99. An engineering report was prepared by PAR's subcontractor to provide an assessment of the erosion at Tower 9 and to provide an engineering solution to repair the slopes. This plan is currently being reviewed by SCE. A site visit to this location took place on April 22 with CDFG to discuss construction within 300-feet of an active red-tailed hawk nest (located in Tower 9). SCE is currently evaluating the nest activity and will provide an update of the nest status to CDFG and the CPUC.

Figure 1: Erosion at Tower 9 in the City of Santa Clarita, Segment 1. A plan for repairs at this location is currently under review by SCE.

3. Erosion repairs are taking place by both ECORP/Nature's Image and PAR construction. Major repairs needed at Towers 9 and 99 are expected to take place in the next few weeks.

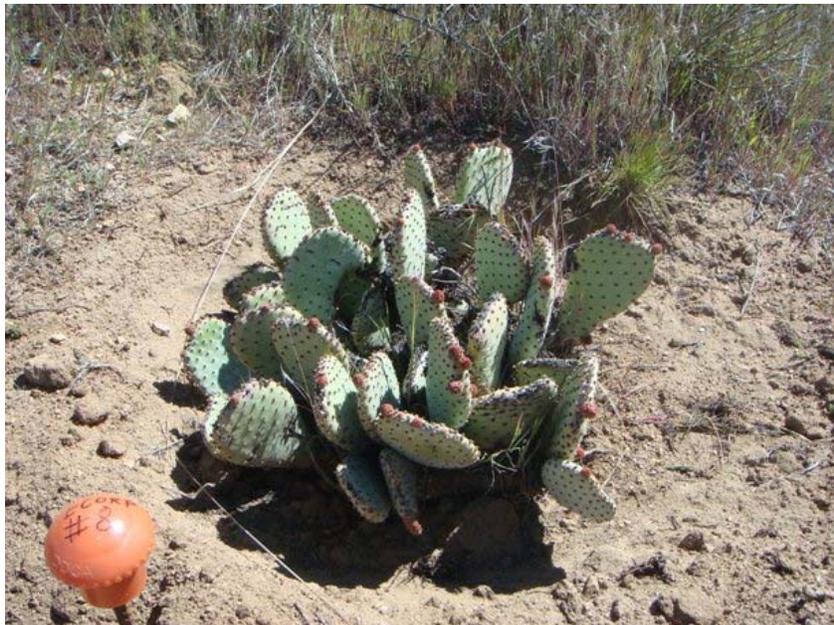
1. Construction crews completed the construction of Yard 28, located on Avenue I in Lancaster. SCE is expecting the delivery of materials in the next few weeks.
2. Vegetation removal with hand tools was completed within the Vincent Substation expansion area. Four additional short joint beavertail cacti were found and transplanted to the relocation site nearby (see Figure 2). A portion of the expansion area was on hold due to an active nest, but was completed after the birds successfully fledged the nest.
3. Equipment and materials were delivered to the Rancho Vista Yard in Rancho Cucamonga.
4. Two equipment yards are currently in use supporting the geotechnical investigations on the Angeles National Forest (Segments 6 and 11). These are the Rodeo Yard (previously permitted under Segment 2) and the Huntington Drive Yard on SCE right-of-way in Duarte.

Figure 2: Transplanted short joint beavertail cactus near the Vincent Substation.

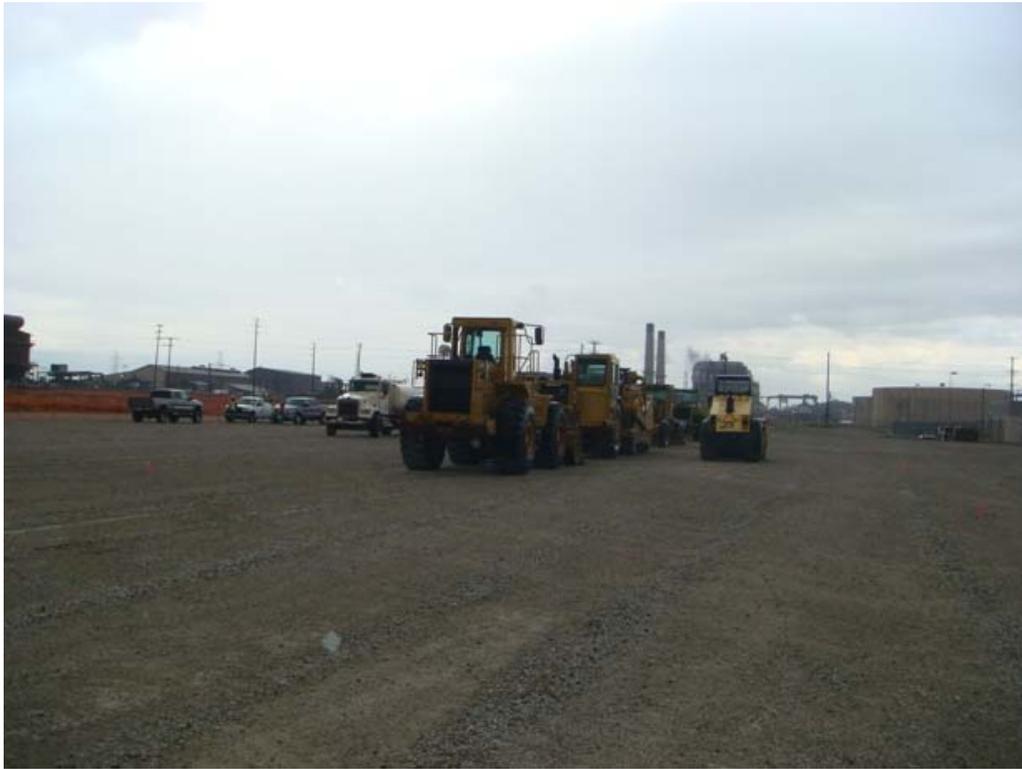
Figure 3: Equipment and Materials at the Rancho Vista Yard.

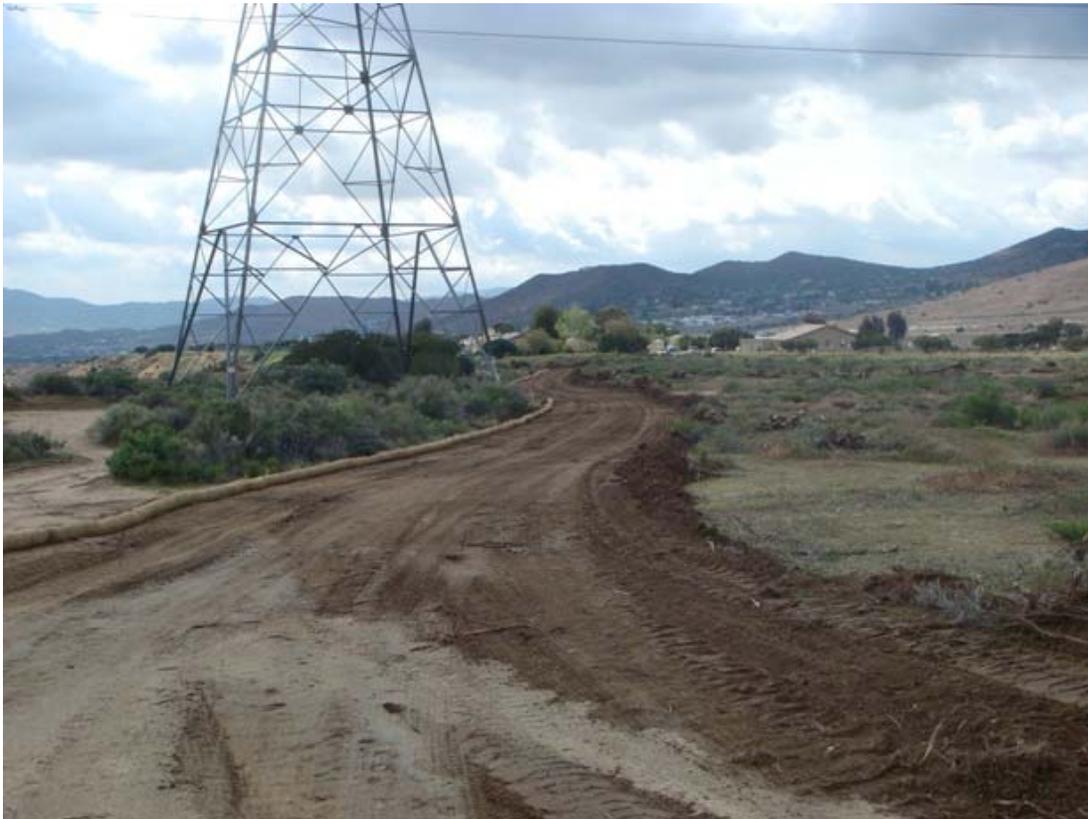
2. During a site visit to the Vincent Expansion area on April 22nd, the CPUC EM noted that installation of fiber rolls was occurring around the perimeter of the construction area. An access road was graded around almost half of the perimeter for the fiber roll installation equipment (see Figure 4). In addition, the crews and monitors onsite were unaware of the topsoil salvage requirements for the temporary disturbance areas (which is also the location of the grading noted above). SCE was reminded that biology clearance sweeps were required in this location since no work had occurred in over two weeks and that other plans and permits were to be submitted prior to work. SCE has since submitted an updated biological sweep survey and the grading permit for the Vincent Expansion site.

Figure 4: Grading of an access road for BMP installation at the Vincent Substation Expansion area.
