**PROJECT MEMORANDUM
SCE TRANSMISSION PROJECTS, SEGMENTS 1 - 11**

To: John Boccio, Project Manager, CPUC
From: Vida Strong, Aspen Project Manager
Date: November 2, 2010
Subject: Weekly Report 143 – October 17 to October 23, 2010

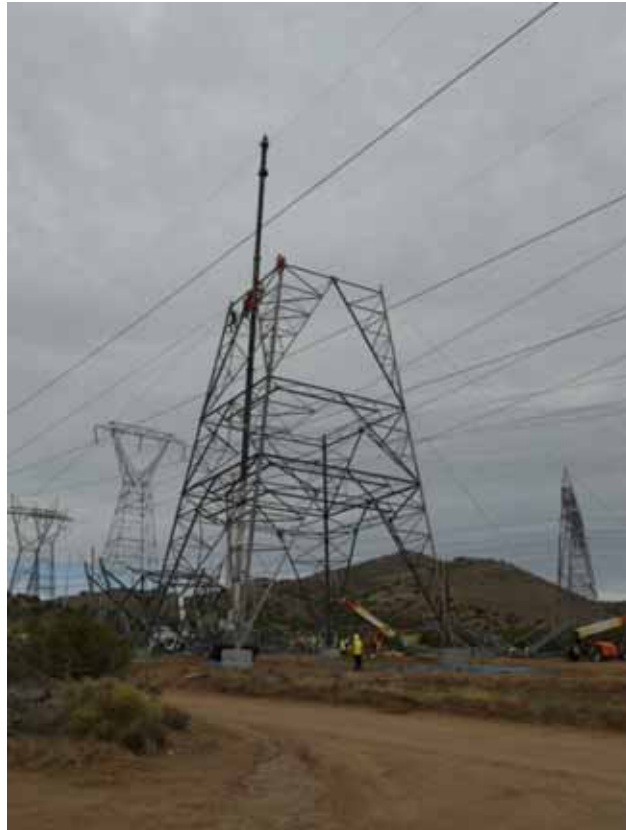
Figure 1: Tower 61 steel assembly near the Town of Acton, Segment 5.

4. The following activities occurred on Segment 5: steel assembly of Towers 60 and 61 (see Figure 1); concrete was poured at TSP 3 near the Vincent Substation; an H&M crew installed guard poles at Towers 37 and 61A (see Figure 2), and another crew unclipped wire and installed travelers between Towers 30 and 40.

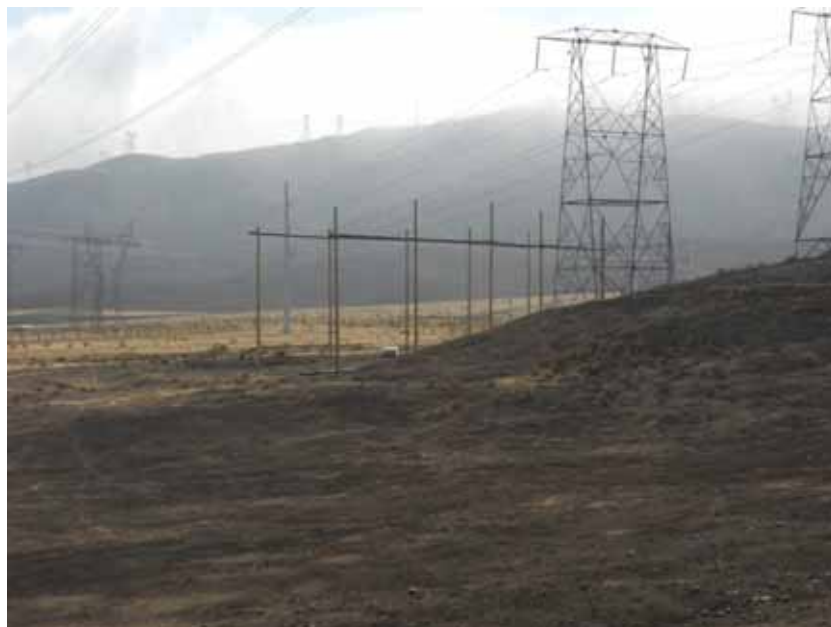
Figure 2: Guard pole structure to protect the Sagebrush Transmission Line at Tower 37, Segment 5.

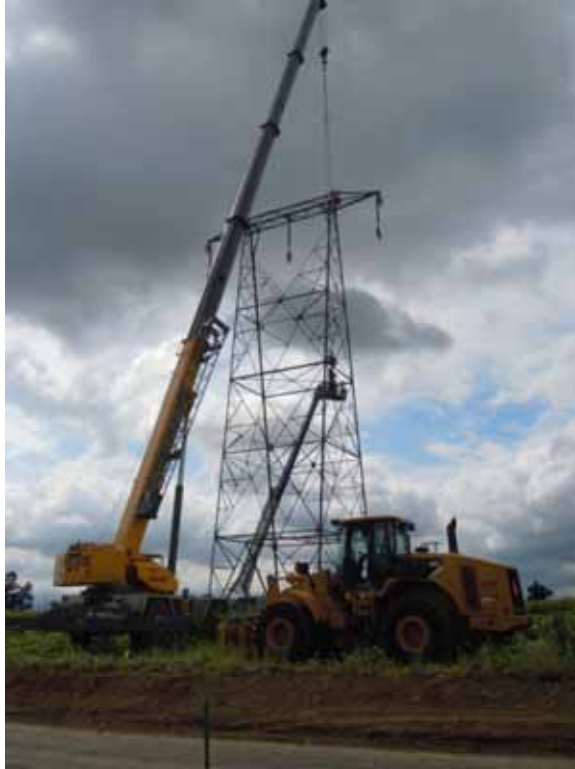
Figure 3: A Wilson crew works to remove a tower in the City of Ontario, Segment 8 Phase 2.

4. Segment 8, Phase 2: Wilson construction crews continued work on the wreck-out of the Chino–Mira Loma No. 1 structures in the Cities of Chino and Ontario during the subject period. Work included the removal of wire and hardware from Towers M2-T3 to M3-T3 and M4-T2 to M5-T1 (see Figure 3). Additionally, DCX crews continued to scrap towers. DCX crews also began tower foundation removal starting at Tower M0-T2 and working eastward (see Figure 4).

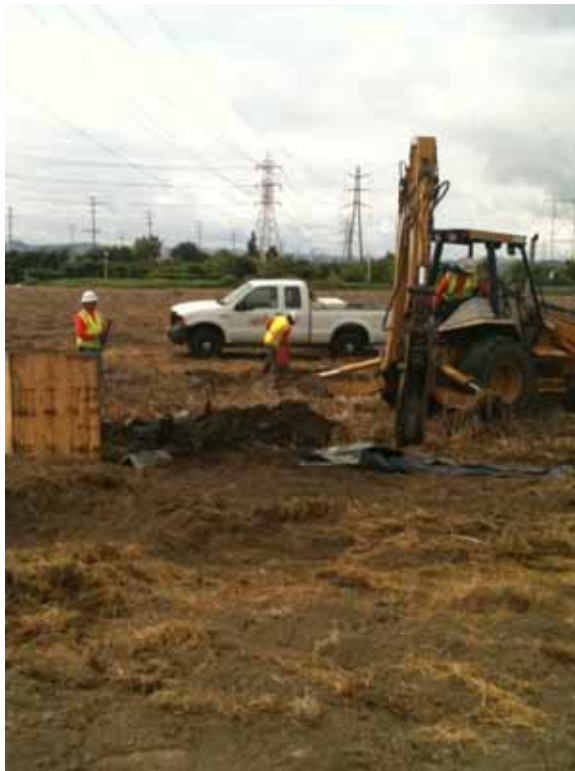
Figure 4: A DCX crew removes a foundation in the City of Chino, Segment 8 Phase 2.

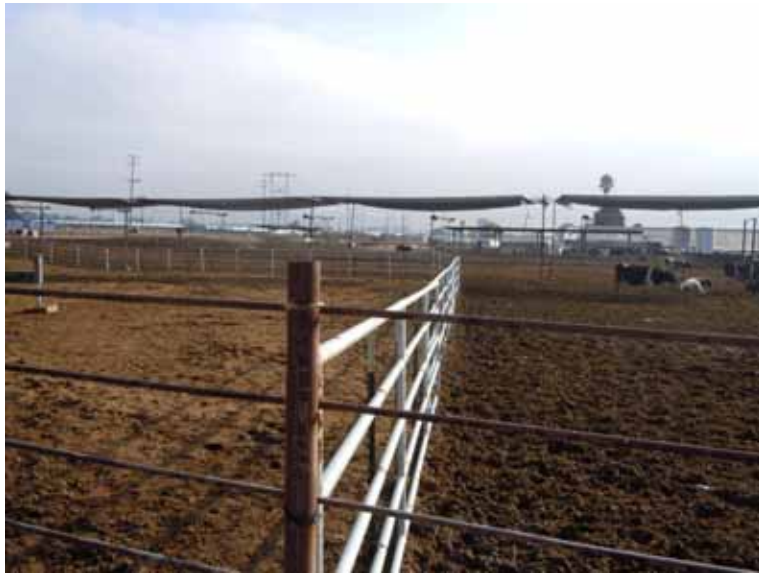
Figure 5: American Construction installed fences like this to block cows from entering construction areas within dairies.

1. Various materials for the 66 kV work in Segment 8 are being stored in areas not approved under TRTP (outside of the Rio Hondo and Chino Substations). The CPUC EMs have informed SCE that a Variance would be required for use of both areas.
2. A crew from American Construction installed panels at various dairies on Segment 8 Phase 2 to block cows from entering construction areas (see Figure 5).
