**PROJECT MEMORANDUM
SCE TRANSMISSION PROJECTS, SEGMENTS 1 - 11**

To: John Boccio, Project Manager, CPUC
From: Vida Strong, Aspen Project Manager
Date: March 8, 2011
Subject: Weekly Report 161, February 20 to February 26, 2011

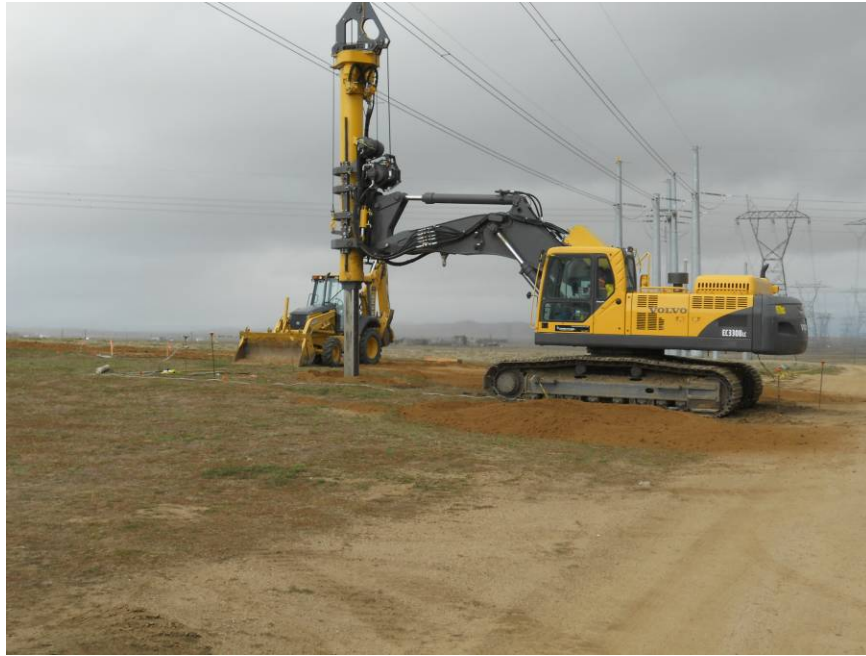
Figure 1: KV Structures drilling Tower 3A-102, Segment 4.

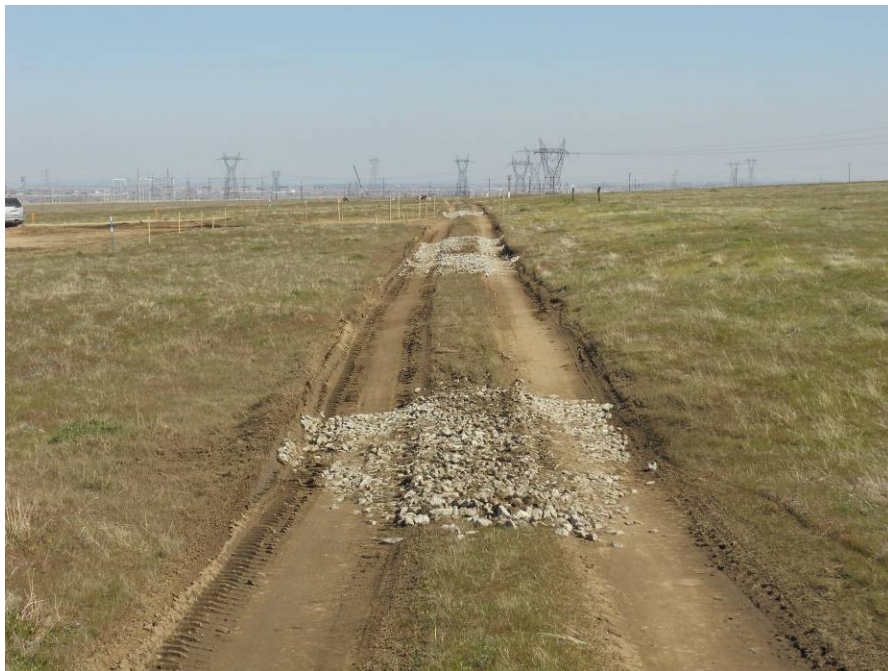
Figure 2: Rock placed in access road that leads from 110th Street to the Antelope Substation, Segment 4.

2. Segment 4: KV Structures (drilling contractor) continued drilling, setting rebar cages using a spider jig for stub angle placement, and concrete pouring at Towers 44 through 54 and Tower 3A-102 (see Figure 1). KV acquired a smaller drill that allows them to access more sites. H&M steel crews continued tower assembly work at Towers 40, 41, 42, and 43. H&H Grading installed BMP's (i.e., fiber rolls) at several disturbance sites between Towers 32 and 24. Due to the lack of survey stakes along the new access spur roads, fiber rolls were not installed at all tower locations. Rock was placed within the ruts along the access road that leads from 110th Street to the Antelope Substation to help prevent trucks from getting stuck (see Figure 2).

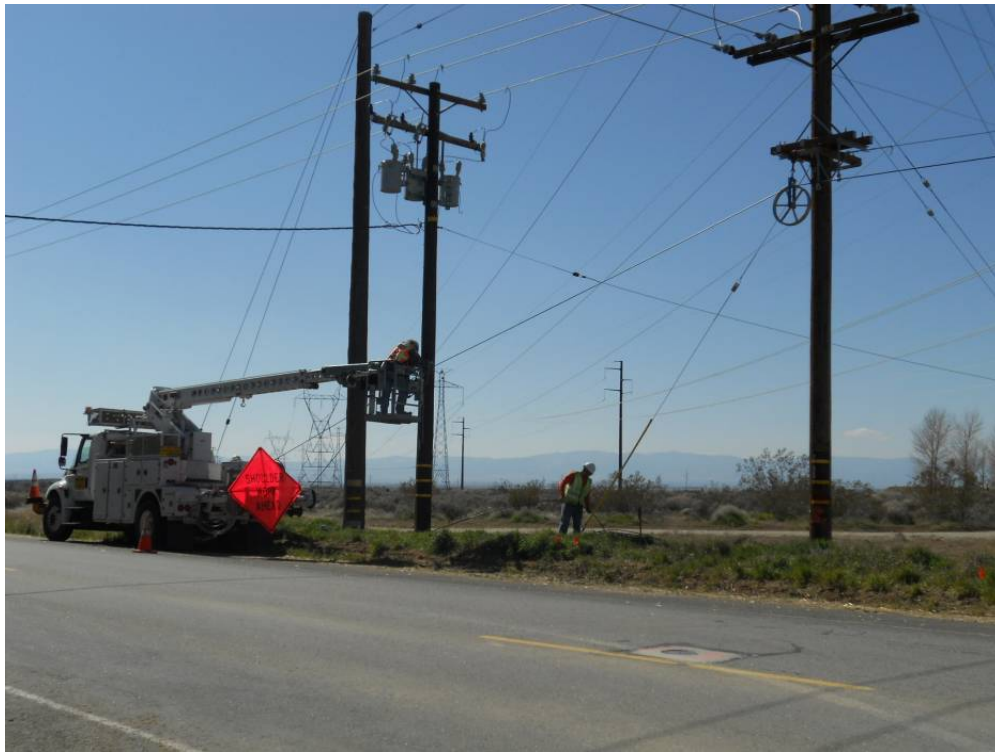
Figure 3: H&M crew pulling fiber optic cable along Tehachapi Willow Springs Road, Segment 10 Telecom.

5. Segment 10 Telecom: H&M crews continued fiber optic cable (FOC) pulling between Rosamond and Windhub Substations (see Figure 3). Wind dampeners were added to the newly installed cable. Griffin Construction continued cable arm installation and FOC pulling between the Rosamond Substation and 170th Street. The trenching outside the Rosamond Substation will be conducted by Griffin next week.

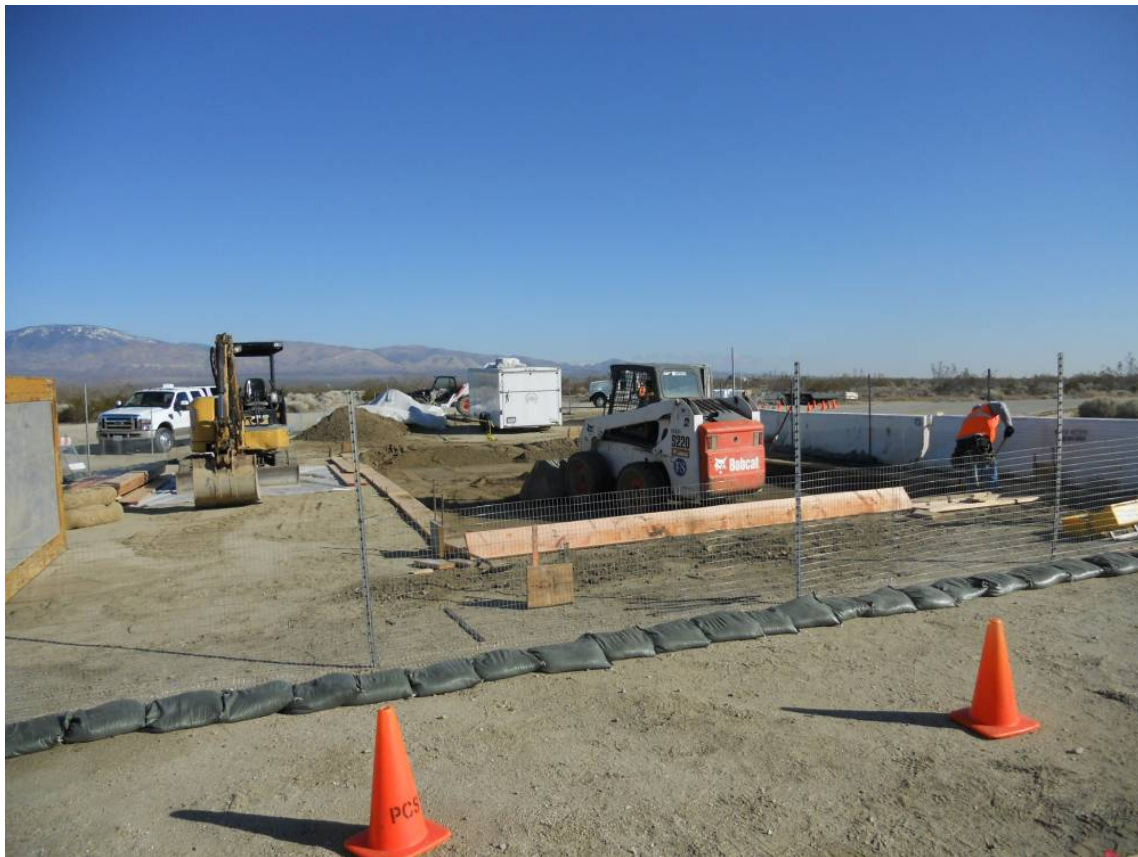
Figure 4: Concrete slab installation over the LADWP aqueduct in the disturbed area along Rosamond Boulevard and 170th Street at Whirlwind Substation, Segment 9.

6. Whirlwind Substation: Moore Fence Company completed the tortoise and chain link fence installation, including the gated entrances to the substation. The 100% clearance sweep for desert tortoise and Mohave ground squirrel (MGS) was conducted on February 20th. Some areas (such as the new drainage channel and spreader) were skipped in order to get the grubbing and grading operation underway, so the fence company began trenching along the fence limits on the west side of 170th Street. Once this portion of the fence is complete, biologists will conduct a 100% clearance sweep of the area prior to grubbing. Work on the concrete slab over the LADWP underground aqueduct began on February 22nd (see Figure 4).

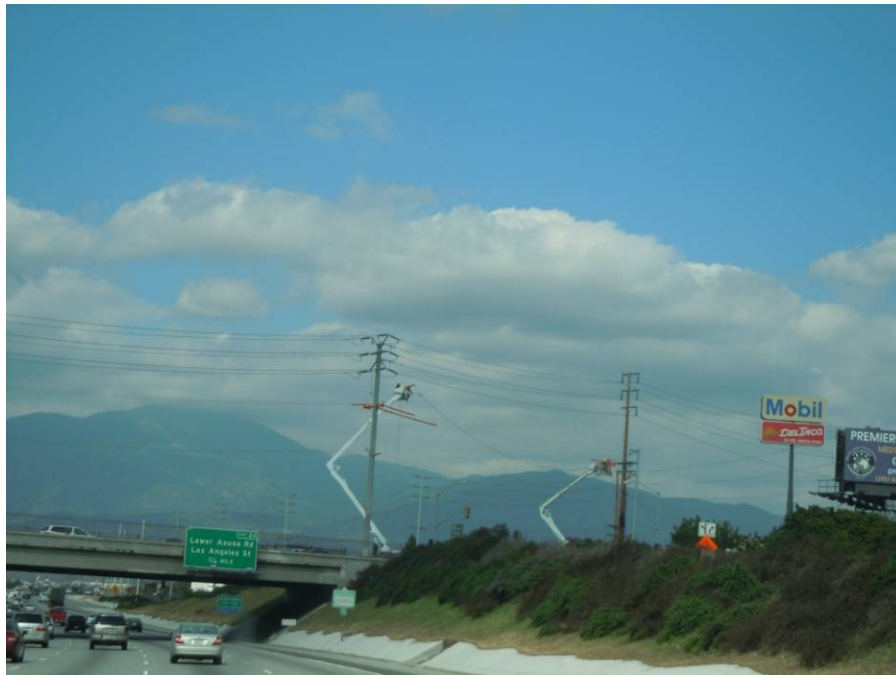
Figure 5: Crews stringing wire, Segment 7 66 kV.

1. Segments 7 & 8, 66 kV: During the subject period, Wilson crews continued work on the foundations for riser and non-riser poles for the Chino 66 kV Relocation. Crews drilled holes and placed cages. Wilson and SCE crews also continued work on the Rio Hondo Substation to Ramona Boulevard overhead portion of the Rio Hondo–Amador-Jose-Mesa and the Rio-Hondo Amador/Rio Hondo–Anita No. 2 line in the City of Irwindale. Work included stringing wire along Rivergrade Road and Lower Azusa Road (see Figure 5). SCE crews were scheduled on non-TRTP projects for the week.

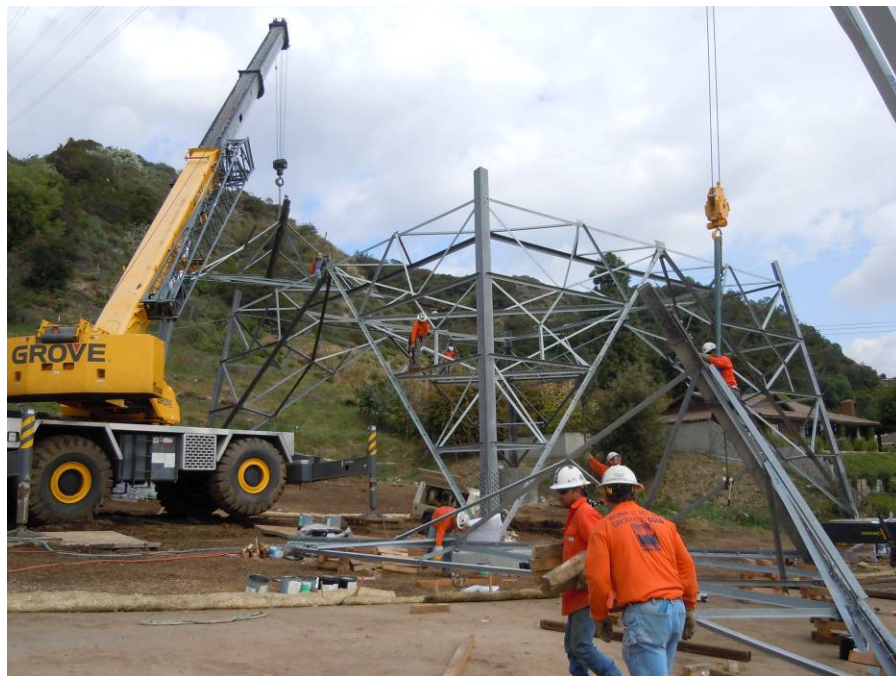
Figure 6: Crews assembling Tower M54-T3a, Segment 7.

2. Segment 7: Tri-State began drilling two foundations in the City of Duarte. Wilson removed conductor across five spans and wrecked out three towers and began assembly at Tower M54-T3a (see Figure 6). Additionally, DCX crews continued to mow within disturbance areas around towers and wire setup sites.

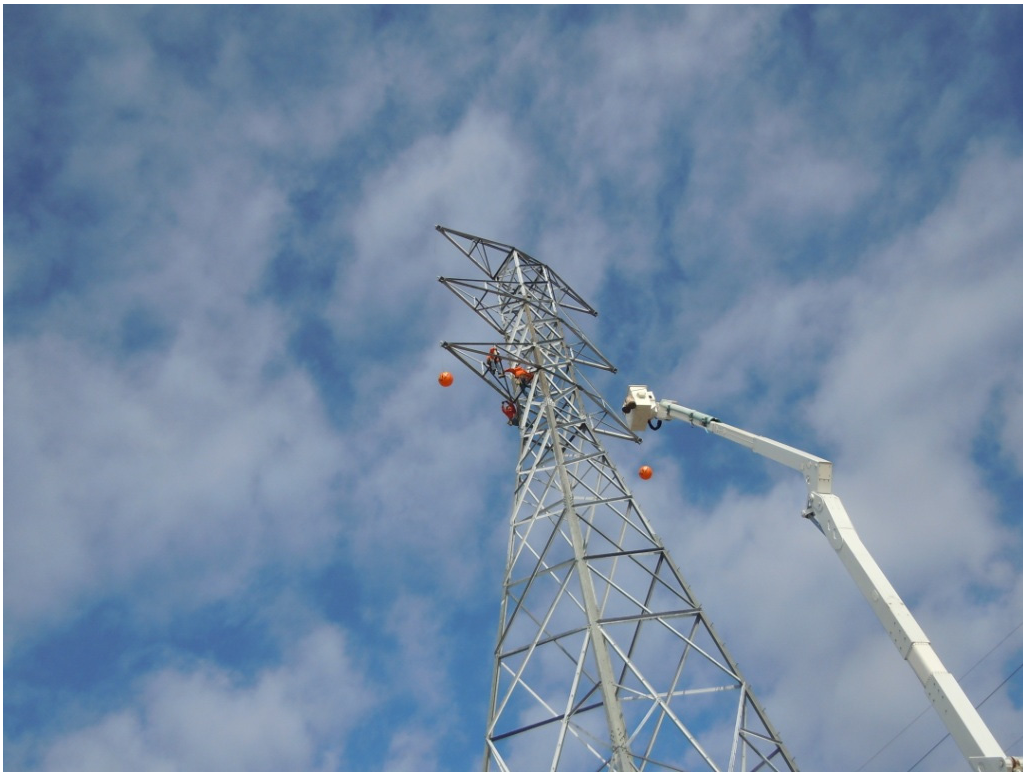
Figure 7: Crews assembling a tower and installing bird deterrents, Segment 8 Phase 2.

4. Segment 8, Phase 2: Wilson crews continued assembly work at four towers on the Chino–Mira Loma No. 1 line (see Figure 7). Tri-State and DCX crews drilled foundations at five tower locations. Additionally, DCX crews continued to mow within disturbance areas around towers and wire setup sites.
