**PROJECT MEMORANDUM
SCE TRANSMISSION PROJECTS, SEGMENTS 1 - 11**

To: John Boccio, Project Manager, CPUC
From: Vida Strong, Aspen Project Manager
Date: April 25, 2011
Subject: Weekly Reports 167 and 168, April 3 to April 16, 2011

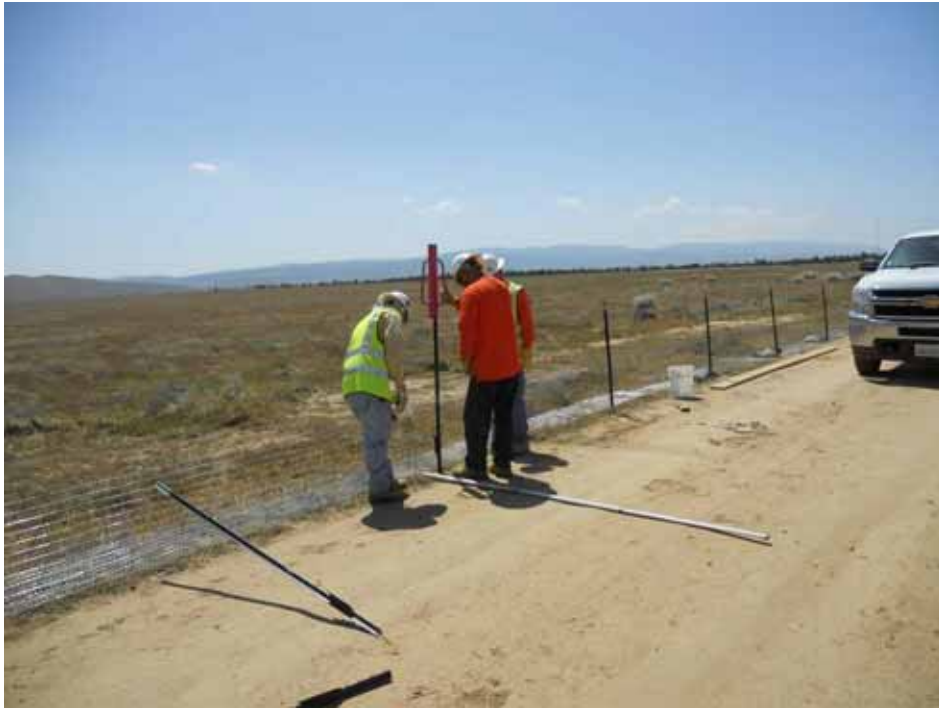
Figure 1: Tortoise fence installation (no-dig option) along Avenue C, Segment 4.

Substation) and Tower 18. Installation of the above-ground (i.e. no-dig) tortoise fence began along the Avenue C access road between 150th and 140th Streets (see Figure 1).

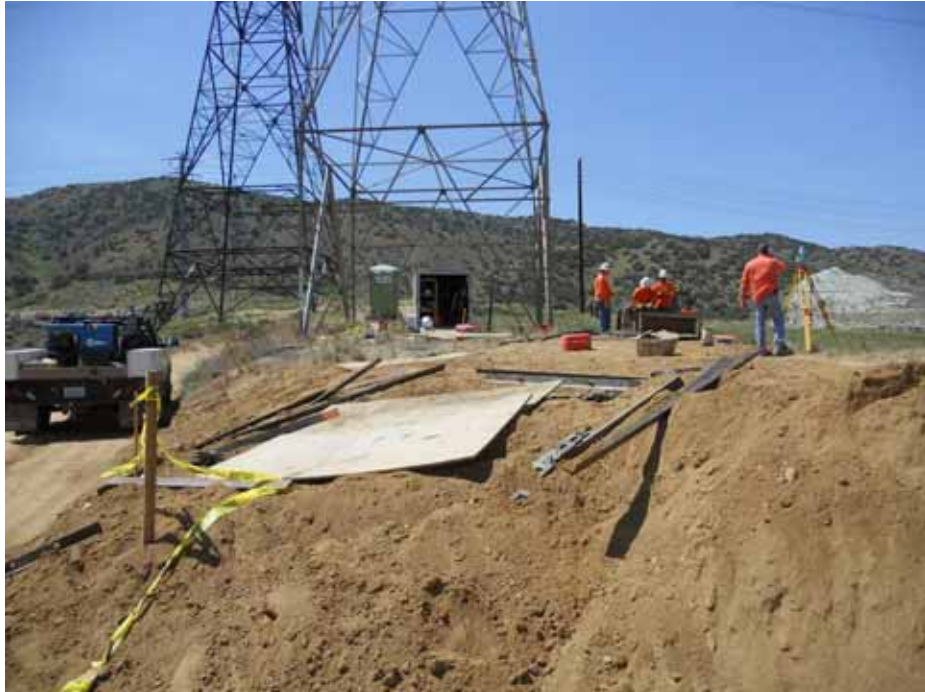
Figure 2: Woodward Brothers (drilling contractor) setting up Tower 16, Segment 5.

3. Segment 5: Woodward Brothers (drilling contractor) continued drilling, setting rebar cages, and concrete pouring at Towers 16, 18, 20, 22, 50, and 51 (see Figure 2). H&M steel crews worked at Towers 4, 6, 10, 14, 15, 54, 58A, and 61A (see Figure 3). Wire stringing occurred from Tower M88-T1D and Tower 2 to Rack 6 inside the Antelope Substation (see Figure 4). Wreck-outs of the 220 kV towers and steel removal continued. Tower footing removal occurred at Towers 18, 38, 39, and 57. A road grader conducted heavy improvements on the access roads between Towers 13 and 15. BMP installation occurred at various locations throughout the segment.

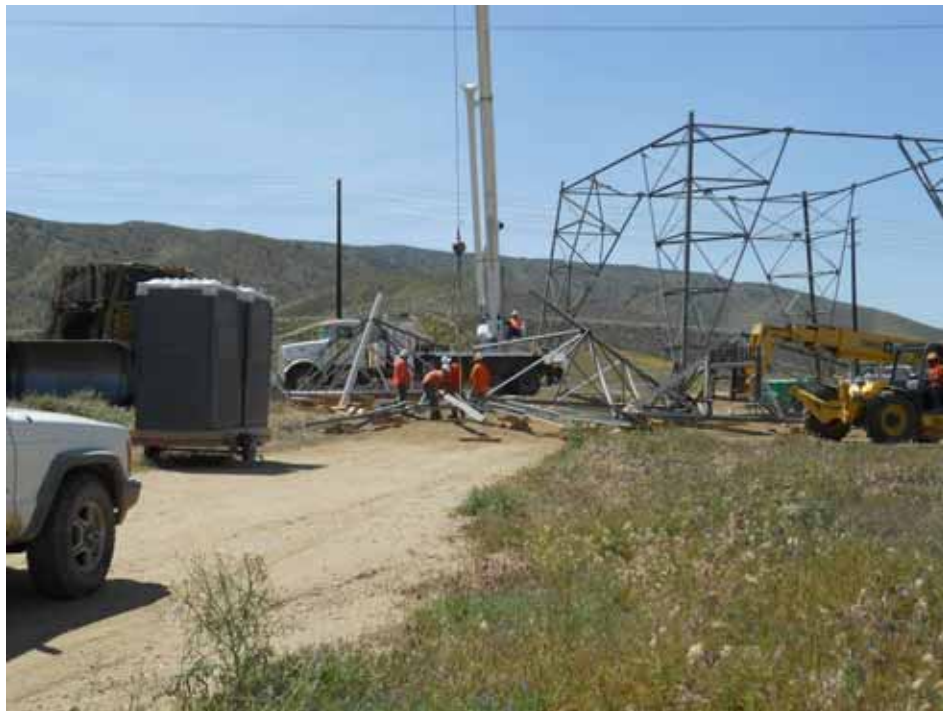
Figure 3: H&M steel crew assembling Tower 14, Segment 5.

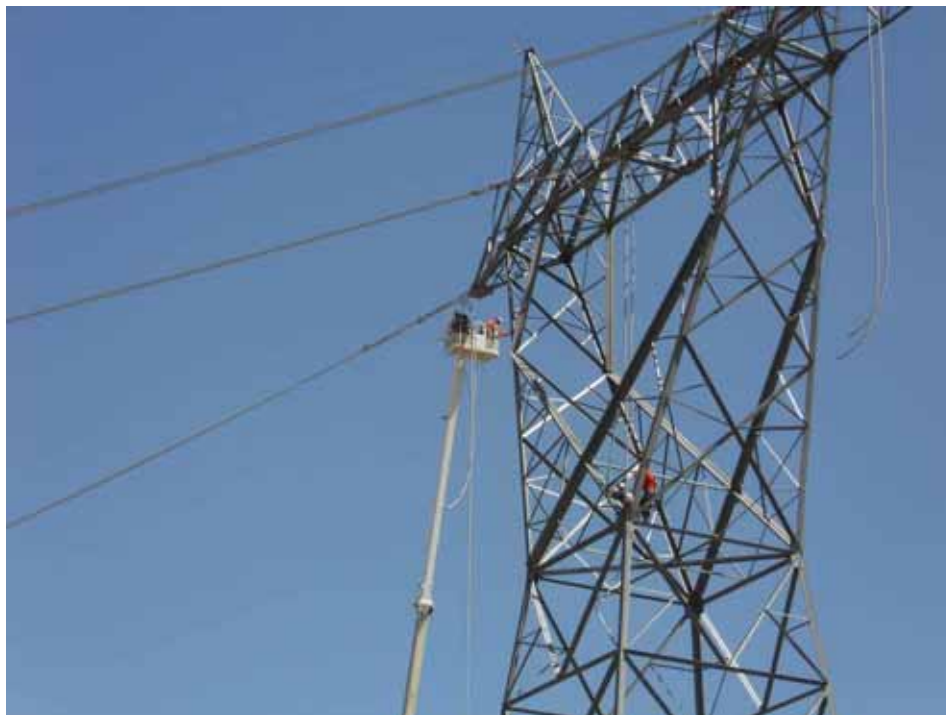
Figure 4: H&M wire crew tensioning wire from Tower 2 into the Antelope Substation, Segment 5.

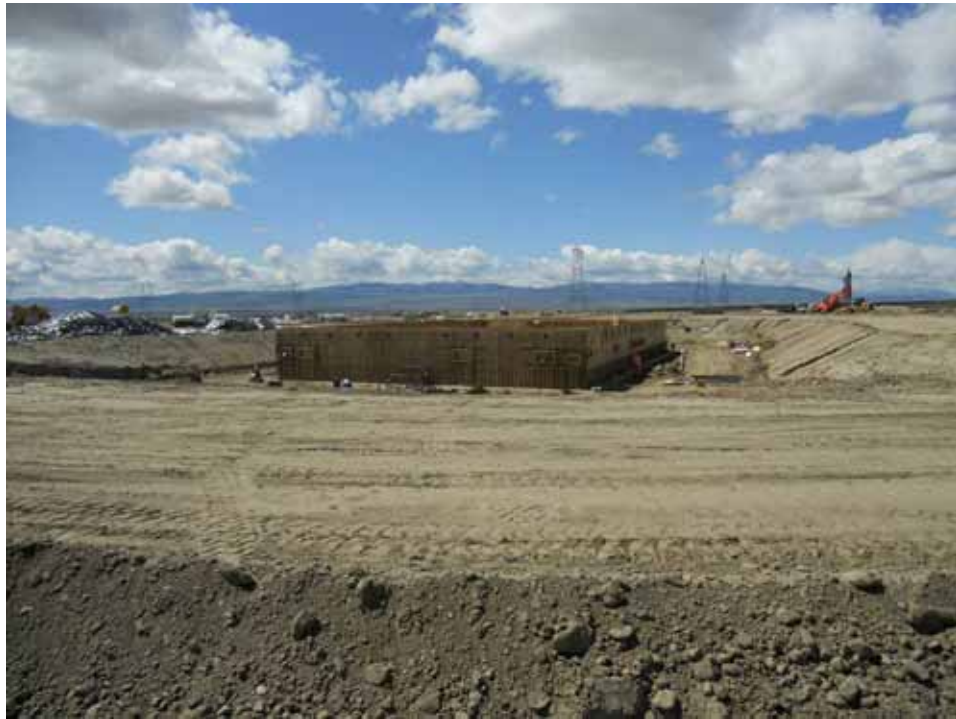
Figure 5: View of the MEER building inside the Whirlwind Substation, Segment 9.

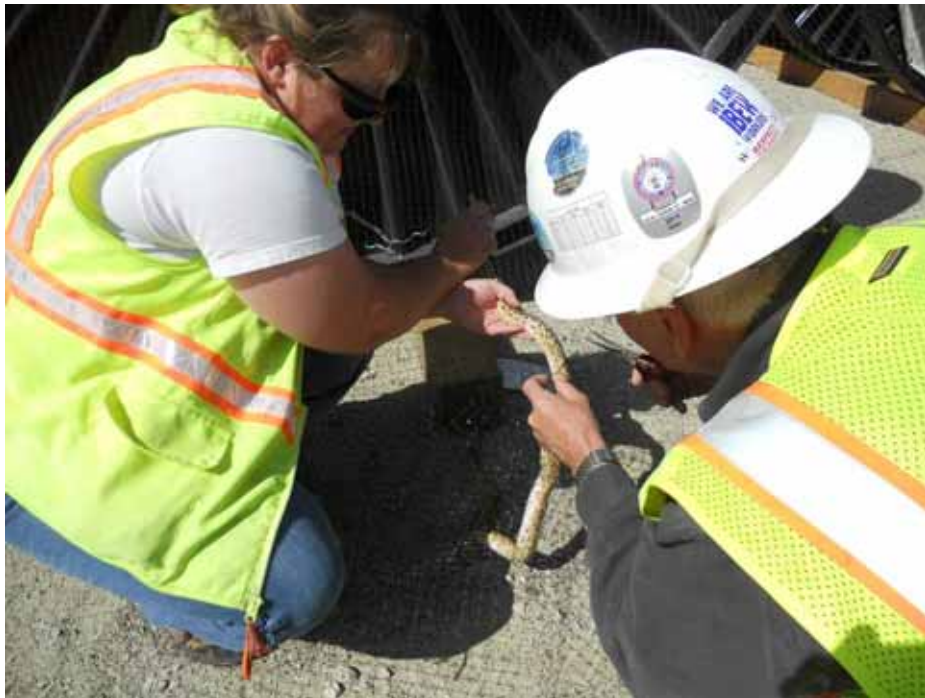
4. SCE reported a gopher snake being entangled in the bird netting within Material Yard 28 on March 30th. The snake was released unharmed (see Figure 6).

Figure 6: Trapped gopher snake being released from bird netting in Material Yard 28.

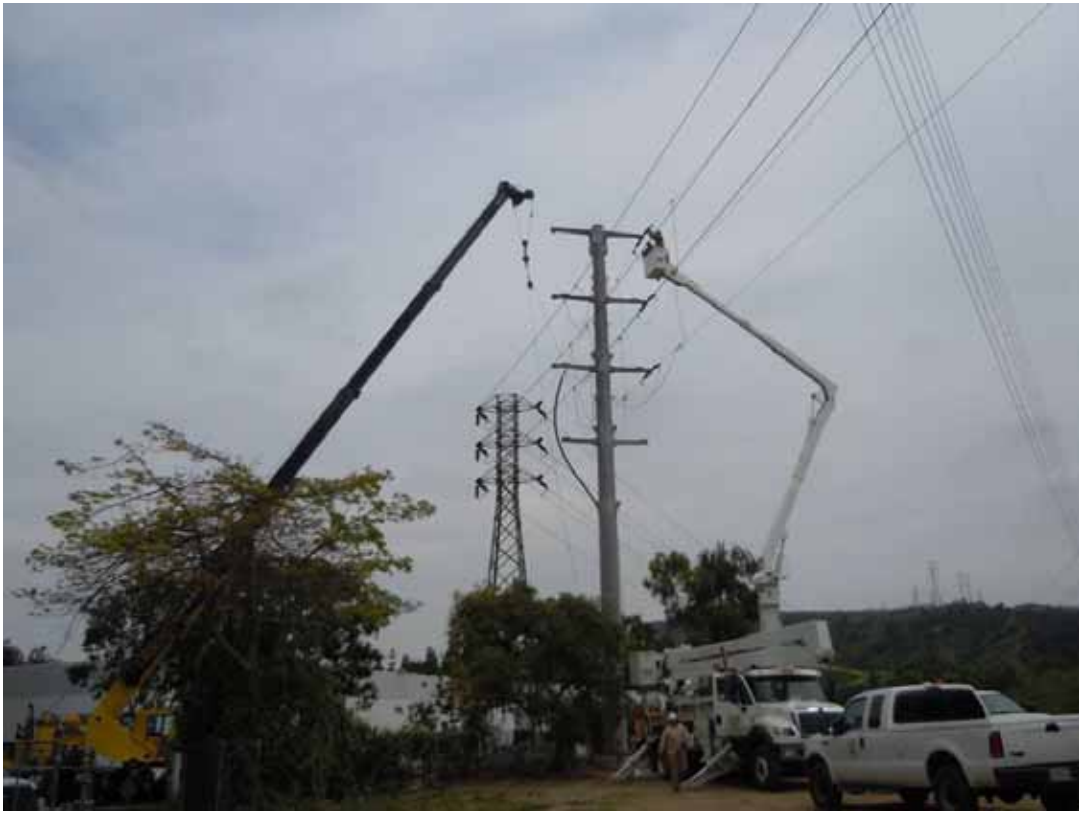
Figure 7: Crews install a pole at Pellisier Place, Segment 8 66 kV in the City of El Monte.

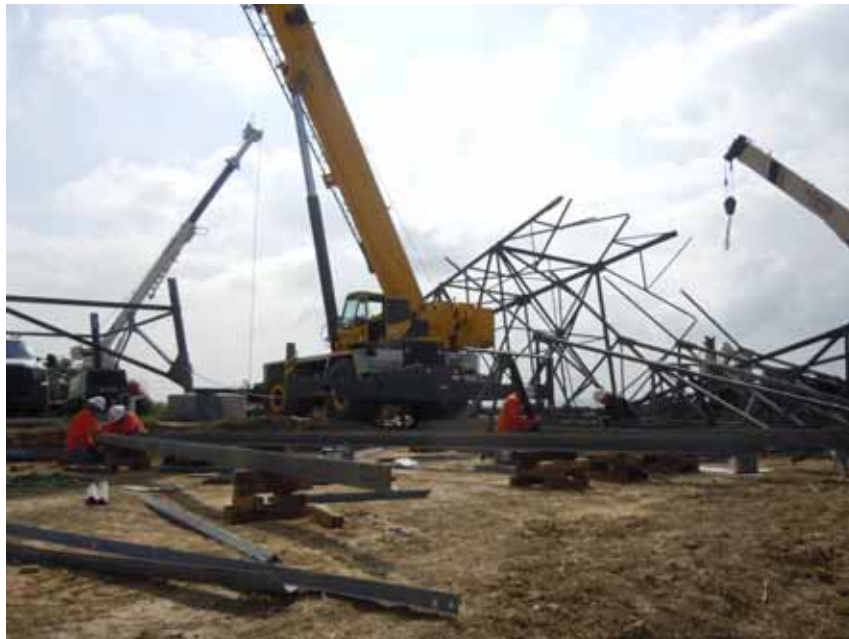
2. Segment 7: DCX crews continued grading at Van Tassel Mountainway and began pad construction at Tower M27-T4 in the City of Duarte.
3. Segment 8, Phase 1: Wilson, DCX and Tri-State crews continued to work within Tonner Canyon in the City of Industry and in the City of Chino Hills. Crews continued drilling three foundations and began assembling and erecting three towers for the new double circuit 500 kV Mira Loma–Vincent line (see Figure 8).

Figure 8: Crews assemble a tower, Segment 8, Phase 1.

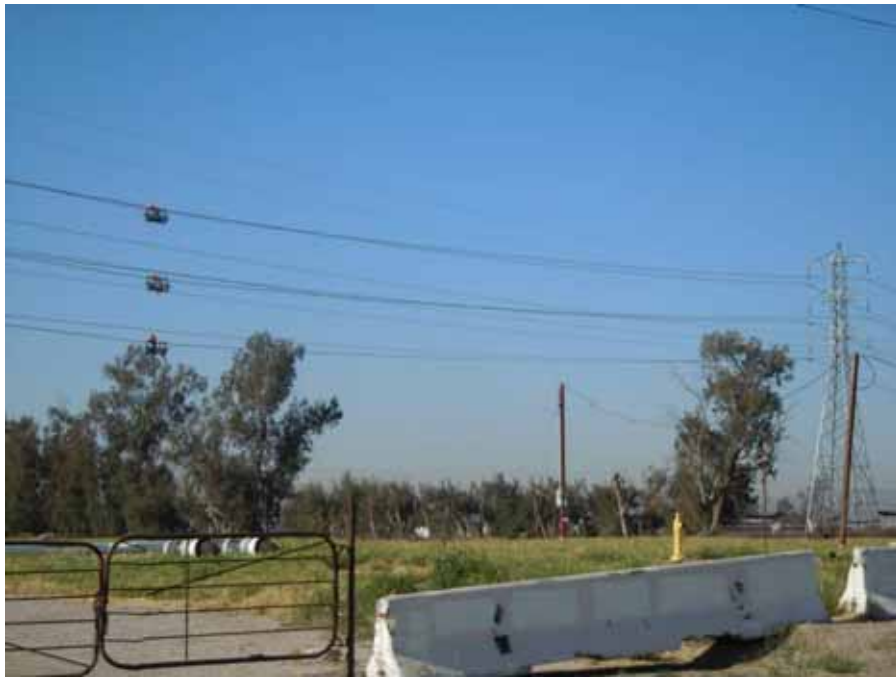
4. Segment 8, Phase 2: Wilson crews continued wire stringing on the Chino–Mira Loma No. 1 line from Towers M0-T1 to M0-T6 and from M0-T6 to M2-T2 (see Figure 9). Additionally, Wilson crews continued assembly work at two towers. Tri-State and DCX crews drilled foundations at two tower locations. Wilson began working extended hours in order to complete stringing the line approximately 6 weeks early.

Figure 9: Crews install spacers along the Chino–Mira Loma No. 1 line, Segment 8, Phase 2.

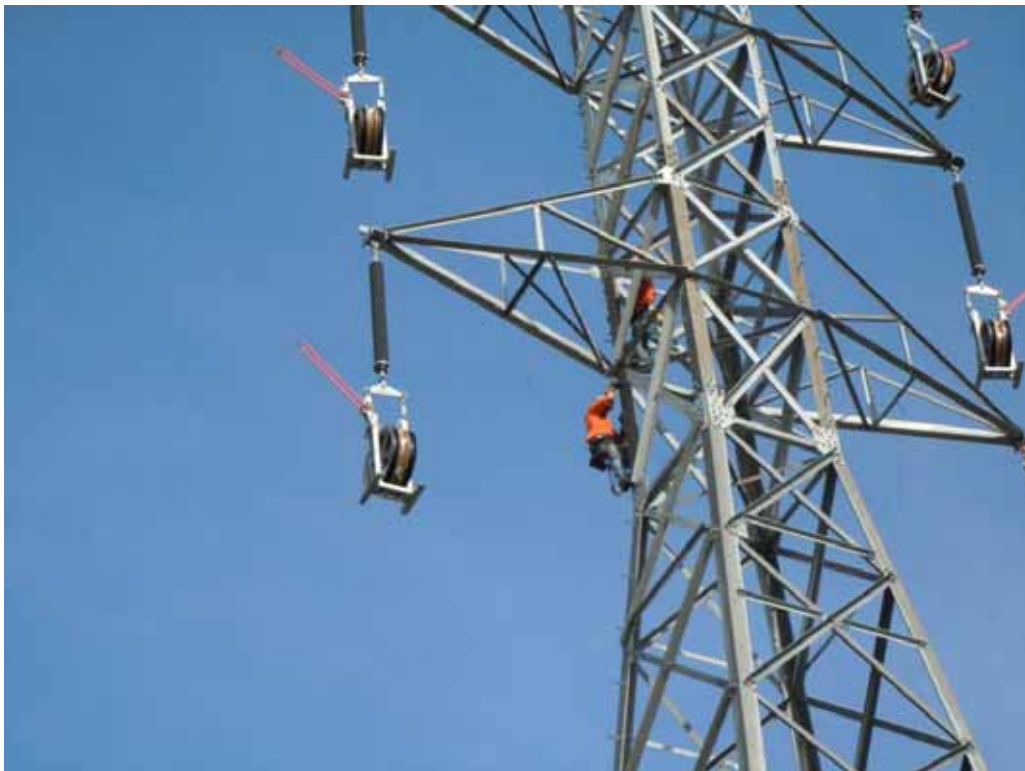
5. SCE received concurrence from CDFG to remove two partially completed Cassin’s kingbird nests from towers on Segment 8, Phase 2. One nest was within a traveler and the other was in the lower tower arm. Wilson linemen climbed the towers and removed the nests (see Figure 10).

Figure 10: Wilson linemen remove a partially built Cassin's kingbird nest Segment 8, Phase 2.

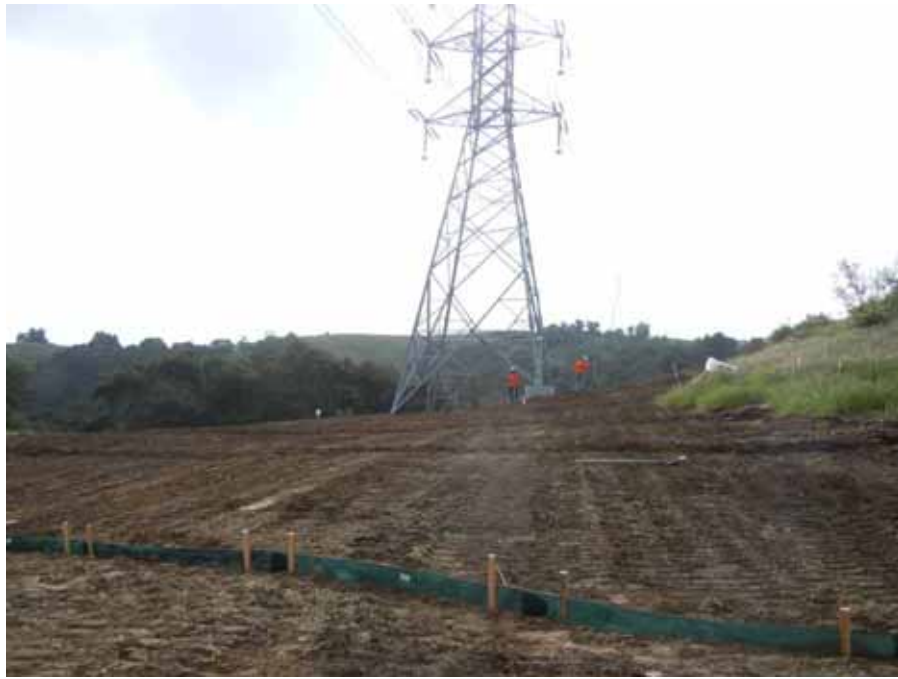
6. Wilson began restoration for SWPPP compliance within the Tonner Canyon shoo-fly area. Topsoil stored on-site was exposed with an excavator and then prepared for hydroseeding (see Figure 11).

Figure 11: Wilson crews begin restoration at the Tonner Canyon shoo-fly, Segment 8, Phase 1.

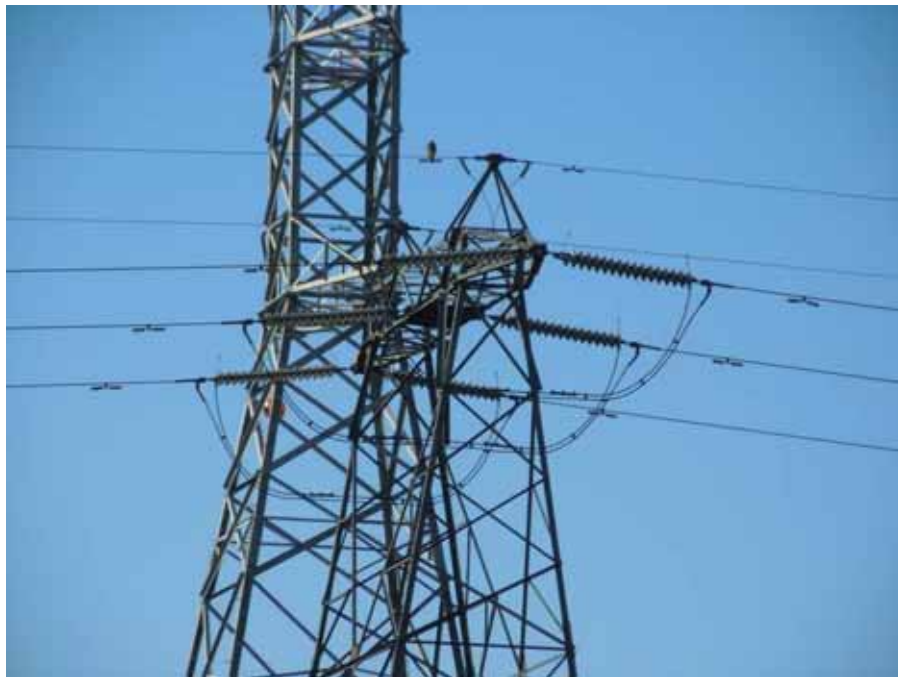
April 3rd in order to continue wire stringing from Towers M2-T2 to M3-T3. The hawk nest is located on an adjacent, non-TRTP tower and adults were observed incubating the nest at the time of the request. SCE deliberated with raptor experts and proposed a strategy to minimize the request of nest failure, including issuing two-hour holds to crews so that the adults could incubate the nest undisturbed. CDFG told SCE to proceed at their own risk. Crews attempted to begin stringing at the TRTP tower on April 8th. During an initial climbing inspection that morning, the adult flushed from the nest and did not return for several hours (see Figure 12). SCE is currently evaluating how to continue work at the tower.

Figure 12: An adult red-tailed hawk perches on the static line at Tower M2-T3. Wire stringing was halted to allow the hawk to incubate the eggs.
