**PROJECT MEMORANDUM
SCE TRANSMISSION PROJECTS, SEGMENTS 1 - 11**

To: John Boccio, Project Manager, CPUC
From: Vida Strong, Aspen Project Manager
Date: July 19, 2011
Subject: Weekly Report 180, July 03 to July 09, 2011

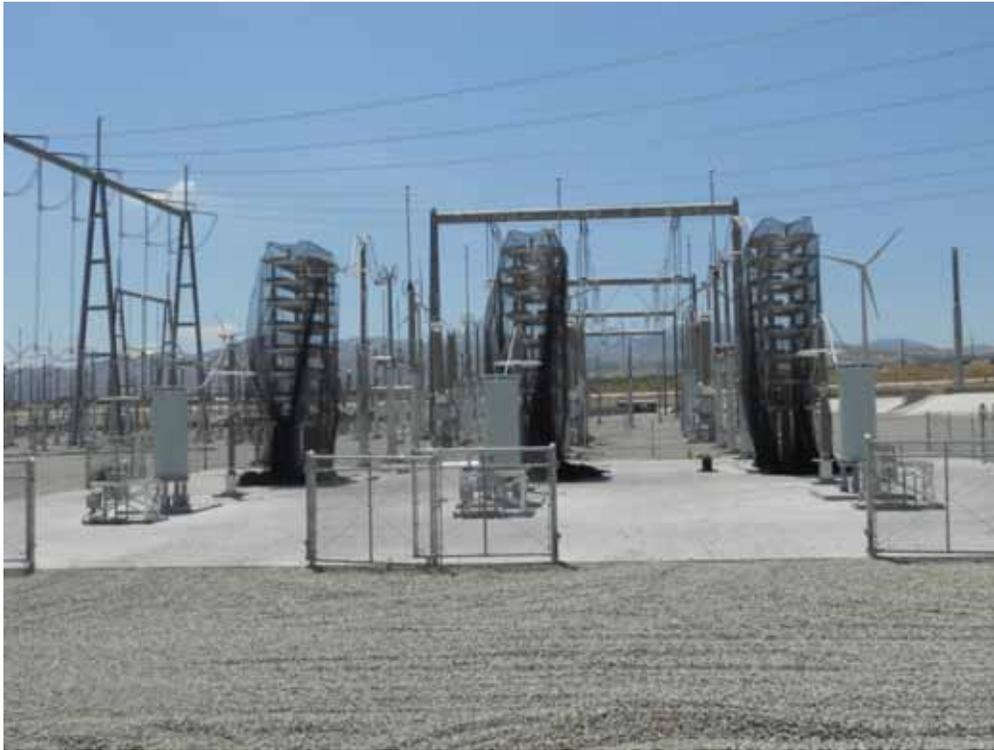
Figure 1: Bird netting covering capacitors in the Windhub Substation, Segments 1-3.

4. Construction activities at the Windhub Substation focused on steel and conductoring. Overhead conductor installation from the transformers to the 220 kV rack occurred. Four out of the seven transformers are filled with oil. Capacitor below-grade foundations and conduit is 98% complete. Transportation of materials to Whirlwind Substation is ongoing. Bird netting installation over materials and steel continued (see Figure 1).

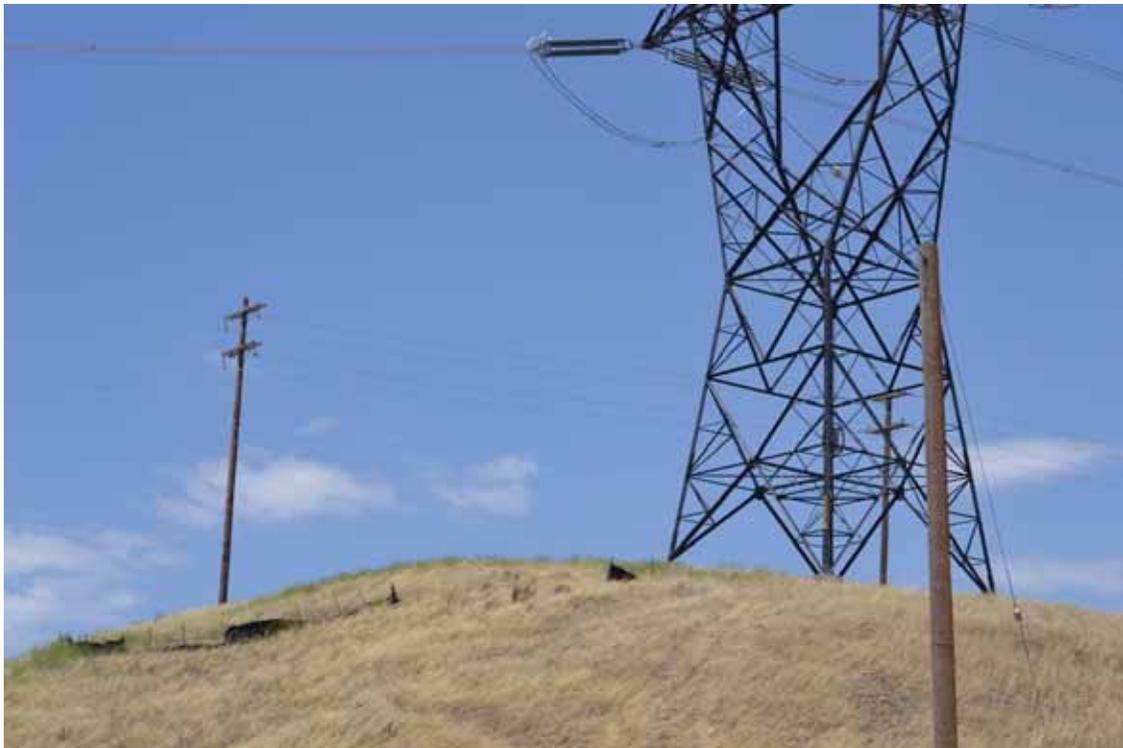
1. BMPs installed during construction of Segment 1 were observed to be in disrepair. SCE has been notified of the location of the damaged silt fencing (see Figure 2).
2. SCE has developed a solution for the channel incision that occurred immediately downstream of the riprapped stream channel at the Windhub Substation site for which an Addendum was approved by the CPUC. SCE is also reviewing the need for a modified Streambed Alteration Agreement for the effort.

Figure 2: Damaged silt fencing surrounding Segment 1 Tower, near Elizabeth Lake Road.

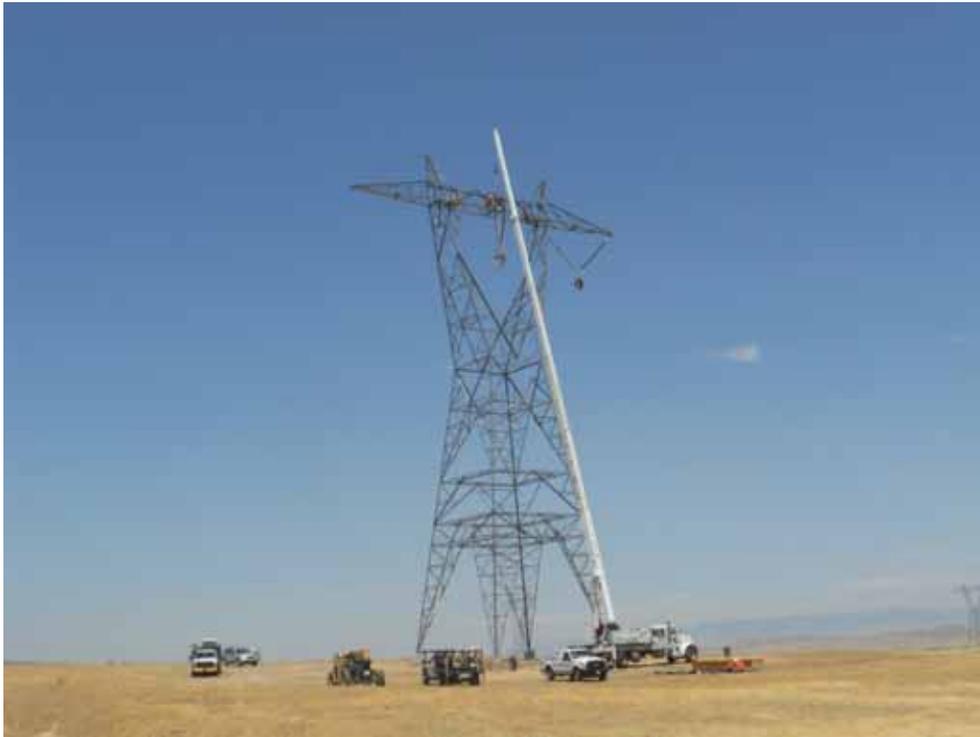
Figure 3: H&M wire crew installing travelers on Tower 49 in preparation for wire stringing, Segment 4.

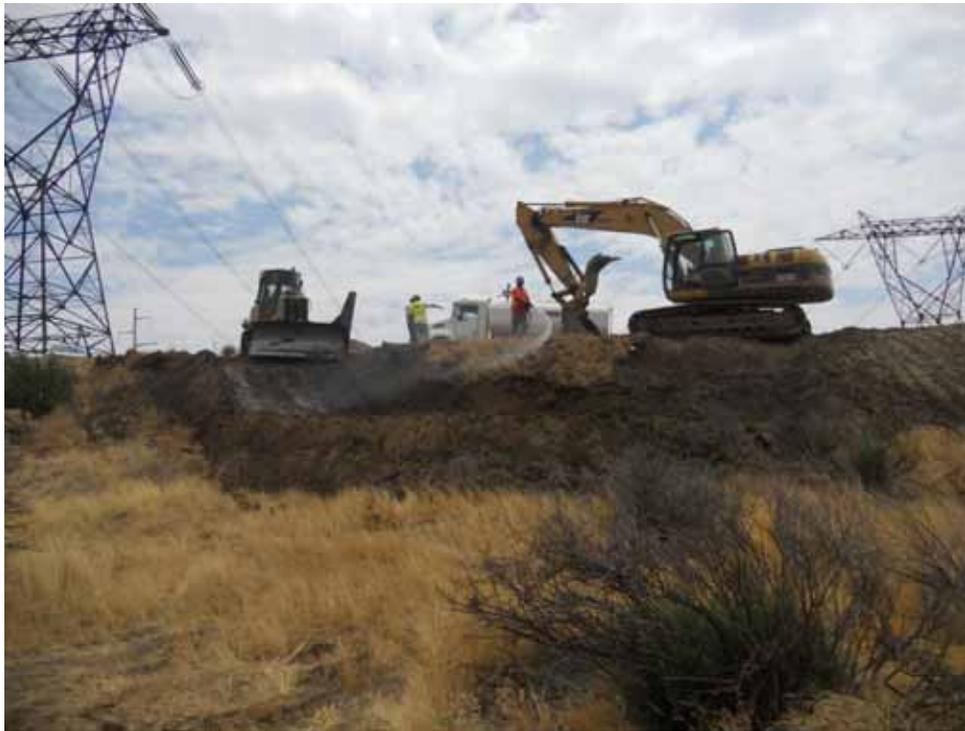
Figure 4: H&H grading crane pad site where cultural resource monitors were present, Segment 5.

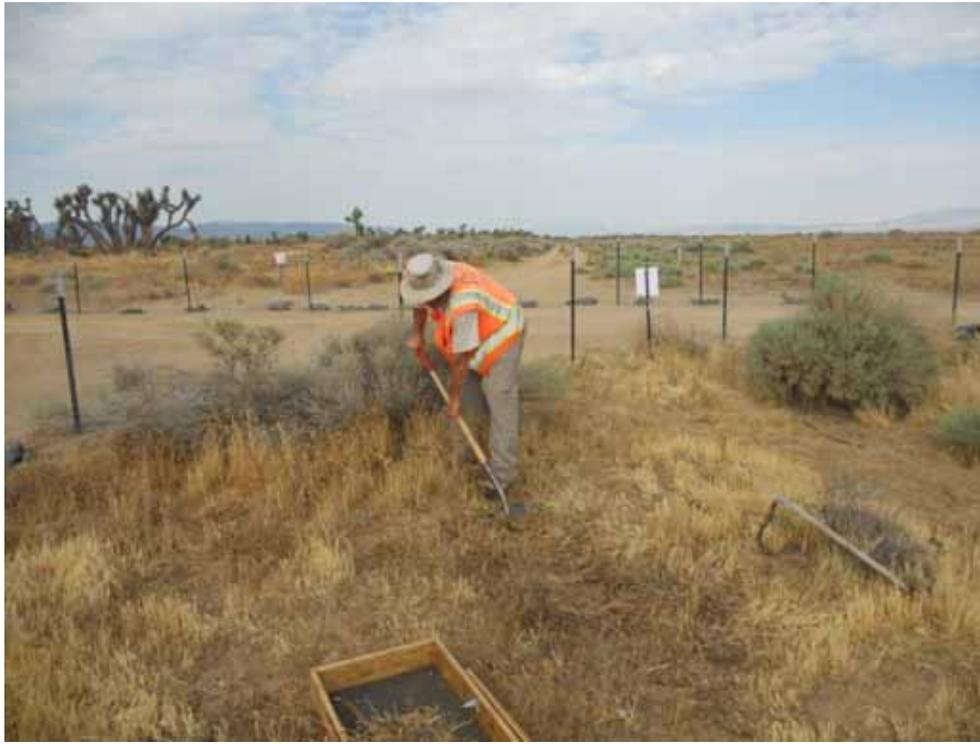
4. Pacific Legacy archaeologists conducted additional testing of a cultural site in the turning radius for an access road on Segment 4 (see Figure 5). The original cultural report will be updated with the new test results and submitted for agency review.

Figure 5: Pacific Legacy archaeologist digging test pit at site along an access road, Segment 4.

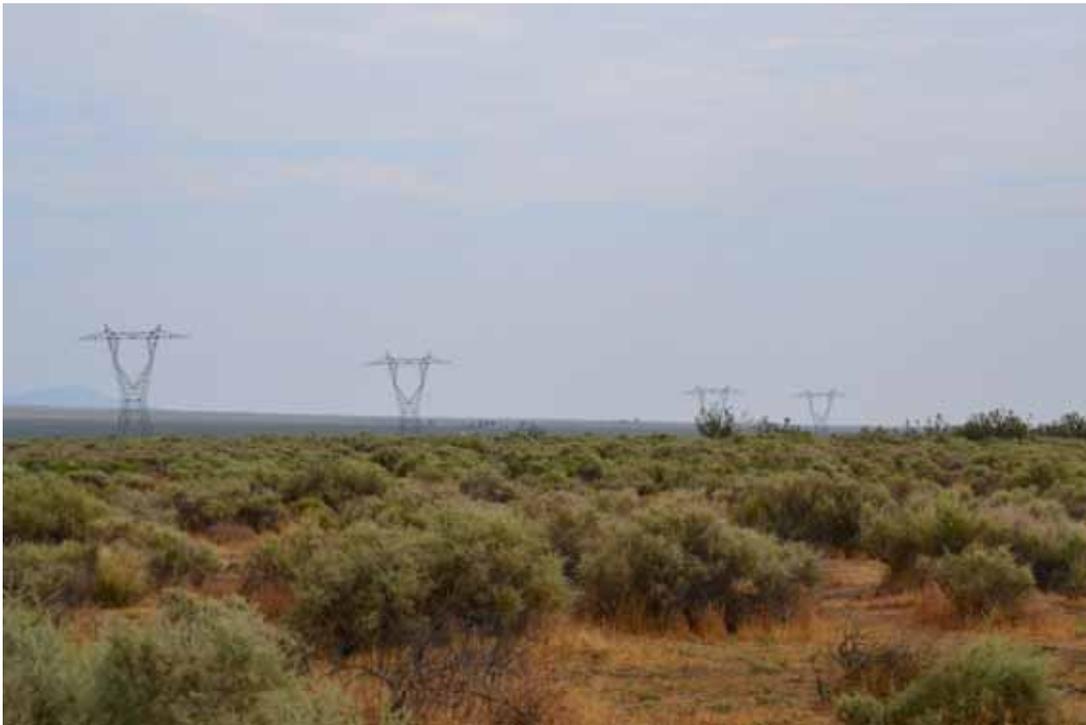
Figure 6: Segment 10 Towers erected in new TRTP right-of-way, Kern County.

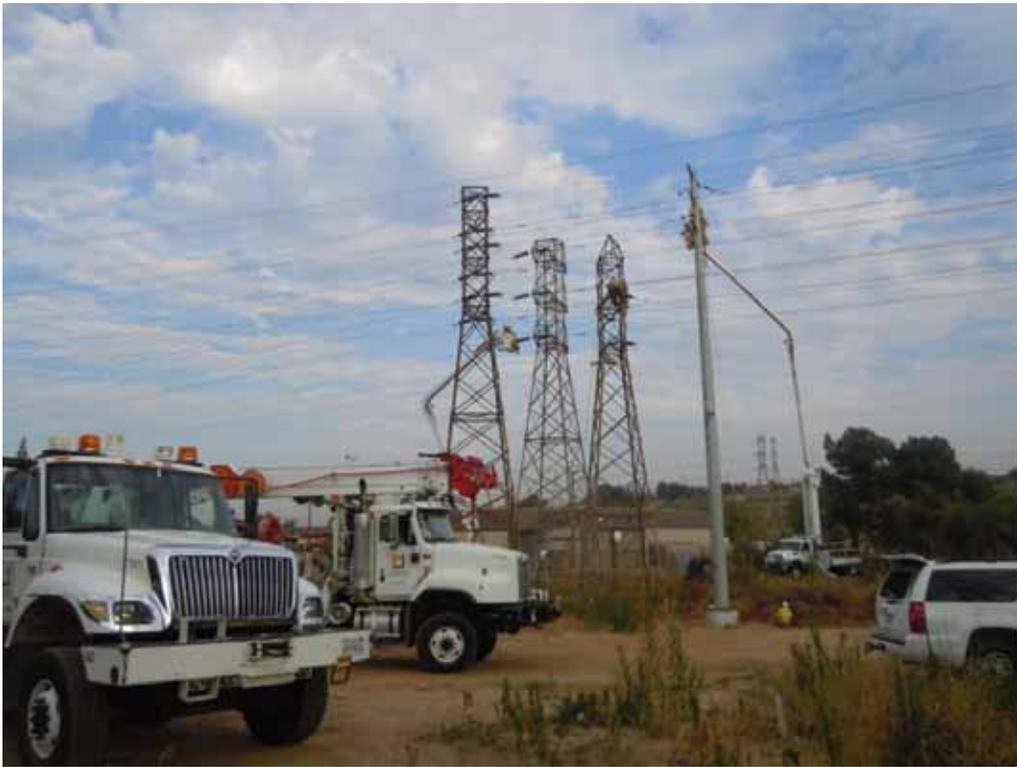
1. Segments 7 & 8, 66 kV: During the subject period, Wilson crews continued worked on the overhead portion of the Rio Hondo-Amador-Jose-Mesa line. Crews continued transferring the 12 kV circuits and the 66 kV circuits and continued drilling foundations for tubular steel poles (TSPs) on the west side of Interstate 605 (I-605) on USACE land. SCE crews continued pulling conduit along Durfee Avenue in the City of South El Monte and continued pulling conduit on the Rio Hondo-Anita No. 2/Rio Hondo-Amador lines west of the I-605 freeway. Additionally, SCE crews continued setting TSPs and stringing wire on the Rio Hondo-Amador-Jose-Mesa line behind Mesa Substation (see Figure 7). These crews began working extended hours, starting at 5:30 a.m.

Figure 7: SCE crews work on a newly installed lightweight steel pole, Segment 7 66 kV.

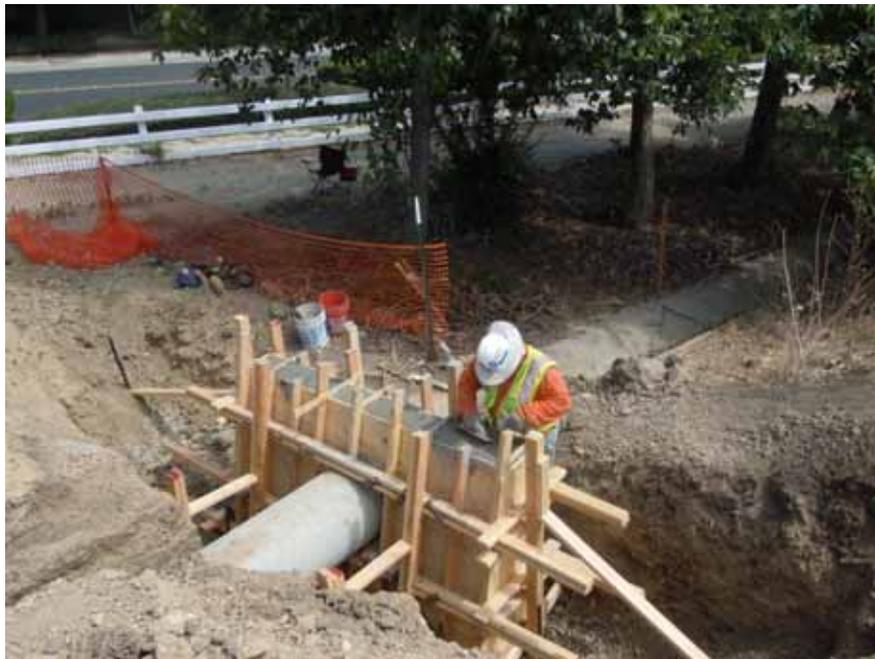
3. Segment 8, Phase 1: Wilson crews mowed and installed BMPs at tower sites and wire setup sites to keep environmental surveys active. DCX finished grading and installed a headwall at Tower M61-T1 (see Figure 8). No tower construction occurred in Tonner Canyon, City of Industry, due to biological resource restrictions (see #1 below).

Figure 8: DCX installs a head wall, Segment 8, Phase 1.

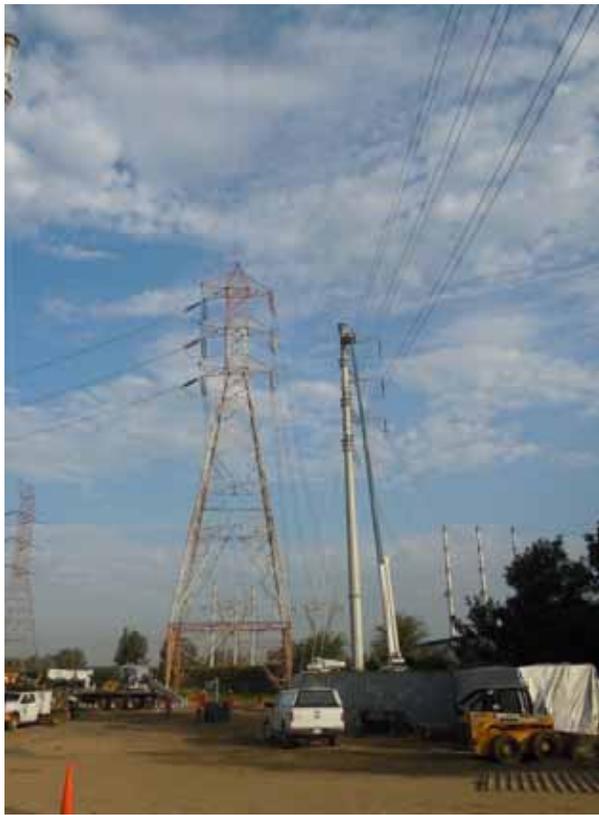
6. Segment 8, Phase 4: DCX continued drilling at one tower location. Wilson crews continued work at the I-605 Shoofly, stringing conductor across the I-605, wrecking out towers and installing three Shoofly poles (see Figure 9).

Figure 9: Crews string a shoofly pole at the I-605 shoofly, Segment 8 Phase 4.

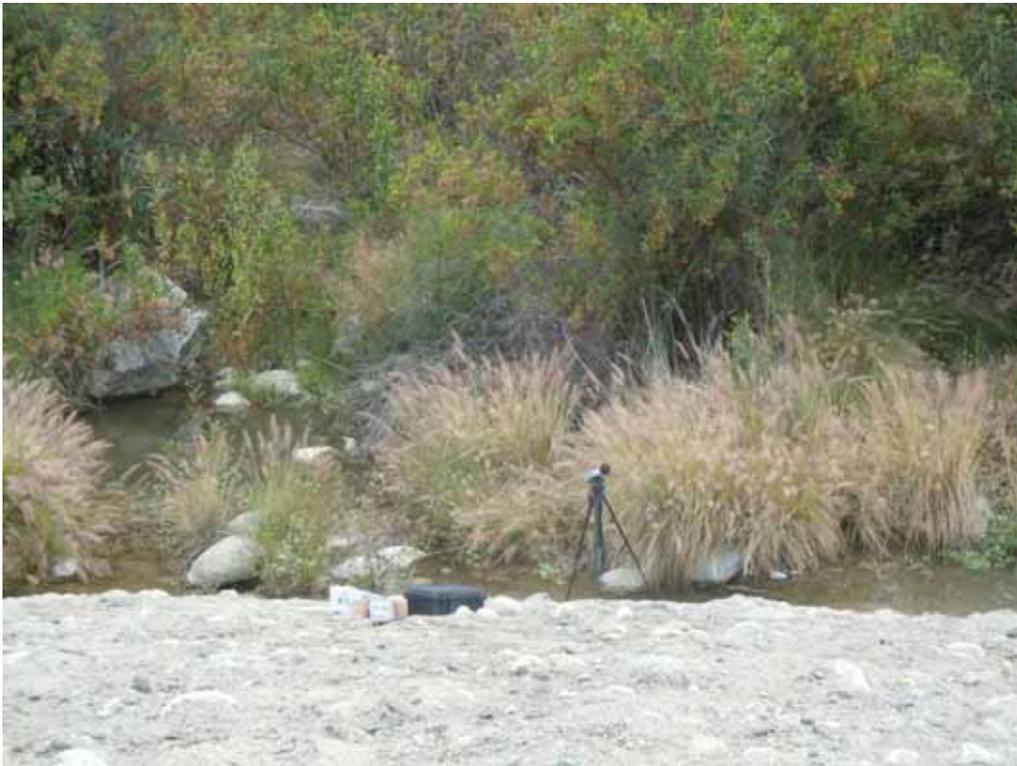
3. ICF Biologists continue to monitor construction noise adjacent to least Bell's vireo and coastal California gnatcatcher nests (see Figure 10). Per the USFWS Biological Opinion, construction noise shall not exceed 60 decibels. The ICF Biologists also monitor the birds for signs of distress and harassment caused by construction activity.

Figure 10: Sound monitoring equipment adjacent to a least Bell's vireo nest on the San Gabriel River, Segment 7.
